# POST-FAILURE BEHAVIOR OF 2-PLY LAMINATED GLASS PLATES WITH DIFFERENT INTERLAYERS

Luigi Biolzi, Sara Cattaneo, Marco Simoncelli

<sup>1</sup> Department of Architecture, Built Environment and Construction Engineering  
Politecnico di Milano, Milano-Italy

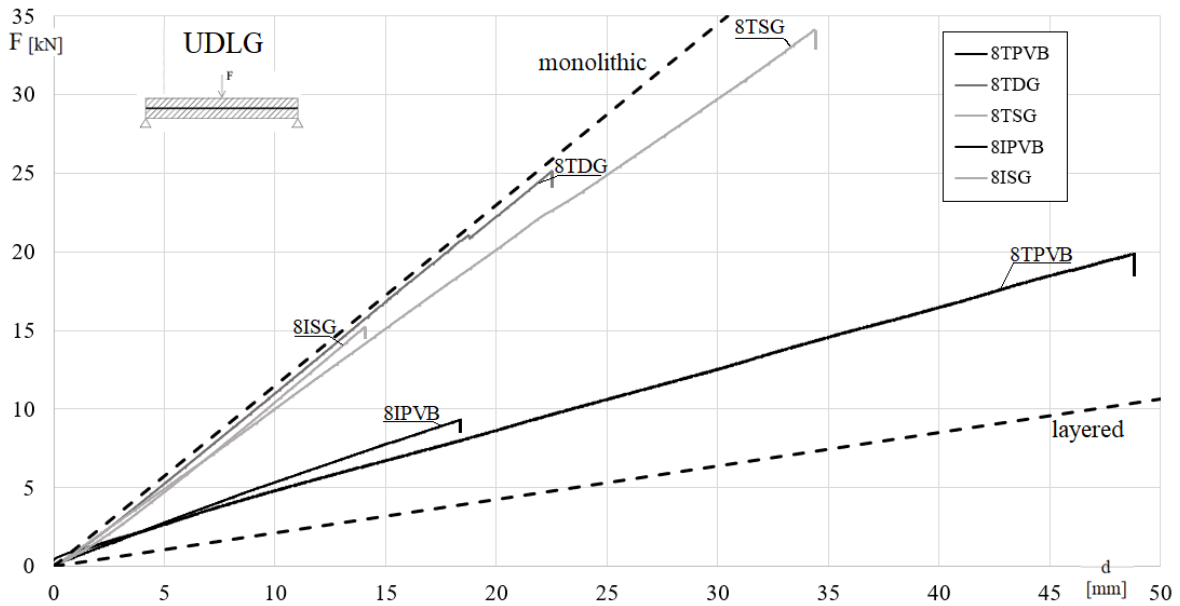
A direct comparison of the response of UDLG specimens is also proposed in Fig. 7. It can be concluded that:

- LG specimens with same interlayer type (and thickness) but with different glass types, have approximatively the same elastic behavior, i.e. same slope of the force-displacement curve. The specimens made by toughened glass (I-type) reached lower breakage load;
- the influence of the interlayer thickness on the UDLG behavior can be appreciated by comparing 8TSG with the 8ISG case. Increasing SG thickness, the stiffness of the LG plates

- direct comparison can be made between PVB and DG41 interlayer by comparing 8TPVB with 8TDG. The higher stiffness of DG41 interlayer led to a failure load 1.4 times greater and to a slope which is almost 3 times greater;
- upper and bottom dashed black lines represent the theoretical upper and the lower bounds of LG plates behavior: if the interlayer is sufficiently stiff the behavior of the plate is equivalent to a unique *monolithic* glass plate; otherwise, if the film is too deformable is not able to avoid the relative sliding of the glass plies (*layered* response). It is confirmed that plates with PVB behave close to the layered limit while the other plates are close to the monolithic limit.

Figure 7. Comparison between the results obtained on UDLG specimens

The pre-breakage behavior presented in Fig. 7, can be predicted by using the well-known Enhanced Effective Thickness (EET) method [5,10]. Starting from the definition of the number of layers, type of interlayer, geometry of the specimen and the boundary conditions, equivalent thickness were estimated that were used in the determination of displacements and/or normal stresses. In particular, the considered cases should be assumed equivalent as a simply supported beam with a concentrated load in the middle. Therefore, the maximum bending moment ( $M_{max}$ ) and displacement ( $\delta_{max}$ ) are defined as:

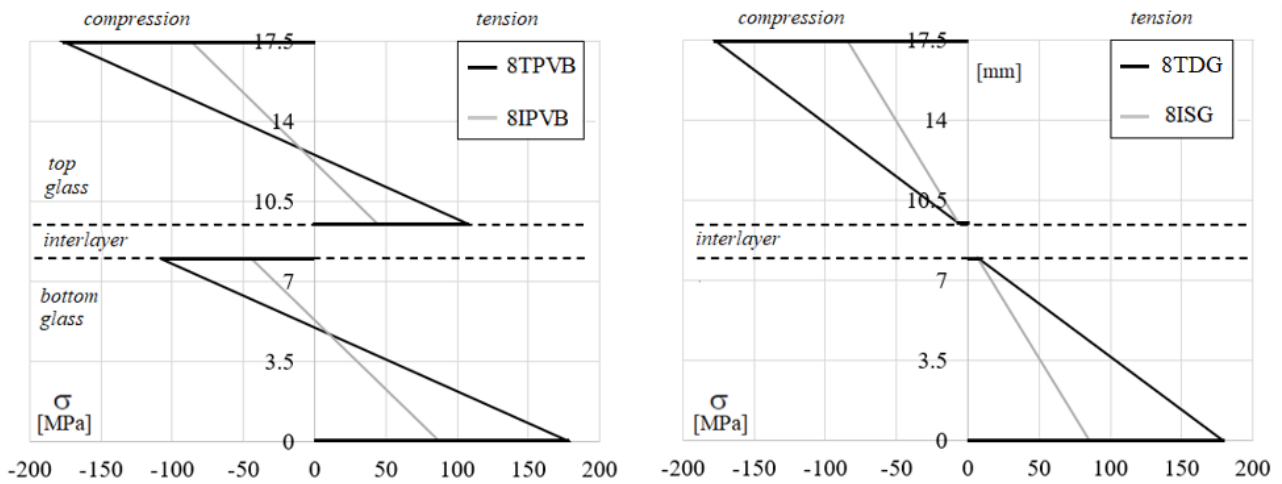
Figure 8. Normal stresses distribution in the considered specimens.

The normal stresses distribution confirms once again that specimens with PVB as interlayer behave close to a layered plates while with the stiffer interlayer the behavior became monolithic. The maximum stress located on the outer face in the bottom glass of the tempered glass (178 MPa) is almost 2 times greater than the one in toughened glass (87 MPa).

Finally, a simple analytic model is proposed for 8TSG specimen in Fig. 15, starting from the UDLG case till the global collapse. As reported in Fig. 8 normal stresses distribution is close to the typical ones of monolithic plates.

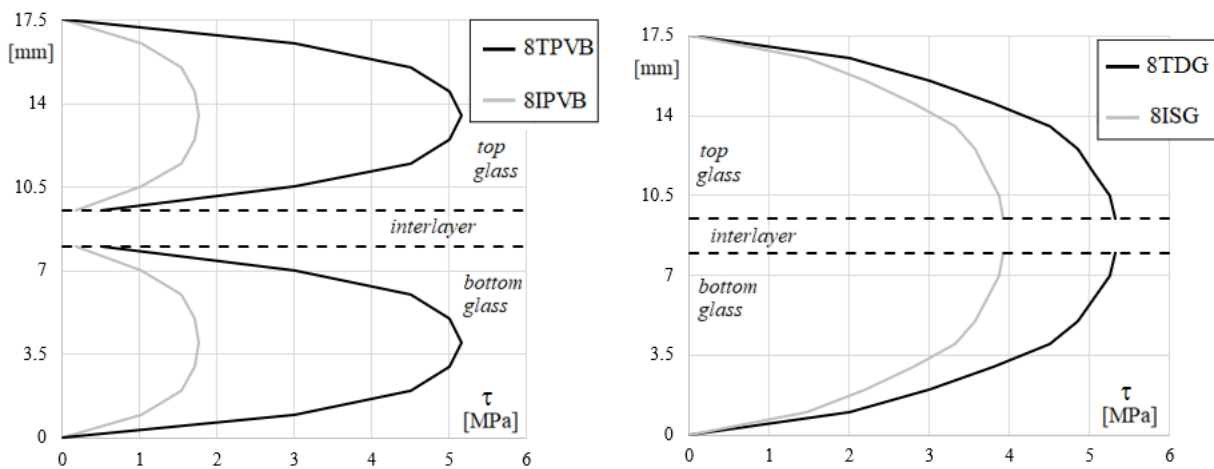
Focusing attention on shear stresses (Fig. 9), when a stiff interlayer is considered the distribution in the glass plies is the typical parabolic one, which is generally associated to monolithic cross-sections. On the contrary, when PVB interlayer is considered, shear stresses follow two separate paraboles which became almost zero close to the interlayer.

Figure 9. Shear stresses distribution in the considered specimens.

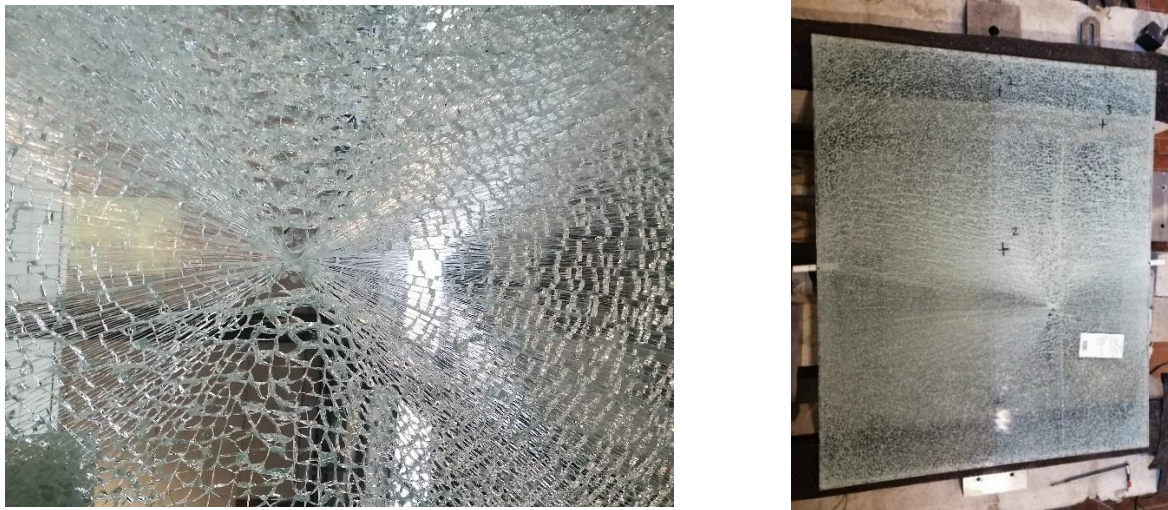
In Fig. 10, a view of a damaged ply of glass after the breakage, reached in configuration 0, is reported for the specimen 8TPVB. A zoom on the initial propagation of the crack from the loaded zone is proposed. As a comparison of the influence of the tempering process on the crack path, in Fig. 11 the damaged ply of glass for 8IPVB specimen is reported too. As expected, tempered glass ply breaks into a great number of small pieces (Fig. 10) while the non-tempered one (Fig. 11) was characterized by small pieces around the collapse zone which became greater and greater moving away from the

middle region. It should be remarked that the glass failure origin was always located in the central part of the plates revealing that the glass ply edges were adequately grinded and polished.

*Figure 10. Damaged bottom ply glass for 8TPVB specimen.*

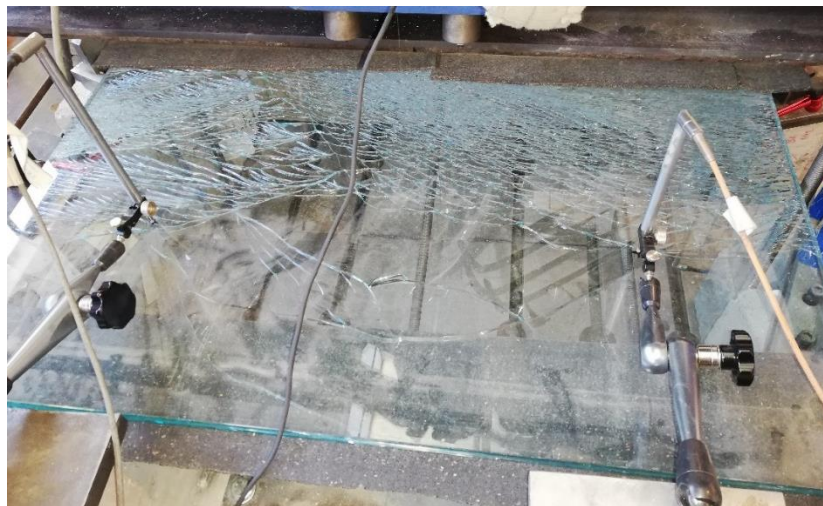
*Figure 11. Damaged bottom ply glass for 8IPVB specimen.*

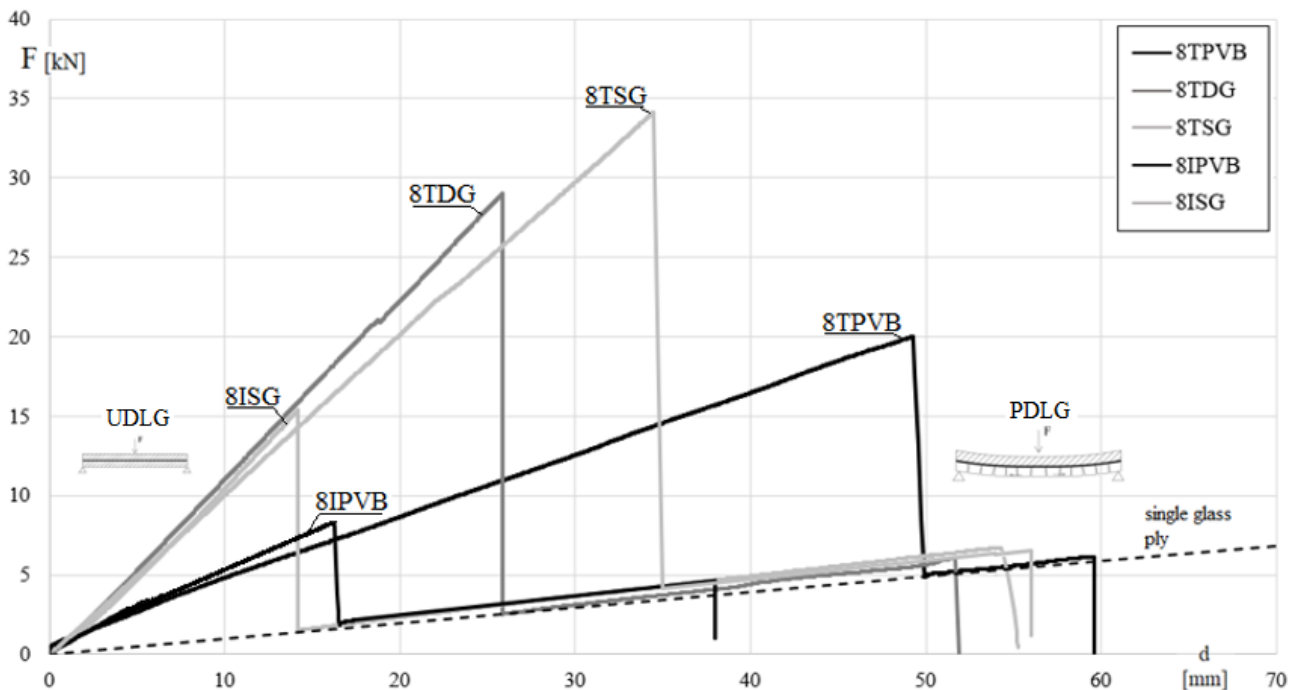
The complete force-displacement curve with the load increased until the total collapse is reported in Fig. 14.

Figure 14. Specimens behavior on configuration 0 and I.

The LG stiffness with the bottom ply cracked was greatly reduced with respect to the UDLG case. From an engineering standpoint, the first breakage of the bottom ply could be intended as an ultimate limit state (ULS) while when both plies crack, a collapse limit state (CLS) is identified. Independently

of the type of glass (T or I) plates with PVB always showed a limited capacity between ULS and CLS identifying a low reliability. On the contrary plates with DG41 and SG showed a great deformability capacity before the CLS. In the same Fig. 14, with the dashed black line is reported the theoretical force-displacement response of a plate consisting of only one, 8mm, glass ply. It can be noted that for all the specimens, the slope of the post-breakage branch is never coincident with the dashed one. In fact, despite the bottom ply being completely cracked it still gives a non-negligible contribution on the global stiffness. This contribution is the so-called *tension stiffening* and mainly depends on two factors:

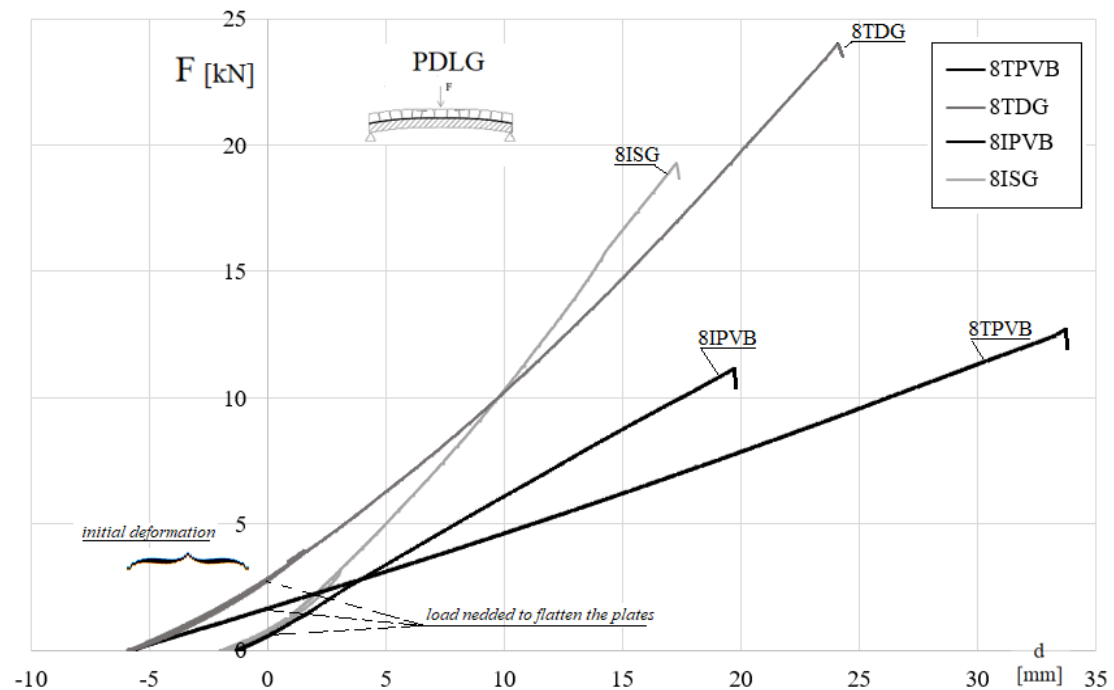
In Fig. 18 a direct comparison between the response of the considered specimens is reported. Due to the initial deformed shape, an initial load is needed to flatten the LG plate and hence brings to nil deformations. The toughened specimens were characterized by a lower initial deformation than the tempered ones. All the specimens are characterized by an initial non-linear behavior, due to the transition phase in which the glass fragments tend to fill the internal gap generated after the fracture. Once this gap is filled the behavior of the PDLG became quite linear until the final collapse.

Figure 18. Comparison between the results on PDLG specimens with top ply damaged.

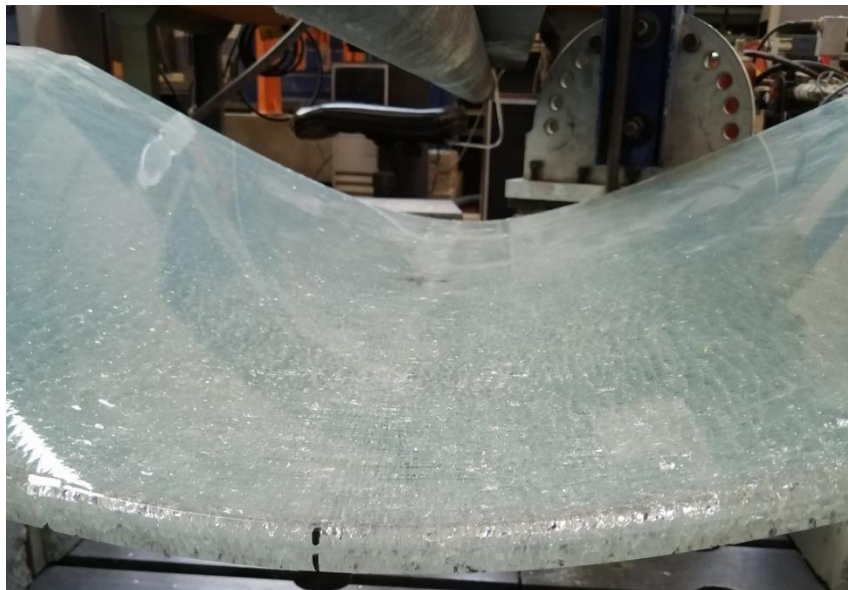
Figure 20. Global failure of 8TPVB specimen after tests in configuration II.
