# Cyclic behavior of masonry walls retrofitted with post-installed twisted bars or bonded rebars

S. Cattaneo<sup>a,b,\*</sup>, P. Crespi<sup>a</sup>, M. Scamardo<sup>a</sup>, N. Vafa<sup>a</sup>

<sup>a</sup> ABC Department, Politecnico di Milano, Italy

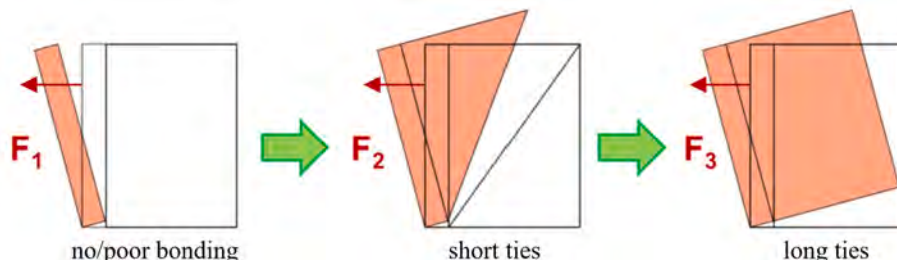
Fig. 2. Possible failure mechanisms.

Young Modulus 122 GPa) were screwed in pre-drilled holes. The number of twisted bars was evaluated with the intention to increase the horizontal force from  $F_1$  (Fig. 2), associated to the detachment of the front wall from the rear one, up to the force  $F_3$  associated to the overturning of the whole structure. Considering the walls as located at the ground floor of a hypothetical three stories masonry building, a vertical prestress of about 0.2 MPa was assumed acting on top of the walls. By imposing the equilibrium of the structure, the theoretical forces  $F_1$ ,  $F_2$  and  $F_3$  resulted in 10 kN, 45 kN and 50 kN, respectively.

Three possible failure configurations (Fig. 2) were examined to design the reinforcement, considering that the bond pattern between the

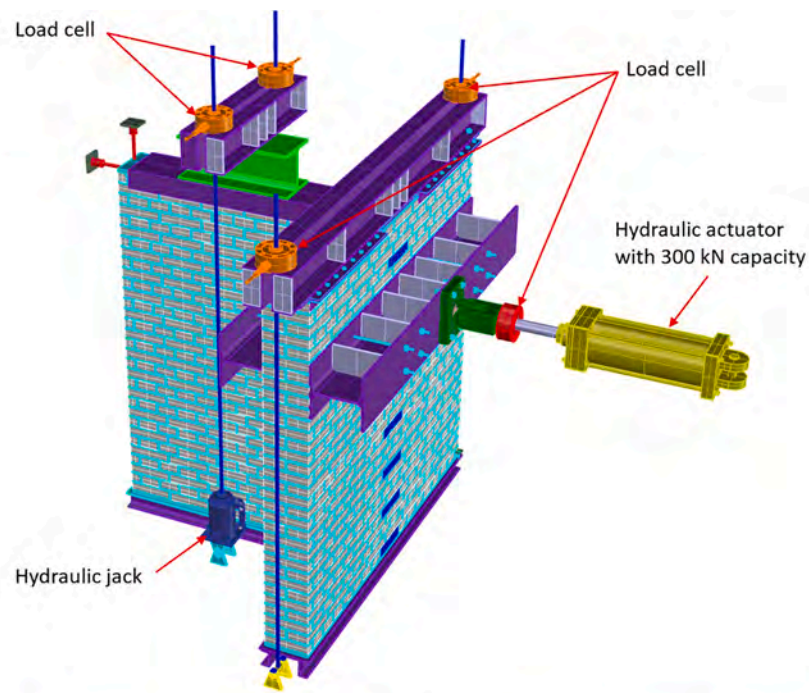
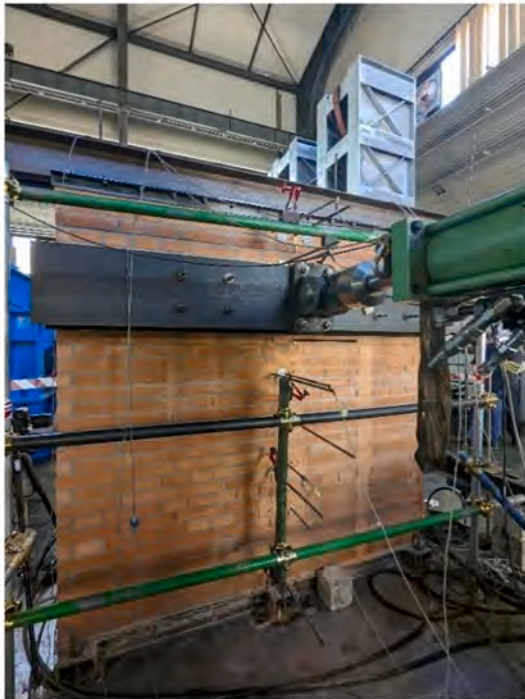
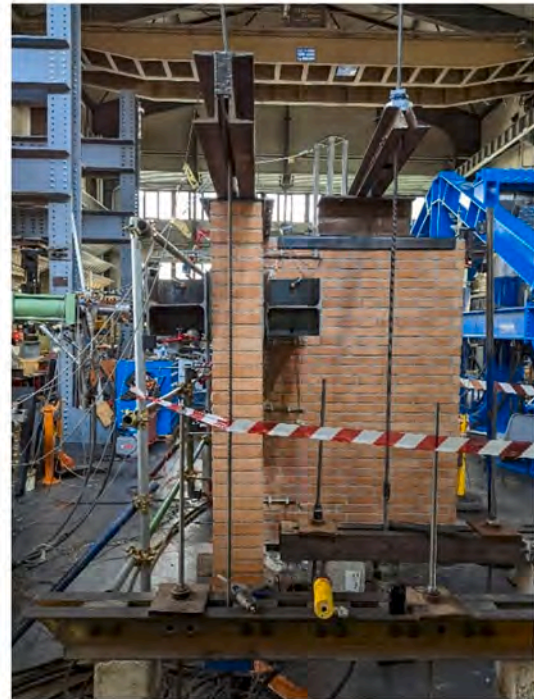
Fig. 4. Sketch of test set-up (a), front (b) and side (c) view.

A servo-hydraulic actuator with capacity of 300 kN (Fig. 4a) was located at the height of 172 cm above the floor to apply the horizontal load on the front wall. This measure was selected to maximize the lever arm of the horizontal load with respect to the ground and to fit the reaction frame of the laboratory, given the height of the specimen (211 cm). The point load was distributed along the width of the wall by means of a horizontal steel beam connected to the jack (Fig. 4b). Two additional horizontal steel beams, placed on the back side of the front wall (Fig. 4c), were connected to the front beam by mean of threaded rods to

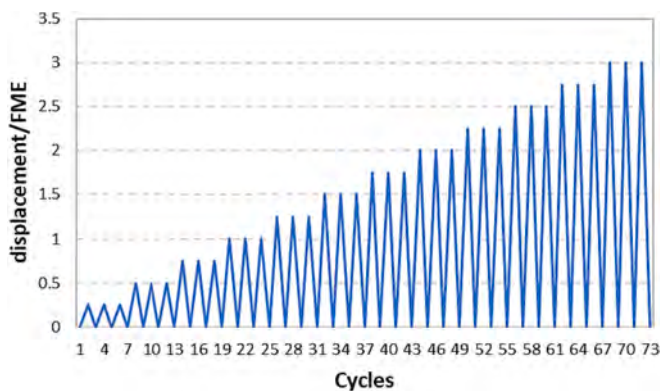
Fig. 6. Test protocol.

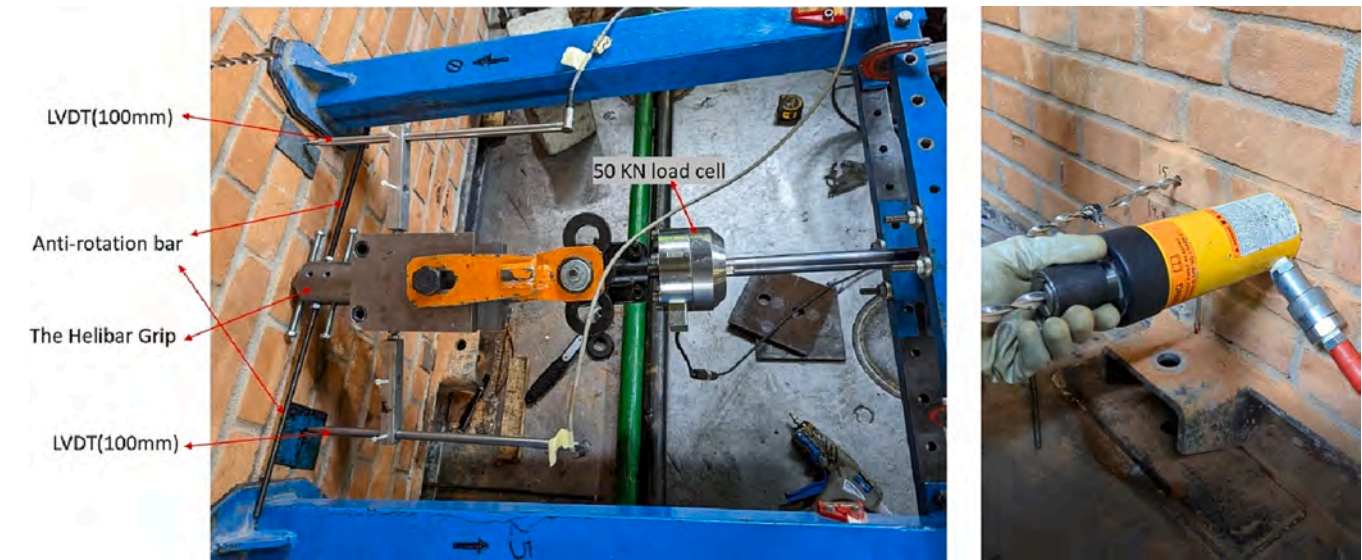
Fig. 7. Twisted bar pull-out test equipment.

Once the specimen was unloaded, the twisted bars were pulled out with a hydraulic jack and the residual resistance was measured via a load-cell of 50 kN capacity. The displacement of the twisted bar was measured by two LVDT's with 100 mm gauge length, as depicted in Fig. 7 (left). The test was performed unconfined to evaluate the peak load. After that, due to the deep embedment length (85 cm), a hydraulic hollow jack was used to completely extract the bar in a confined setup (Fig. 7, right).

After the full-scale tests, all twisted bars were loaded in a residual pulled-out test according to the procedure described in §2.4 (Fig. 7), and still exhibited a good ductility as shown in Fig. 13. The mean pull-out loads were 7.43 kN (coefficient of variation 9.8 %) and 6.73 kN (coefficient of variation 10.7 %) on specimen W1 and W2, respectively.

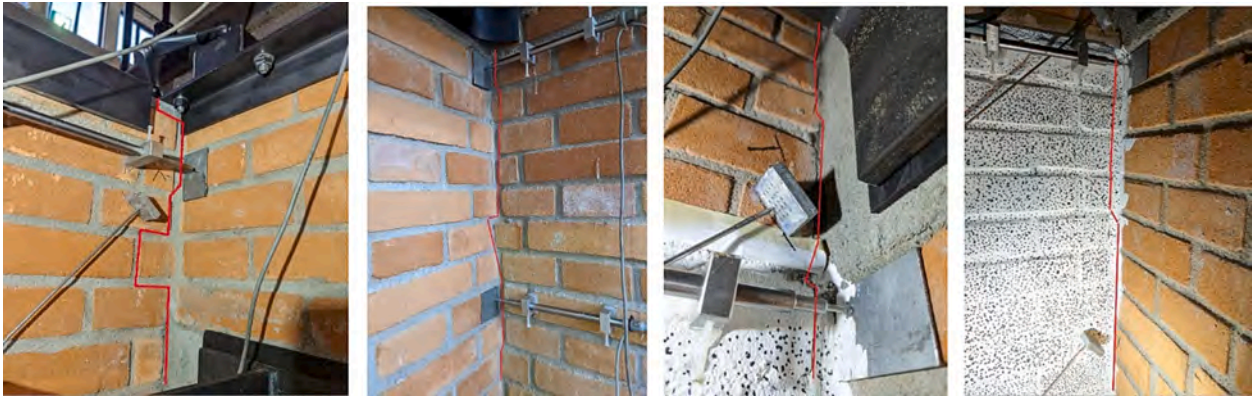
Fig. 8. Details of the crack between the front and the rear wall.

The specimens were subjected to a monotonically increasing displacement (0.03 mm/s) until the first crack was detected. Both specimens showed similar behavior with a crack at the intersection between the front and the rear wall, visible on both sides of the wall, and running from the top of the specimen down to about 50 cm from the bottom of the wall (Fig. 8).

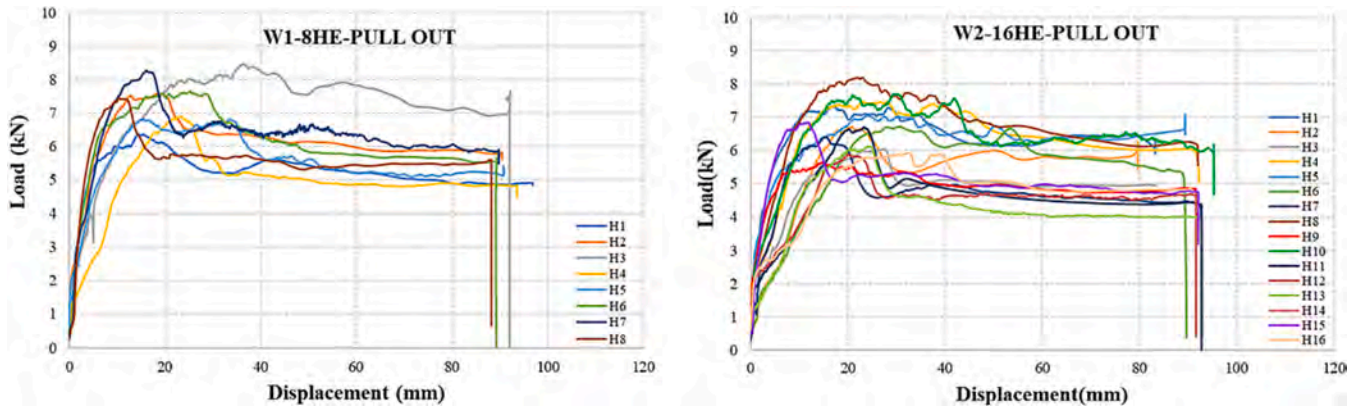
Fig. 13. Residual pull-out tests on twisted bars (first and second wall).

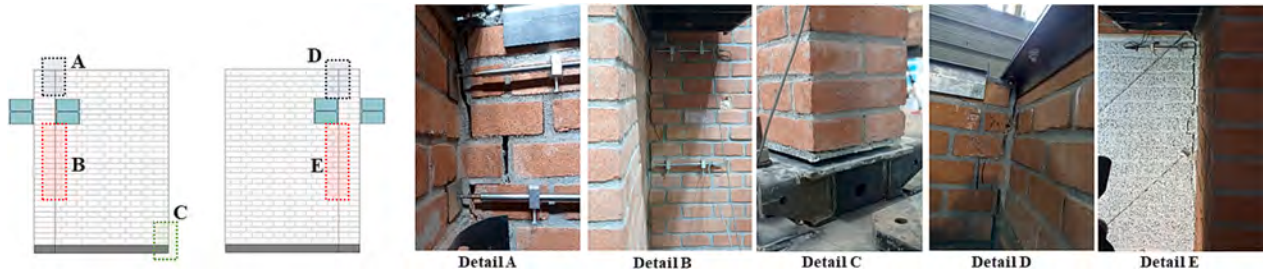
Fig. 14. Crack pattern after cycles and uplift of rear part (specimen W1).

After the cyclic tests with the twisted bars, both specimens were retrofitted with 8 post-installed rebars using adhesive, as described in section §2.2 (see Fig. 3a). The final failure crack pattern in both tests was similar, featuring very large cracks with the uplifting of both specimens when the horizontal load reached about 50 kN (Fig. 14), thanks to the ability of this type of connection to achieve a perfect box-like behavior.

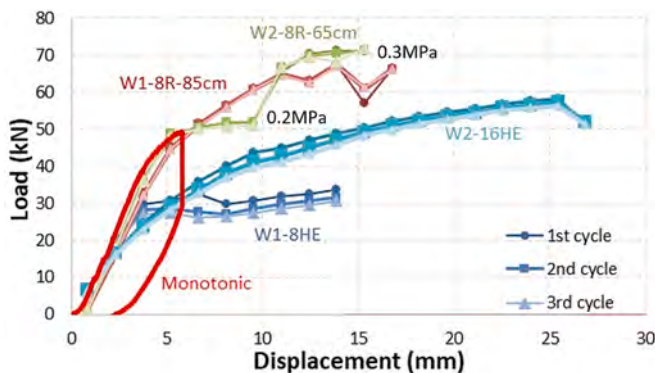
Fig. 17. Envelope load-displacement curves for each cycle vs. monotonic test.

comparing the envelope curves (Fig. 17) of the first (dot), second (square) and third (triangle) cycles within a test series, it can be noted that they are very close. This behavior was already observed by Cattaneo et al. [35] in tension cyclic tests on single bars, and it is probably due to the load transfer mechanism which is governed by the shape of the bar and by the characteristic of the base material.

From the comparison between the cyclic and monotonic test results (Fig. 17), it is interesting to observe that the specimen retrofitted with 8

twisted bars (poor design) was not able to restore the initial capacity of the wall, as expected, while 16 twisted bars (correct design) allowed to improve the initial strength by almost 20 %, with high dissipation and large displacements.

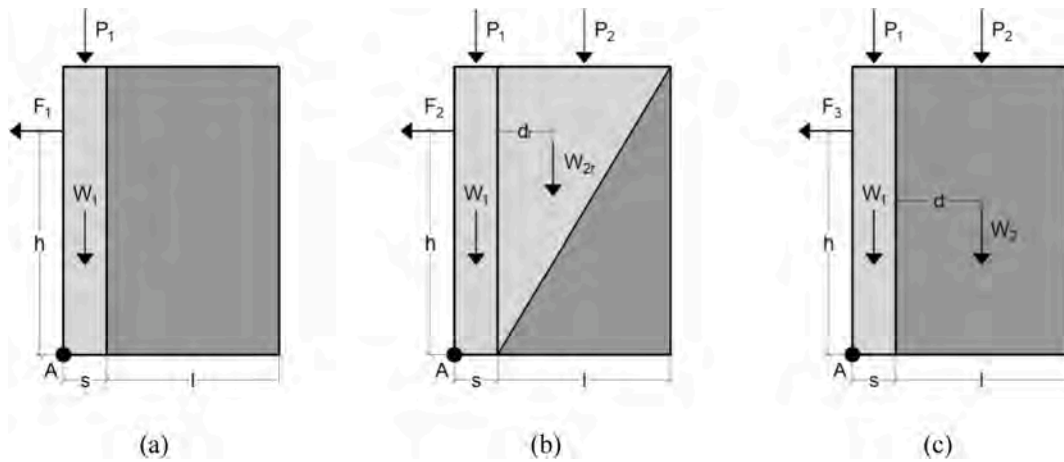
Fig. 18. Failure mechanisms.

reinforcement and were used to evaluate the necessary number of twisted bars. One is associated to short ties ( $F_2$  of about 45 kN, Fig. 18b), and the other to long ties ( $F_3$  of about 50 kN, Fig. 18c). To achieve the overturning of the whole structure, the connecting bars should be able to sustain the load  $F_3$ - $F_1$ . In the case of twisted bars, the minimum number of required bars was 15, accounting for a design strength of 3 kN for each

This behavior can be easily explained by imposing the overturning equilibrium of all the loads acting on the walls. In this regard, the sketches of Fig. 18 show the specimen accounting of possible failure mechanisms with the involved loads and lever arms. The walls are subjected to the external horizontal force  $F$  as well as to their self-weight and to the weight of the steel beams, namely  $W_1$  for the front wall (equal to 23.15 kN),  $W_2$  for the back wall (equal to about 14 kN, with a slight difference in the two specimens), and to the vertical prestress  $P_1$  (front load) and  $P_2$  (rear load). In the case of “triangular” failure the self-weight of the rear wall is reduced to  $W_{2r}$ .

By imposing the rocking equilibrium with respect to the point A, the equilibrium load, in the three possible failure configurations, results:

$$F_1 = \frac{(W_1 + P_1) \cdot \frac{s}{2}}{h} \quad (1)$$

$$F_2 = \frac{(W_1 + P_1) \cdot \frac{s}{2} + W_{2r} \cdot \left(s + \frac{l}{3}\right) + P_2 \cdot (s + d)}{h} \quad (2)$$

$$F_3 = P_{eq} = \frac{(W_1 + P_1) \cdot \frac{s}{2} + W_2 \cdot \left(s + \frac{l}{2}\right) + P_2 \cdot (s + d)}{h} \quad (3)$$

where  $s$  is the thickness of the front wall (25 cm),  $l$  is the length of the back wall (137 cm),  $d$  is the distance between the back of the front wall and the axis of application of the vertical prestress  $P_2$  (equal to 69 cm for specimen W1 and to 71 cm for specimen W2), and  $h$  is the height of application of the horizontal load from the strong floor (1.72 m).
