IMPACT TOLERANCE OF CERAMIC MATRIX COMPOSITES FOR AEROSPACE APPLICATIONS

Ceramic Matrix Composites (CMCs) guarantee the right balance of stiffness, strength, temperature and oxidation resistance to be the best choice for hot structure of reusable space vehicles. Nowadays specific design approach for aerospace CMCs are not fully developed. The aim of this study is to define a methodological procedure to assess the damage tolerance of a C/SiC CMC in the case of low-energy impacts. For this reason, in the first part of this work, a low-energy impact testing campaign was performed on beam and plate specimens with the aim of determine the threshold energy that causes a Barely Visible Impact Damage (BVID), which is a damage that is hardly detectable during the inspections. In the second part of the work, the effectiveness of different tests in evaluating the specimen's residual strength was assessed. Firstly, Compression After Impact (CAI) test was tried, showing that it is not effective on CMCs, which are stiff and particularly resistant to compression. Then, flexural testing was tried, first on specimens cut out from the panels, then on the entire panels. A Computed Tomography (CT) sc

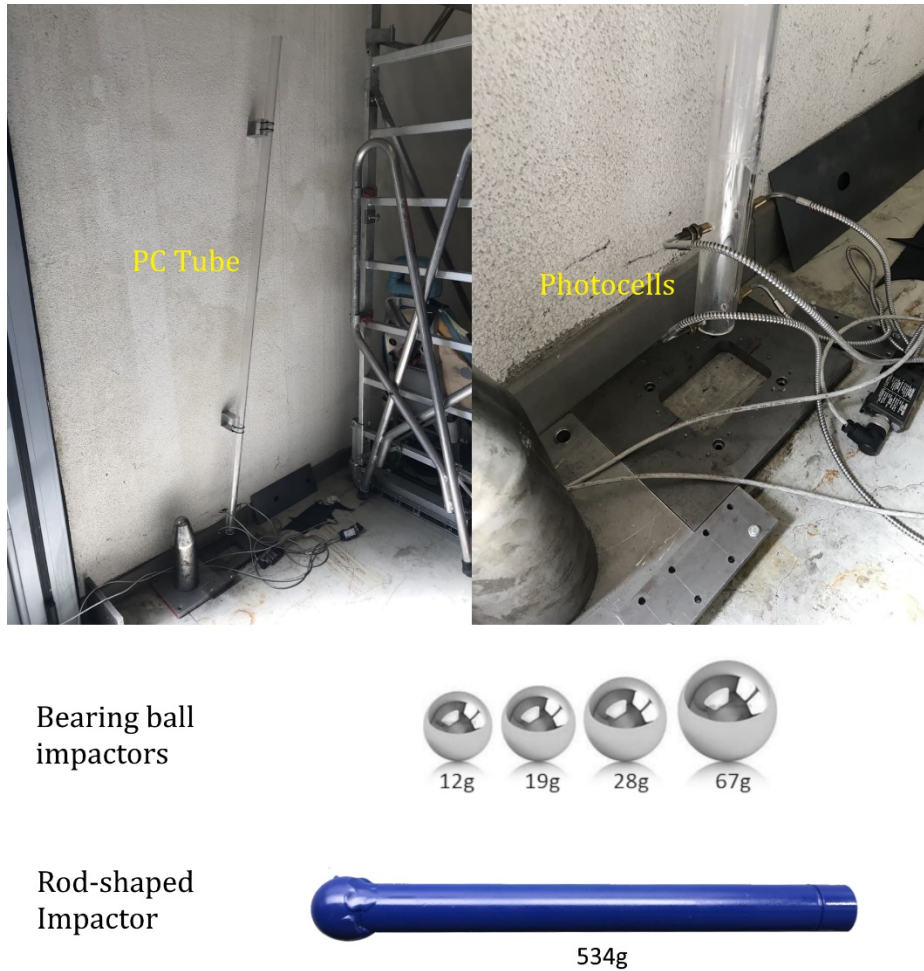
Figure 1: Low-energy impact experimental setup. Details of the polycarbonate tube equipped with photocells and the two types of impactors used, with their masses.

A custom low-energy impact facility was built to test the C/SiC specimens. It consists of a polycarbonate (PC) tube with a diameter of about 40 mm, vertically fixed to a wall, in which the impactors were dropped. At the end of the tube, on the floor, the different specimens' fixtures were placed. To avoid secondary impacts, the PC tube is tilted at an angle of 15° in the plane of the wall to which it is fixed. In this way, the impactor hits the specimens with a certain angle, and rebounds away. A picture of the testing setup is shown in Figure 1. The first kind of impactor used was steel bearing ball with different diameters. Then, to increase the impactor mass without modifying the setup, a rod-shaped impactor was built by soldering a steel bar to one of the previous bearing balls. A picture of the impactors is shown in Figure 1.

To have a reliable measurement of the impact energy, two photocells were mounted at the outlet of the tube, 10 mm apart. Their signal, acquired at 12.5 kHz, was used to determine the exit velocity of the impactors. At the same time, a high-speed camera was used to capture the images of the impact. It was placed on the floor, pointing normally to the wall to which the tube is fixed, and it was used to verify the accuracy of the impact.

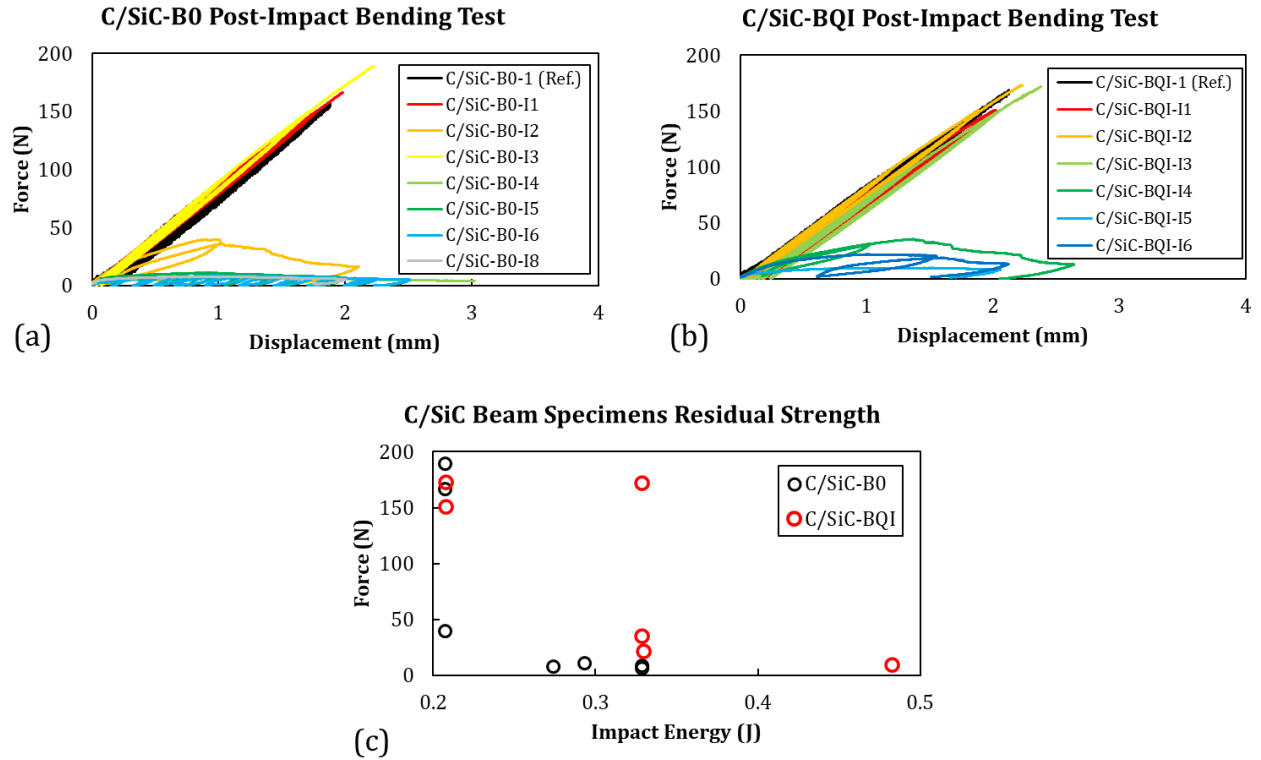
Figure 4: Post-impact bending on C/SiC beam specimens: (a) C/SiC-B0 and (b) C/SiC-BQI flexural curves, and (c) residual flexural strength as a function of impact energy.

All the specimens, except the one broken during the impact, were tested in three-point bending, using a span of 128 mm between the cylindrical supports, which have a diameter of 15 mm. An imposed velocity of 1 mm/min was used. All the curves are reported in Figure 4-a for C/SiC-B0 specimens and in Figure 4-b for C/SiC-BQI specimens. In Figure 4-c the residual strength as a function of the impact energy is plotted. From the graphs, a certain threshold of tolerated impact energy for the two types of specimens can be identified, around 0.2 J for C/SiC-B0 and around 0.33 J for C/SiC-BQI, showing that the presence of 45° oriented plies increases considerably the toughness of the material. Moreover, even if most of the impacted specimens never reached complete failure, the post-impact flexural curves showed almost only two extreme results, a

complete retention of the properties or an almost complete loss.

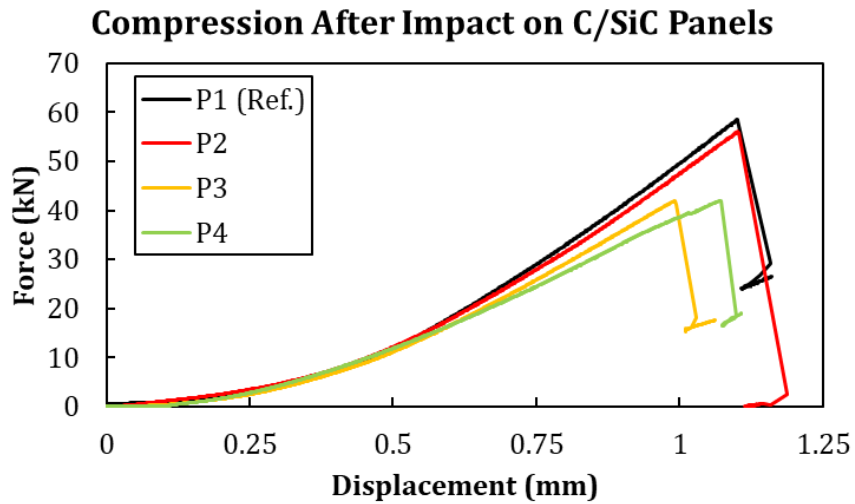
Figure 8: Force/displacement curves of Compression After Impact test of impacted C/SiC plates.

The force/displacement curve is reported in Figure 9. The indented panels showed a reduction in strength of about 30% compared to the reference test and to the BVID one. Nonetheless, this technique showed to be not very effective for C/SiC which is particularly resistant to compression, and the failure was never triggered by the impact damage.
