# Comparative pushover and limit analyses on seven masonry churches damaged by the 2012 Emilia-Romagna (Italy) seismic events: Possibilities of non-linear finite elements compared with pre-assigned failure mechanisms

Gabriele Milani \*, Marco Valente

*Department of Architecture, Built Environment & Construction Engineering ABC, Politecnico di Milano, Piazza Leonardo da Vinci 32, 20133 Milan, Italy*

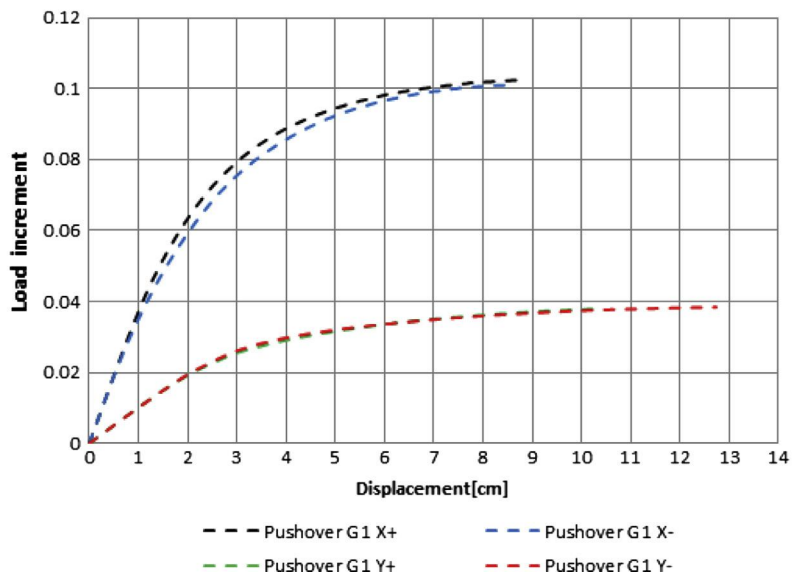
Fig. 18. Church 5, pushover G1 curves and deformed shapes at collapse for G1 distributions X- and Y+.

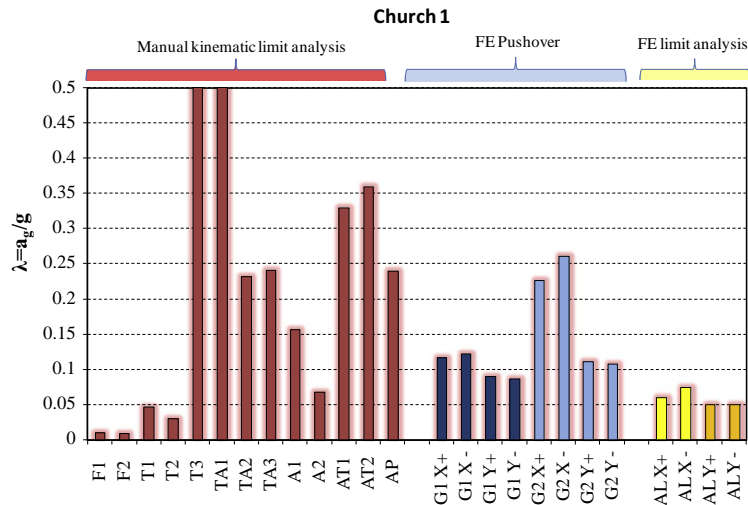
Fig. 28. Church 1. Comparison among the different failure multipliers (representing  $a_g/g$ ) obtained with the different approaches. Red: limit analysis with pre-assigned failure mechanisms. Blue: pushover. Yellow: FE limit analysis. (For interpretation of the references to color in this figure legend, the reader is referred to the web version of this article.)

The resultant horizontal accelerations are summarized in bar graphs reported for each church from Figs. 28–34.

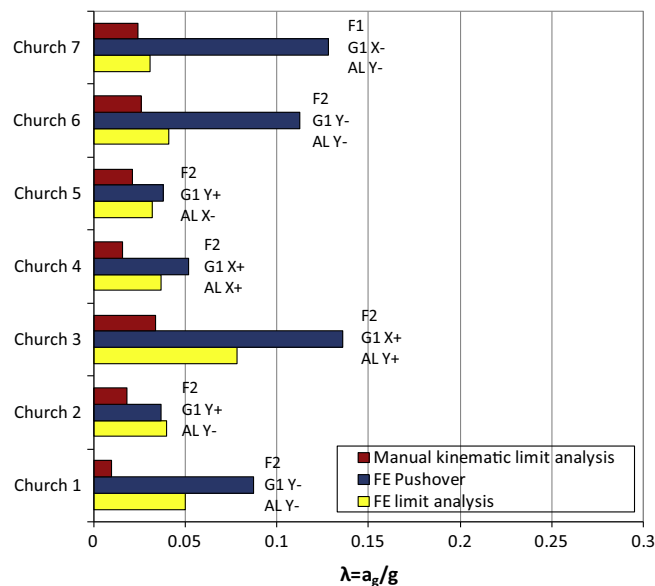
**Fig. 35.** Synopsis of the normalized accelerations at collapse found with the three approaches investigated (at-hand kinematic limit analysis, FE pushover, upper bound FE limit analysis).
