Failure analysis of seven masonry churches severely damaged during the 2012 Emilia-Romagna (Italy) earthquake: Non-linear dynamic analyses vs conventional static approaches

Gabriele Milani*, Marco Valente

Department of Architecture, Built Environment & Construction Engineering ABC, Politecnico di Milano, Piazza Leonardo da Vinci 32, 20133 Milan, Italy

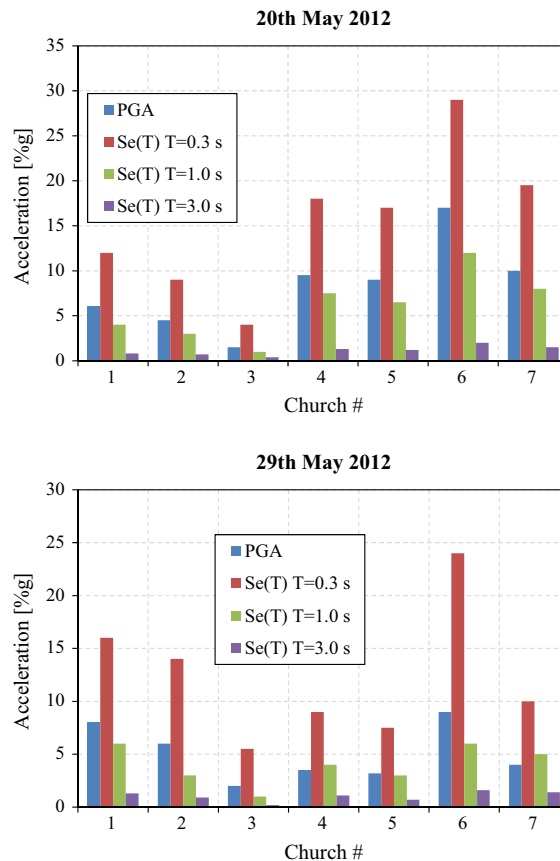
Fig. 2. PGA and spectral accelerations (for three vibration periods of a single-DOF elastic system), 20th and 29th May 2012 seismic events.

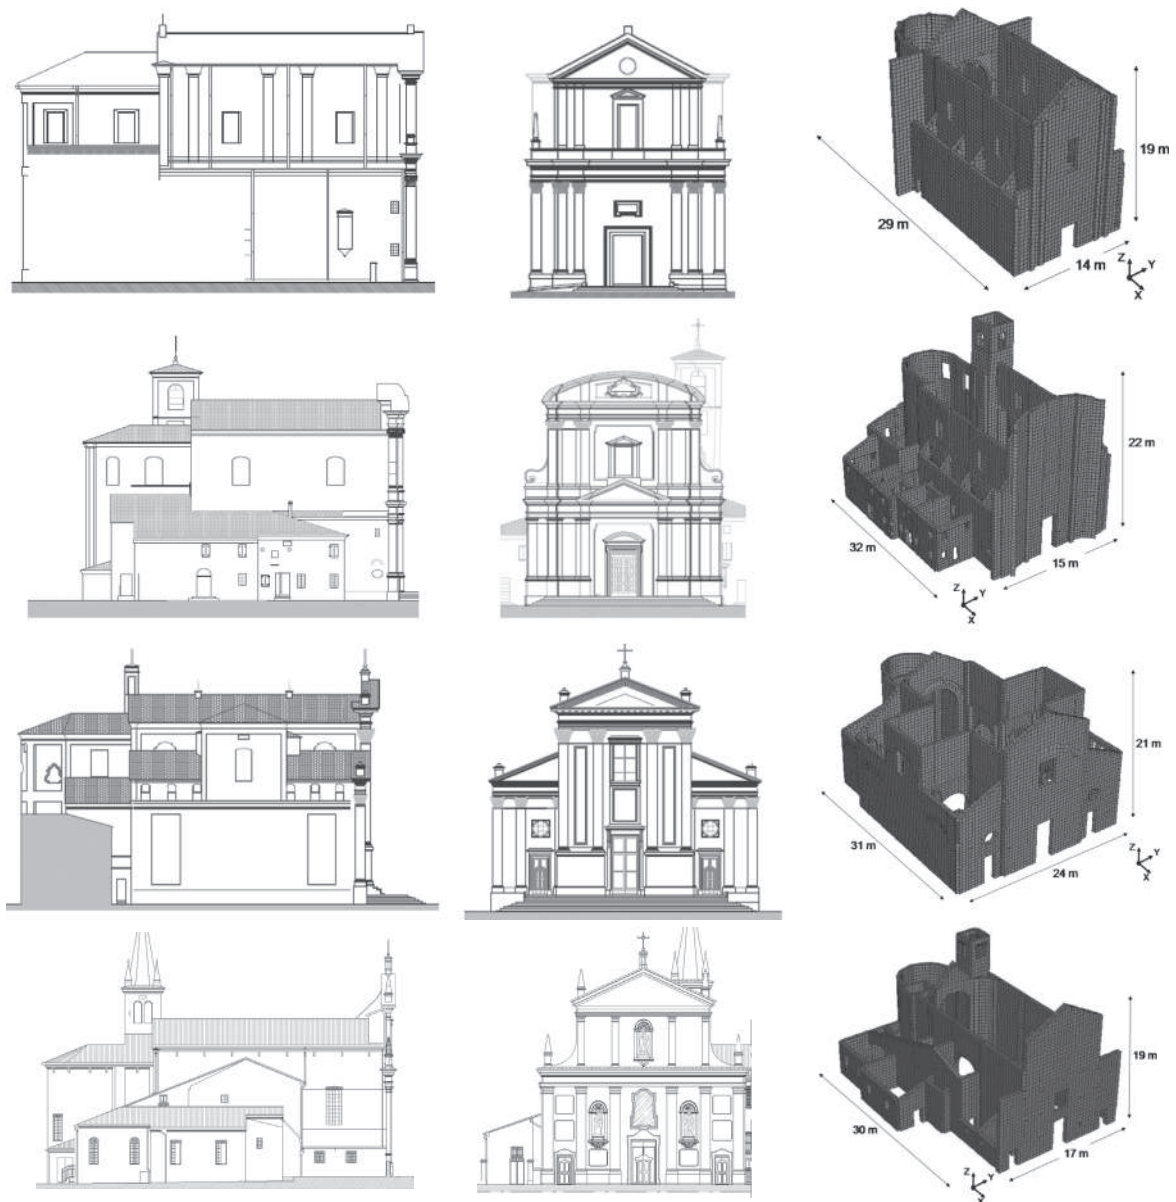
Fig. 3. Lateral and front views of Churches 1–4 and 3D FE discretization.

The FE discretizations along with a rough indication of the dimensions of the analyzed churches are shown in Fig. 3 for Churches 1–4 and in Fig. 4 for Churches 5–7. All the plan views with a rough indication of the dimensions of the churches are reported in Fig. 5. The reader interested in a detailed description of the geometry and in a survey of the damages observed after the seismic events is referred to [11].

- Church 2, San Sisto II in Palidano di Gonzaga, has a single nave approximately 23 m long. The façade, 22 m high, exhibits a curved shape. The nave is flanked by two chapels on either side and the apse is circular, with height equal to 13.50 m. The presbytery is rectangular, 8 m long. The inclined bell tower, survived the demolition of an old church, results incorporated into the new building. Some rectangular masonry columns (section equal to 80 × 60 cm), built in adhesion to perimeter walls, better diffuse vertical loads transferred by the roof.

- Church 3, San Giorgio Martire in Castellucchio, has a Greek cross plan, 31.5 m long, with four internal large columns carrying a non-structural central vault. The intersection of the naves with the transept architecturally defines five distinct zones with different heights: the central vault reaches a height equal to 15.7 m, while the four lateral zones are 8 m high. The thickness of the external walls is equal to 60 cm. The façade is a typically Romanesque one and has a thickness equal to 70 cm.

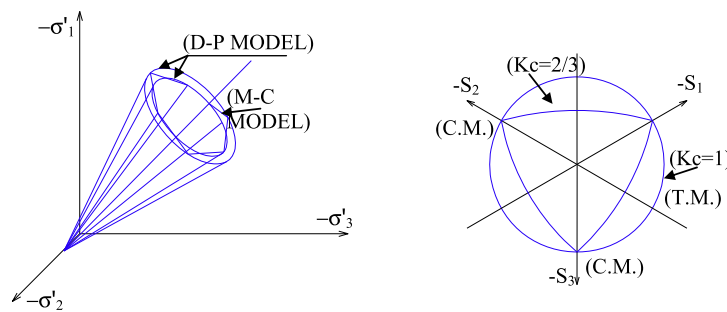
Fig. 7. Left: 3D strength domain adopted in the dynamic simulations, principal stresses space (D-P: Drucker-Prager failure criterion; M-C: Mohr-Coulomb failure criterion). Right: K_c parameter to approximate with a D-P failure criterion a M-C failure criterion in a smooth way.

To describe the multi-dimensional behavior in the inelastic range, masonry is assumed obeying a Drucker-Prager strength criterion with non-associated flow rule, Fig. 7. A value equal to 10° is adopted for the dilatation angle, which seems reasonable for a masonry material subjected to moderate-low levels of vertical compression, also in agreement with experimental evidences available in the literature, see e.g. [42,43]. To avoid numerical convergence issues, the tip of the conical

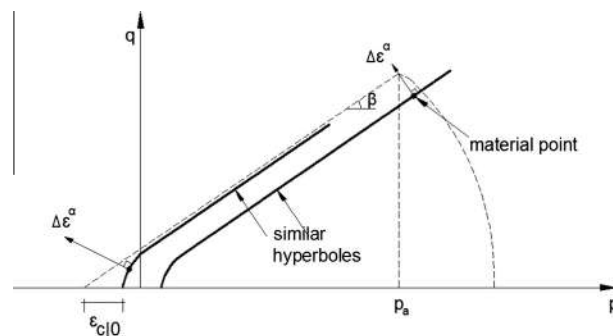
Fig. 8. Smoothed Drucker-Prager failure criterion adopted in the simulations, p - q plane.

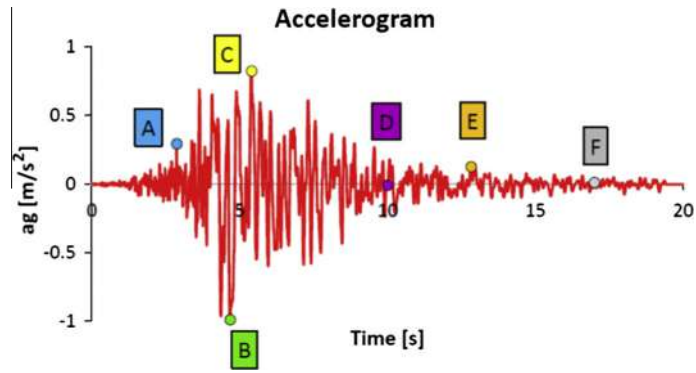
Fig. 9. Scaled real accelerogram used in the dynamic analyses and meaningful points used to evaluate the damage state of the churches under study.

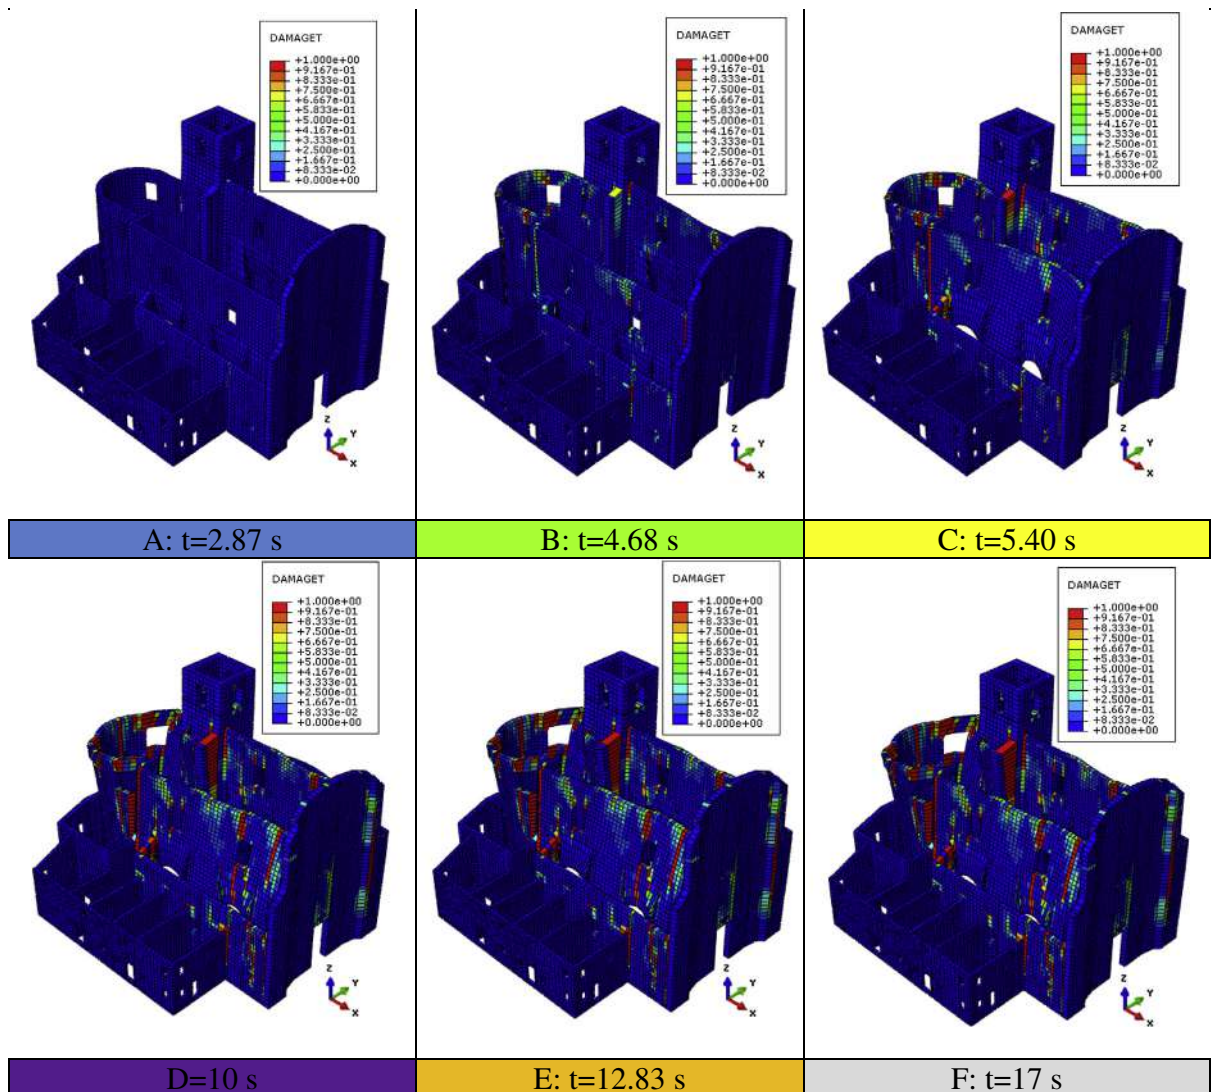
Fig. 17. Church 2. Seismic excitation in the transversal direction of the church. Deformed shape at different instants during the time-history with indication of damage (red, 1: full damage; blue, 0: no damage). (For interpretation of the references to color in this figure legend, the reader is referred to the web version of this article.)

The evolution of damage at different instants is represented in Fig. 15 (longitudinal direction) and Fig. 17 (transversal direction). Similarly to the previous case, for the longitudinal direction the active macro-block is represented by the upper portion of the façade, whereas for the transversal one it is represented by the lateral walls, with quite relevant concentration of damage in the apse and the bell tower too.

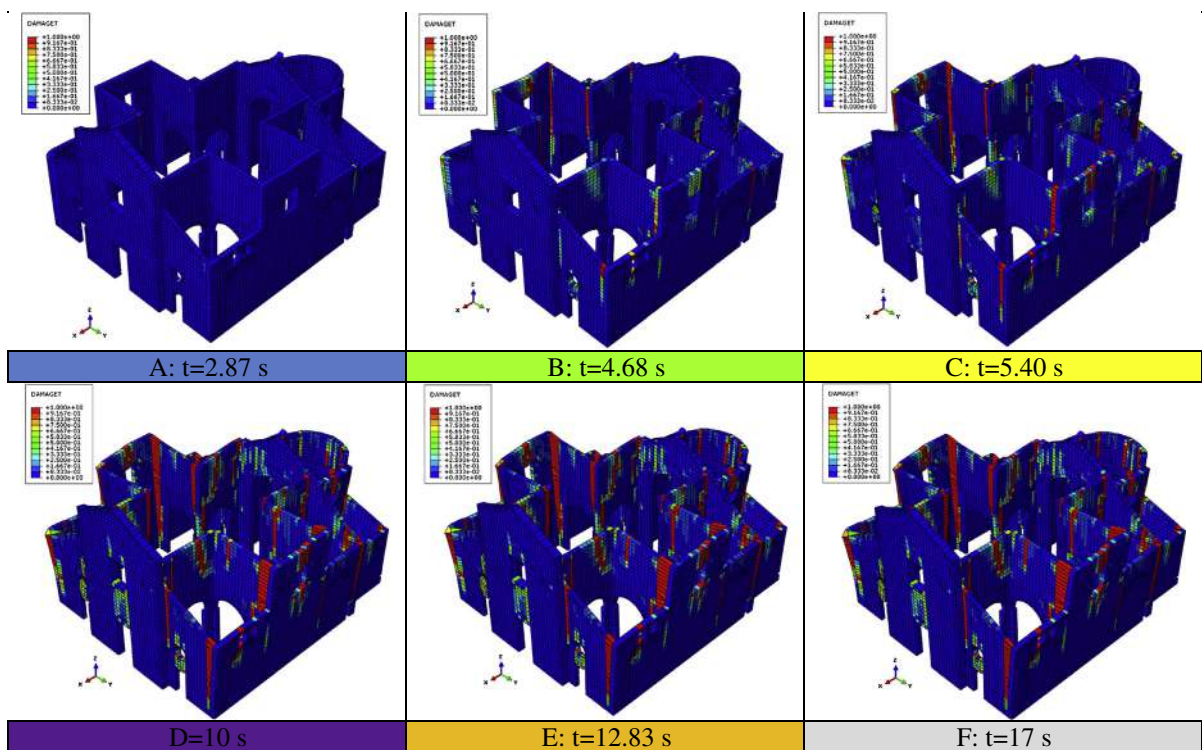
Fig. 21. Church 3. Seismic excitation in the transversal direction of the church. Deformed shape at different instants during the time-history with indication of damage (red, 1: full damage; blue, 0: no damage). (For interpretation of the references to color in this figure legend, the reader is referred to the web version of this article.)

A synopsis of the results of the dynamic analyses performed on Church 3 is reported from Figs. 18–21. In particular, the longitudinal behavior is summarized in Fig. 18 (displacement, KE and DMD time-history) and in Fig. 19 (damage evolution and amplified deformed shapes at different instants). The same diagrams/figures are replicated for the transversal response in Fig. 20 and 21.

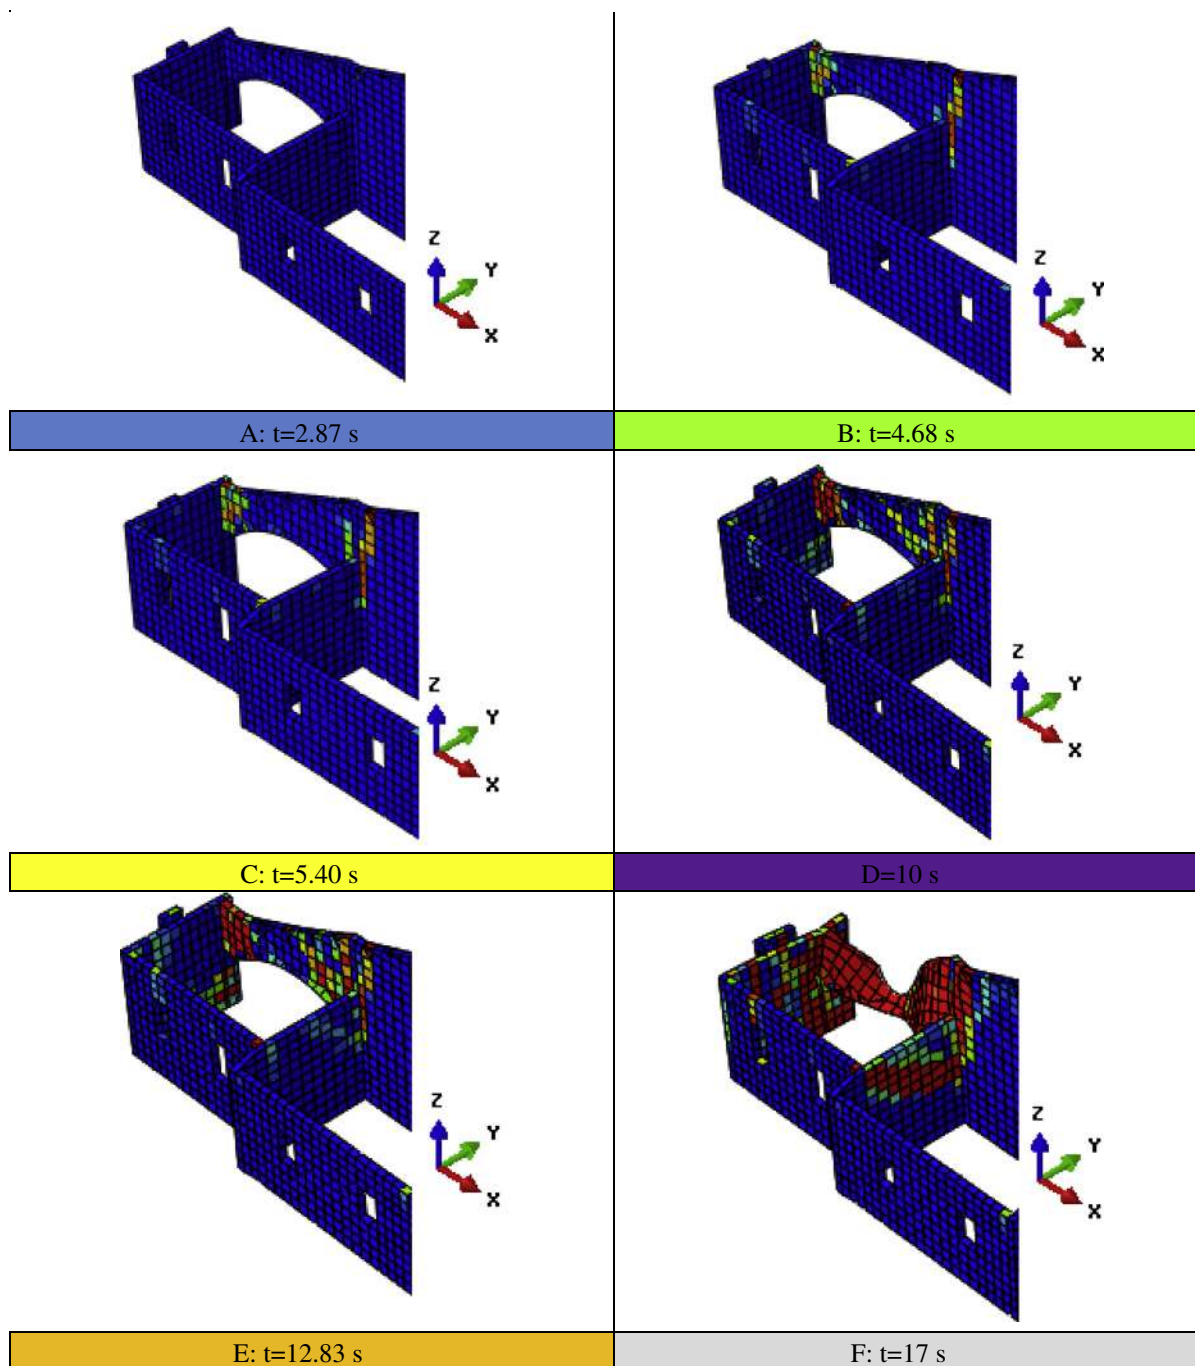
Fig. 24. Church 4. Seismic excitation in the longitudinal direction of the church. Detail of deformed shape at different instants during the time-history with indication of damage (red, 1: full damage; blue, 0: no damage). (For interpretation of the references to color in this figure legend, the reader is referred to the web version of this article.)

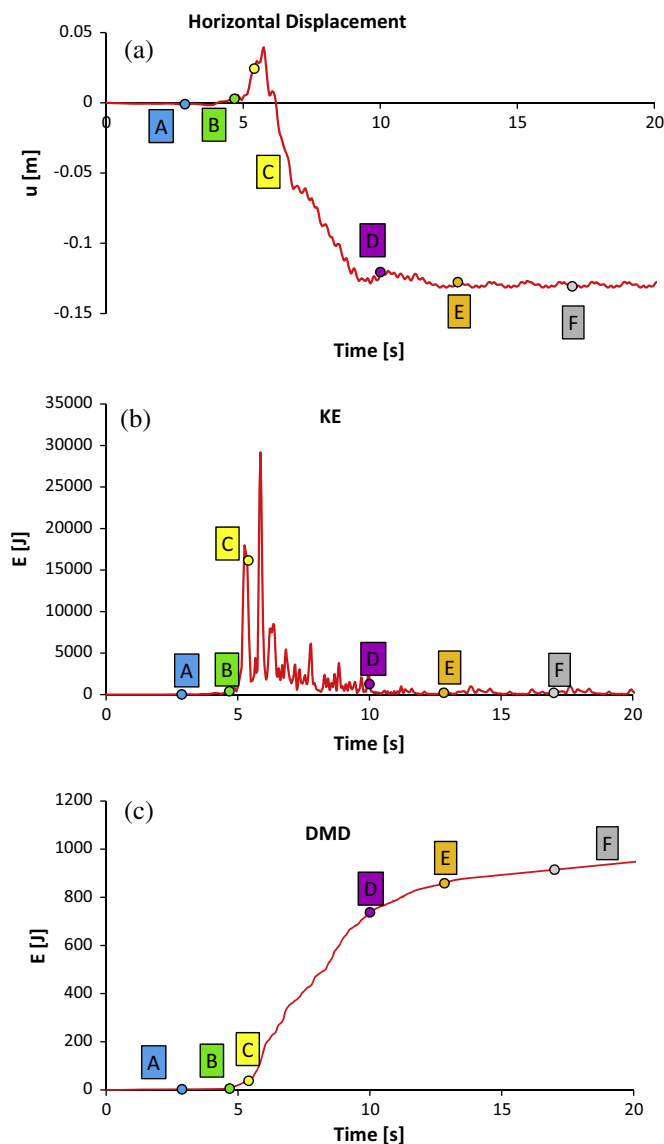
Fig. 31. Church 6. Seismic excitation in the longitudinal direction of the church. (a) Control point horizontal displacement time-history diagram. (b) Kinetic energy time-history diagram. (c) Energy dissipation in tension time-history diagram.

The results of the dynamic analyses carried out on Church 6 are summarized in Figs. 31 and 32 for the longitudinal direction and in Figs. 33 and 34 for the transversal one.

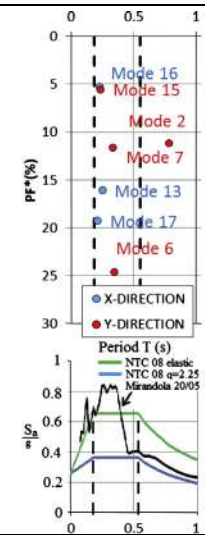
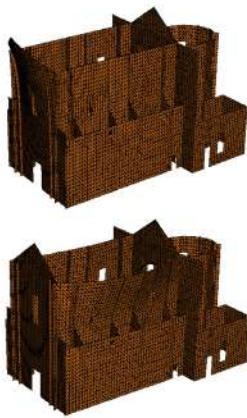
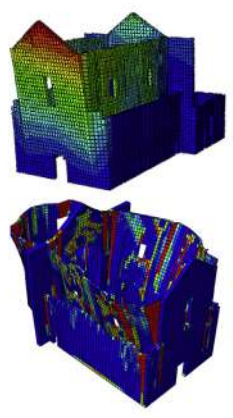
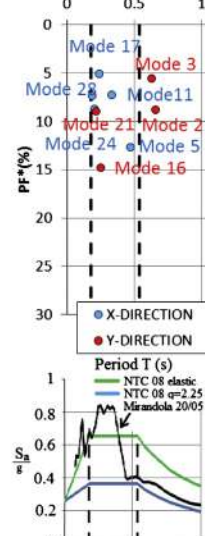
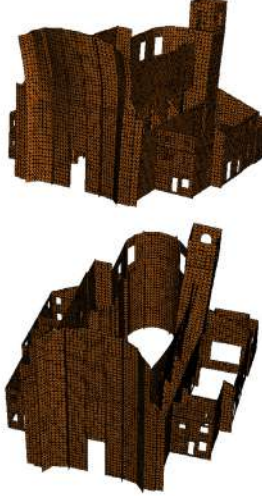
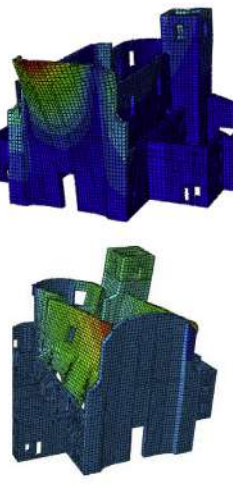
Church 2	Period/participating mass	Collapse acceleration	Residual displacement
Longitudinal direction	0.48 s / 13%	0.047g / 0.055g	100 mm
Transversal direction	0.6 s / 10%	0.041g / 0.042g	80 mm
<p>Mode 5</p>

Fig. 39. Churches 1 and 2. Seismic excitation in the longitudinal and transversal direction of the church. Comparison of the structural behavior by means of different approaches.

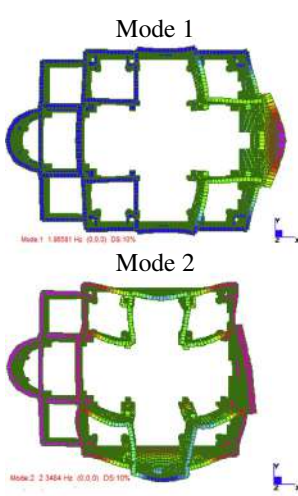
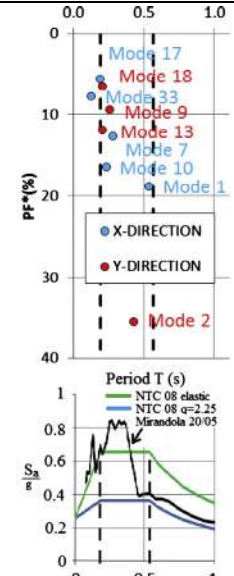
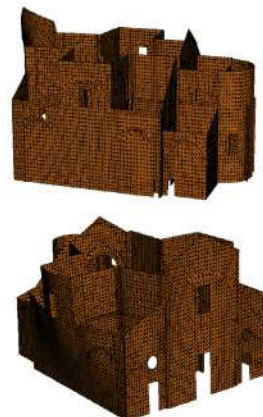
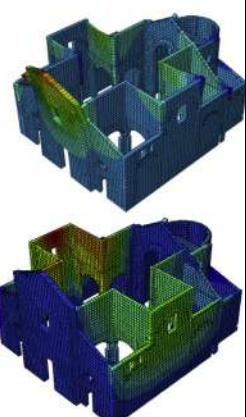
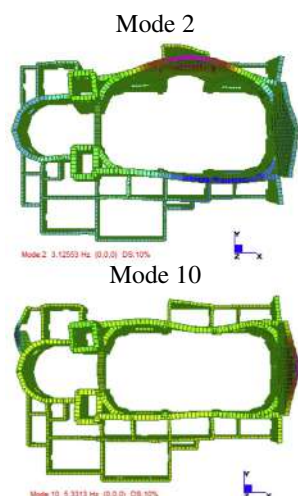
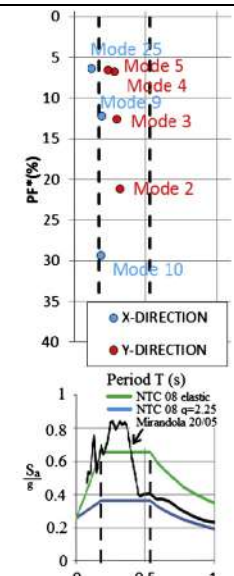
Church 4	Period/participating mass	Collapse acceleration	Residual displacement
Longitudinal direction	0.48 s / 13%	0.039g / 0.041g	110 mm
Transversal direction	0.6 s / 10%	0.078g / 0.084g	60 mm

Fig. 40. Churches 3 and 4. Seismic excitation in the longitudinal and transversal direction of the church. Comparison of the structural behavior by means of different approaches.

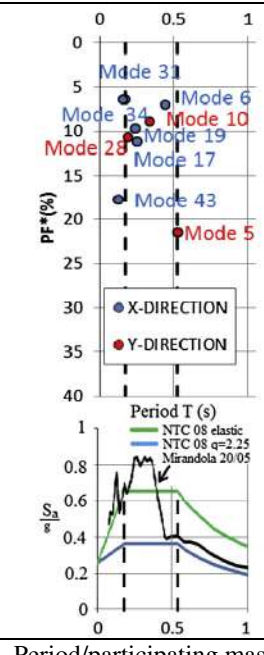
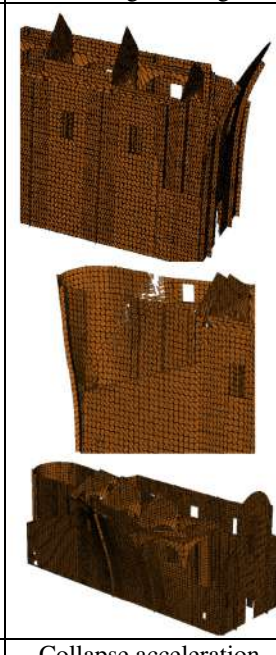
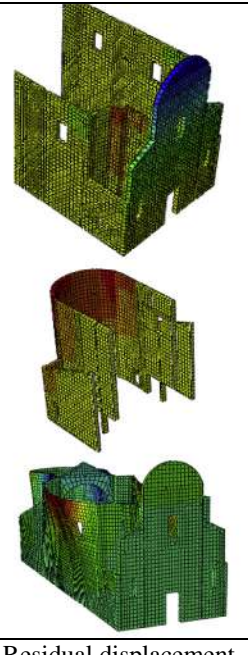
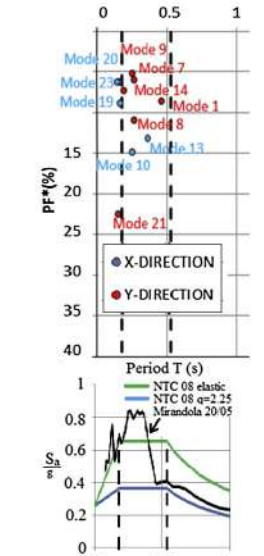
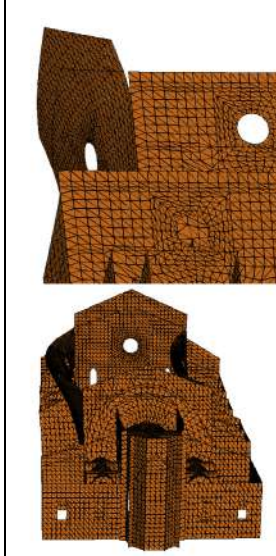
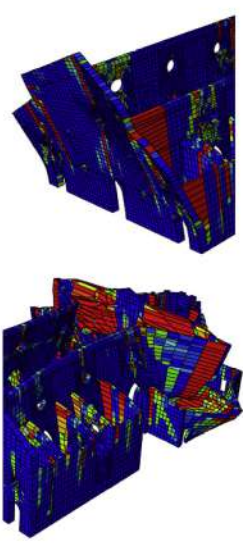
Church 6	Period/participating mass	Collapse acceleration	Residual displacement
Longitudinal direction	0.25 s / 15%	0.067g / 0.044g	140 mm
Transversal direction	0.195s / 22.5%	0.048g / 0.045g	300 mm
Mode 21

Fig. 41. Churches 5 and 6. Seismic excitation in the longitudinal and transversal direction of the church. Comparison of the structural behavior by means of different approaches.

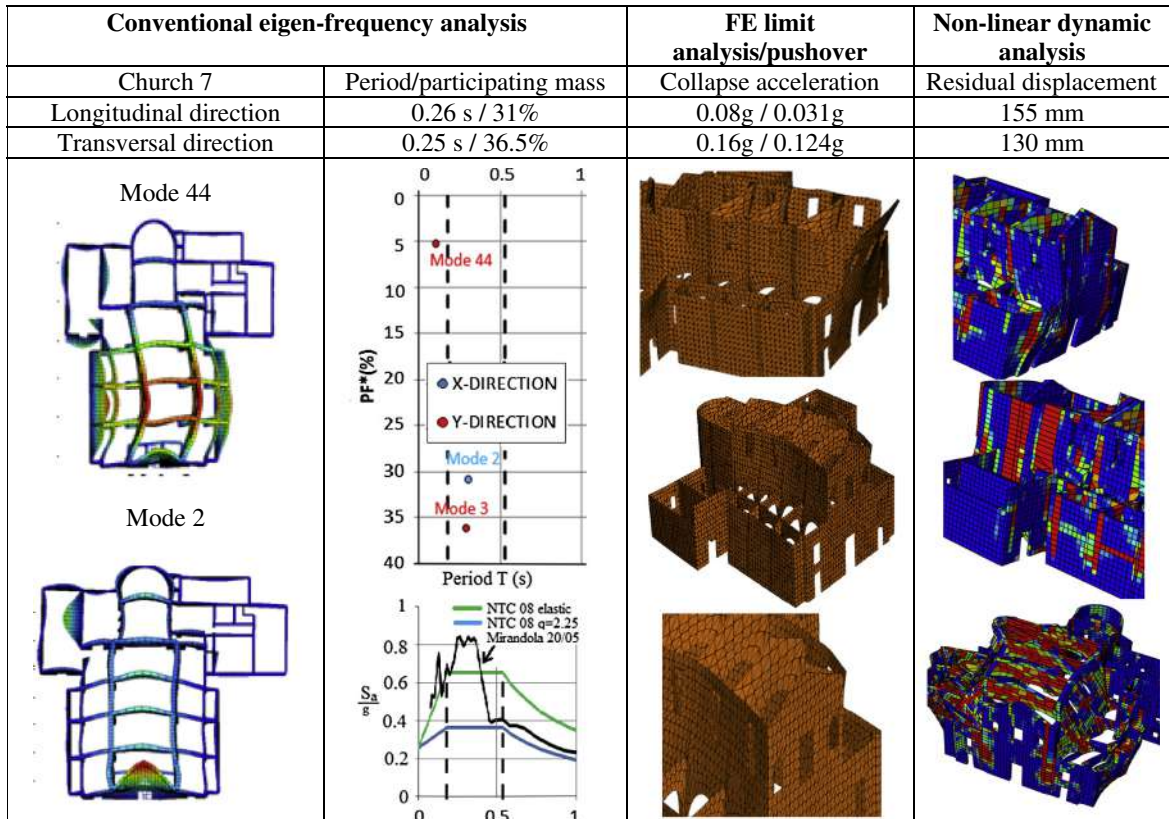
Fig. 42. Church 7. Seismic excitation in the longitudinal and transversal direction of the church. Comparison of the structural behavior by means of different approaches.
