# ANTAEUS Project for the Regional Vulnerability Assessment of the Current Building Stock in Historical Centers

This article presents a methodology for the seismic vulnerability assessment of current buildings, suitable for the study of historical centers at the regional scale. The applicability is demonstrated with reference to four case studies: the historical center of the city of Foggia (Italy) and three other small towns of this province, for a total of 4519 housing units. Field data were collected by several teams of technicians by means of a survey form, provided in electronic format. The subsequent data processing and drawing of vulnerability maps was performed using geographical information system (GIS) technology. The collected data were used also for the validation of the algorithm, by comparing the results with those of the methodology used by the Gruppo Nazionale per la Difesa dai Terremoti (GNDT [Italian National Group for Defense Against Earthquakes]), which is widely adopted in Italy. The results of the research study and the application showed some critical points, related to the poor nature of the information collected and to the reliability of the final results.

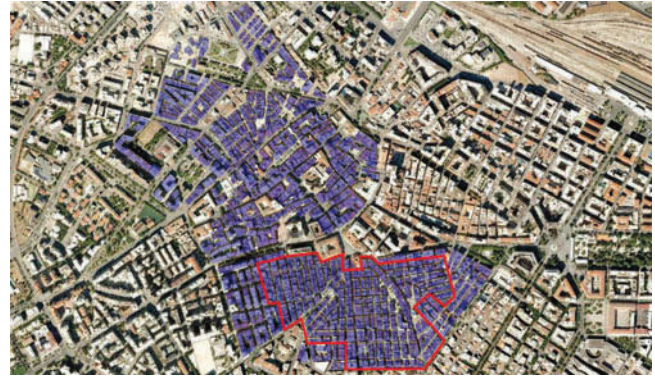
**Figure 4.** The historical center of Foggia, with the surveyed buildings in evidence. The area object of the reconstruction of 1731 is marked in red.

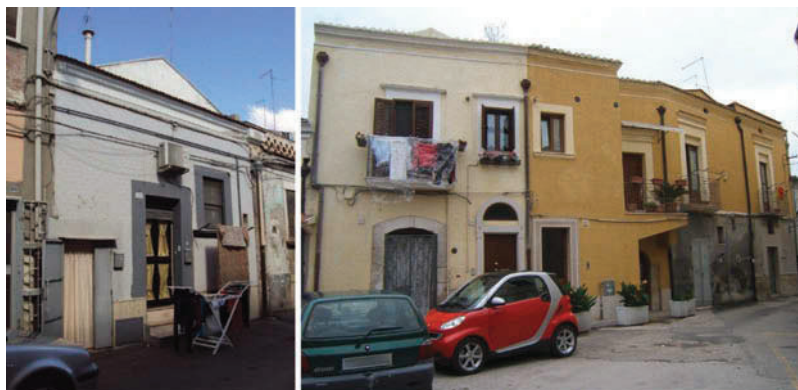
**Figure 3.** On the left, an example of the original configuration of the houses built after the 1731 earthquake. On the right, the same typology of houses after the addition of a story and an enlargement.

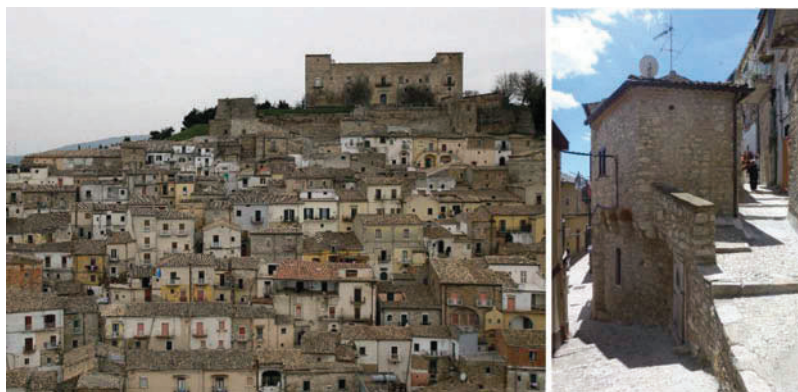
**Figure 6.** A view of Sant'Agata historical center (left), and an example of the typical structural aggregate, built on a slope with two level elevations (right).

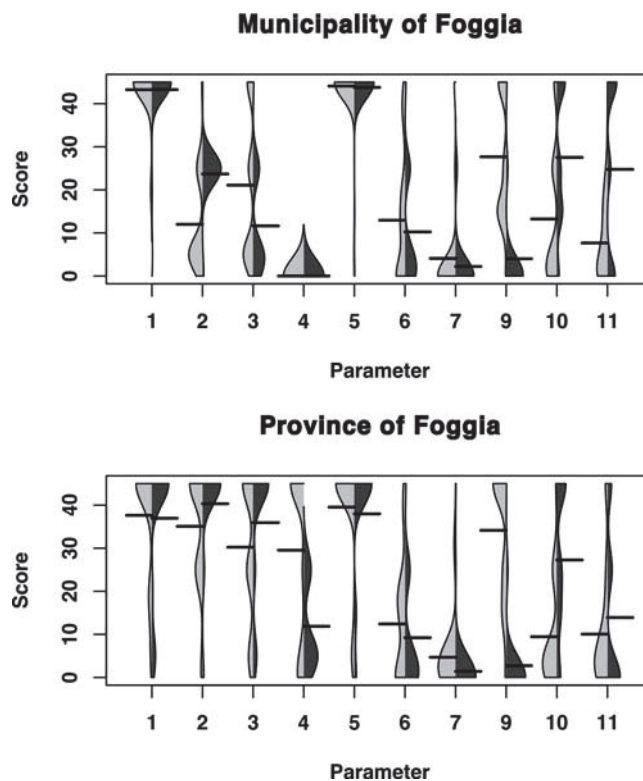
**Figure 7.** Sample of Foggia (top), Carlantino, Sant’Agata, Vico del Gargano (bottom): distribution curves of the vulnerability parameters for GNDT/GNDT-Tuscany (light gray) and ANTAEUS (dark gray).

In the first instance, the analysis was performed on the sample of buildings of the City of Foggia that is the largest one (75 buildings). Figure 7 reports the average score provided by the three methods for each of the 11 vulnerability parameters in absolute terms, i.e. without normalizing scores and without applying weighting coefficients (the values provided by GNDT and GNDT-Tuscany, in absolute terms, are coincident). The major deviations are encountered for parameter 2 (quality of resisting system), parameter 3 (conventional resistance), and parameter 10 (non-structural elements), which are those for which the ANTAEUS methodology has introduced significant simplifications or variations. After the application of the weights and normalization, however,

the situation changes, and the incidence of these discrepancies is much reduced (thanks to the fact that the ANTAEUS algorithm attributes a lower weight to these parameters). By analyzing in detail the individual weighted parameters, the performance of the three methods is different: variations can be noticed among all approaches, for almost all parameters. At this stage, it is difficult to perform a direct comparison, whereas it is more useful to look at the final objective, which consists in guaranteeing that the vulnerability index is substantially consistent among the different approaches. In this sense, the discrepancy between the overall vulnerability index in the ANTAEUS method and in GNDT/GNDT-Tuscany is quite limited, and could be compatible with the purposes of a large regional scale assessment. It is anyway possible to further reduce it, and, to this aim, it is convenient to operate on parameter 1, which contributes for approximately 40% to the final value (19.9 points on a total of 48.9). After some simulations aimed at the optimization of the result, it was decided to reduce the weight of the parameter from 1.50 to 0.75.
