Diagnosics Of Traction System Of Very High Speed trains: Experimental Results And Selection Of The Most Suitable Signal Processing Techniques

Paolo Pennacchi^{1*}, Steven Chatterton¹, Dimitrios Marinis², Antonio Didonato².

² Bombardier Transportation, Via Tecnomasio 2, I-17047 Vado Ligure (SV), Italy

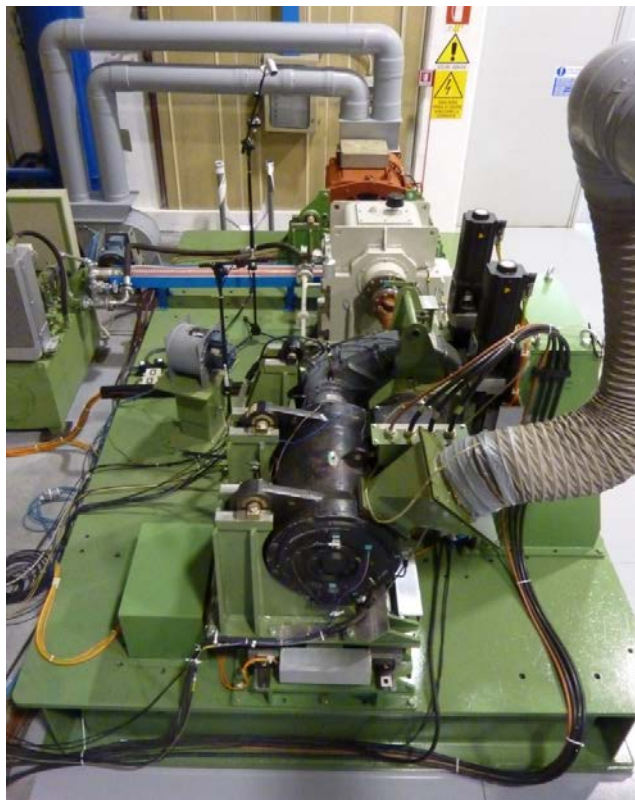
Figure 1. Test-rig

The Traction System was tested by means of a dedicate Test-Rig. All traction equipment (motor and gear-box) were installed on a test bench in which the axle of the train is simulated by a dummy shaft and the train load is simulated by means of an electric brake motor. The vibrations coming from the tracks are emulated by vibrating platforms fixed to the traction components.

These platforms simulate the relative movement between the motor suspended on the bogie primary damper and the gearbox integral with the wheel axle. A moving platform supports the axle of the traction gearbox, by means of two bearings, and shakes it vertically replicating both the movement between the motor and gearbox and the shock and vibrations generated by the tracks. Another moving platform moves the traction motor in the two directions of the horizontal plane, replicating only the movement between the motor and gearbox. The gearbox axle is connected by means of a universal joint to an industrial parallel shaft gearbox, that is connected by means of a second universal joint to the brake motor. A torque meter is placed between the flanges connecting the first

universal joint and the industrial gearbox, in order to measure the actual output torque of the traction equipment under test.

The traction system installed on the test-rig has been taken from "REGINA" high speed train, manufactured by BOMBARDIER, able to reach a maximum speed of 250 km/h. It is composed of an electric motor, fastened, in real application, to the bogie by means of three elastic bushings, and of a gearbox, connected on the real train to the bogie by a reaction rod and to the wheel axle.

The traction motor is a converter driven 4-poles asynchronous motor, whose rotor is mounted on two different bearings: a single row, deep groove ball bearing (MP2) in the non-driven end side and a cylindrical roller bearing on the driven end side (MP1).

The gearbox follows the typical layout with a single reduction gear unit, with helical gearing. The helical pinion (input shaft) of the gearbox is connected to the electrical motor by a coupling capable to allow the relative movements between motor and gearbox. On the gearbox there are two tapered rolling bearings for the output shaft (BG3), that can be mounted directly on the wheel-set or on a hollow shaft fitted on the wheel-set, two cylindrical roller bearings (BG2), and one four contact point ball bearing for the input shaft (BG1). The split inner ring ball bearing supports the axial thrust of the input shaft.

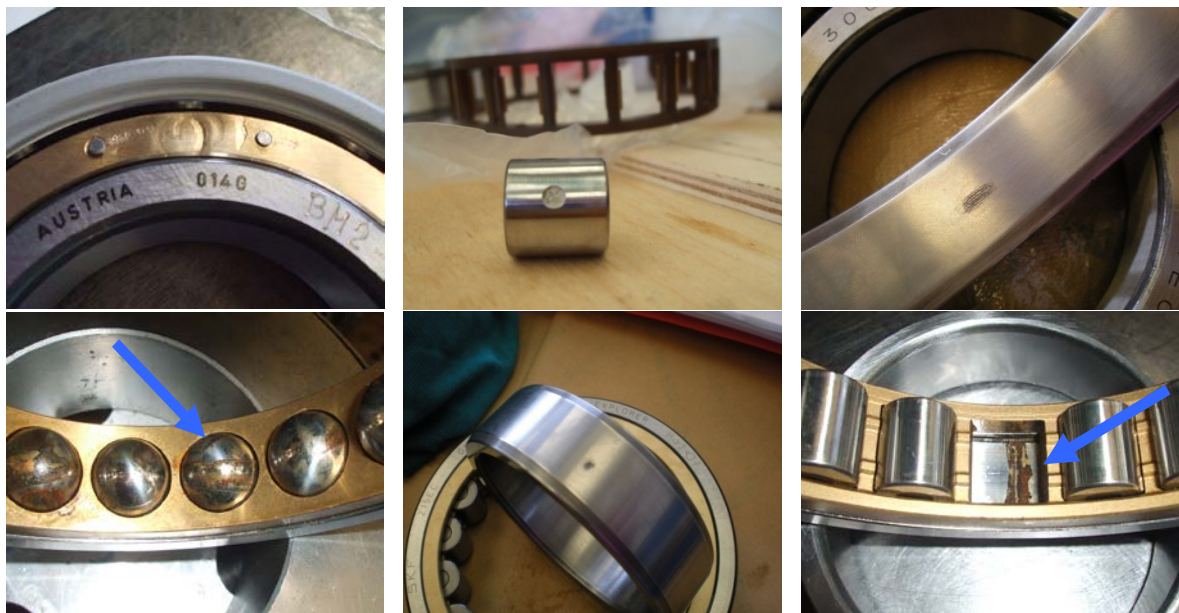
Figure 3. Examples of damage

During the campaign several damaged bearing have been tested. Different level of damages have been investigated, including electrical discharges, bad mounting, spalling, corrosion, oxidation in outer races, inner races and balls. Some examples of damage are shown in Figure 3.

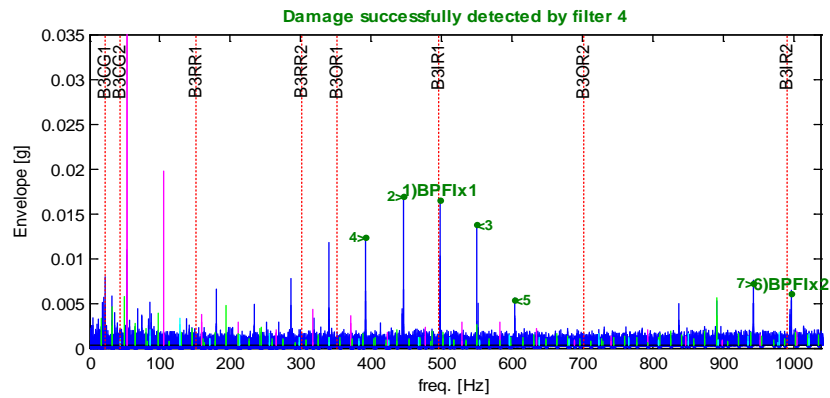
Figure 5. Example of Envelope Spectrum.

Analysis and Spectral Kurtosis. Both the techniques result in a spectrum-like indicator with, on the horizontal axis a range of frequencies, and on the vertical axis a technique-specific amplitude. A typical spectrum obtained by the Envelope Analysis of a damaged bearing is presented in Figure 5, from test campaigns with damaged BG1 (ball bearing on gearbox).

A damage, localized on a specific bearing component is evidenced by the appearance of peaks in the spectrum-like indicator at frequencies close to the nominal defect frequencies of the bearing. For each bearing is possible, knowing its geometrical dimensions to calculate the characteristic frequencies given a specific shaft rotating speeds and then check for correspondences in the indicator.
