Comprehensive FE numerical insight into Finale Emilia Castle behavior under 2012 Emilia Romagna seismic sequence: Damage causes and seismic vulnerability mitigation hypothesis

ABSTRACT

In this paper, a numerical insight on the historical masonry Castle of Finale Emilia, symbol of the consequences occurred after the seismic sequence of 20–29th May 2012 in Emilia Romagna, Italy, is presented.

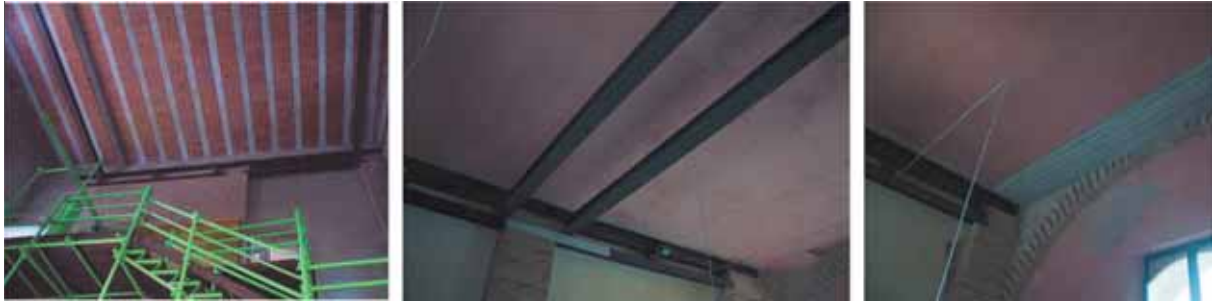
Fig. 4. Two couples of steel beams are present in each room situated on the longer arm of the Castle; one couple runs along opposite walls and the other is aimed at linking the first two beams.

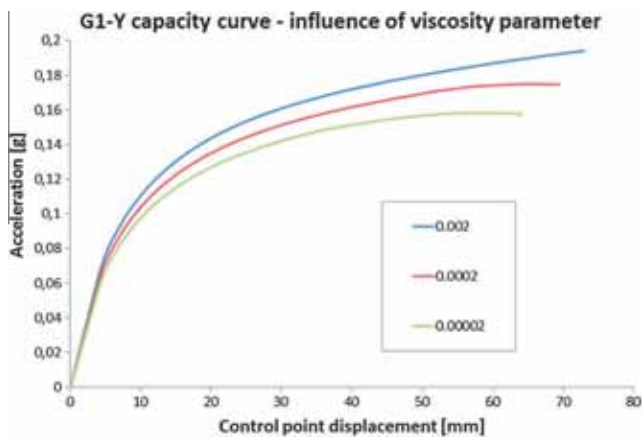
Fig. 11. Influence of viscosity parameter on a capacity curve: the value is respectively set equal to 0.002 (blue), 0.0002 (red) and 0.00002 (green). (For interpretation of the references to color in this figure legend, the reader is referred to the web version of this article.)

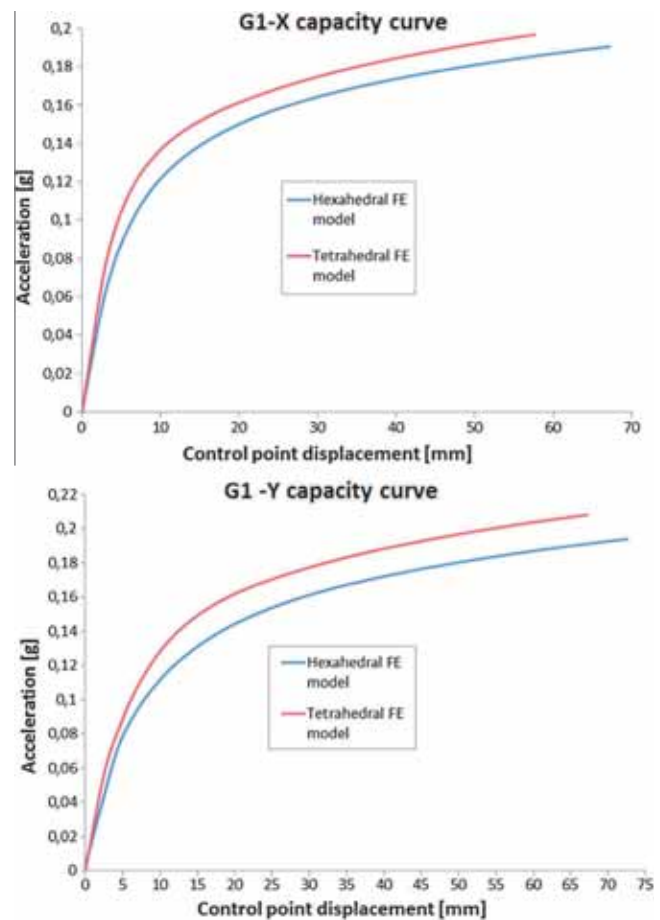
Fig. 12. Hexahedral vs tetrahedral FE model (point 1).

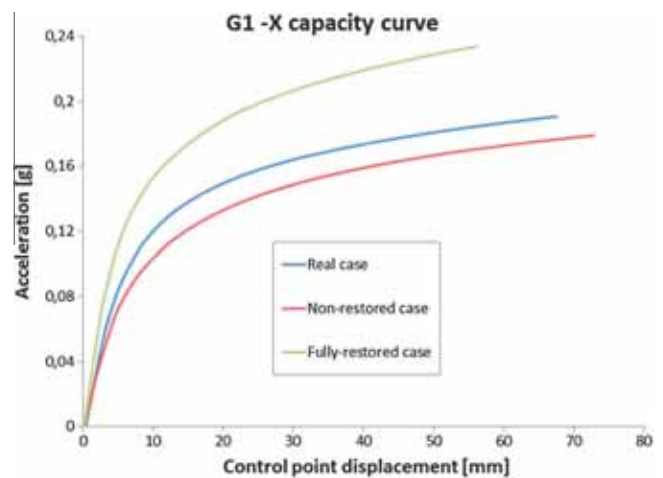
Fig. 13. G1-X capacity curve for the three cases (point 1, Mesh 2).

- For G1-X case, see Fig. 13, the results show that the capacity curve for the non-restored case is beneath the one for the real case, whereas the capacity curve for the fully-restored case is consistently higher. This means that the 2009 renovation has

actually increased both the stiffness and the strength of the Castle along this direction – which is obvious since the main façade itself is located along the direction of application of the load. If the renovation had been extended to the whole building, the global resistance would have further increased, probably precluding the observed damages.

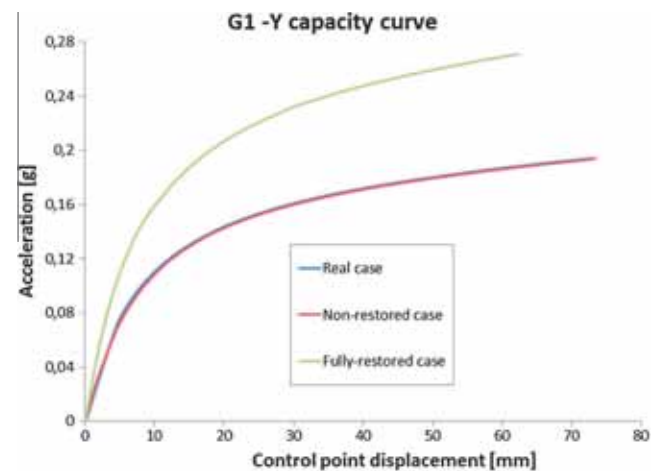
Fig. 14. G1-Y capacity curve for the three cases (point 1, Mesh 2).

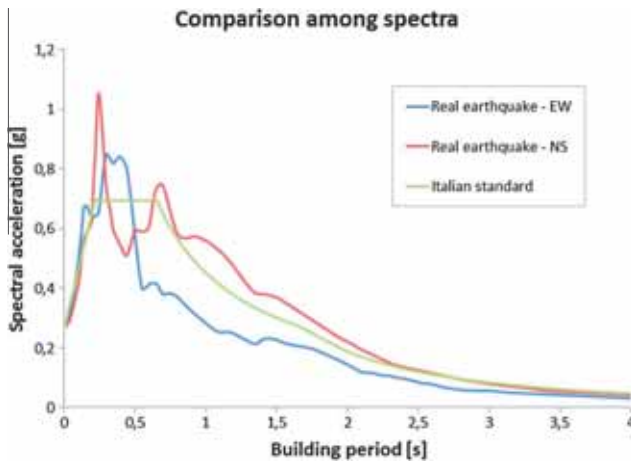
Fig. 17. Comparison among different spectra: spectra obtained for the real earthquake in the East–West (blue) and North–South (red) directions, and spectrum proposed by the Italian standard (green). (For interpretation of the references to color in this figure legend, the reader is referred to the web version of this article.)

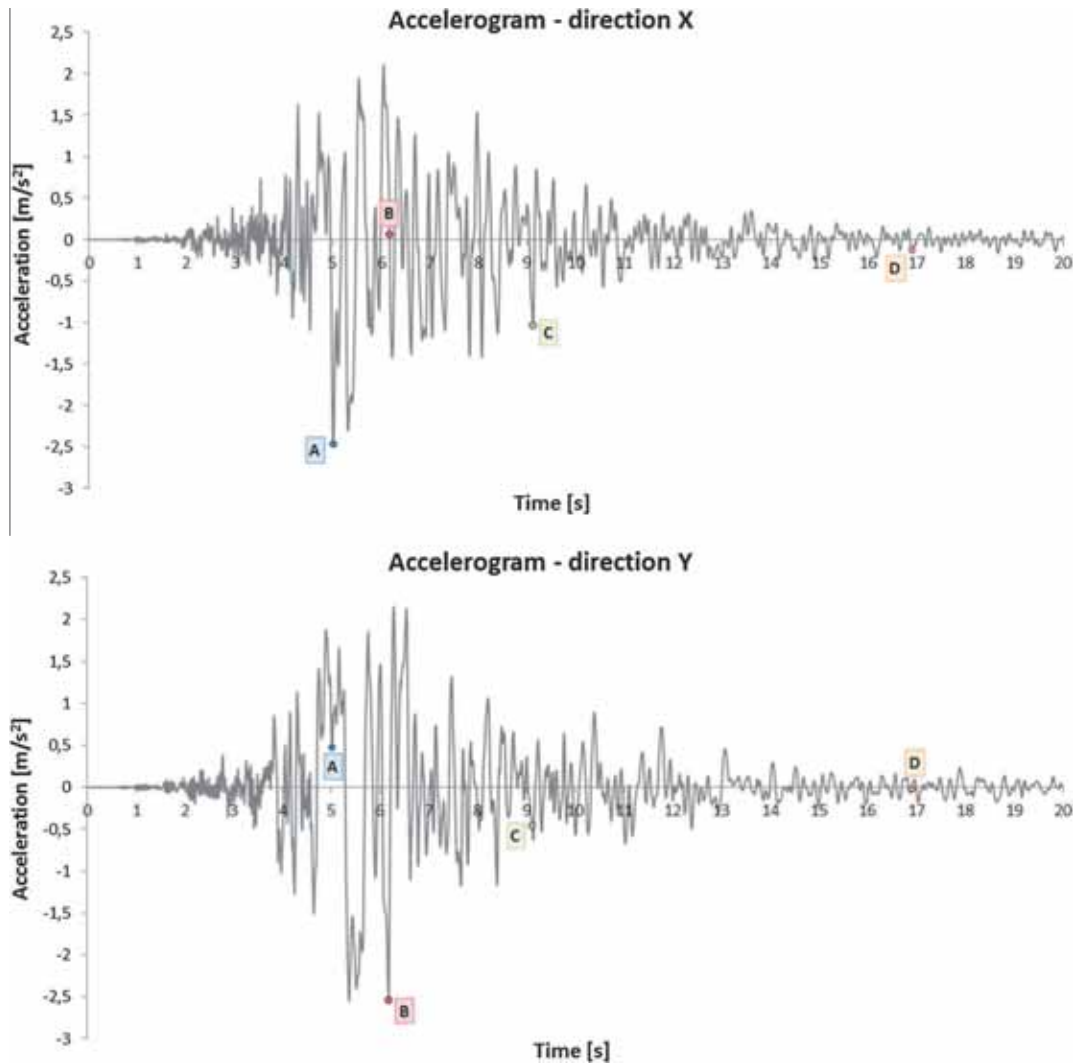
Fig. 21. Real accelerograms used in the non-linear dynamic analyses.

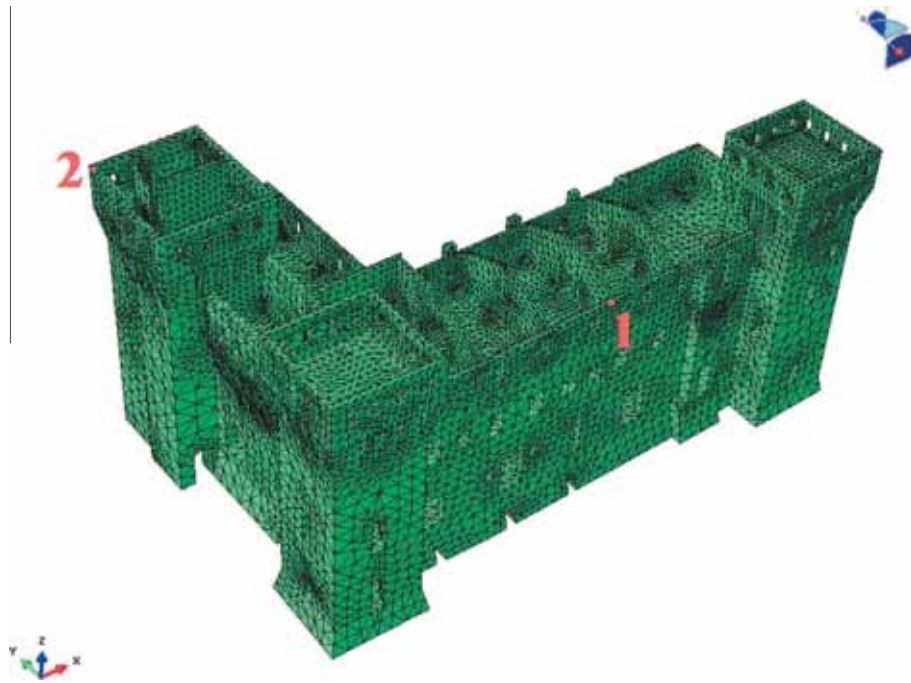
Fig. 22. Control points for the nonlinear dynamic analysis: main façade top edge (1) and West Tower crown (2).

By means of the damage development sequence shown at the different instants, it is possible to have a deep insight into the formation of the damage mechanisms. In addition, it is possible to plot the displacement time-history for the two relevant control points, shown in Fig. 22.

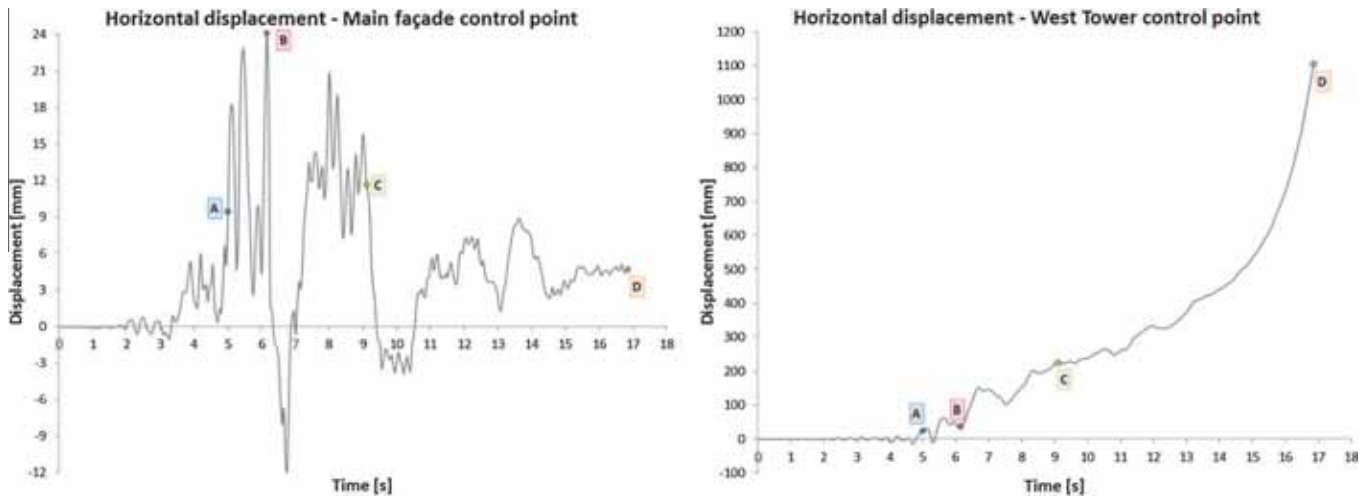
Fig. 24. Real case hypothesis. Horizontal displacement time-history diagrams for the two control points shown in Fig. 22.

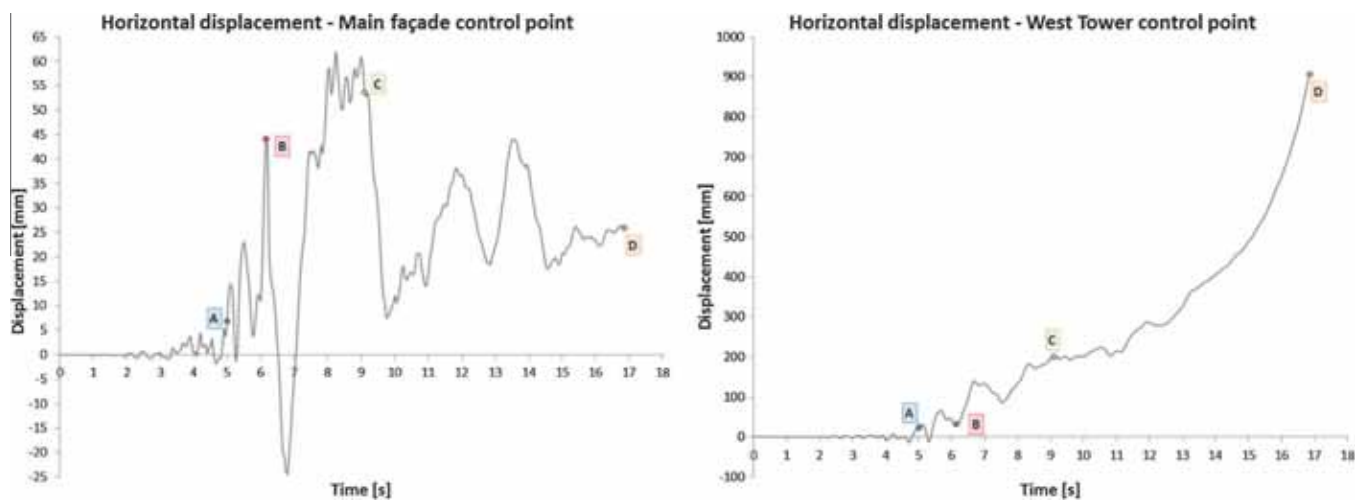
Fig. 26. Non-restored case hypothesis. Horizontal displacement time-history diagrams for the two control points shown in Fig. 22.

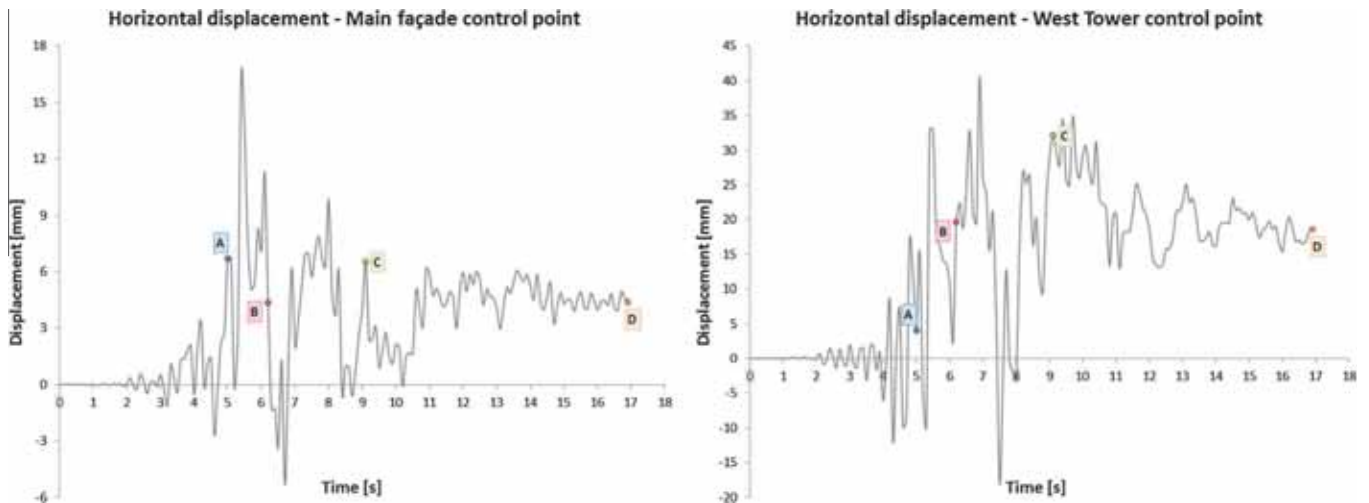
Fig. 28. Fully-restored case hypothesis. Horizontal displacement time-history diagrams for the two control points shown in Fig. 22.

20 mm, which seems still not compatible to the activation of a failure mechanism. In addition, the horizontal displacement diagram of the control point located on the main façade shows a behavior close to the one obtained for the real case, with a residual displacement of 5 mm, again far away from values compatible with a local failure, see Fig. 28.

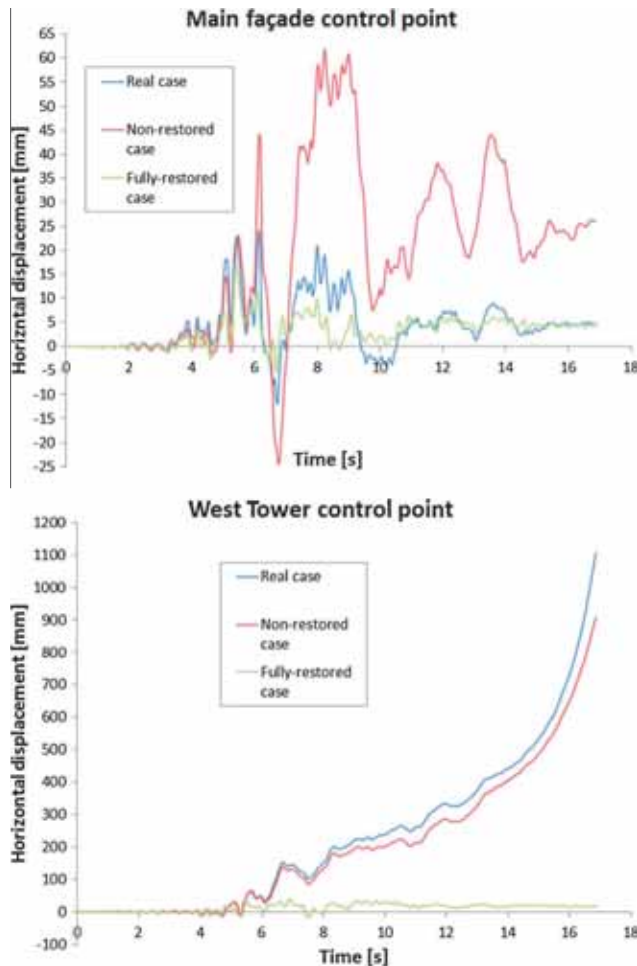
Fig. 29. Horizontal displacement for two control points in the three cases investigated.
