Cyclic behavior of C-shaped masonry wall retrofitted with twisted bars or bonded rebars

M. Scamardo^{a,*}, S. Cattaneo^a, P. Crespi^a, N. Vafa^b

^a ABC Dept., Politecnico di Milano, Milan, Italy

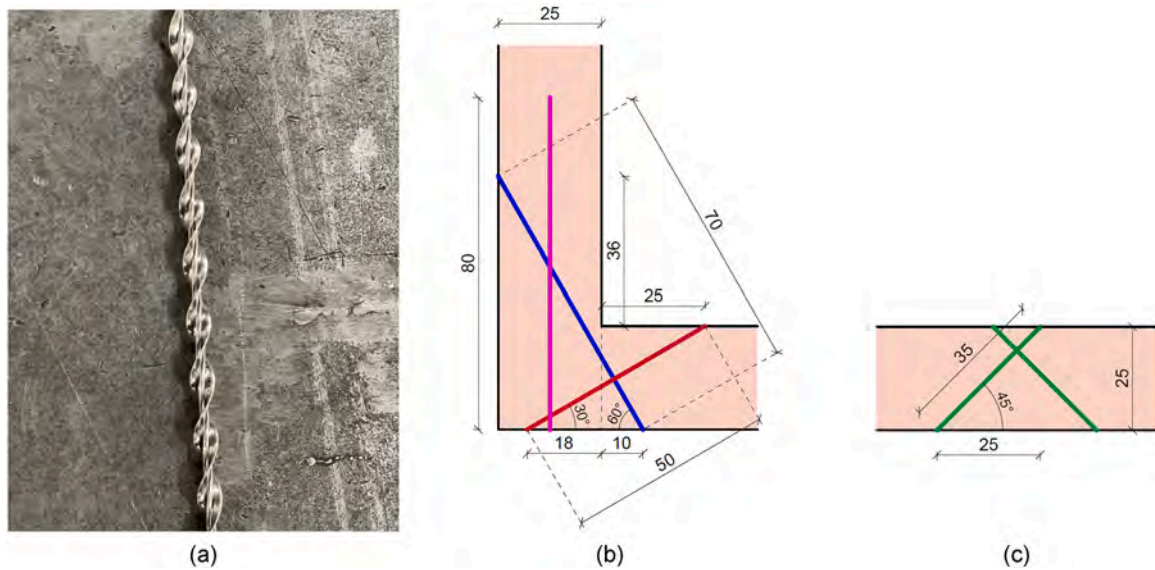
Fig. 2. Twisted bar (a), installation lay-out at the corner (b) and on the front wall for the crack stitching (c) (measures in cm).

Twisted stainless-steel bars (AISI 304) [20] were used to strengthen the unreinforced specimen (Fig. 2a). The bar had a nominal diameter of 12 mm, a nominal cross section area of 15.1 mm² and a total length of 100 cm. The nominal yielding and ultimate loads declared by the producer were 16.1 kN and 18.9 kN, respectively, and the elastic modulus was higher than 122 GPa. The bars layout at each corner is reported in Fig. 2b. The total embedment depth in the wall varied depending on the position/orientation of the bar from 50 to 80 cm. The twisted bars were installed at mid-height of the bricks. A sketch of the front wall with the twisted bars positions and quantities is shown in Fig. 3a. A total of 42 bars were installed to connect the front and the rear walls: 8 twisted bars at 60° (blue), 8 twisted bars at 30° (red), and 5 twisted bars at 90° (pink) were used on each corner. Assuming adjacent buildings on either side and to avoid installation from the (hypothetical) inside of the building, all bars were installed from the front side. Additionally, 20 twisted bars at 45° (Fig. 2c) were used to stitch the bending cracks that appeared on the front wall after the first monotonic loading test of the unreinforced specimen.

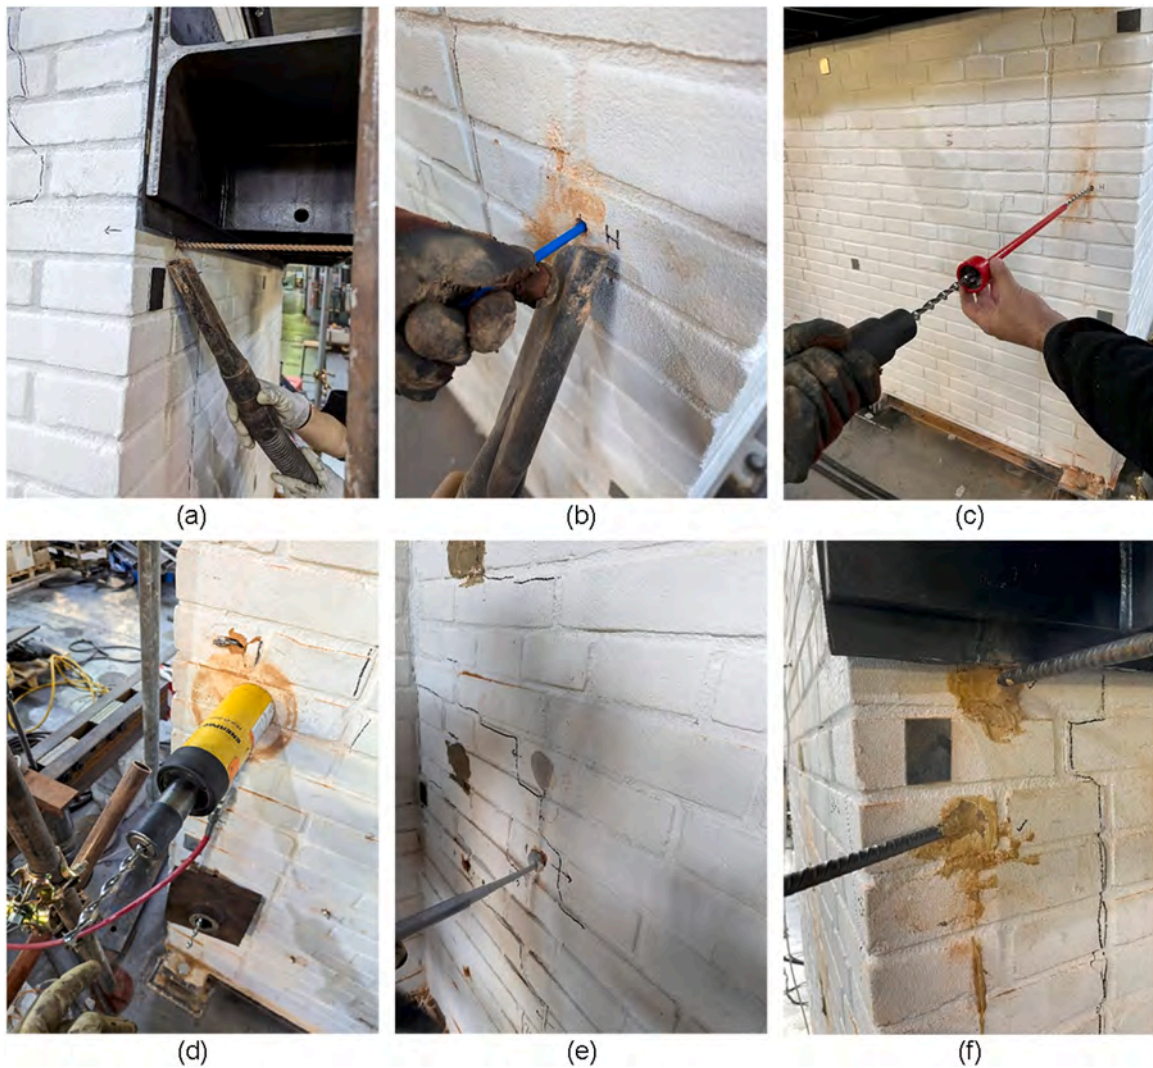
Fig. 4. Retrofitting steps: (a) hole drilling, (b) compressed air cleaning, (c) twisted bar installation, (d) twisted bar removal, (e) adhesive injection, (f) rebar installation.

The twisted bars were installed according to the following steps. After defining and marking the position of the bars on the wall, the holes were realized by using a drilling machine equipped with a drill bit of 8 mm nominal diameter (Fig. 4a). Holes were drilled to a longer depth (10 cm more than required) to avoid any issue related to the accumulation of masonry debris at the tip of the hole during the bar installation. Each hole was then cleaned by compressed air for at least three times (Fig. 4b). Finally, twisted bars were installed by using a hammer drilling machine equipped with a special hammering device supplied by the manufacturer (Fig. 4c). Fig. 5a shows the specimen retrofitted with the

After testing the wall specimen retrofitted with twisted bars, the latter were pulled-out with a hydraulic jack (Fig. 4d) and replaced by a reduced number of 12 mm diameter steel rebars (B450C) installed with injection mortar (Fig. 4e-f). Thereby, the pre-existing hole diameter was enlarged from 8 mm to 14 mm by using a hammer drilling machine to enable the installation of the rebars with injection mortar. In this way,

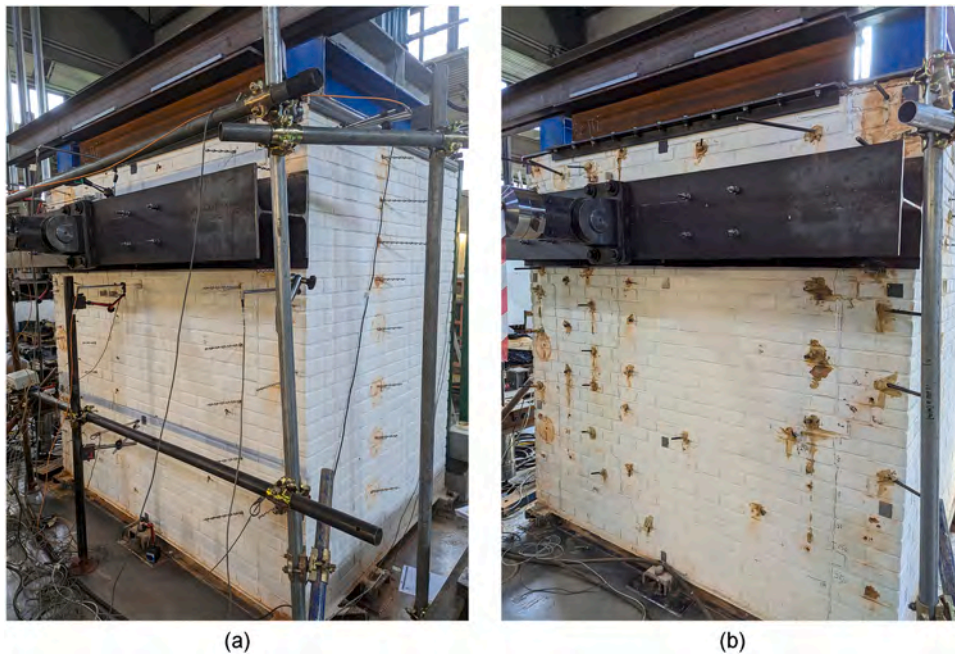
Fig. 5. Specimen retrofitted with twisted bars (a) and bonded bars (b).

A sketch of the wall with the rebars positions and quantities is shown in Fig. 3b. The total number of bars to reinforce the corner connections was reduced from 42 (twisted bars configuration) to 26 due to the higher pull-out strength of the rebars with respect to the twisted bars [22,41]. In particular, 5 rebars at 60° (blue), 5 rebars at 30° (red), and 3 rebars at 90° (pink) were used on each corner. The same embedment depths of twisted bars were considered (Fig. 2b). 20 additional rebars at 45° (green) with 35 cm of embedment depth replacing all twisted bars were used to stitch the bending cracks that appeared on the front wall. Fig. 5b shows the specimen retrofitted with the bonded steel rebars.

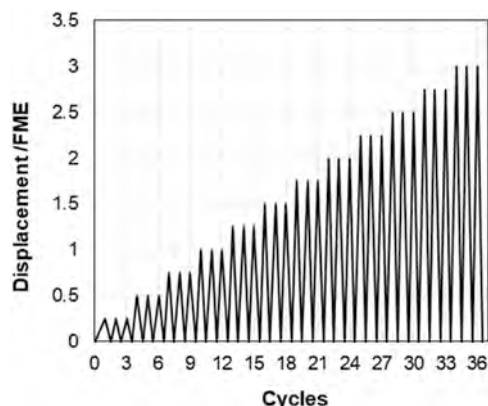
Fig. 9. Cyclic test loading protocol.

performed. The theoretical displacement protocol is reported in Fig. 9. Starting from the zero horizontal displacement of the monotonic test, the displacement amplitude was progressively increased in steps of 25 % of the FME displacement, performing three repeated cycles for each displacement level. The test was stopped when the damage/safety condition of the specimen became risky, and the horizontal jack unloaded. Then, the twisted bars were removed using a hydraulic jack, avoiding any possible damage of the surrounding masonry.

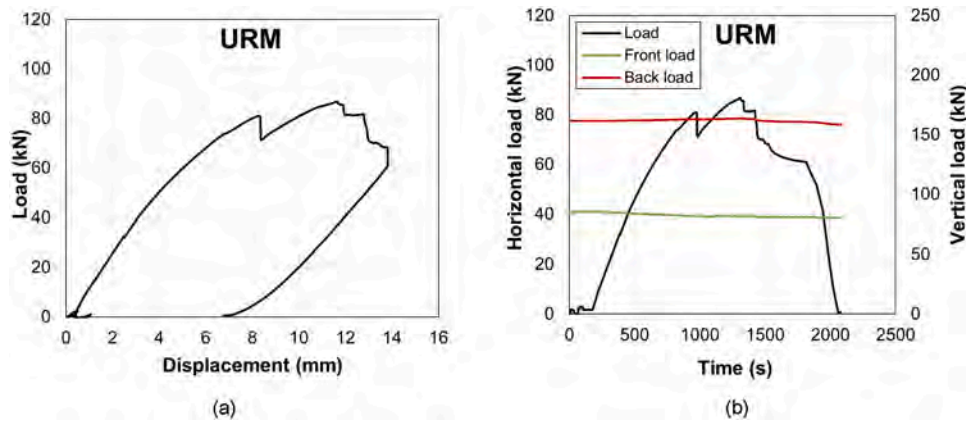
Fig. 10. Load-displacement (a) and load-time (b) curves of the unreinforced monotonic test.

The results of the test on the unreinforced specimen under monotonic horizontal displacement in terms of load vs stroke (at the horizontal jack level) and load vs time are reported in Fig. 10, respectively. Fig. 10b reports also the vertical prestress loads measured on the front (green curve) and back (red curve) walls (right vertical axis). The first observed damage, associated to the FME, was a vertical crack situated in the middle of the front wall (Fig. 11, left). It was detected at a load of 82.0 kN and a displacement (stroke) of 7.9 mm. Right after, a sudden drop of the horizontal load to 72.3 kN was observed. The damage suggested a bending failure of the front wall due to the out-of-plane loading. With further increase of the imposed displacement, two additional cracks appeared along the vertical connecting joints plus another vertical crack on the external side of the left back wall (Fig. 11, right). At this point, the test was stopped, and the specimen unloaded (zero horizontal load).

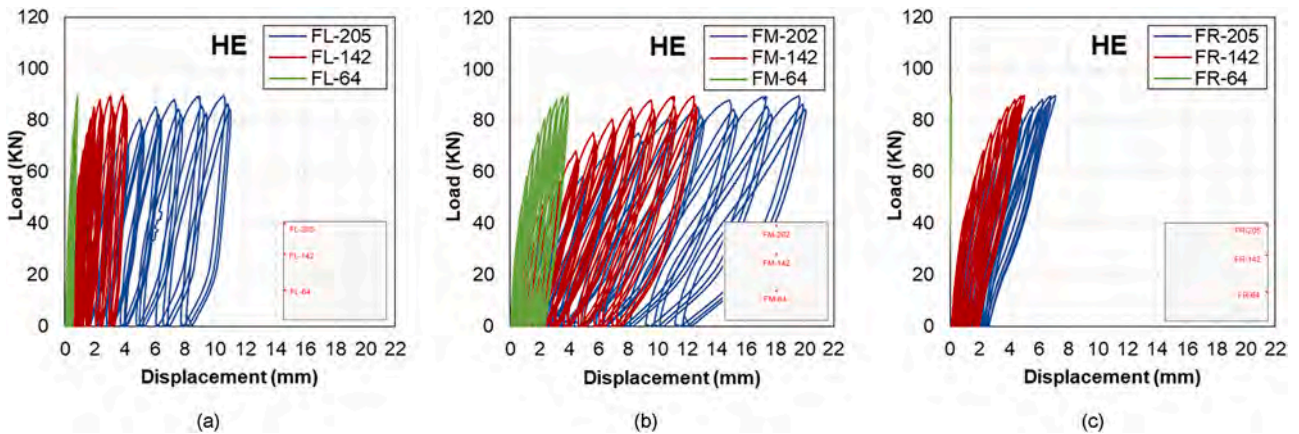
Fig. 16. Load-displacement (LVDT) curves at different height of the front wall: (a) left side, (b) middle, (c) right side.

Looking at the load vs displacement curves reported in Fig. 16 and

obtained from the LVDTs located on the front wall, a larger displacement is evident going from the bottom to the top. The displacements result higher (maximum of 19.63 mm) also in the middle with respect to the sides, confirming the horizontal bending detected during the monotonic test. Moreover, the left side of the wall shows higher displacements (max. 10.59 mm) with respect to the right side (max. 7.11 mm), which is an effect of the pre-existing crack on the side of the left back wall. A

progressive residual displacement was also measured by all transducers, especially the ones located at the top of the wall (11.03 mm).

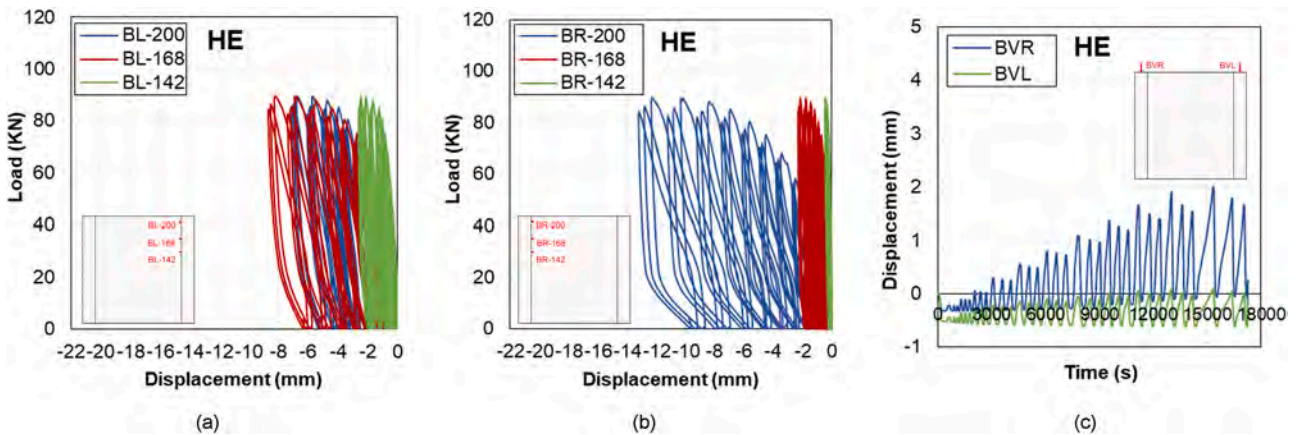
Fig. 17. Load-displacement (LVDT) curves at different height of the front wall measured from the back: (a) relative displacement on left side and (b) relative displacement on right side. In (c), vertical displacement on the back walls.

Fig. 17 shows the relative displacements measured between the front and back walls on the left and right side (Fig. 17a and Fig. 17b, respectively), and the vertical displacement, i.e. uplift, measured on the back walls (Fig. 17c). A significant detachment of the back right wall from the front wall is evident, especially at the top (13.21 mm on BR-

200), while at lower levels the LVDTs showed limited displacement. On the left wall, the maximum displacement was lower (8.71 mm on BL-200) with respect to the right wall, but the detachment was observed also at lower levels. However, despite the observed detachment/cracks, the twisted bars were able to well connect the walls, as proved by the uplift recorded (Fig. 17c), especially on the right wall.

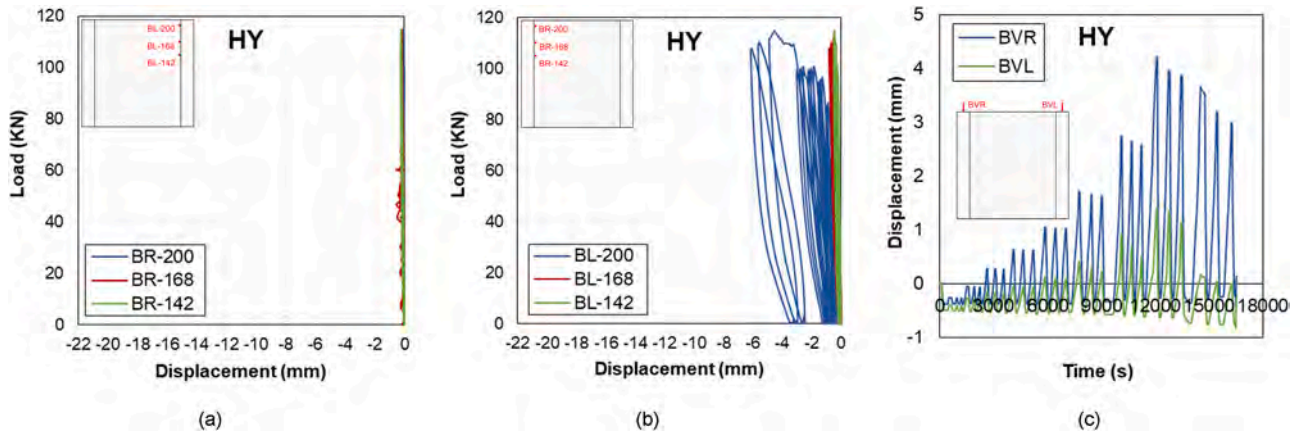
Fig. 21. Load-displacement (LVDT) curves at different height of the front wall measured from the back: (a) relative displacement on left side, (b) relative displacement on right side. In (c), vertical displacement on the back walls.

Looking at the load vs displacement curves obtained from the LVDTs located on the front wall reported in Fig. 20, an increase of the displacement is evident going from the bottom to the top of the specimen. The displacements result higher (maximum of 11.9 mm) also in the middle with respect to the sides, confirming the bending mechanism already observed in the previous tests. Moreover, the right side of the wall shows higher displacements (max. 8.5 mm) with respect to the left side (max. 4.0 mm). A progressive residual displacement was also measured by all transducers. Fig. 21 shows the relative displacements measured between the front and back walls on either side (a and b, respectively), and the vertical displacement, i.e. uplift, measured on the back walls (Fig. 21c). The relative displacement is negligible on the right side, denoting an excellent connection, while on the top-left side (BL-200) a large displacement (6.14 mm) was measured where a crack developed during the monotonic test (Fig. 11b), resulting in a less effective connection. During the test, the back wall uplifted especially on the right side, reaching 4.2 mm of vertical displacement (Fig. 21c), demonstrating the effectiveness of the connection.

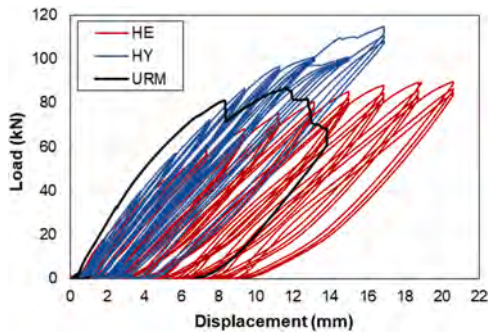
Fig. 22. Load-displacement (stroke) curves for the different tests: monotonic on the unreinforced specimen (URM), cyclic on the specimen retrofitted with twisted bars (HE) and cyclic on the specimen retrofitted with rebars and adhesive (HY).

A significantly different behavior can be observed between the unreinforced specimen (URM) and the specimen retrofitted using twisted bars (HE) or bonded bars (HY). The unreinforced specimen showed a higher initial stiffness with respect to both retrofitted solutions. This may be attributed to the fact that the strengthening was applied on the damaged specimen and that the cracks occurred during the monotonic test could not be completely closed (i.e. zero crack width was not recovered).

The HE specimen showed similar stiffness for the first cycles (up to 100 % of FME) with respect to the HY one. After this point, the HE specimen underwent larger displacements and a stronger loss in stiffness, associated to a high dissipation capability. Both retrofitted specimens showed a maximum load higher than the monotonic test peak load. However, for the HE solution, the monotonic peak load was reached at around 50 % larger displacement due to the stiffness degradation, while the HY specimen approximately continued (with slight parallel shift) the original curve of the URM wall (before the FME had occurred) even at displacements beyond the FME.

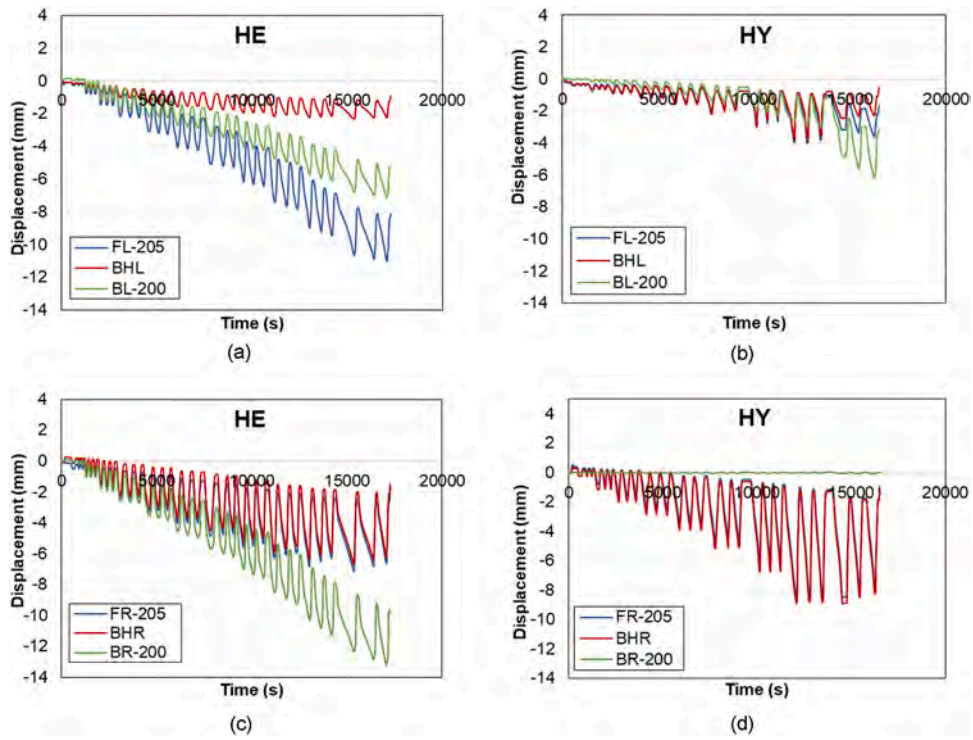
Fig. 25. Time-displacement curves at the top of the specimen for both retrofitting solutions – on the left (a-b) and right side (c-d) of the specimen.

On the left side, a crack developed between the front and the rear wall (Fig. 11b). In case of twisted bars, this resulted in a significant relative displacement between back and front wall (BL-200, Fig. 25a), with smaller absolute displacement associated to the back wall (BHL) in comparison to the front wall (FL-205) due to insufficient crack stitching. A better behavior was observed in case of bonded bars (Fig. 25b), where the relative displacement was limited and emerged only in the final phase of the test.

On the right side, a crack developed on the front wall (Fig. 11a). The rebars with adhesive (Fig. 25d) resulted capable to stitch the existing crack, as proved by nearly zero relative displacement (BR-200), with a perfect superposition of the absolute displacement measured at the top front wall (FR-205) and top back wall (BHR). On the contrary, considering the specimen with twisted bars (Fig. 25c), a very large relative displacement between the two walls of about 13 mm was measured (BR-200), associated to a clearly softer behavior and high dissipation. Nevertheless, since the crack was located on the front wall, coinciding displacements measured at the top front wall (FR-205) and top back wall (BHR) were recorded.
