Seismic Retrofitting of Indonesian Masonry Using Bamboo Strips: An Experimental Study

Keywords: unreinforced masonry housing; bamboo retrofitting; pushover test; diagonal compressive shear test; ductility; seismic retrofitting

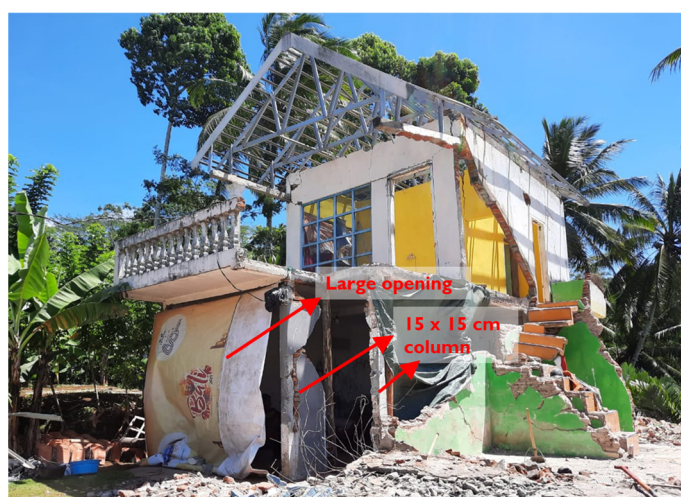
Figure 1. Heavy damage on a two-story confined masonry (CM) with a large opening and substandard RC frame.

In Figures 1–3, the photographs of damaged or collapsed UM or CM housing after the Malang earthquake (East Java, Indonesia) in April 2021 are shown. Figure 1 presents heavy damage on a substandard two-story CM housing with a large opening on the first floor and too small columns with cross section dimension of $15 \times 15 \text{ cm}^2$. In Figure 2, a collapsed single-story building with a heavy concrete roof deck is shown. Several drawbacks of the structure were observed: heavy mass of the roof, reduced column cross area due to the placement of a PVC drainage, poor lap splice, and poor confinement. In Figure 3, two neighboring UM housing are depicted. The building on the left remained intact, while the building on the right was heavily damaged. Since the dimension and the floor plan of both buildings were almost similar, the difference in material quality, particularly the mortar joint, may be the main reason why those two buildings performed very differently against the same earthquake.

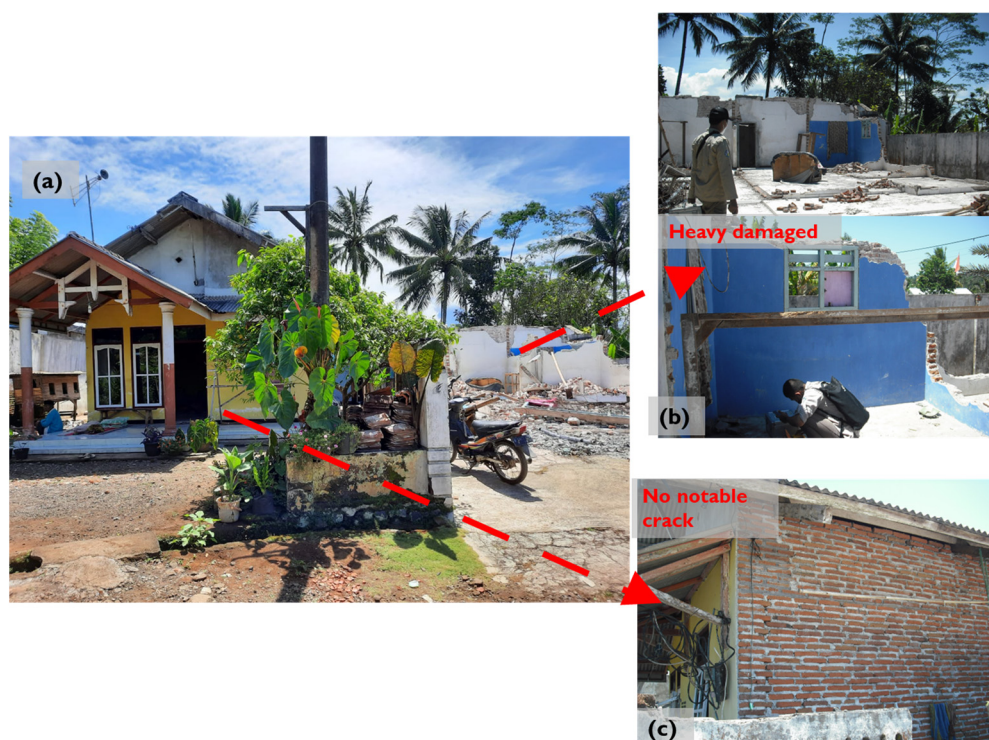
Figure 3. (a) Two neighboring UM housing after an earthquake: (b) heavy damage on the right house, while (c) no remarkable damage on the left house.

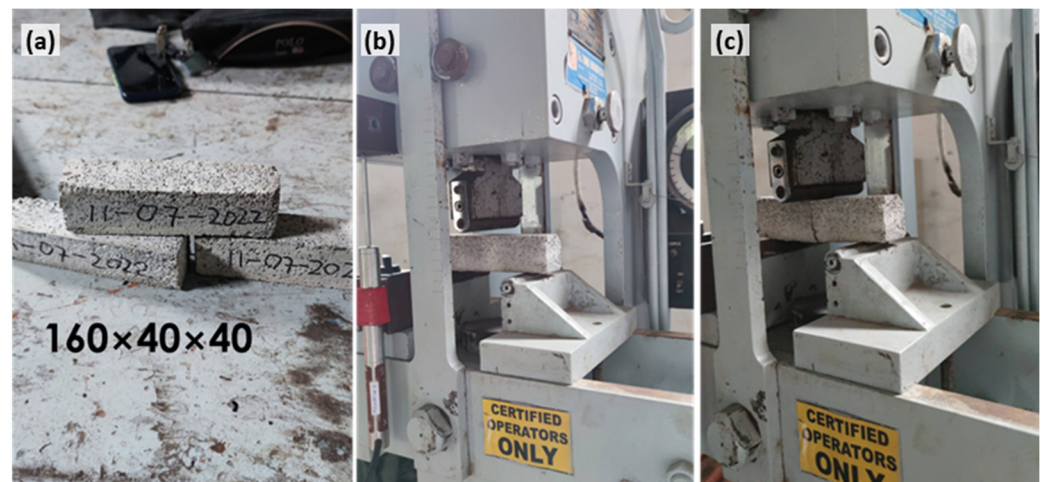
Figure 7. (a) Mortar specimens, (b) the flexural test on the mortar specimen, and (c) the flexural failure of the mortar.

As shown in Figure 7, the flexural test was performed on 30-day-old samples using a one-point load method. The flexural strength (S_f in MPa) of the mortar for the given dimension can be evaluated through Equation (1) [27], where P (in N) is the maximum load.

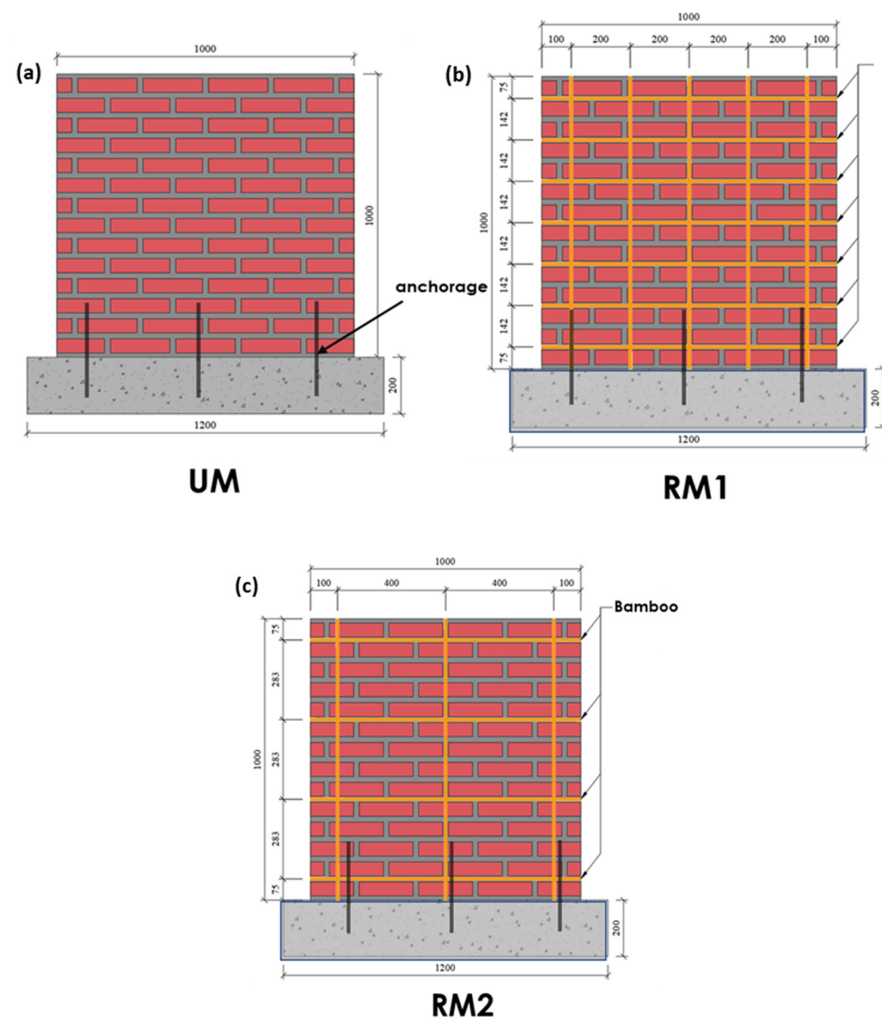
Figure 11. Sketches of three masonry panel models: (a) without retrofitting, (b) with 2.88% of bamboo retrofitting, (c) with 1.44% of bamboo retrofitting.

Six masonry wall specimens with the dimension of $1 \times 1 \text{ m}^2$ were constructed in this study for the pushover shear test, with the configuration as presented in Figure 11. Two samples of unreinforced masonry (UM), two samples with a 2.88% volume ratio of bamboo retrofitting (RM1), and two samples with a 1.44% volume ratio of bamboo retrofitting (RM2). Such percentages were computed as the volumetric ratio of bamboo to the masonry wall.

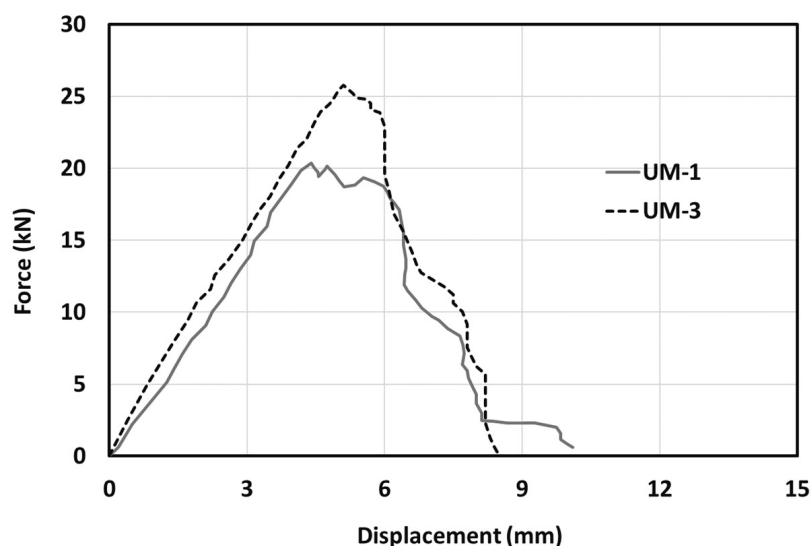
Figure 15. Force–displacement curves of two UM panels under diagonal compressive test.

Diagonal compressive tests were performed on two masonry assemblages. In Figures 14 and 15, the crack pattern of the panels and the force–vertical displacement curves during the test are shown, respectively. The forces at the crack were found about 20 kN and 25 kN, respectively. Table 4 shows the resulting shear strength of the masonry panels under the diagonal compressive test through Equation (2). The average shear strength was found 0.13 MPa. Such value is much lower compared to the data obtained from the experimentation in Europe [29] and India [30], 1.678 and 0.220 MPa, respectively.

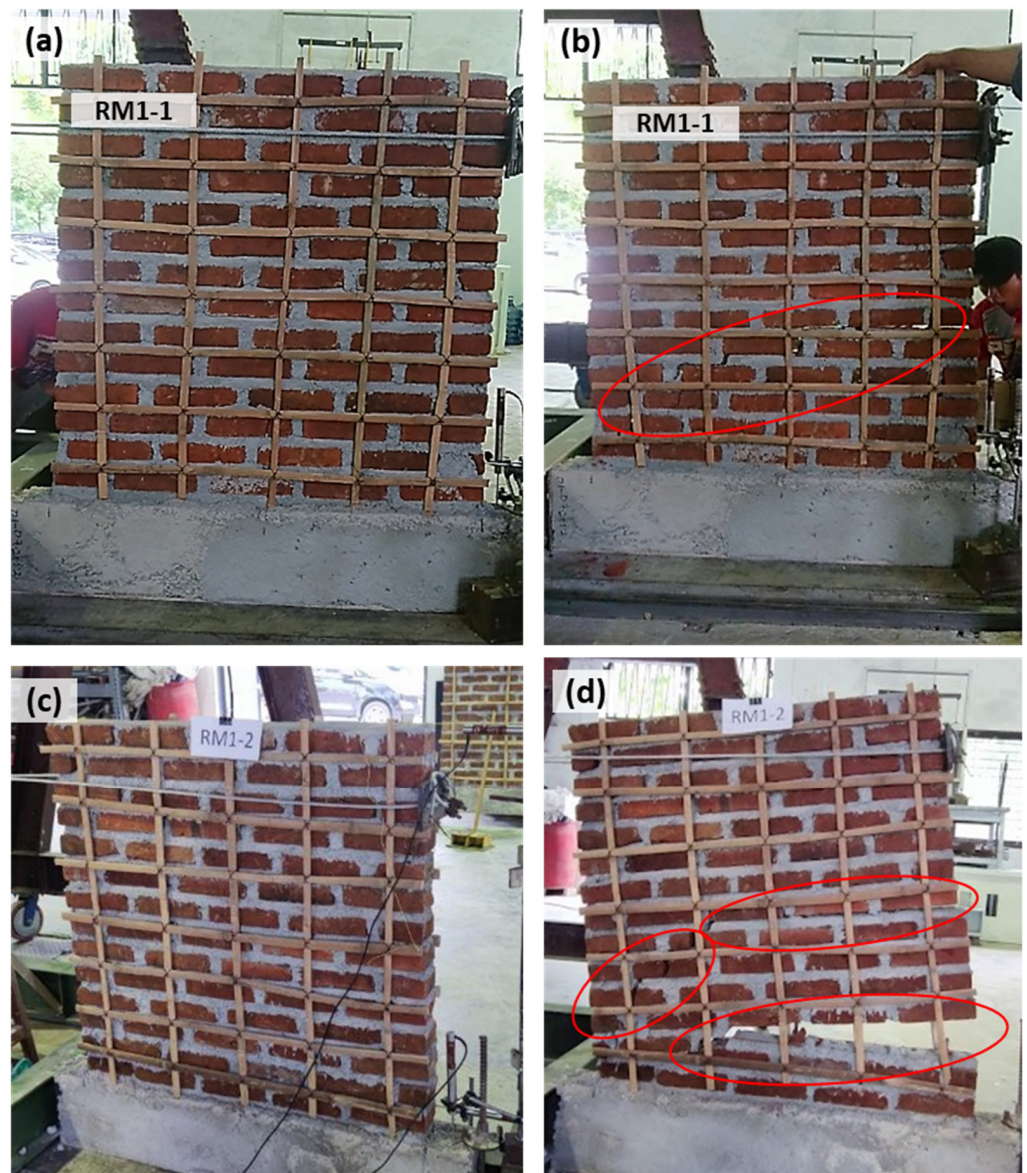
Figure 17. The pushover shear test and crack patterns of the retrofitted masonry panels with 2.88% of bamboo retrofitting: (a,b) RM1-1, and (c,d) RM1-2.

In the case of reinforced specimen RM1, as presented in Figure 17, one specimen presented shear crack patterns (see Figure 17b), while the other one showed a combination of a shear crack pattern followed by a flexural crack pattern (see Figure 17d). When compared to the result of the unreinforced specimens, as shown in Figure 16, the bamboo reinforcement tends to change the failure mode from flexural failure to shear failure.

During the test of the retrofitted models, no notable damage on the bamboo strips was observed. However, at large displacement, remarkable slips on the bamboo wire ties were reported, as clearly seen in Figure 17d. Even though such a failure seems to not significantly decrease the performance of the retrofitted models (RM1), the application of an adhesive agent between bamboo and masonry is recommended to eliminate the slip failure mode, as reported in reference [15]. In real construction, the finishing mortar may also improve the integrity of the masonry and bamboo reinforcement.
