# Effects of changing temperature in the vibration-based model updating of a masonry bridge

P. Borlenghi, A. Saisi & C. Gentile  
*DABC, Politecnico di Milano, Milan, Italy*

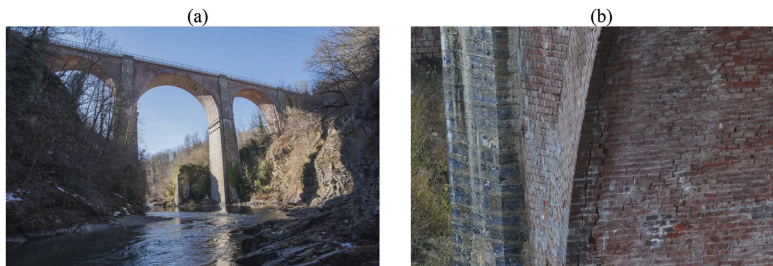
Figure 1. The *Olla* bridge: (a) picture from the Stura River; (b) existing damages on the second arch.

The investigated structure (Figure 1a) – called *Olla* bridge (Borlenghi et al. 2023) – is a multi-span masonry arch bridge that crosses the Stura River between the small municipalities of Gaiola and Borgo San Dalmazzo. The structure is approximately 120 m long and comprises 5 arches, with a maximum span of 25 m, 4 piers and end abutments, with the tallest pier being 26 m high. Piers and abutments are in a good quality ashlar stone masonry, whereas arches and spandrel walls are in brick masonry.

The complete representation of the structure was obtained with the Terrestrial Laser Scan and topographic survey. The processing of the point clouds allowed the extraction of an accurate 3D model and a series of conventional 2D drawings from which the FE model was developed. In addition, the visual inspections highlighted the presence of local damages on the arches (Figure 1b) and diffused surface decay.

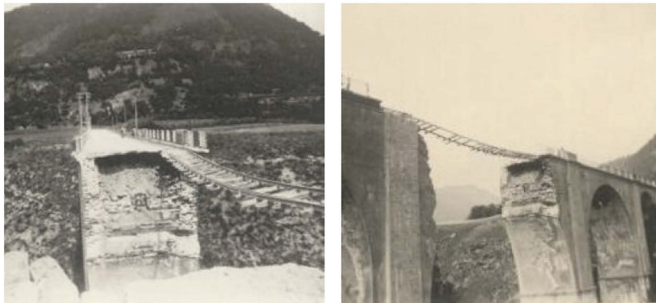
Figure 2. The collapse of the central arch occurred in 1944.

The documentary research revealed the collapse of the central arch in 1944 (Figure 2) and the subsequent reconstruction in 1945.
