## Simplified Vulnerability Assessment of Historical Churches in Banat Seismic Region, Romania

# Simplified Vulnerability Assessment of Historical Churches in Banat Seismic Region, Romania

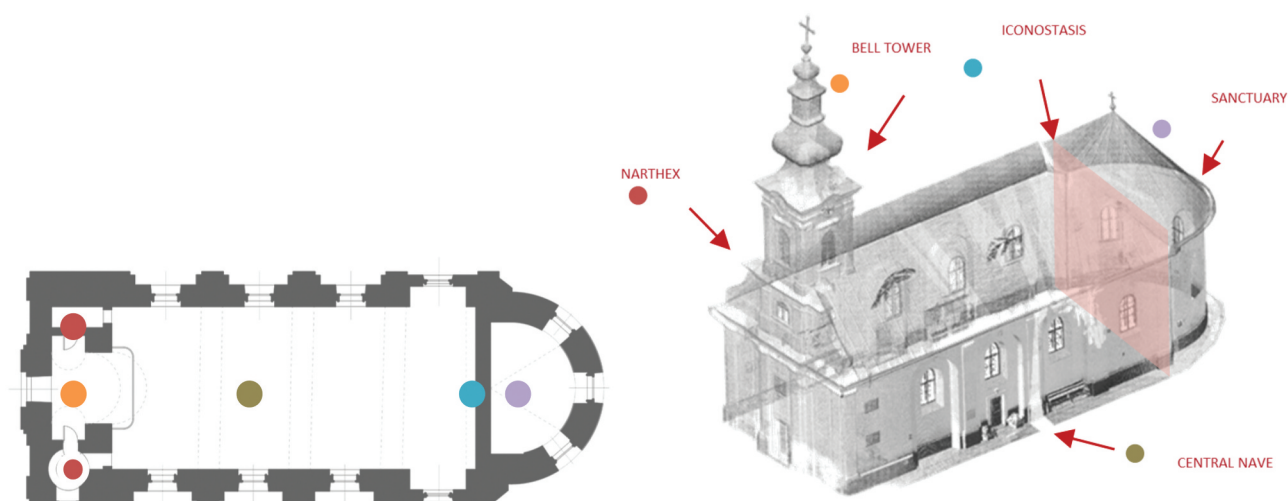
**Figure 3.** Architectural typical configuration of the investigated churches (Lo Monaco et al. 2022).

(which is the wooden wall that separates the naos from the altar), the altar (sanctuary) and the bell tower, which is always located in the main façade, centrally, leading to a typical architectural configuration, as illustrated in [Figure 3](#) (Lo Monaco et al. 2022).

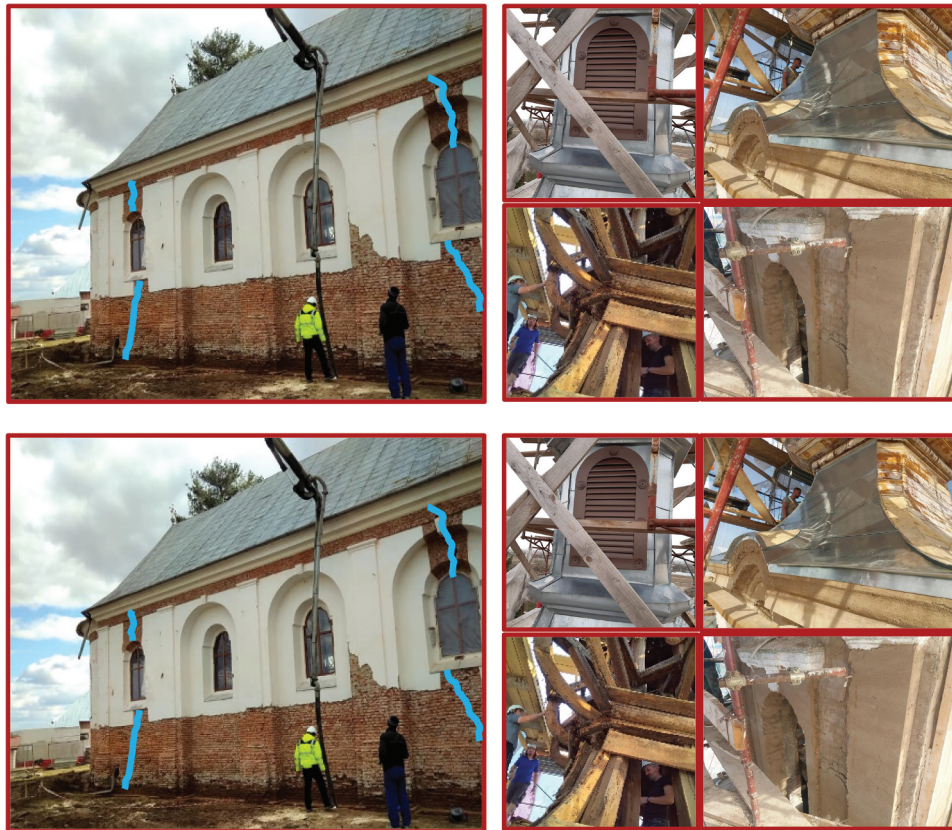
Figure 4. Constructive details of the Belint church.

As a conclusion of the typological structure and architecture of all investigated churches, the bearing walls, and the bell tower are made in brick or mixed stone-brick masonry, the vaults are made in brick masonry or plaster-board-wooden plank, the spire and mezzanine are made in wood, and the pitched roofs are also made in wooden frameworks. All six churches are configured with a single central nave, one central bell tower incorporated in the main façade, and a rounded sanctuary. The differences are related to the dimensions of the six churches, the highest of them being the one in Bocsa, with a bell tower height of 35.33 meters. Some constructive details can also be seen in [Figure 4](#).

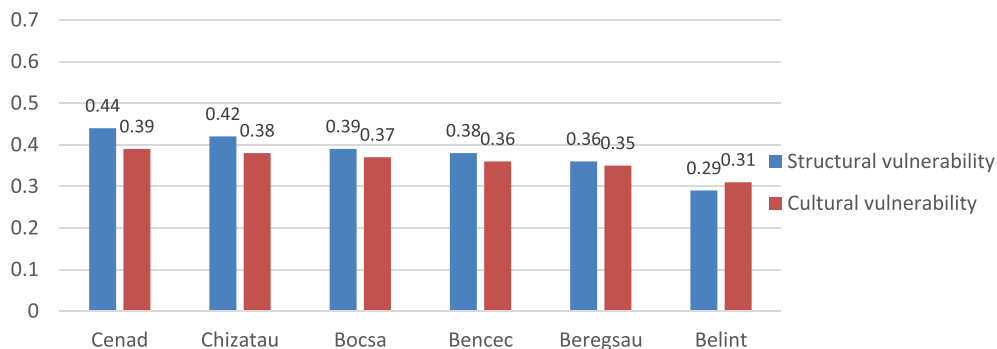
Figure 8. The results ordered in a top of the most vulnerable churches according to empiric methodology.

they were very similar to each other. Moreover, the consideration of cultural value tends to bring all the vulnerability indexes in the same range, as all the investigated buildings are very similar in terms of architectural-artistic, urbanistic, and socio-economic values. So, even if the structural vulnerability of the six churches is a bit different, the cultural vulnerability is much more similar, as presented in Figure 8.

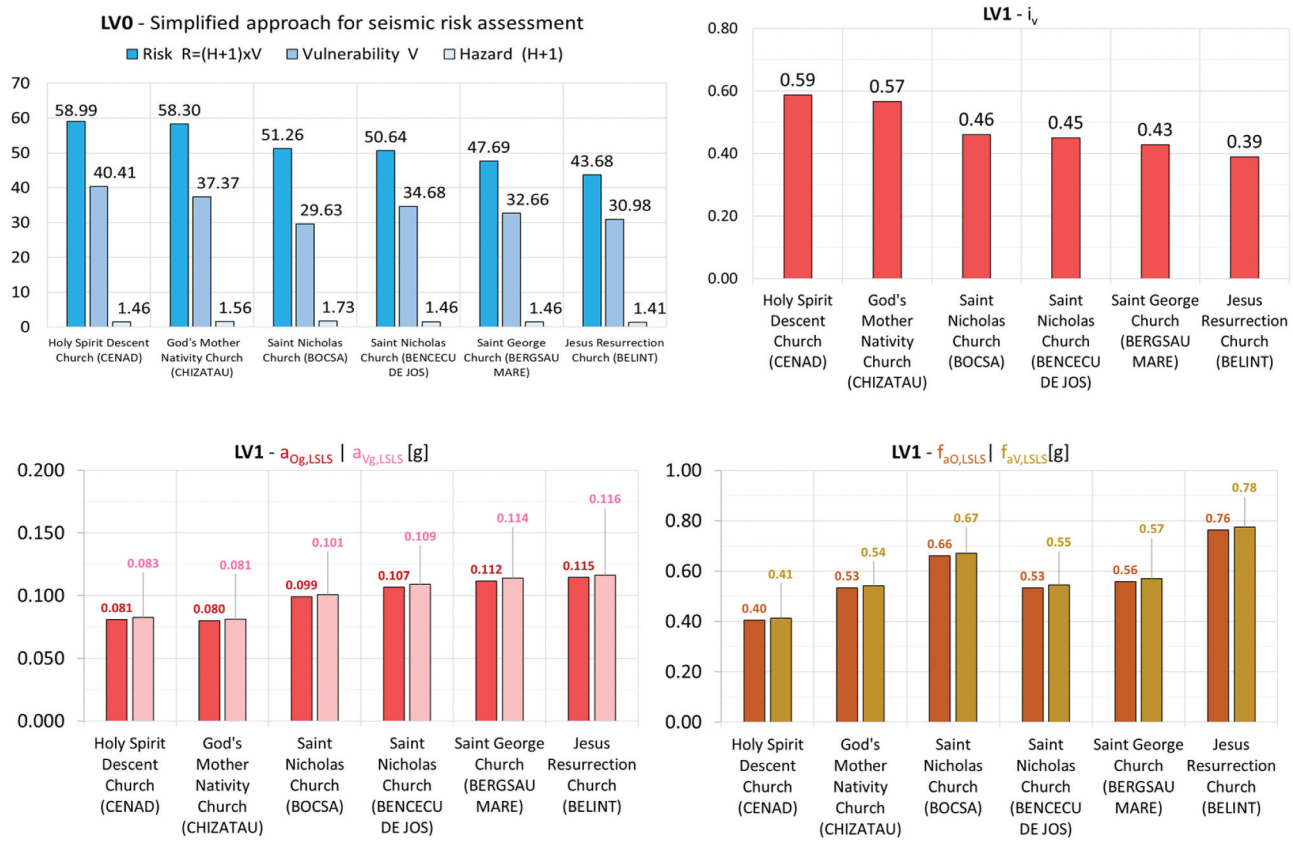
Figure 9. The results following LV0 and LV1 methodology.

less vulnerable is the Church in Belint. The Romanian empiric vulnerability assessment methodology that takes into consideration also the cultural value proposed tends to underestimate 10–15% the seismic vulnerability of the investigated churches in terms of vulnerability indexes but estimates correctly the expected damage state (Figure 9). None of the investigated churches satisfies the LSLS verification.

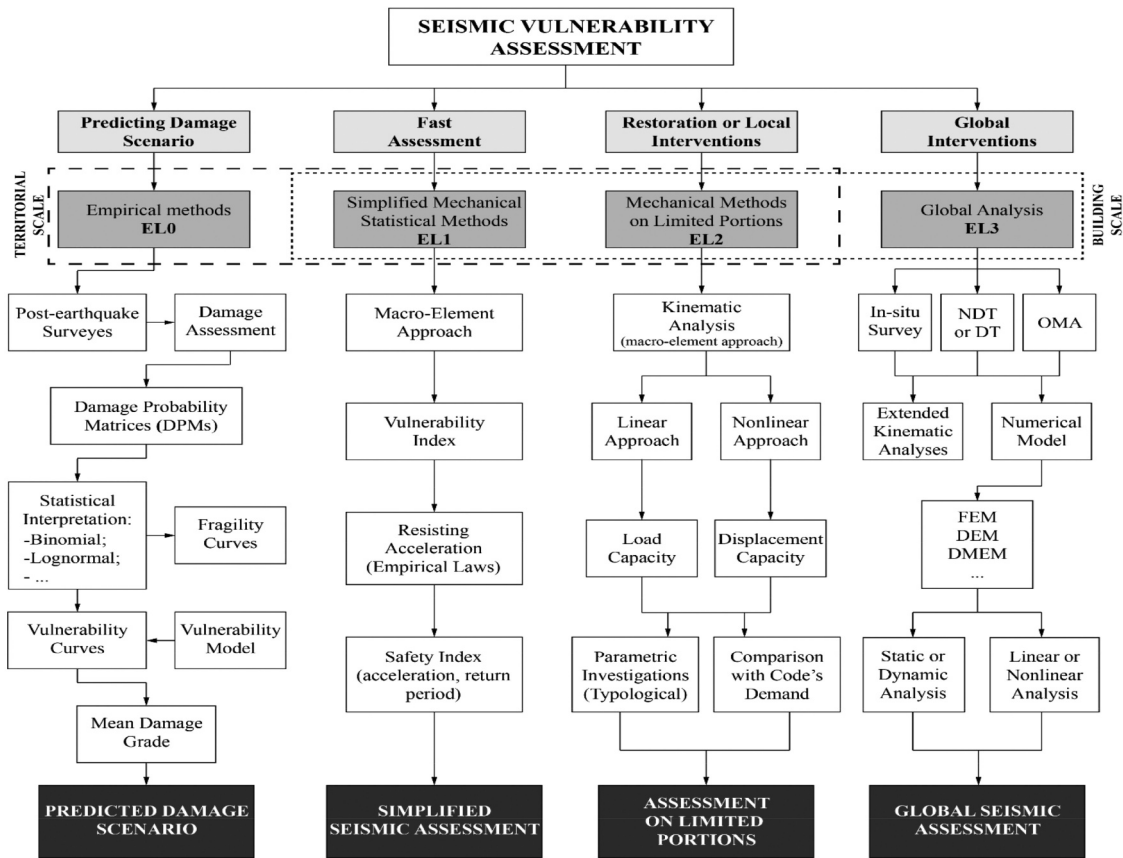
Figure 12. Approaches in the seismic vulnerability assessment process [15].

The surveys that were conducted after past earthquakes, especially in Italy, showed considerable damage to masonry churches, highlighting the necessity of increasing the knowledge level and of improving the existing assessment methodologies for preserving the valuable cultural heritage by means of risk mitigation. The first step in the risk mitigation process is the proper seismic vulnerability assessment of the vulnerable churches, which is a complex process that can be achieved following a large number of approaches, each one corresponding to a different level of accuracy, as presented in Figure 12 (Zizi et al. 2021).

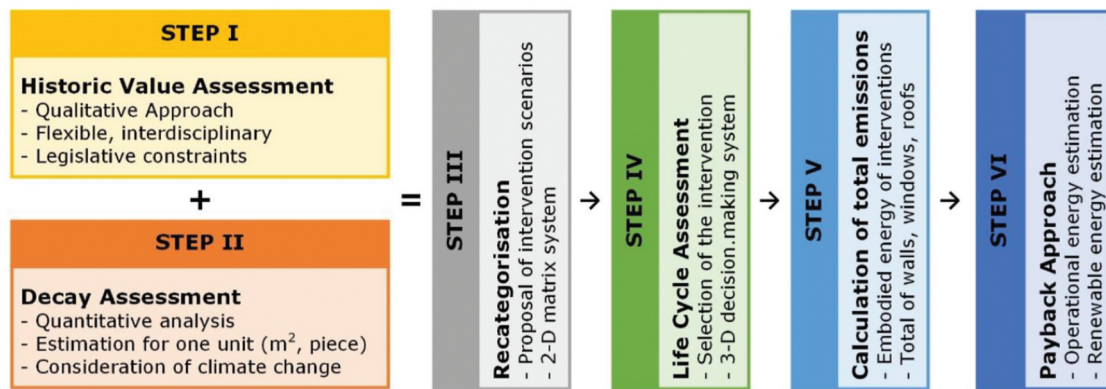
Figure 13. Methodology steps of the Zero Emission Refurbishment procedure for existing buildings and built areas (Loli and Bertolin 2021).

The new urban planning policies recommend considering always a balance between design features and economic, social, and environmental aspects (Tsimplokoukou, Lamperti, and Negro 2014). This aspect is very important when designing new buildings, but assessing the emissions of existing ones, especially historical heritage buildings, is very difficult (Mazzarella 2015). A new procedure was developed by Prof. Bertolin, the Zero Emission Refurbishment method, which aims to reduce the carbon footprint of large-scale interventions on old building stocks. The methodology follows several steps, such as the assessment of the historic value of the investigated buildings, the assessment of the existing decay, recategorization, life cycle assessment, calculation of emissions, and payback approach, as illustrated in Figure 13 (Loli and Bertolin 2021).
