Deep Learning-Based AI-Assisted Visual Inspection Systems for Historic Buildings and their Comparative Performance with ChatGPT-4O

Mayank Mishra ^{1,2}, Kai Zhang ², Chiara Mea ², Luigi Barazzetti ², Francesco Fassi ², Fausta Fiorillo ², Mattia Previtali ²

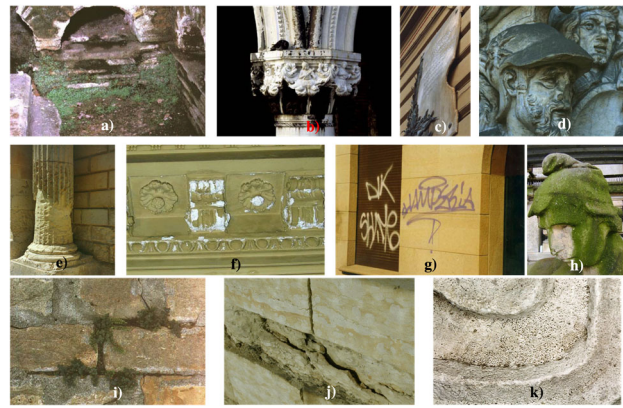
Figure 1. Test images for ChatGPT chosen from UNI 11182 (2006) showing various types of damages: a) biological colonization, b) crust deposit, c) deformation, d) superficial deposits, e) disintegration, f) efflorescence, g) graffiti, h) biological colonization, i) presence of vegetation, j) detachment, and k) pitting.

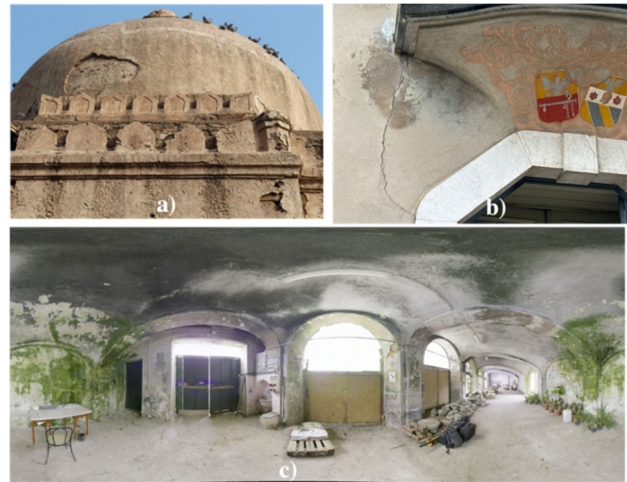
Figure 2. Additional images chosen from a) Mishra et al. (2024), b) Photo by L. Barazzetti, c) Limonaia case study (equirectangular image by F. Fassi and K. Zhang) for ChatGPT showing various types of damages.

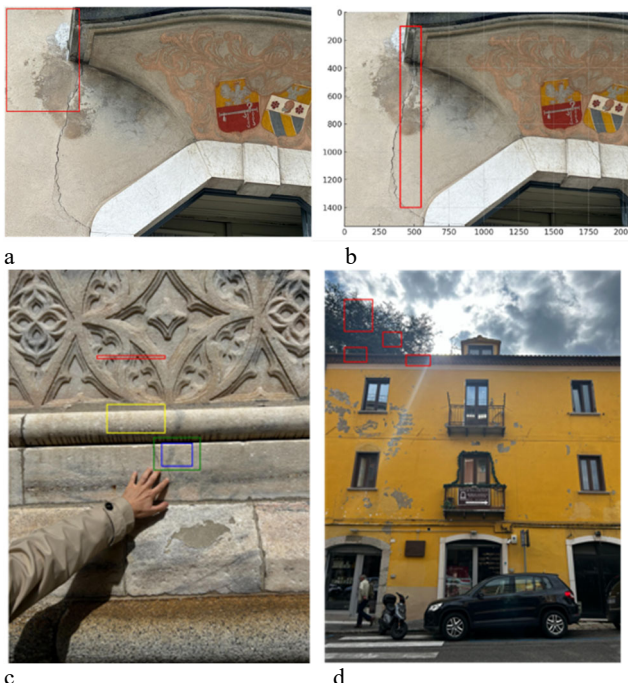
Figure 3: Limitations in identifying damages using ChatGPT (bounding boxes are not at exact locations).

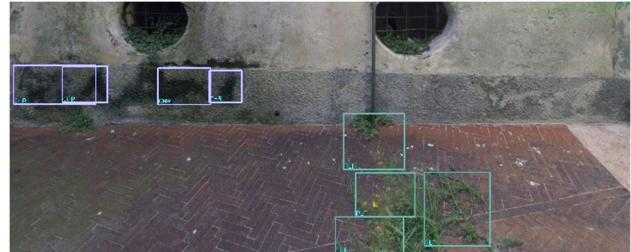
Figure 4. YOLOv5 model prediction (Zhang et al. 2024) on an image of Casa Parrocchiale in Civate (photo by F. Fassi): green squares correctly detect plants, purple ones detect black crust.

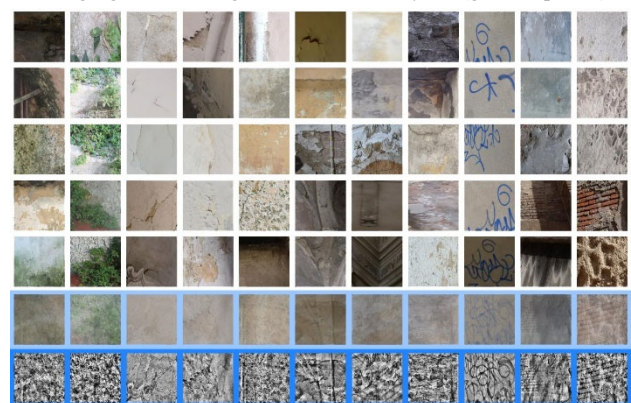
Figure 6. Every column represents a category used to train the model, from the left: Biological Colonization, Plant, Crack, Delamination, Disintegration, Peeling, Discoloration, Crust and Deposit, Graffiti, Subflorescence and Efflorescence. The first 5 rows are sample images, the light blue row is an Average Image, and the last one is the Strengthened Pattern Image derived from it. (Adapted and modified from Zhang., et al., 2024)

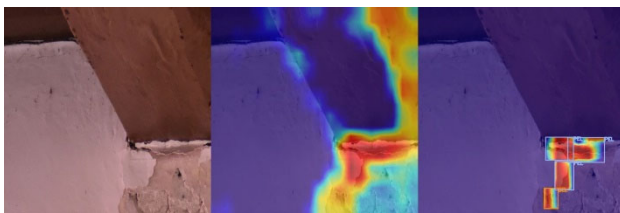
Figure 7. Object Detection Model Visualization with Eigen-CAM (Muhammad and Yeasin, 2020). Left to right: Test image with peeling pathology; Eigen CAM extracted from the 7th layer; Scaled CAM within the bounding boxes.

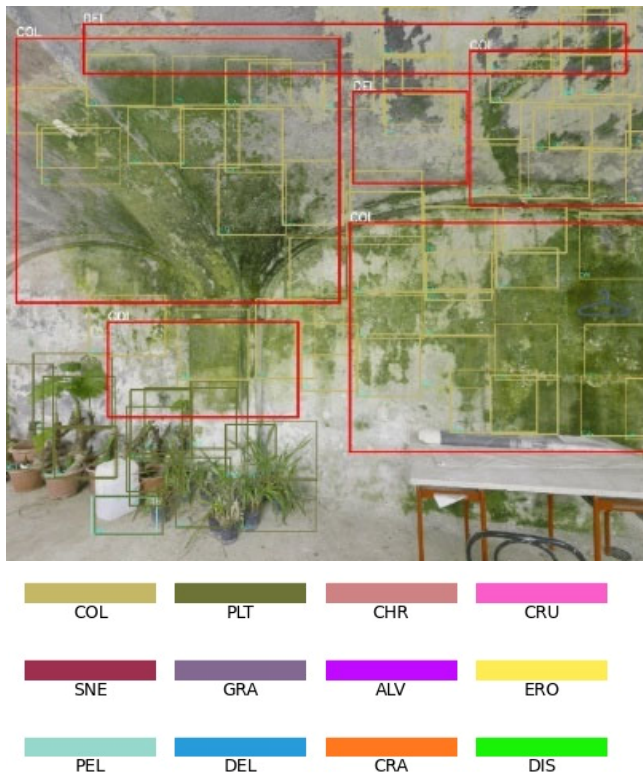
Figure 8. YOLOv5 object detection (cyan-labeled little boxes) vs. human annotation (red-labeled bigger boxes). Limonaia, Lainate (photo by F. Fassi).
