Engineering Failure Analysis

Seismic assessment of Romanian Orthodox masonry churches in the Banat area through a multi-level analysis framework

Firstly, territorial Level of Valuations (*LVO* and *LVI*) are conducted on the churches sample examined. Afterwards, local (*LV2*) and global (*LV3*) valuations are performed on a case study, the Învierea Domnului church, assumed representative of all the churches sample under consideration. In particular, local analyses are performed on some church architectural portions with the kinematic limit analysis. Whereas, global analyses are conducted with non-linear push-over approach. Comments and comparisons of the obtained results are reported for each *LV* examined.

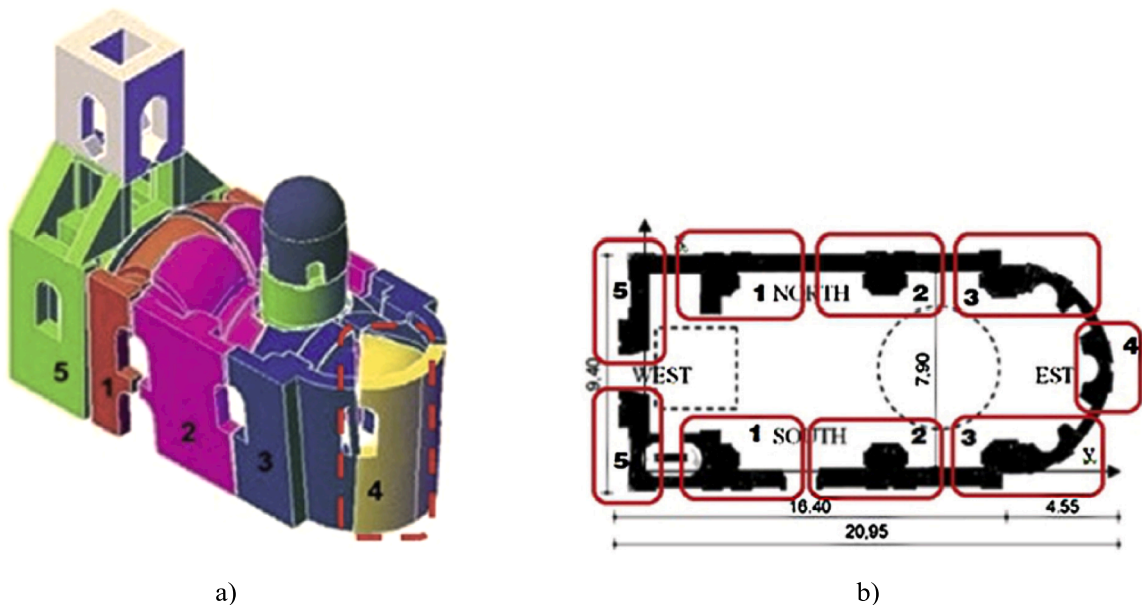
Fig. 1. Failure rigid blocks schematization: a) axonometric view; b) plan view.

The work presented in this paper is part of a research focused on existing Romanian Orthodox masonry churches located in the Banat region [41–42], which is the second most important seismic area in Romania [45]. These churches are characterized by a particular structural configuration: they have a rectangular plan with a single nave, a circular or polygonal apse, and a bell tower centrally incorporated into the main façade. Similarly to the Italian ones [28], also for these churches previous works have shown that the seismic damage is localized in architectural parts, validating also in this case the macro-elements approach [43]. Fig. 1 depicts a

division in rigid blocks (macro-elements) for existing Romanian Orthodox masonry churches investigated in [41,43]. Moreover, recent investigations have highlighted that in this area earthquakes with a significant vertical component occurred, resulting in severe damage on masonry structures, such as vertical shear cracks deriving from the differential vertical soil movements, that can furtherly facilitate out-of-plane collapses [7,44].

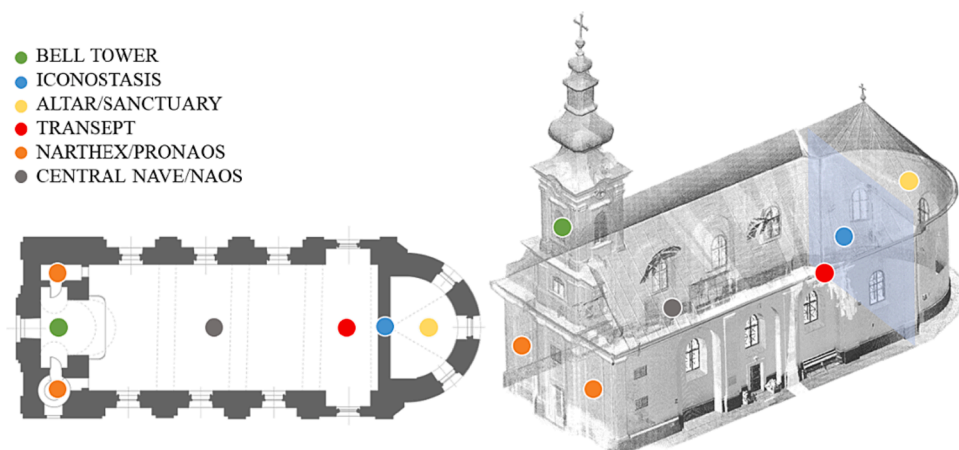
Fig. 3. A representation of a typical Romanian Orthodox masonry church in the Banat area.

From an architectural point of view, the selected case studies are representative of Romanian Orthodox masonry churches with an architectural typology of the XVIII-XIX Century in the Banat area. This church typology is characterized by a rectangular simple plan and a unique nave, covered by barrel vaults and arches, with a bell tower centrally positioned within the main façade. Gable or Dutch roof is recurrent for this church typology. The division of the interior space is specific of the Orthodox churches. The first main space is the *pronaos*, also called as narthex. It is followed by the main space, the *naos*, also called the central nave. The wall separating the naos from the altar is called *iconostasis* and is usually made of decorated wood. The last space is the altar, usually oriented to the East, named the *sanctuary* as well. A representation of a typical Romanian Orthodox masonry church is presented in Fig. 3 [42].

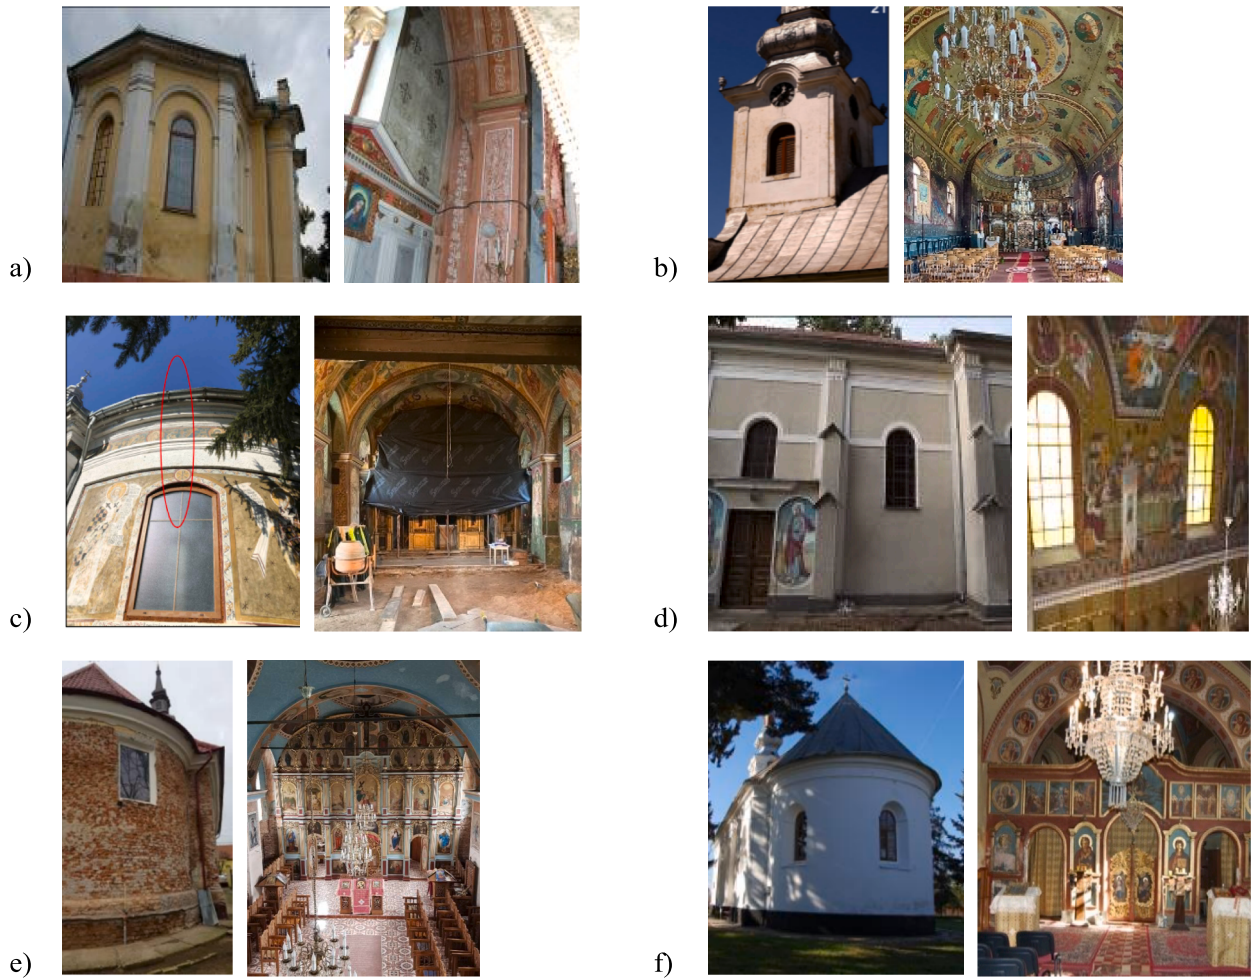
Fig. 4. Exterior and interior pictures which show the conservation state of the investigated churches: a) Holy Spirit Descent Church of Cenad; b) Virgin Mary's Nativity Church of Chizătău; c) Saint Nicholas Church of Bocea; d) Saint Nicholas Church of Bencecu de Jos; e) Saint George Church of Beregsău Mare; f) Jesus Resurrection Church of Belinț.

All the investigated buildings present a plan with a unique central nave, built in brick masonry with perimeter massive walls with thicknesses up to 160 cm. The most common damages observed on the investigated churches are due to lack of preservation in the past years, showing cracks on the structural walls, damaged plaster and paintings (Fig. 4).

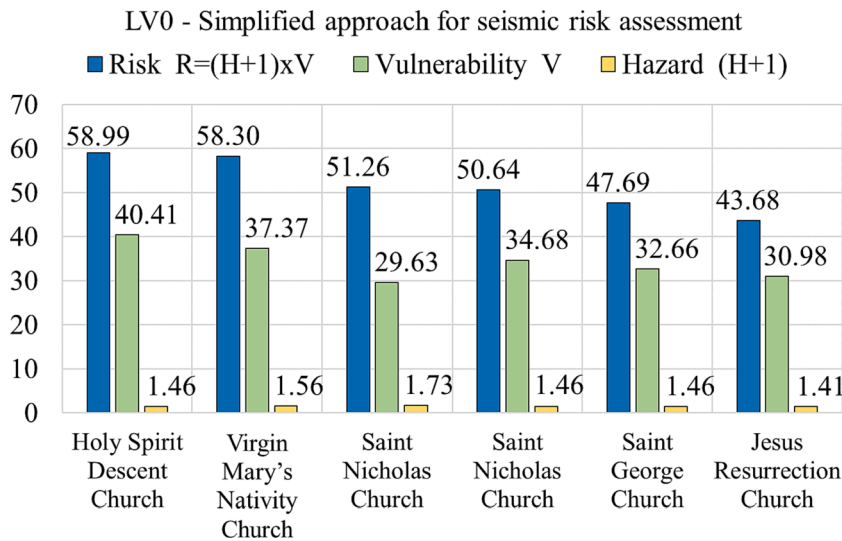
Fig. 7. LV0 results of the six case studies considered.

Appendix A reports, for each of the six churches considered in this study, the values assigned for calculating the resulting Hazard *H* and the Vulnerability *V* score (from Tables 6-11). They are plotted in the histogram of Fig. 7, together with the resulting Risk score *R*, listed in descending order. The highest *R* score is found in the case of the Holy Spirit Descent church (biserică Pogorârea Sfântului Duh) located in the municipality of Cenad. On the contrary, the lowest *R* score is obtained in Jesus Resurrection Church (biserică Învierea Domnului) in the Belinț municipality. As one may note the resulting risk *R* depends on the combination of the two scores estimated (that are *H* and *V*). Moreover, the church with the lowest seismic risk *R* score (Jesus Resurrection Church) has not the lowest vulnerability *V* score (*V* = 29.63 obtained for the Saint Nicolas church), since the latter church is located in an area having the highest seismic hazard *H* among the ones considered in this study.

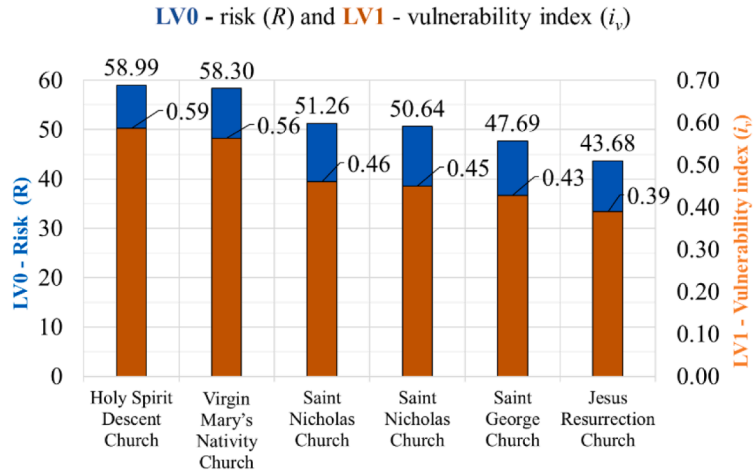
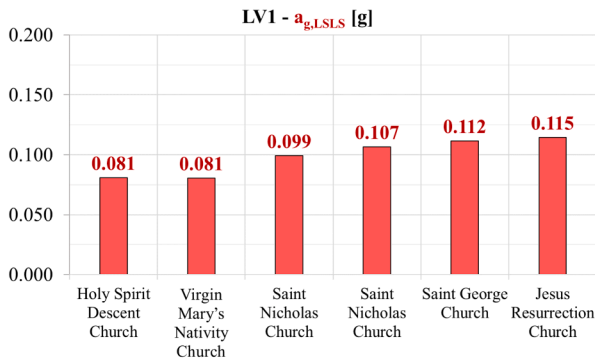
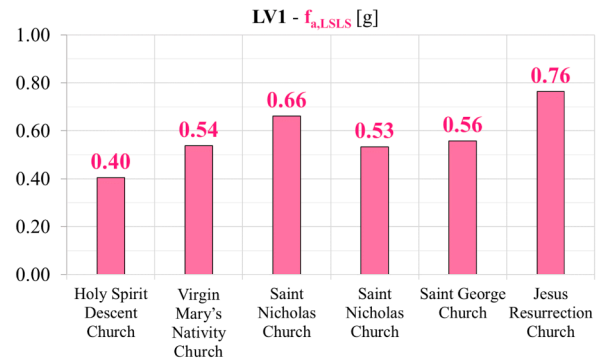
Fig. 8. a) LVO and LV1 results comparison; b) the calculated LSLs acceleration $a_{g,LSLS}$; c) the calculated LSLs acceleration factor $f_{a,LSLS}$ for each church.

As expected, there is a close correlation between a_g and i_v . A higher vulnerability index corresponds to a lower seismic capacity of the structure, and vice versa. According to the LV1 approach, it results that the church with the best seismic performance is still the Jesus Resurrection Church, as found by applying the LVO approach. Moreover, the LVO (Fig. 7) and the LV1 (Fig. 8) results are in agreement in ranking the seismic performance of the churches considered.

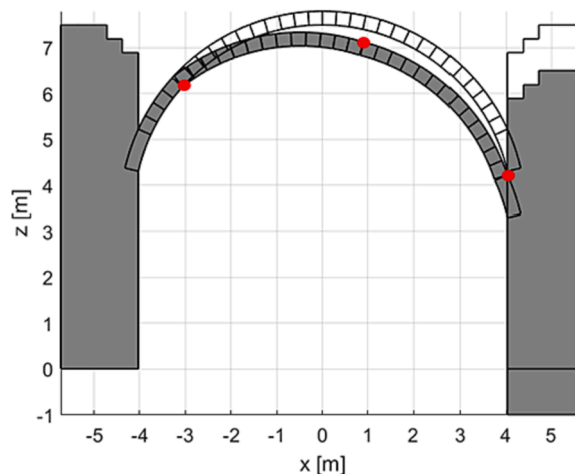
Fig. 10. Jesus Resurrection church. Analysis of the arch subjected to differential vertical settlements: deformed structure scaled by 100 (vertical displacement applied equal to 1 cm).

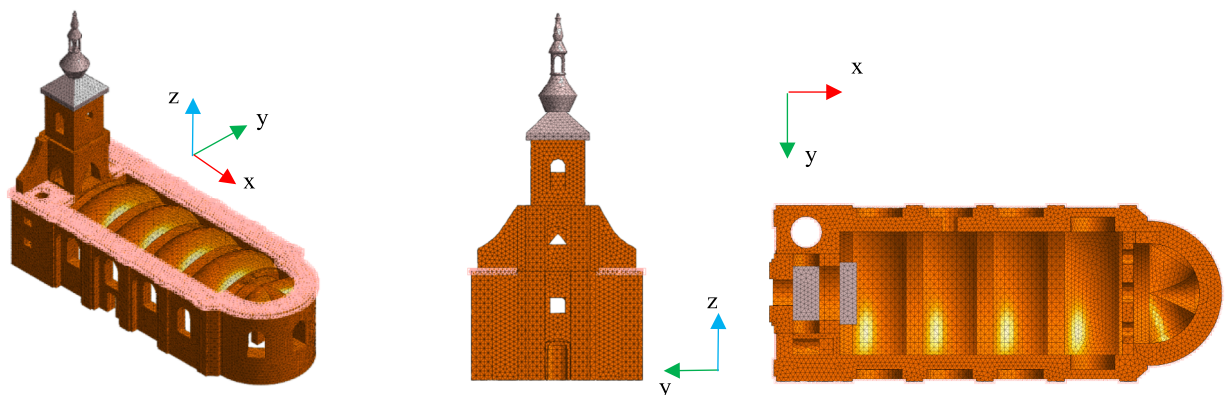
Fig. 12. Jesus Resurrection church (Învierea Domnului) FEM model.

- the sloping wooden roof is not modelled for simplicity but considered only as distributed vertical load acting at walls top. In the modal analyses, this load and the roof elements self-weight is converted into the corresponding mass;
- belfry and the mezzanine floor made of wooden material are modelled with linear material;
- elements mesh takes into account variations in thickness and geometry, as in the case of curved vaults, and also the presence of windows;
- the church is fixed at the base of the vertical walls.

The existing brick masonry is modelled through a smeared crack-model for simulating cracks initiation and propagation within the

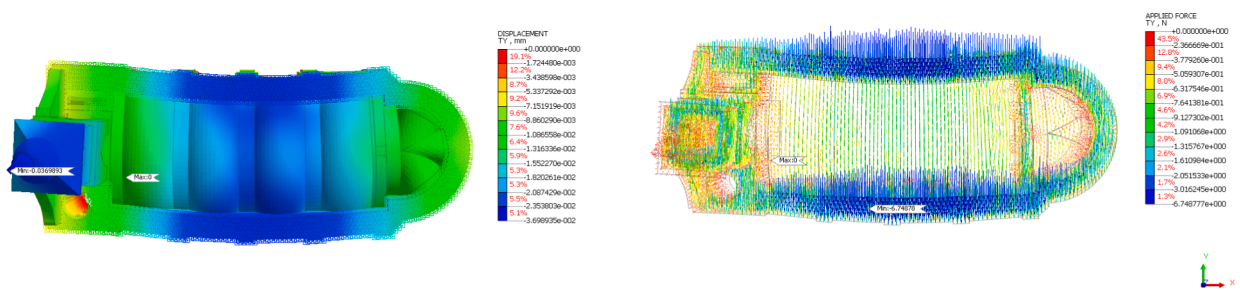
a) Mode n. 1 ($T_1 = 0.187$ s, $\%Mass_1 = 14.12\%$)

b) Mode n. 2 ($T_2 = 0.148$ s, $\%Mass_2 = 56.78\%$)

c) Mode n. 6 ($T_6 = 0.079$ s, $\%Mass_6 = 45.57\%$)

Fig. 13. Vibration mode shapes and Static inertial nodal forces: a) Mode n. 1, b) Mode n. 2 and c) Mode n. 6.

A modal analysis is preliminarily performed. In particular, for sake of brevity Fig. 13 illustrates the results of the vibration Modes n. 1, n. 2 and n. 6. For each vibration mode considered the mode shape is reported together with the corresponding static inertial nodal forces resulting from a spectral analysis. The Mode n. 1, along X direction, is a local mode involving the bell tower within the main façade ($T_1 = 0.187$ s, $\%Mass_1 = 14.12\%$). The Mode n. 2 ($T_2 = 0.148$ s) and n. 6 ($T_6 = 0.079$ s) are global vibration modes along, respectively, Y (transverse direction) and X (longitudinal direction) having the highest participation mass percentages ($\%Mass_2 = 56.78\%$, $\%Mass_6 = 45.57\%$).

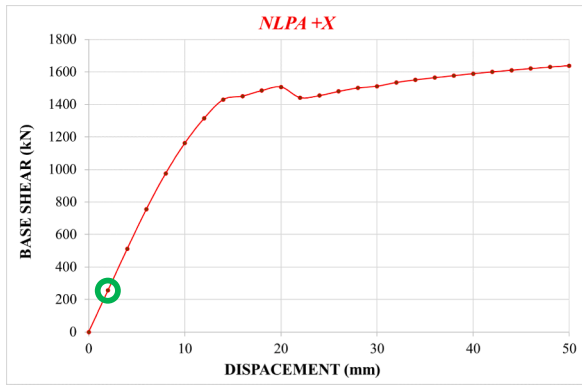
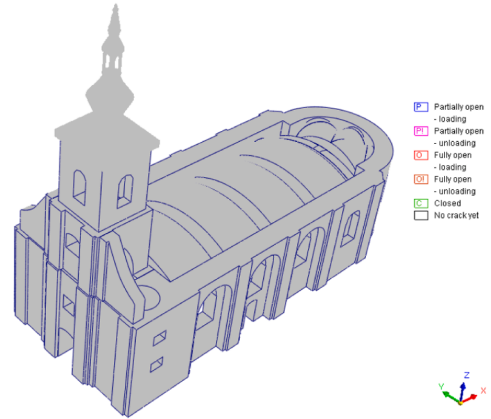
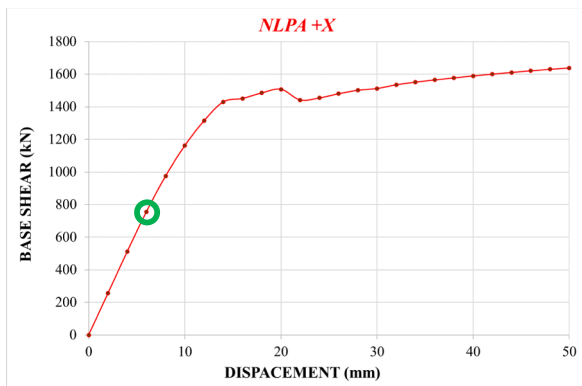
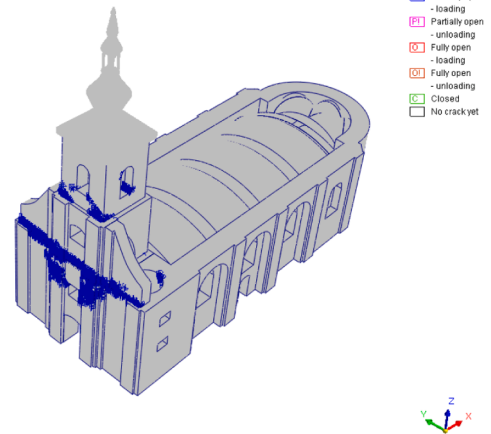
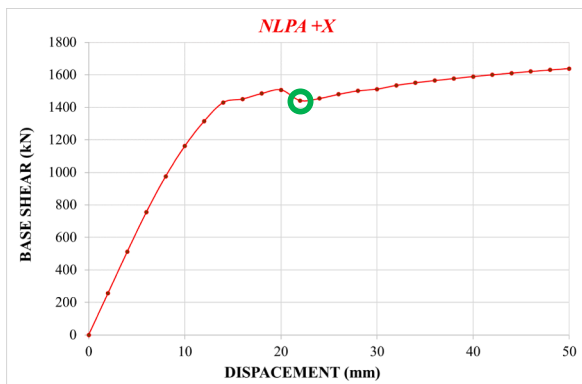
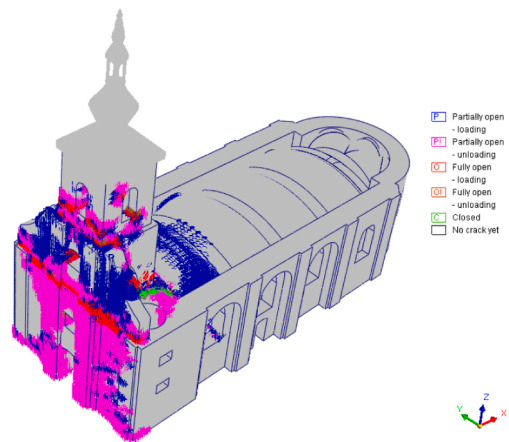
Fig. 14. *NLPA+X*: capacity curve and crack status for several load steps increments.

Fig. 14 through Fig. 18 report the results of the *NLPAs* performed. In particular, each figure shows the capacity curve (in the form of base shear vs displacement, the latter referred to the control node choice in all the analyses corresponding to the upper masonry portion of the belfry, at a height of 17 m, centrally on the side facing the nave), and a crack status for three load steps highlighted on the capacity curve.

In particular, as one may note as for *NLPA+X* (Fig. 14) localized horizontal cracks, due to an overturning, occur at base of the soaring portion of the bell tower and of the belfry. The same conclusion may be drawn in the case of *NLPA-X* (Fig. 15). The *NLPA+X* reaches higher values of base shear than the *NLPA-X* since, as it is possible to note, along this direction the aula vaulted structure is compressed while, in the case of the *NLPA-X*, it is in tension offering, on the contrary, a lower strength when the tower is pushed along the direction *-Y*. Both *NLPA+X* and *NLPA-X* highlights that along the longitudinal direction arises the overturning of the bell tower soaring portion, that is the most church vulnerable portion. Therefore, this conclusion validates the assumption of having this part as macro-element in the *LV2* approach. For completeness, Fig. 16a and Fig. 16b depict a detail of crack status onset where the bell tower damage is localized, referred respectively to the *NLPA+X* third load step and *NLPA-X* fourth load step of the *NLPAs*.

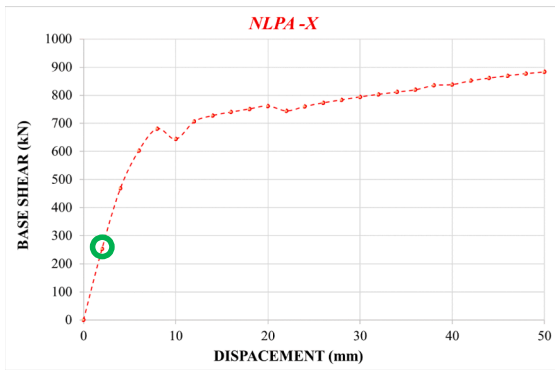
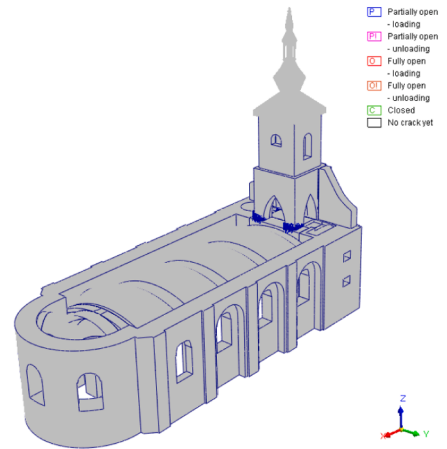
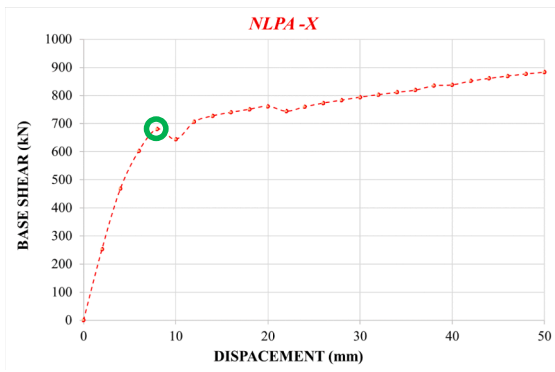
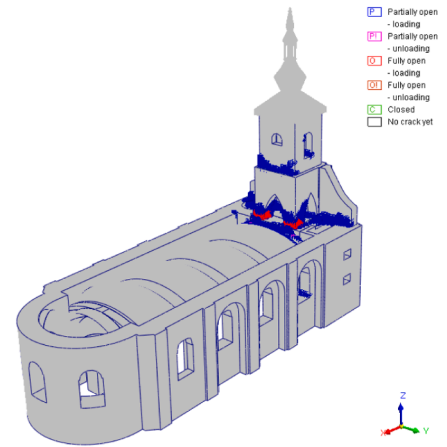
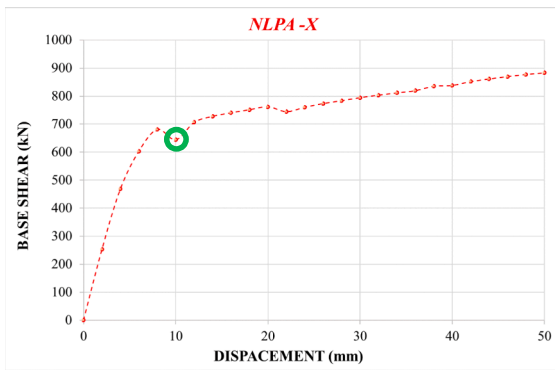
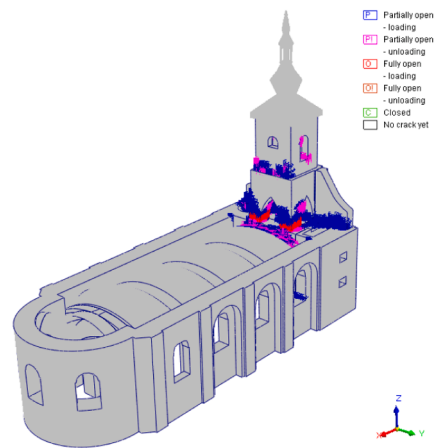
Fig. 15. *NLPA-X*: capacity curve and crack status for several load steps increments.

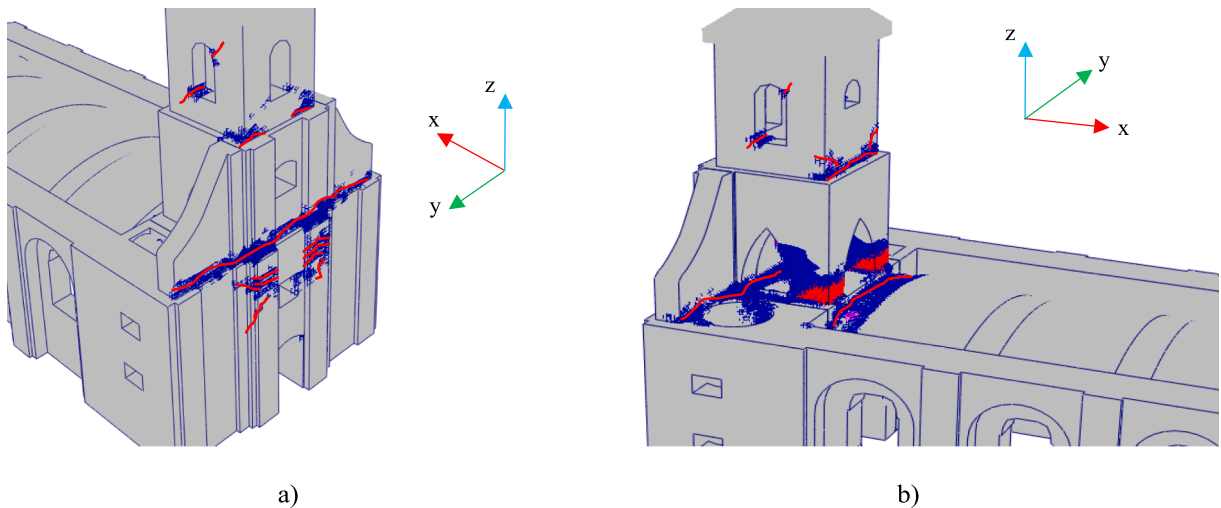
Fig. 16. Detail of the bell tower crack status: a) *NLPA+X*, third load step; b) *NLPA-X*, fourth load step.

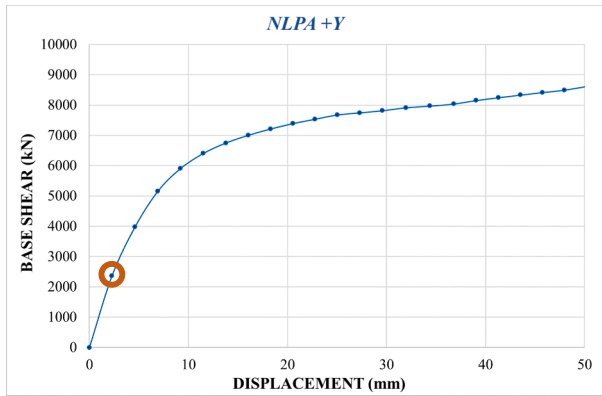
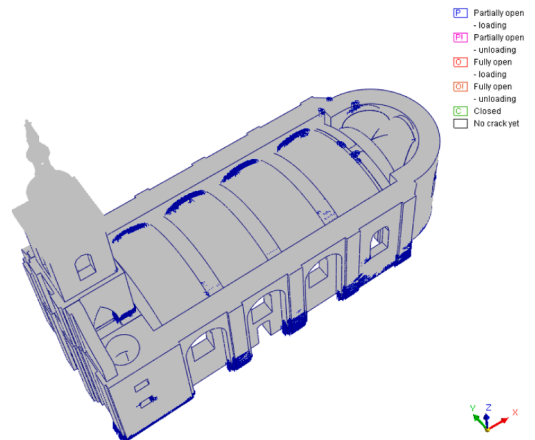
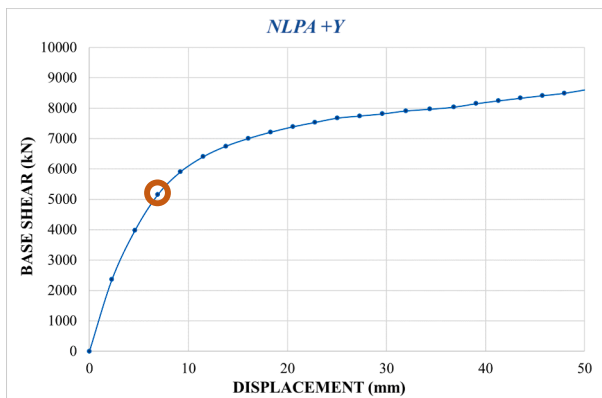
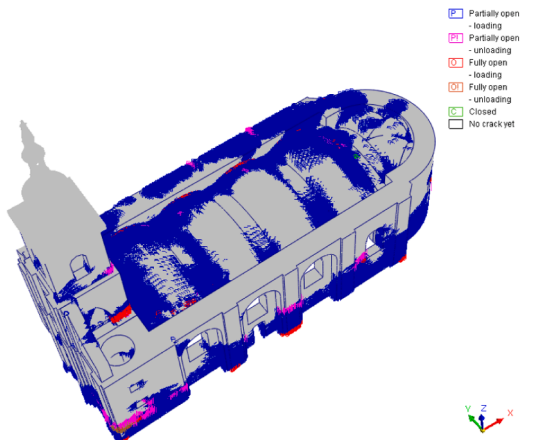
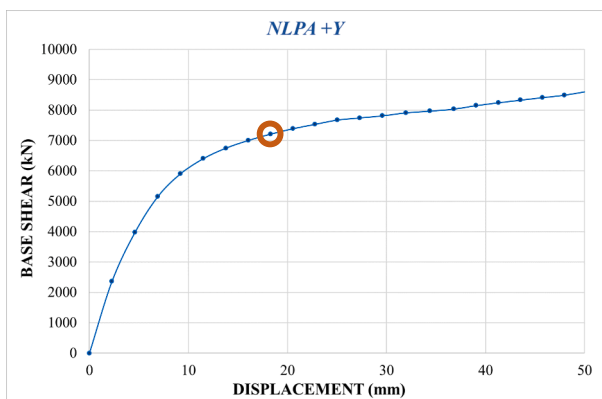
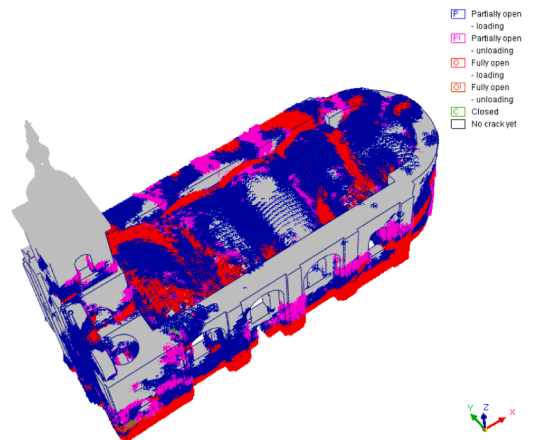
Fig. 17. *NLPA+Y*: capacity curve and crack status for several load steps increments.

As regards the *NLPAs* performed along the transverse direction (*Y* direction), the results obtained are plotted in Fig. 17 and Fig. 18 for *NLPA+Y* and *NLPA-Y*, respectively. In this case, differently for the *NLPAs* along the *X* direction, cracks are not localized in a specific portion of the church, but they are widespread in all the masonry elements, such as walls, aula arches, triumphal arch, barrel vaults, bell tower, and apse. Moreover, cracks distributions are quite similar for both *NLPA+Y* (Fig. 17) and *NLPA-Y* (Fig. 18). Therefore, in this case it is not possible to identify a unique local mechanism (such as the bell tower in the case of *NLPA+X/NLPA-X*), but all the architectural portions (i.e. macro-elements) interact among them in the global response. Fig. 19 reports a particular of the crack status referred to the second step of the push-over analyses. Of course, this result is deeply conditioned by constructions details knowledge (such connection degree among the elements, presence of interventions, and of current crack patterns) that, as known, heavily influence the numerical modelling. They are essential in defining numerical models and in identifying the potential local response mechanisms that may occur. In the case analysed all the elements are assumed to be perfectly collaborating each other by ignoring, therefore, any local situation that may modify the assumption made. Therefore, the assumption made with the *LV2* method with respect to the lateral response tends to overestimate the church current capacity since, due to the interaction among the elements, a premature failure may occur in lateral walls before the aula arches collapse.

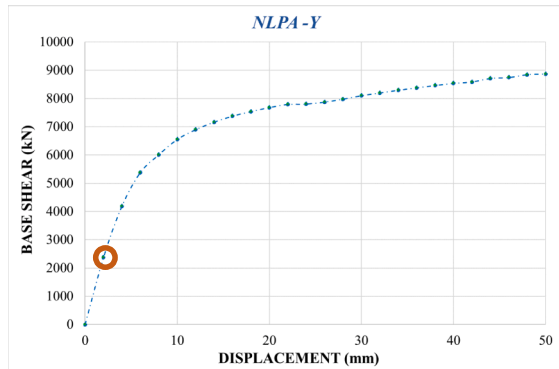
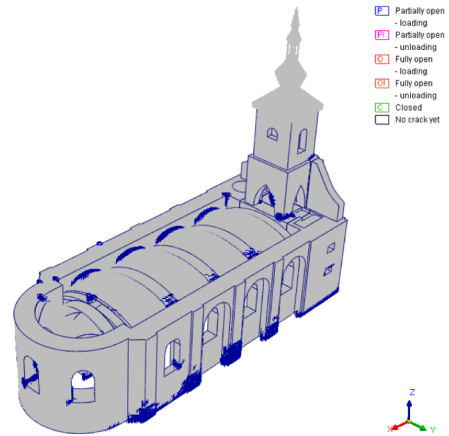
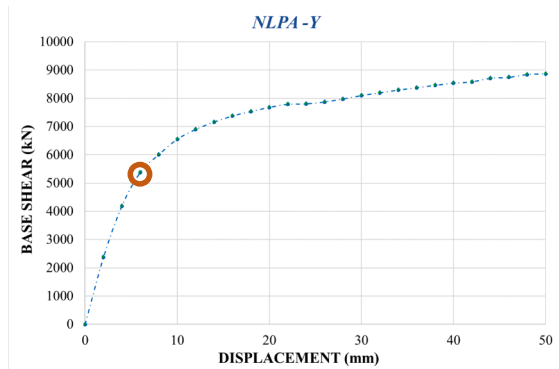
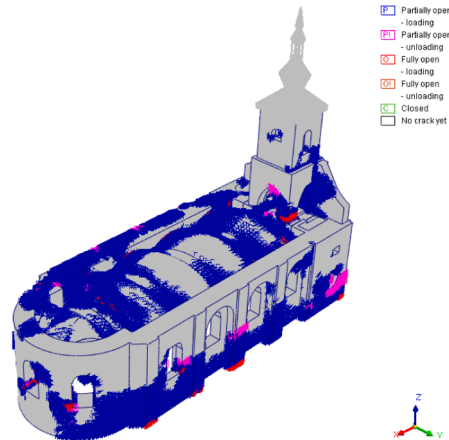
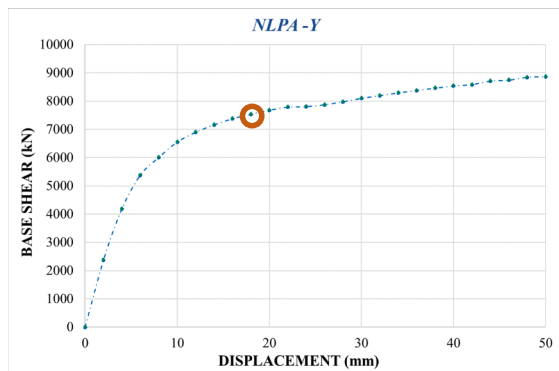
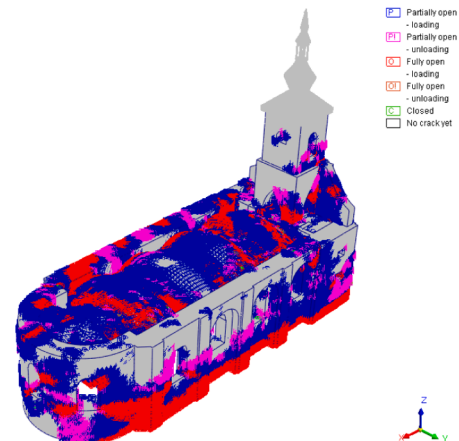
Fig. 18. NLPA-Y: capacity curve and crack status for several load steps increments.

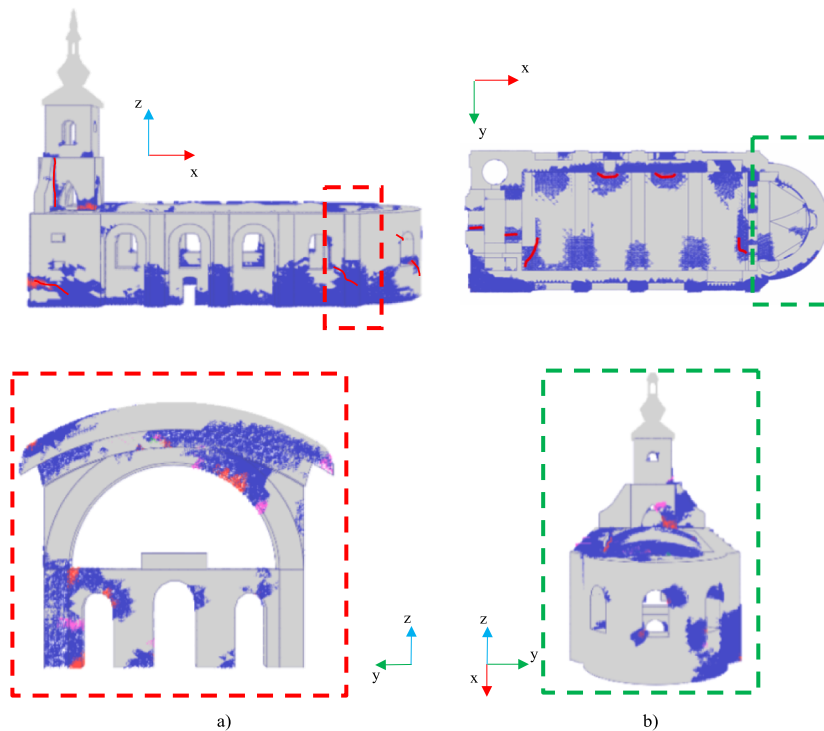
Fig. 19. Crack status: a) NLPA+Y, second load step; b) NLPA-Y, second load step.

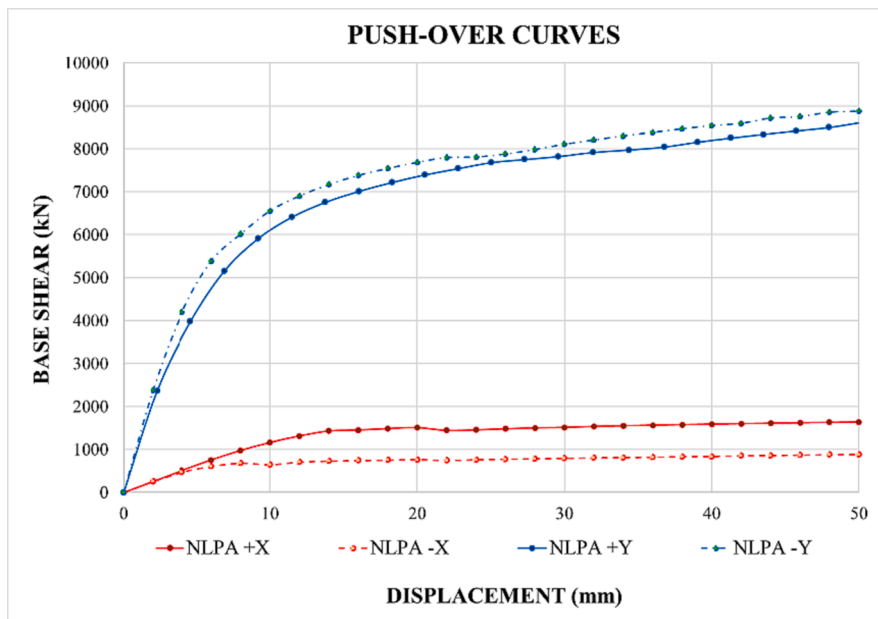
Fig. 20. Comparison among the non-linear pushover curves obtained.

Finally, for sake of completeness, Fig. 20 plots a comparison among the four pushover curves obtained (such as *NLPA+X*, *NLPA-X*, *NLPA+Y* and *NLPA-Y*). One may easily note that *NLPA+Y* and *NLPA-Y* (along the transverse direction) are quite similar providing higher curves with respect to *NLPA+X* and *NLPA-X*. This is due to the fact that, as already discussed, under the assumption made along the *Y* direction a global response is obtained, contrarily to the *X* direction, where a clear local response is observed given by the bell tower overturning.
