Experimental evaluation of out-of-plane strength of masonry walls retrofitted with oriented strand board

Ornella Iuorio ^{a,*}, Jamiu A. Dauda ^a, Paulo B. Lourenço ^b

Structural retrofitting is carried out as an economical alternative to demolishing and rebuilding existing masonry structures. Retrofitting is provided to offer structural upgrade and damage-control. This paper presents the application of oriented strand board type 3 (OSB/3) for retrofitting unreinforced masonry walls. Out-of-plane bending test in form of four-point loading was performed on six masonry walls. The test results show that OSB/3 can considerably increase the load and flexure capacity by (1.4 & 1.8), limiting-toughness by (1.6 & 2.4) and overall-toughness by (16 & 10) times compared to plain wall subjected to out-of-plane loading for (single & double-sided) application respectively.

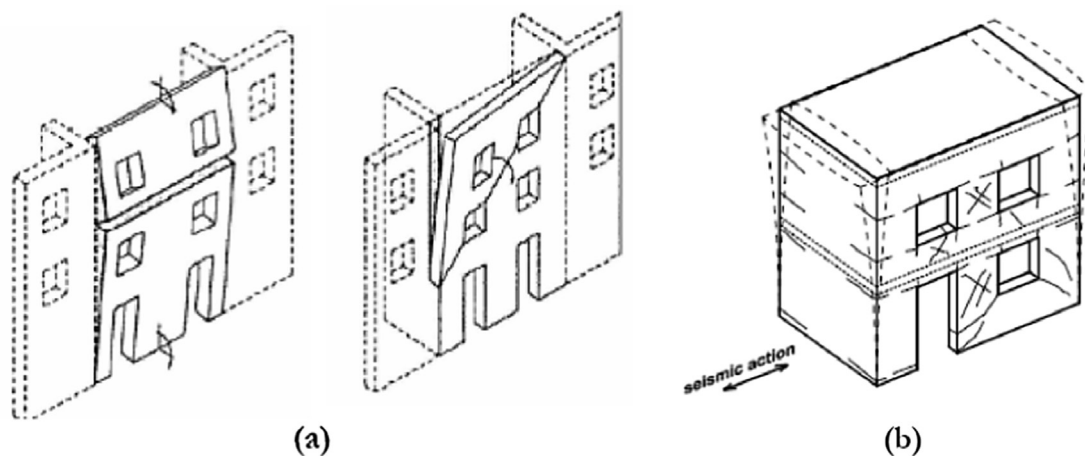
Fig. 1. Failure mechanism modes; (a) Mode I: local [15], (b) Mode II: global [19].

(shear) failure, rocking or toe crushing [6]. Meanwhile, the out-of-plane failure of URM walls is, usually, characterized by either one-way or two-way bending of the walls. The failure mechanism of masonry building can be local (mode I) or global (mode II) as shown in Fig. 1. These can result in a partial or total collapse of the wall (Fig. 2). Previous works [8–11] have demonstrated that URM walls are particularly susceptible to excessive out-of-plane loading. The major cause of out-of-plane failure of URM walls is their weaker resistance to out-of-plane loading. Although they have good resistance to gravity loads and compression [12], they are very weak in bending due to their limited ductility and lack of tensile resisting elements [9,13,14]. Out-of-plane failure of a structural URM wall is also caused by the lack of adequate building connections between the walls and floor diaphragms [15,16]. Out-of-plane failure is the most devastating failure mode of URM walls and buildings [17,18]. Hence, this research specifically aims to improve the out-of-plane capacity of URM walls.

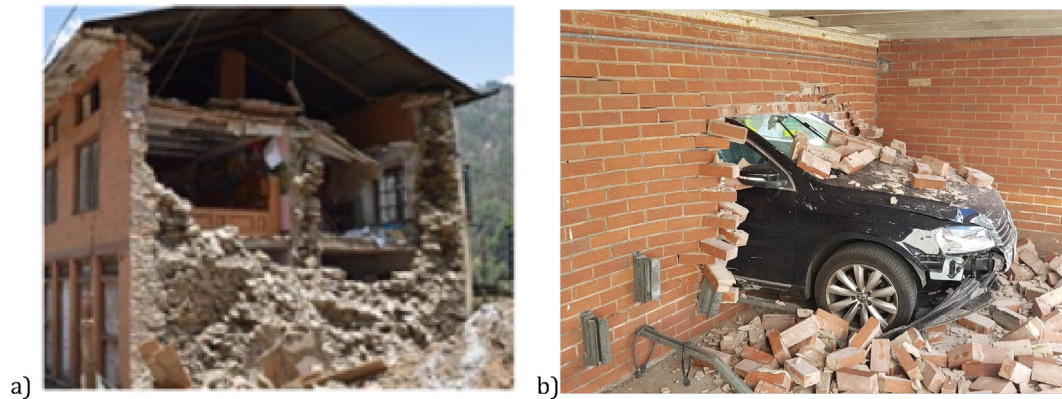
Fig. 2. Examples of out-of-plane failure of URM due to (a) Excessive loading [20], (b) Car impact [21].

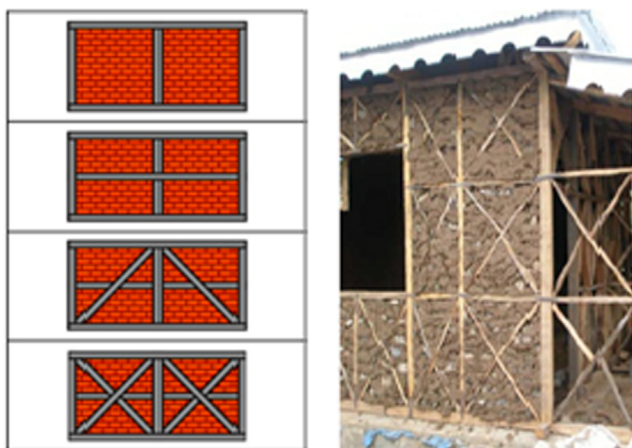
Fig. 3a. Timber confinement of URM.

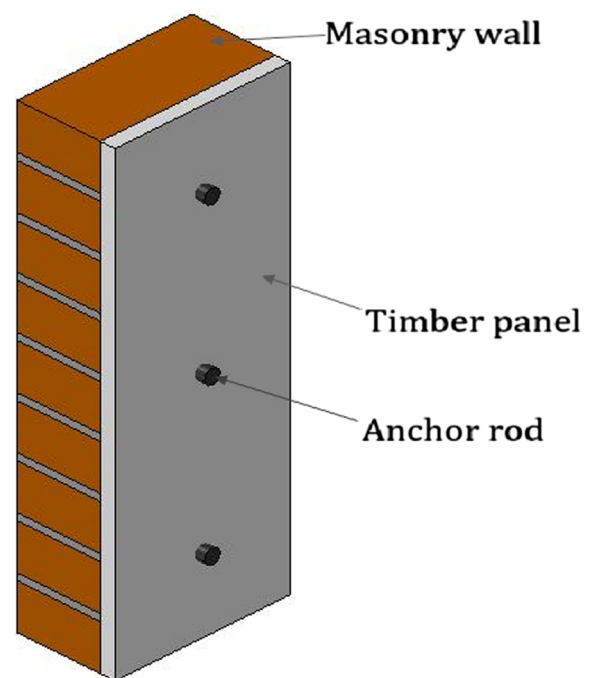
Fig. 3b. Proposed timber panel retrofit.

This research investigated the performance of OSB type 3 panels connected to URM wall by threaded dry rod connections and injectable chemical adhesive anchor readily available in the European market. However, it is imperative to point out that the novelty in this proposed retrofit technique is different from the well-known timber-framed masonry (or half-timber) building (Fig. 3a). In timber-framed masonry building, the masonry wall is confined with the timber frame to enhance the stability and integrity of masonry walls for the in-plane and out-of-plane loads. Differently, the proposed technique considers securing timber panel behind the masonry wall (Fig. 3b). In this study, 18 mm thick

OSB type 3 was connected to URM walls using $\varnothing 8\text{mm}/\text{L}50\text{mm}$ threaded anchor rods together with an option of plastic plug or injection mortar to investigate how the out-of-plane behaviour of the retrofitted URM wall changes under out-of-plane loading. The study investigated only the out-of-plane performance of the proposed techniques because URM walls are more vulnerable when loaded in the out-of-plane direction and generate costly damages and losses of lives upon failure.

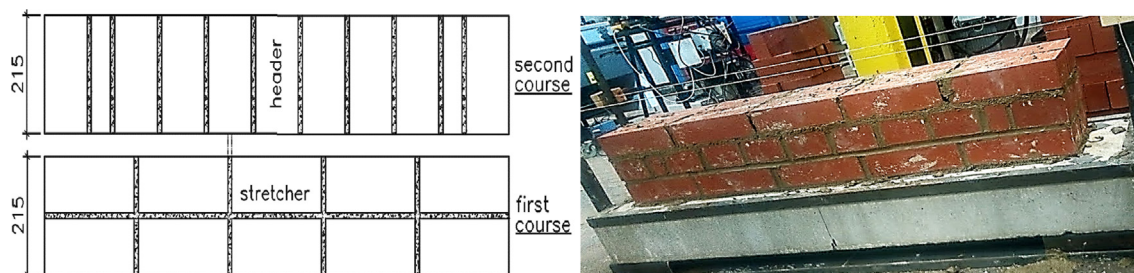
Fig. 4. Wall specimen bonding pattern (a) plan drawing, (b) image during construction.

Six single leaf, double wythes URM wall specimens measuring 1115 × 1115 × 215 mm (length × height × width) were constructed. The selected geometry of the walls is such that each of the two wythes of the walls has 15 courses with each course having 5 units of brick bonded together by 10 mm thick mortar joint. The walls were built in English bond consisting of alternate rows of headers and stretchers, which is the oldest form of brick bond popular in the UK since the late 17th century [62]. The bonding pattern is such that the joints between the stretchers are centred on the headers in the course above as can be seen from the plan sketches of first and second courses of the bonding pattern in Fig. 4a and the image in Fig. 4b.

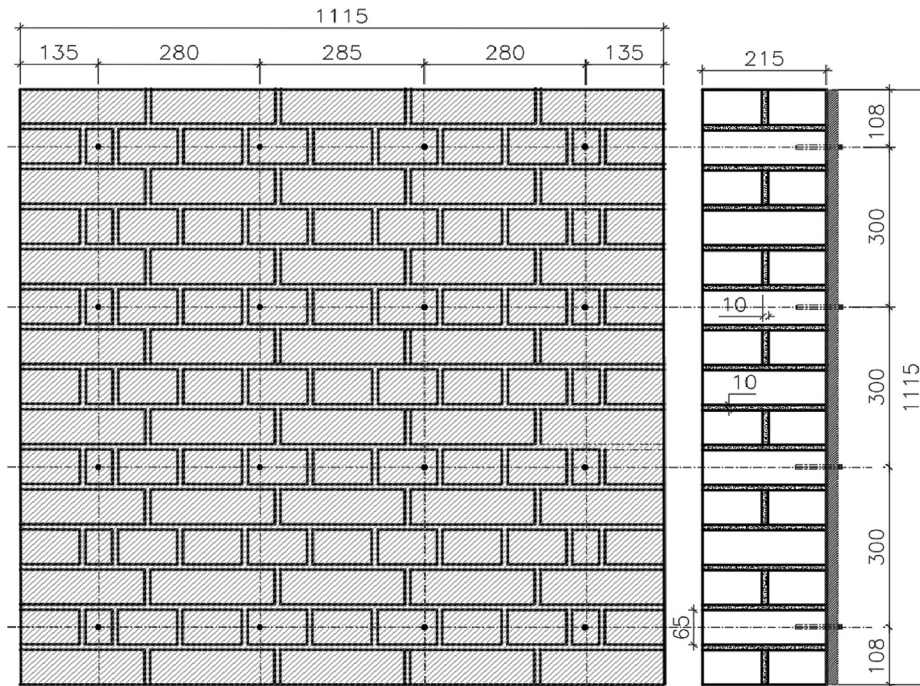
Fig. 5. Typical connection layout for retrofitted wall specimens (all dimensions in mm).

For the retrofitted wall specimens, brick units were pre-drilled in specific locations and bonded to have a connection layout as shown in Fig. 5. The connection layout ensured that the spacing of the connections has 50 mm as minimum edge clearance and 250 mm as the minimum spacing between two connections. All wall specimens were constructed on 1315 × 150 × 350 mm (length × height × width) reinforced concrete (RC) footing with

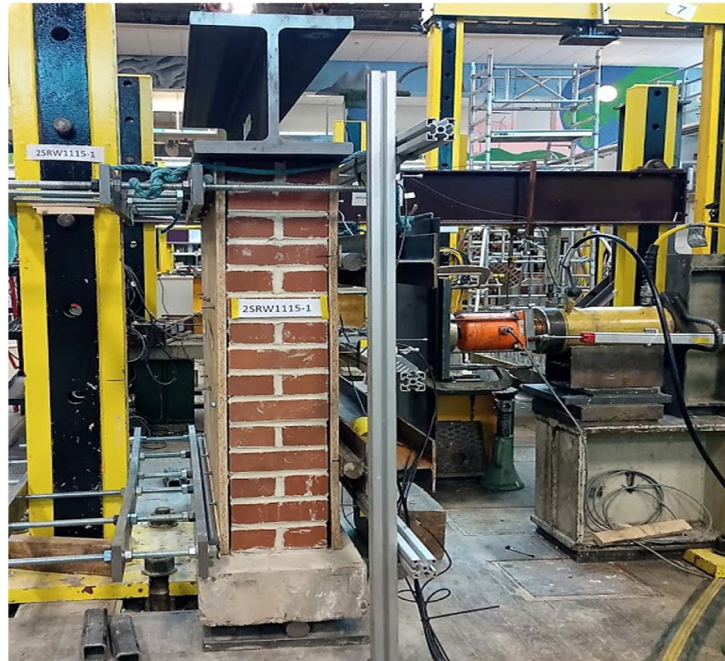
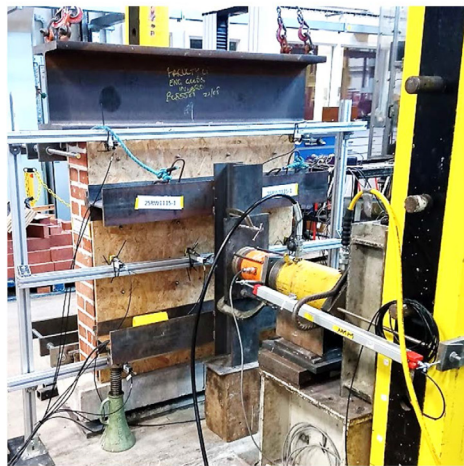
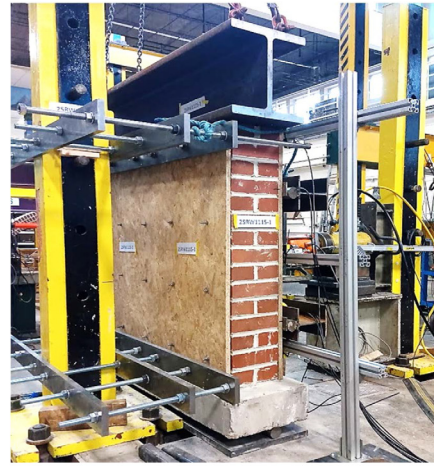
a) Side view showing the general test arrangement

b) Front view showing loading area

c) Back view showing upper and lower support

d) Roller under wall specimen

Fig. 8. Out-of-plane testing arrangement (as-built).

The general test setup (Figs. 7 & 8) was designed to replicate a four-point loading test arrangement, which is suitable for assessing the flexural behaviour of masonry wall as described in [58]. Each wall specimen was tested by applying an out-of-plane load in the middle section of the wall to induce a constant flexural bending moment in the central area of the wall. The load was applied to each tested specimen using a hydraulic ram and was distributed through a steel spreader arrangement in the central area of the wall (Fig. 8b). The spreader arrangement spanned between the

The simply supported boundary condition of the specimen was achieved by supporting the back of the wall across the middle of the top and bottom course with backing steel frames. The backing frames were connected to an existing stanchion as a reaction frame at the top and bottom of the wall (Fig. 8c). A 25 mm diameter roller was placed between the back face of the wall and the supporting steel plate on the reaction frames to provide for smooth distribution of load action across the length of the wall and avoid point contact. On the front side of the specimen, two metal plates (50 × 5 mm thick) were fixed at 1/4th and 3/4th of the height of the specimen each to provide a contact for the roller on the steel load spreader arrangement.

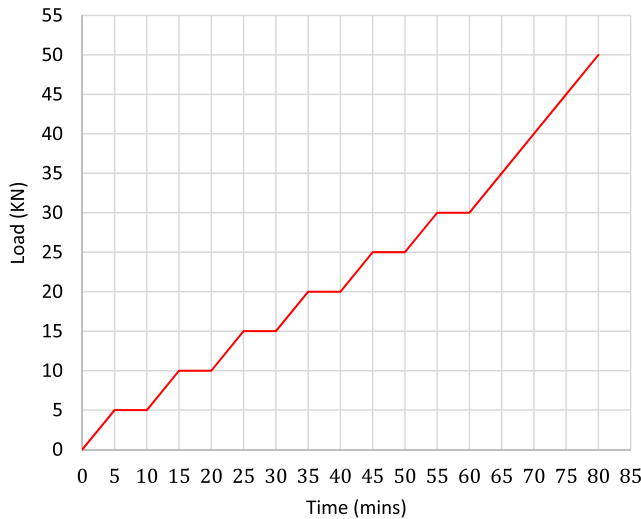
Fig. 9. Applied out-of-plane load history.

The direction of the load application was perpendicular to the wall specimen surface. The test was load controlled, and the loading scheme was such that an initial load was applied continuously at a rate of 1kN/min for up to 5kN and then maintained the load for 5mins period. The purpose of maintaining the applied load was to

allow the wall assembly to come to substantial rest before taking the next set of reading as recommended in [58]. Also, this helped to observe any time-dependent deformation and load redistribution. The load steps were repeated continuously for 10kN, 15kN, 20kN, 25kN, and 30kN load and maintained for 5mins period at each load step (Fig. 9). After that, the load was increased continuously to the failure of the test specimen. To obtain the maximum capacity of the retrofitted walls, the applied load was increased continually after the first crack until additional cracks were formed in the retrofitted specimens and ultimately the timber at the back of the masonry walls was broken. For the constant pre-compression load, a 305 × 305 × 240 UC section amounting to

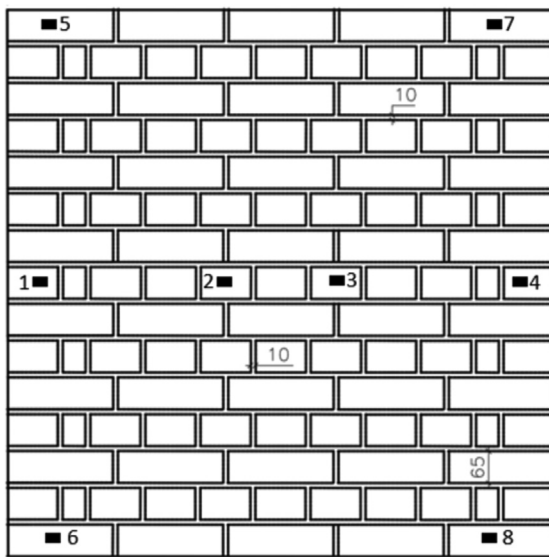
Fig. 10. Position of LVDTs on wall specimen.

The values of the applied load on the wall were monitored using a 200kN capacity ring load cell. Simultaneously, 8 linear variable displacement transducers (LVDTs) were used to record the deflections of the test specimen along the wall centre (LVDT1, 2, 3 and 4), top (LVDT 5 and LVDT7) and bottom (LVDT 6 and 8). The locations of these gauges were as shown in Fig. 10. All the eight LVDTs used during the test were fixed on an independent steel tripod stand, which was not connected to the test rig. For the plain walls and one-sided retrofitted wall, the LVDTs were applied directly on the face of the brick unit at the respective location identified in Fig. 10. While in the double-sided application, the LVDTs were applied to the timber panels at the same location identified in Fig. 10. The force and the displacements were real-time monitored by connecting the measuring equipment (load cell and LVDTs) to an electronic acquisition unit interfaced with a computer.

Here, the wall was considered as a single part with three regions as the top, mid and bottom. In order to estimate the net displacement in the specimen mid-height, the average value of horizontal displacement at the top and bottom of the specimen was removed from the mean value of the displacement measured at the specimen mid-height using Eqn (1) to (4)

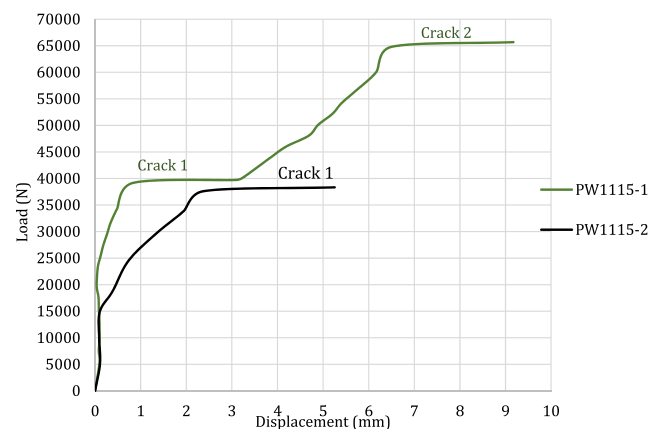
Fig. 11. Load vs Displacement curve for plain specimens.

Throughout the loading steps, out-of-plane loads and the corresponding net out-of-plane displacements were obtained and presented in the form of the load-displacement curve (Fig. 11). The observed failure pattern (Fig. 12) in the plain walls is characterised by the sudden formation and rapid opening of the crack in the unit/mortar joint interface throughout the thickness of the walls.

The analysis of the load-displacement curve (Fig. 11) shows that the two plain specimens have a quasi-linear behaviour up to about 15,000 N load, which corresponds to the onset of crack formation in PW1115-2. After that, the load continuously increased with a little increase in the out-of-plane displacement before the specimen failed. At the failure point, the displacement suddenly increased. This increment is due to the brittle nature of the failure pattern. The maximum load attained by PW1115-2 is 38,330N and the corresponding net out-of-plane displacement at this point is 5.25 mm. Meanwhile, PW1115-1 appeared very stiff after first crack (Fig. 12a) with increased bending capacity because the axial load keeps increasing as the horizontal load increases, preventing significant out of plane displacements. At about 25,000 N load capacity, there is an onset of crack 1 in the specimen, which later failed at maximum load of 39,720 N with a corresponding net out-of-plane displacement of 3.4 mm. Then, because of the increasing pre-compression load, there is a redistribution of the stresses in the wall, which then allowed PW1115-1 to carry more out-of-plane load until crack 2 formed at 65,000 N applied out-of-plane load.

Clearly, the applied load on PW1115-1 has passed the normal load capacity of the wall, which is 38,330 N for PW1115-2. So, the loading was stopped after the failure of crack 2. This was to avoid the total collapse of the wall and damage of the instruments. It was evident that the higher axial load increased the out-of-plane

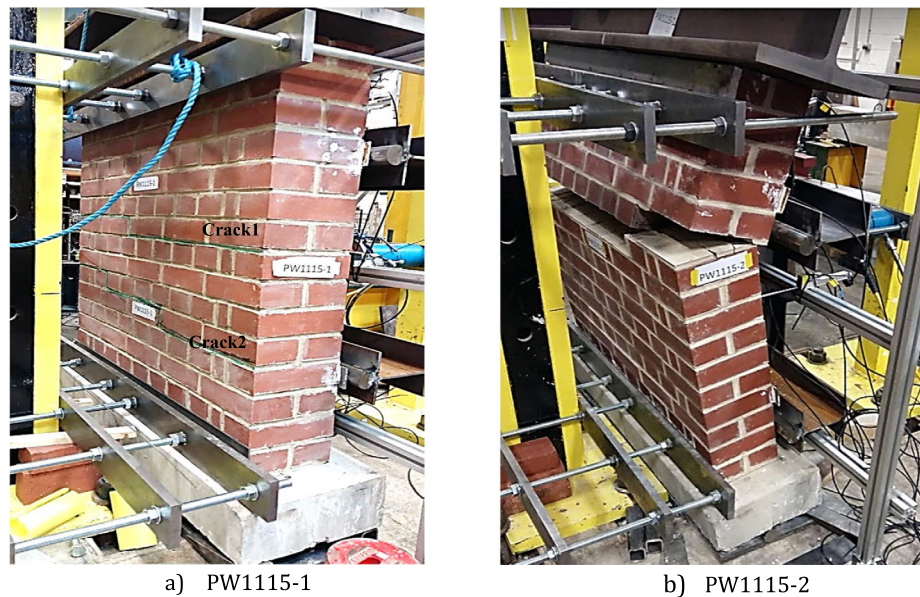
Fig. 12. Failure patterns of PW1115-1 & 2.

The failure of the plain masonry wall is quasi-brittle and started with the formation of a crack opening in one bed joint at the tensile face of the walls (i.e. the side opposing the loading face). Subsequently, this crack was propagated through the perpendicular joint to the next bed joint (Fig. 12b). The crack occurred throughout the whole thickness of the wall and led to the complete separation of the unit-mortar interface at the failure load (maximum load the wall can resist). In the case of PW1115-1, the pre-compression load applied varied according to the applied out of plane loading during testing because a hydraulic jack was used to imposed additional 7KN load to the 3KN (i.e. the self-weight of 305 × 305 × 240 UC) on top of the wall. However, the hydraulic jack used to simulate the pre-compression load was unstable. Thus, PW1115-1 experienced an increasing axial compressive stress after the first crack. This loading effect makes PW1115-1 fail in multiple bed joints as highlighted in Fig. 12a (image taken at the end of the test when the out-of-plane load has been released and the wall returned to its original position with the cracks closed up). In PW1115-2, the self-weight of the steel beam on the top of the wall is the only additional compressive load on the wall, which is the configuration adopted in all other tests. Therefore, the result of PW1115-1 is only valid until the first crack occurs.

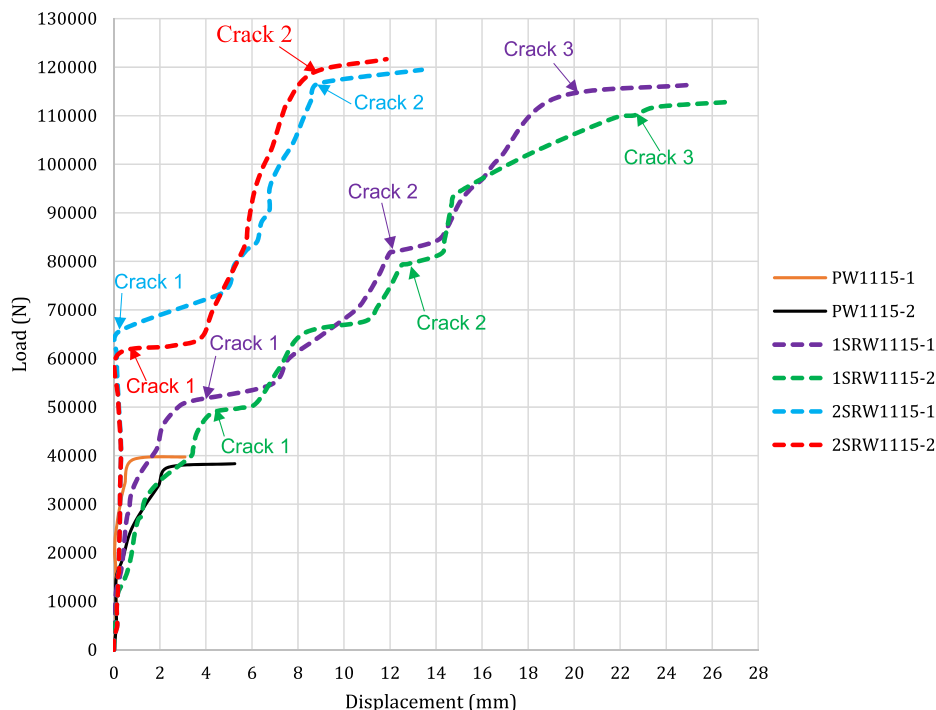
Fig. 13. Load vs Displacement curve for specimens.

For the sake of comparison, the load–displacement curve of plain walls is included in Fig. 13, with PW1115-1 shown up to crack 1 formation only. This is because the additional strength gained by PW1115-1, which led to the formation of crack-2 was due to the increased axial load, which is not available on the retrofitted samples. An inference from Fig. 13 reveals that the proposed retrofit technique has substantially increased the out-of-plane load capacity of retrofitted walls. Specifically, 1SRW and 2SRW attained an average of 114,600 N and 120,600 N maximum load. Remark-

ably, the load capacity of the retrofitted walls before the first crack occurred is much higher than the maximum load capacity of the plain wall as discussed in detail below. On the load–displacement curve, the points at which the cracks occurred in the walls were indicated with numbers. This numbering corresponds to the numbers marked on the images from the test (Fig. 14). For instance, a second crack at 81,765 N load and a third final crack at 116,400 N for 1SRW1115-1.

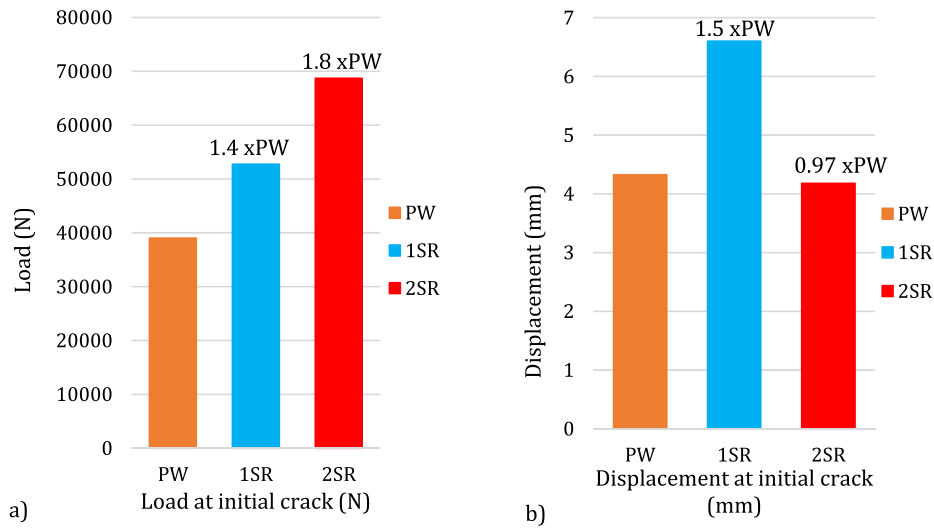
Fig. 15. Performance at the occurrence of the first crack; (a) Load capacity (b) Displacement.

Thereafter, comparison charts at the occurrence of first crack (Fig. 15) and failure (Fig. 16) were developed for the performance evaluation of the proposed retrofit technique. The average load and displacement for each group of specimens (i.e. PW, 1SRW and 2SRW) were used to develop the charts. The comparison in term of capacity at the first crack (Fig. 15) shows that the load that caused the first crack in 1SRW is 1.4times the maximum load at the failure of PW. Also, the first crack on the 2SRW specimen occurred at a load that is 1.8times the failure load of PW. This shows that the 2SRW resist more load before the first crack, about 1.4times that of 1SRW. At the failure point, the maximum load capacity of masonry wall retrofitted with OSB panel is 2.9times and 3.1times that of PW for 1SRW and 2SRW respectively (Fig. 16). Unlike the load at the first crack, the load capacity of 2SRW is only 1.04 times that of 1SRW.

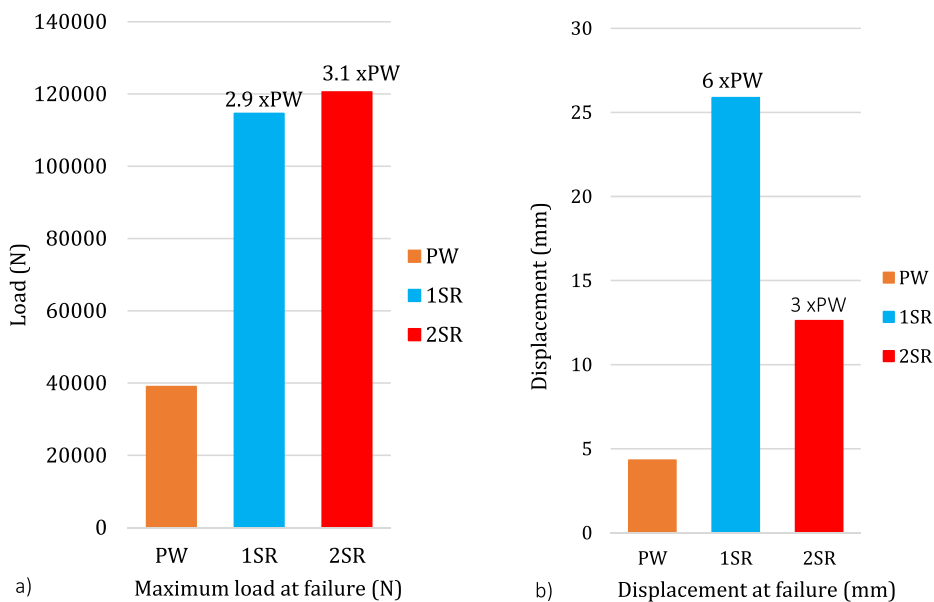
Fig. 16. Performance at the failure; (a) Load capacity (b) Displacement.

Also, the analysis of the test results shows a significant increase in the out-of-plane displacement of retrofitted walls. This is due to the application of the OSB timber panel that has offered the masonry wall a significant lateral resistance once the masonry joint interface cracked. As such, the retrofitted specimens were able to take more loads and absorbed more energy by displacing more without sudden failure. The increment in the out-of-plane displacement of the retrofitted walls is 6 times and 3.1 times that of PW for 1SRW and 2SRW, respectively.

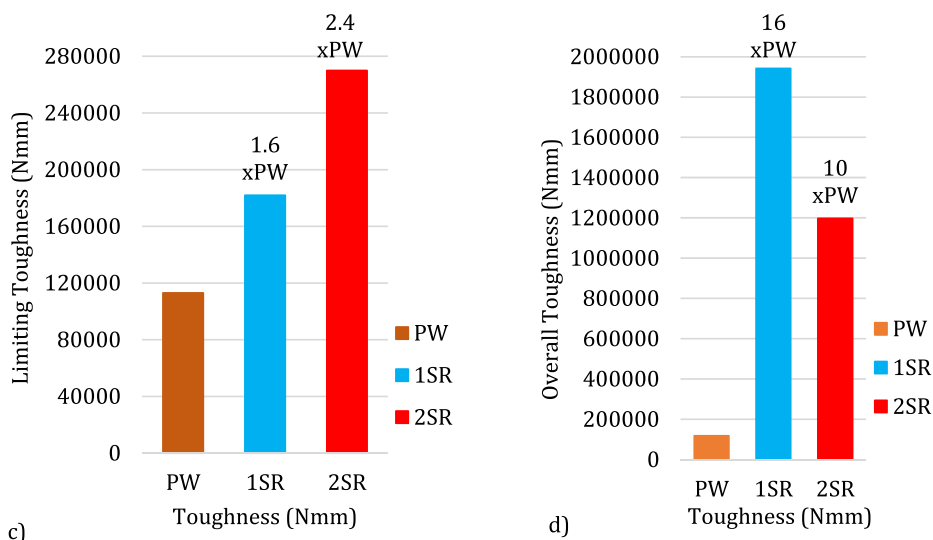
Fig. 17. Performance at the failure; (c) Limiting Toughness (d) Overall Toughness.

The overall toughness gained due to the retrofit application when taken up to the failure of the OSB is enormous. An improvement of 16 times and 10 times that of the plain wall is estimated for application on single and both sides, respectively (Fig. 17a). However, the performance of the technique at the limiting displacement (Fig. 17b) is otherwise with the double-sided showing more toughness gained than one-sided application (2.4xPW and 1.6xPW for double and single-sided application respectively). The analysis shows that the double-sided application offers the largest
