HERITAGE 2022 INTERNATIONAL CONFERENCE VERNACULAR HERITAGE: CULTURE, PEOPLE AND SUSTAINABILITY

Architectural Heritage and seismic vulnerability: mapping the available knowledge to reduce damage during an emergency

Topic: T4.4. Management and maintenance of vernacular architecture

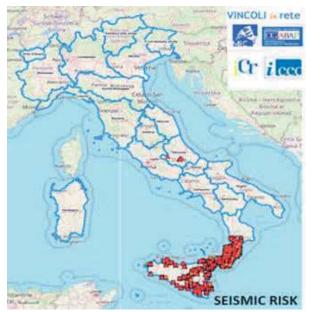
Fig. 2. An example from the Italian 'CdR'. The map shows the areas where the seismic risk has already been assessed.

information system developed to map, on a cartographic basis, what are the assessed risk conditions for the architectural and archaeological immovable heritage. The system evaluates the risk of each item by assessing its vulnerability and the hazard of the area. These parameters allow for the evaluation of the level of danger from environmental, hydrogeological or seismic risk.

Concerning the seismic risk assessment, the evaluation is determined both through filling in specific forms which catalogue the vulnerability level of buildings⁴ and through the seismic hazard level, which is determined by the 'Istituto Nazionale di Geofisica e Vulcanologia – INGV' (National Institute of Geophysics and Vulcanology) depending on the seismo-geological properties of the region. Some analyses of this type have been carried out in Southern Italy, especially in Calabria and in Sicily. Nonetheless, they have not yet been completed everywhere, nor in those areas that are characterised by high seismic activity.
