MICROCLIMATE MONITORING OF HISTORICAL BUILDINGS: THE CASE STUDY OF SAN ROMERIO CHURCH (ITALY)

Elisabetta Rosina¹, Megi Zala², Antonio Ammendola³

*Department of Architecture, Built Environment and Construction Engineering, Politecnico di
Milano, Italy*

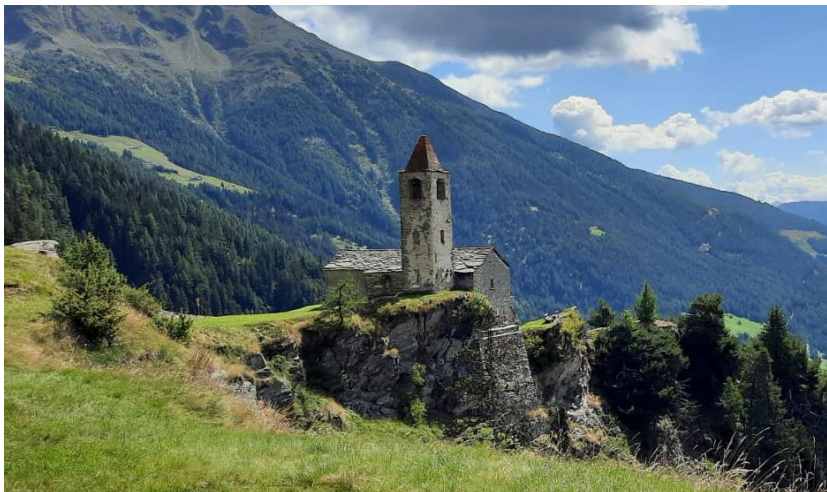
Due to the church location on a cliff and at an elevation that exposes the building to thermo-hygrometric conditions possibly critical, it is posed to serious conservation issues (Figure 1).

Figure 1: Photo of San Romerio Church.

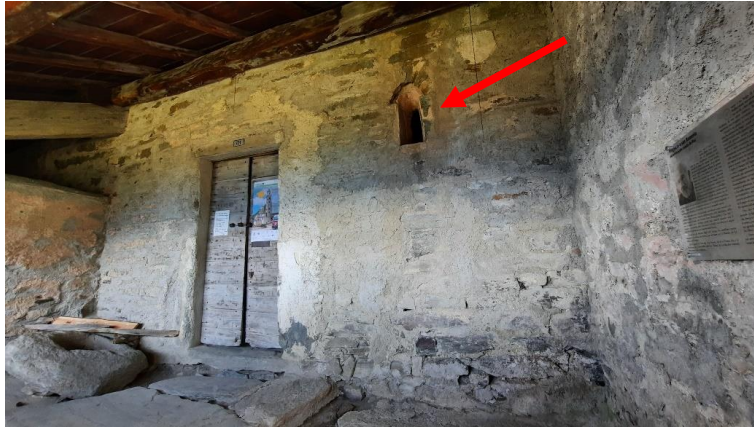
Figure 3: Location of the external probe (south-western wall, outside).

Based on the obtained results, the indoor condition is considered stable and not strongly correlated to the outdoor condition. The data of the outdoor probe have almost the same trend as the ones inside, which is due to the location outside in a protected part of the building (Figure 1, b).

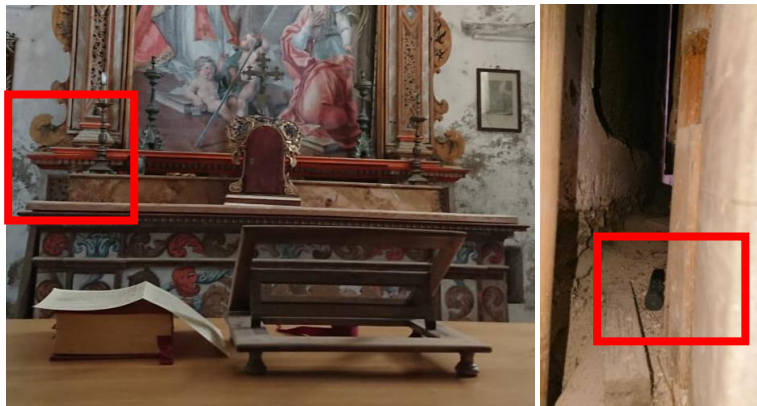
Figure 4: Location of the internal probe, behind the altar (south-western wall inside).

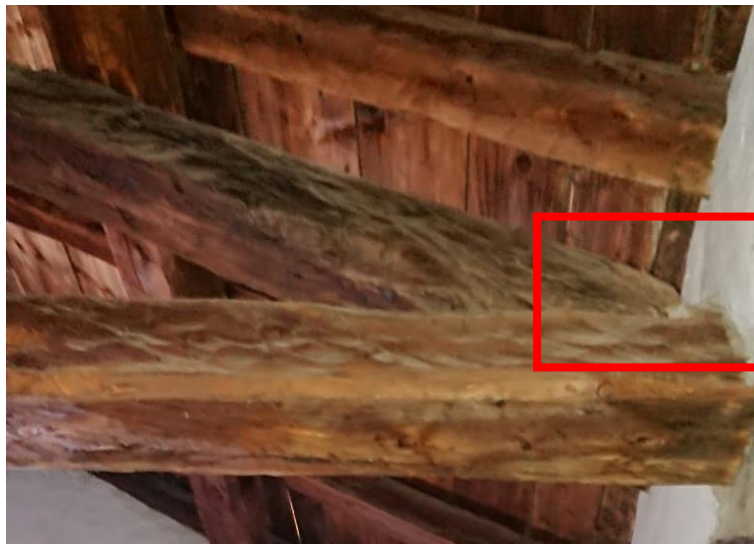
Figure 5: Location of the internal probe, placed on the truss.

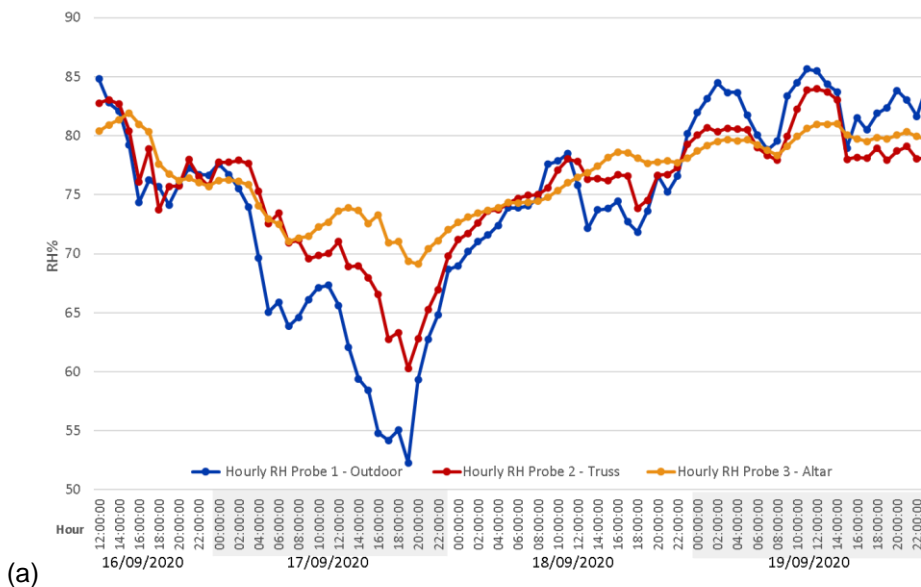
Figure 17 presents the hourly variation of internal RH% of few events, due to a sudden decrease/increase of external RH%. For instance, on 17 September 2020 (Figure 17, a) the interior RH decreases of 22% reaching a minimum peak of 60% and following the outdoor trend. Similar observation can be seen on 24 September (Figure 17, b) and during the Spring months (Figure 17, c).

Figure 17: Hourly values of RH% from 16–19 September (a), from 24-30 September. (b), from 9-14 April (c).
