**Remarkable historic timber roofs. Knowledge and conservation practice.
PART 1 - Construction history and survey of historic timber roofs**

REMARKABLE HISTORIC TIMBER ROOFS. KNOWLEDGE AND CONSERVATION PRACTICE

Part 1 - Construction history and survey of historic timber roofs

TECHNIQUE AT THE SERVICE OF A NEW LITURGICAL MODEL: THE TIMBER ROOF OF THE CHURCH OF SAINTS MARCELLINO AND PIETRO IN CREMONA

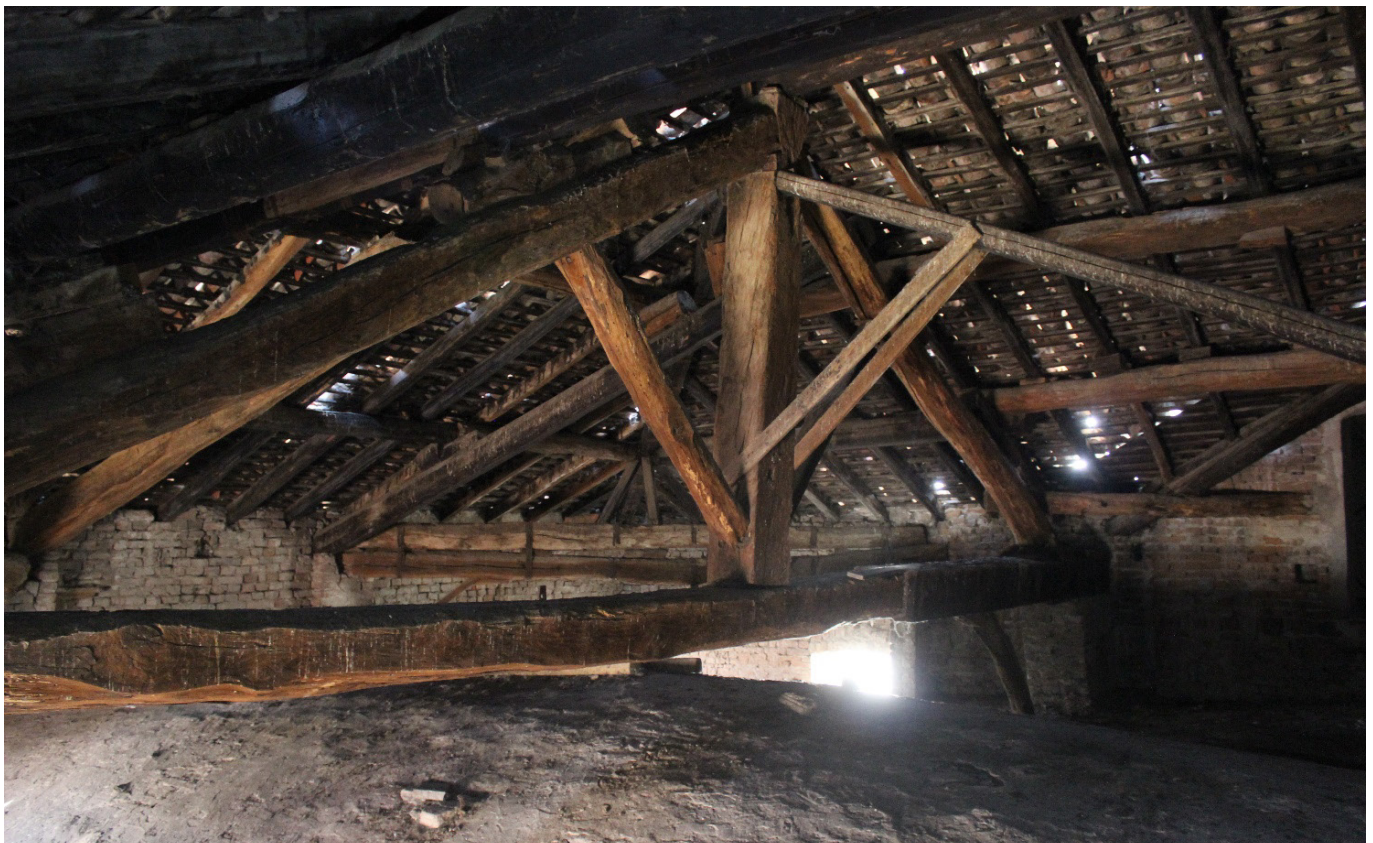
Fig. 3. Closed joint king post truss in the attic above the presbytery of the church. (Photo by Emanuele Zamperini).

A single truss (T1) is on the roof of the presbytery; its span is significantly minor to that of the nave (about 11 m compared to about 15.15÷15.20 m in the nave). The truss support: on its west side, towards the nave, the ridge beam and four purlins (two for each pitch); on the east, two half-principal rafters, two hip rafters, and four purlins (also in this case, two per pitch). Transversely to the hip rafters, two diagonal, horizontal beams reinforced with struts are intended to support the rafters by vertical posts. Above this structure, there are the joists placed at a distance of about 60 cm, which support the laths on which the roof tiles are placed.

The roof of the presbytery has been significantly reashed: it indeed underwent at least one significant maintenance intervention, of which, however, no documentary trace has been found; however, it can be dated to the period between the 1920s and 1950s, in which the parish archives show some gaps. The reinforcement works of the southern joint of the truss and the construction of the hip rafters certainly belong to this period; in both cases, thick boards connected with bolts and thin iron strips were used. The replacement of some purlins and joists probably dates back to this same period. These works most likely involved dismantling the entire roof frame and its repositioning with significant changes. The substitution of laths for flat bricks as the supporting element of the roof tiles has allowed a reduction in loads and the overcoming of the dimensional constraints imposed by the bricks; in the presbytery, in fact, the joists are placed at a distance of about 60 cm, unlike what happens in the nave in which the length of the “one arm long flat bricks” – used for the construction of the roof deck – is about 48 cm, equal to a Cremonese arm, as mentioned by Capra in his treatise written shortly after the construction of the church [22].

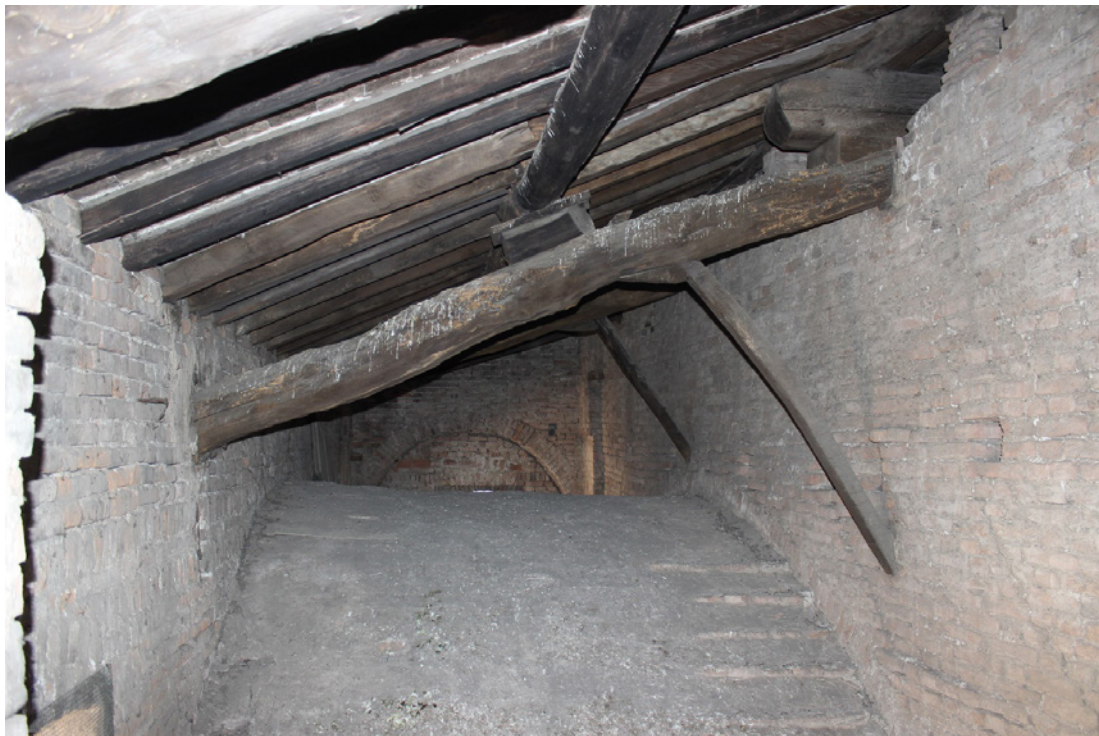
Fig. 4. Roof of the band on the northern side of the nave; it is possible to see the extrados of the barrel vault of the pseudo transept. (Photo by Emanuele Zamperini).

The roof structure of the side chapels is simpler, consisting of rafters (generally placed in correspondence with the trusses of the nave, but some are probably added later

and placed between those) which support a single purlin placed in the middle of the pitch on which the joists rest. The rafters and the purlins are almost all made of oak timber, but some of them – probably even these still original – are made of larch, and others of spruce, which are probably recently replaced or added. The joists are mainly made of oak and discontinuous in correspondence with the purlin, but there are some made of poplar and some others of spruce which are recently added and usually continuous on the two spans. In this part of the roof, no significant differences are visible between the two construction phases of the church.

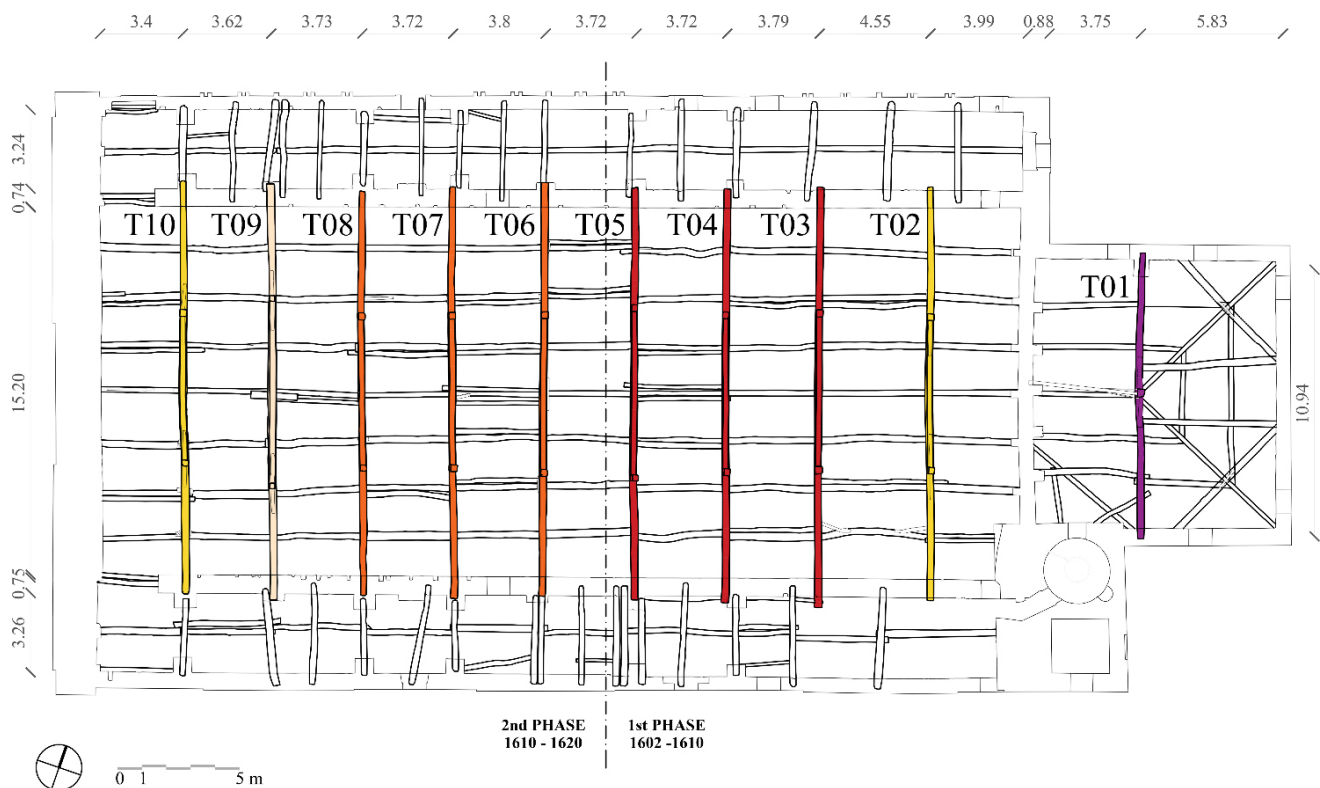
Fig. 5. Plan of the roof structure. (Geometrical survey: Courtesy of R.T.C. di Colturato & Pedrini). In purple the king post truss of the roof of the presbytery (T1); in red the Palladian trusses of the first phase in which the queen posts rest on the tie-beam (T3-T5); in orange the Palladian trusses of the second phase in which the queen posts are linked to the tie-beam with tenon-mortice joints (T6-T8); in pink the Palladian truss reworked probably in the first decades of the 19th century with queen posts detached from the tie-beam (T9); in yellow the Palladian trusses reworked in 1841 with queen posts detached from the tie-beam (T2 and T10).

The structure is made of nine trusses (T2-T10), supported by masonry corbels or engaged pillars protruding from the longitudinal walls; the trusses – together with the wall above the arch that separates the nave from the presbytery and with that of the façade – support ten bays of purlins. All the bays have the same span, with the exception of the second from the presbytery (between T2 and T3), wider due to the greater height of the groin vault of the pseudo-transept, which would have interfered with the tie-beams of the trusses. There are three purlins per pitch plus the ridge beam, which are all discontinuous at the trusses; above each of the walls between the nave and the chapels, there are two other purlins. Almost all the purlins are made of oak wood, but some – even in this case obviously replaced in maintenance works or placed side by side with the pre-existing ones – are of spruce wood. In the organization of the joists (almost all of oak, except for a very few of poplar and some, recently made, of spruce), there is a clear difference between the first and second construction phase: in the bays of the first phase, the joists of the upper part of the pitches

are continuous from the ridge beam to the second purlin of each pitch, while the other has a single span, from a purlin to the adjacent; instead, in the bays of the second phase, almost all the purlin have a single span. An exception to this general system occurs in the second bay of the first phase, in which the joists of the lower part of the north pitch are also continuous on three supports and are all made of spruce, like the underlying purlin; this – together with the traces of woodworking – suggests a recent replacement. Among the oak joists, there are some – perhaps coming from the houses demolished to build the church – that show evident signs of previous uses as floor joists due to the presence of notches intended to accommodate the laths covering the joints between the boards, and the *bussole*, thin inclined or concave boards placed between the joists to close the space above the girders.

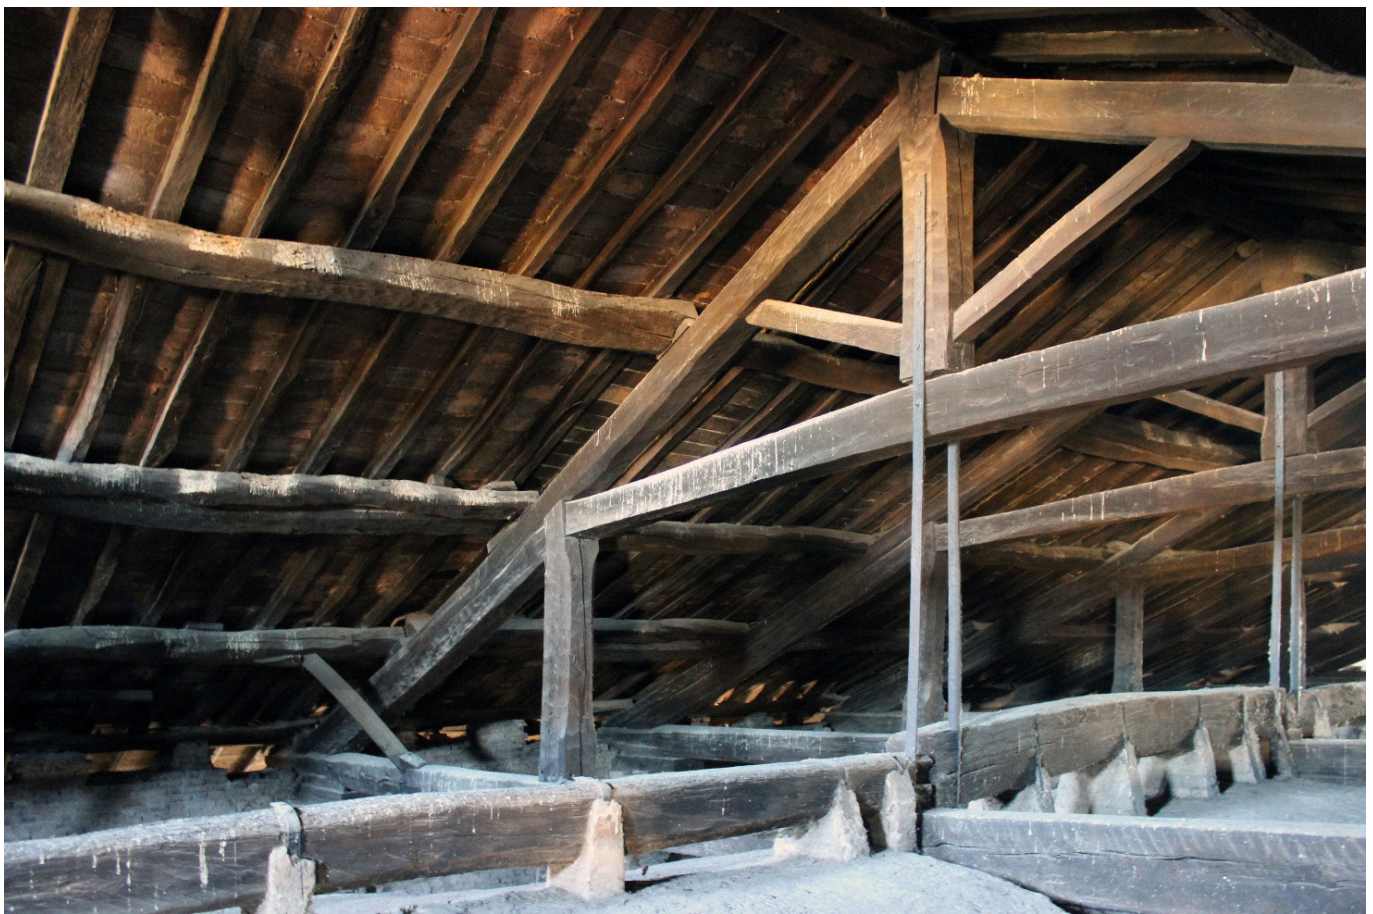
Fig. 6. Unmodified truss of the first phase: T3 truss seen from the north-east. (Photo by Emanuele Zamperini).

The nine trusses of the nave roof are all “Palladian” or queen post trusses. Also in the case of the trusses, differences can be noted between the first and second phases, to which are added others connected to the reinforcement interventions carried out over the years. Observing the trusses that have not undergone significant alterations, it can be seen that: in those of the first phase (T3-T4-T5), the queen posts rest on the tie-beam, which in its midpoint is hung from the king post by means of a long metal bracket; in the unmodified trusses of the second phase (T6-T7-T8), instead, we see that the queen posts are

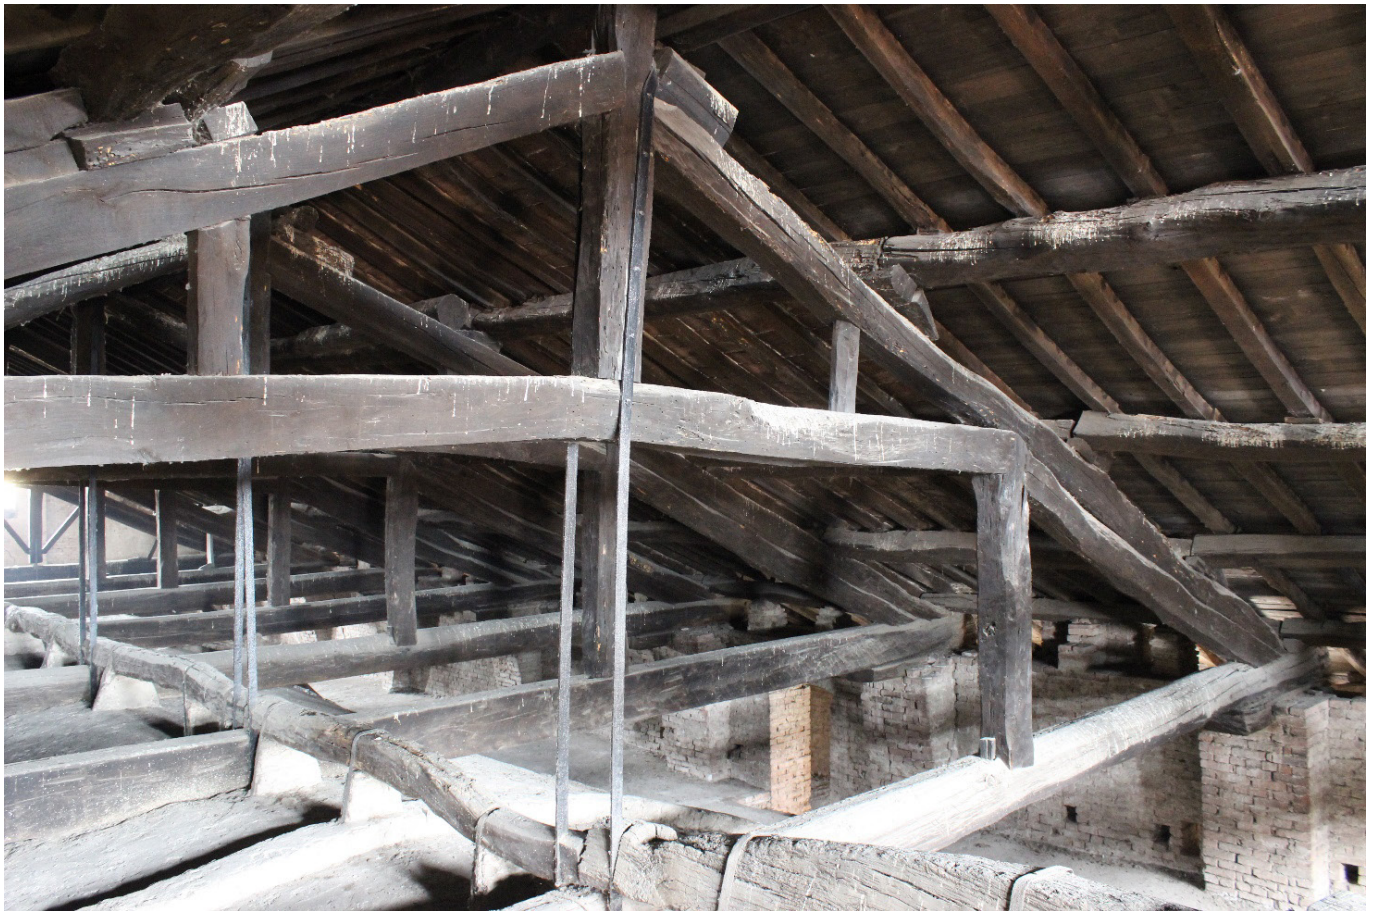
Fig. 7. Unmodified truss of the second phase: T8 truss seen from the north-west. (Photo by Emanuele Zamperini).

ond phase, the queen posts are connected to the tie-beam with a joint capable of resisting both compression and traction; therefore, in case of asymmetrical loads, one of them will press against the tie-beam, and the other will lift it, subdividing the force necessary to stabilize the structure between two points, in one of which it would also reduce the bending of the tie-beam induced by its own weight and by the other loads applied to it. In the trusses of the first phase, instead, the queen posts simply rest on the tie-beam, and this ensures that in case of asymmetrical deformation, only one of them comes into action, pressing on the tie-beam and increasing the stresses induced in it by the other loads.

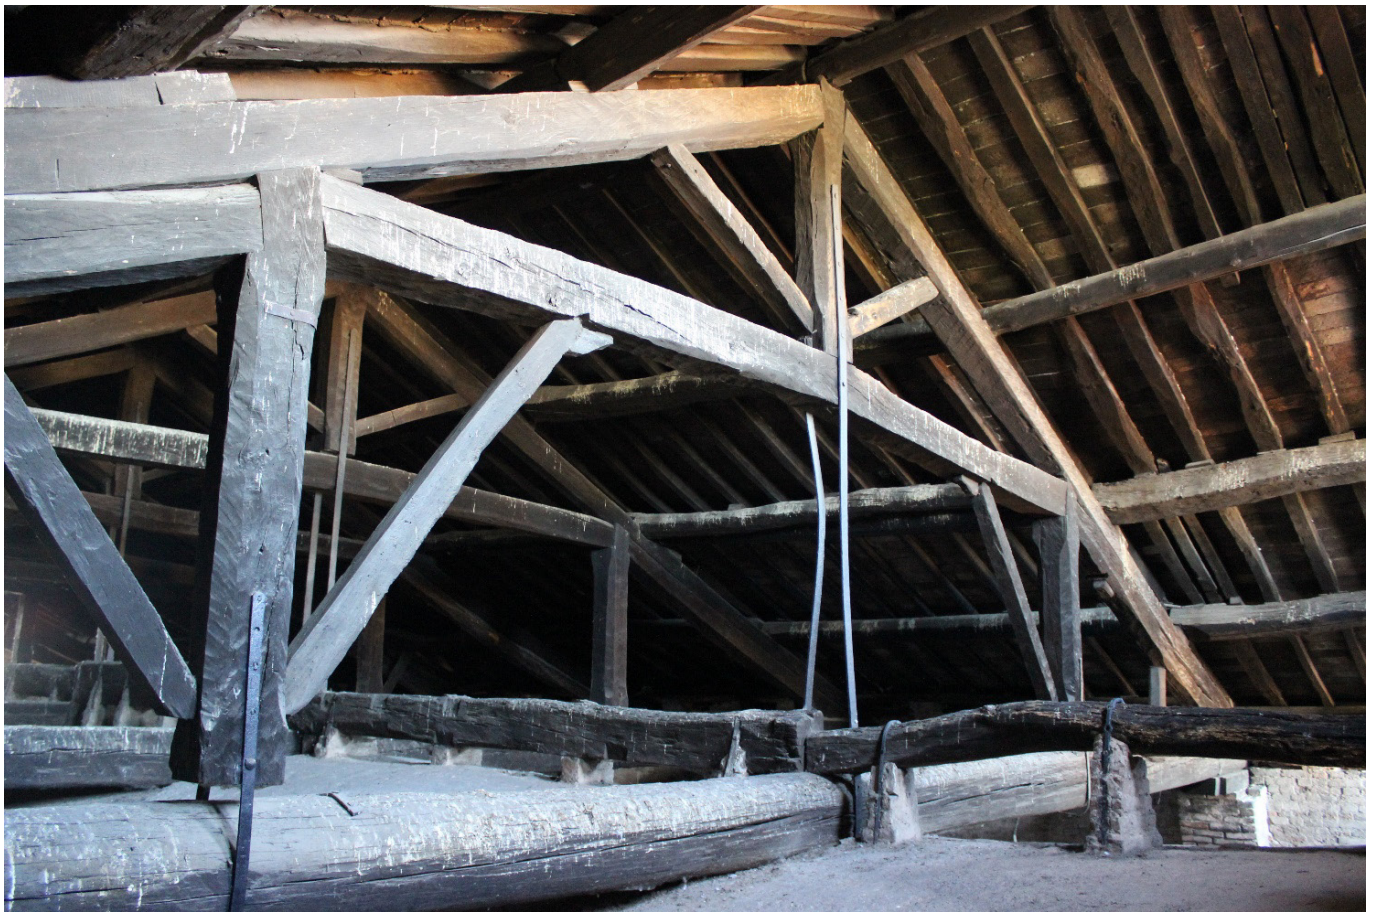
Fig. 9. Modified truss of the first phase: T2 truss seen from the south-east. (Photo by Emanuele Zamperini).

As already written, three of the trusses of the nave (T2, T9, and T10) underwent significant modifications and, therefore, now present a different structural configuration. As regards two of them (T2 and T10), it is possible to date the interventions with certainty, thanks to the archive documentation.

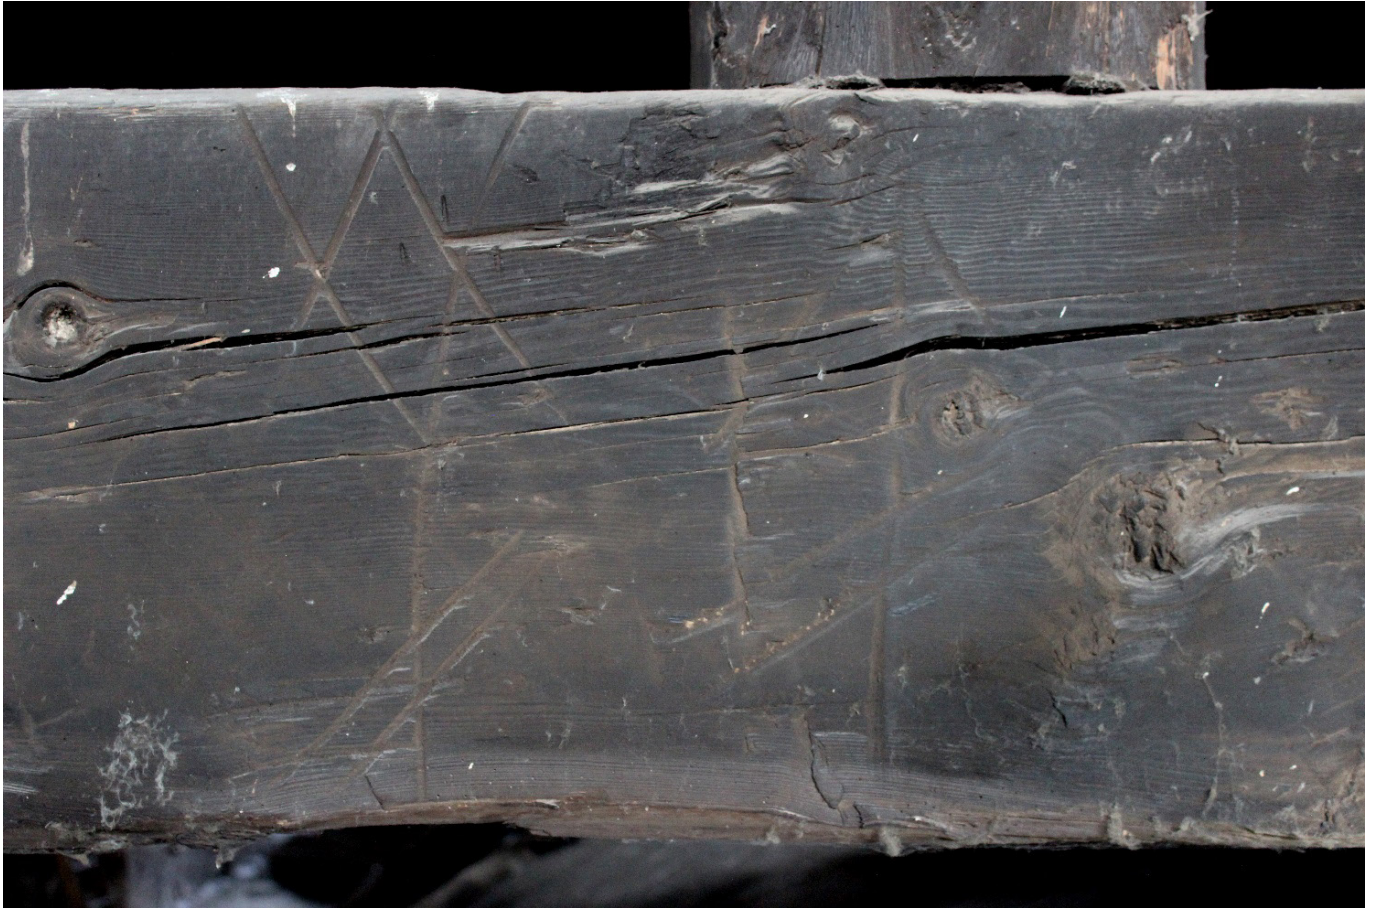
Fig. 11. Trading mark on the west side of the tie-beam of the T7 truss. (Photo by Emanuele Zamperini).

The original tie-beams of the church's trusses – and also some of the other elements of larch wood – keep both holes that testify to its transport in the form of a raft and transportation marks. The survey of these marks and their comparison with the repertories of marks relating to the eastern Dolomites [39], the only ones published so far with a certain systematicity, while showing strong similarities, did not allow for recognizing exact correspondences and therefore to identify with certainty the timbers provenance.
