Composite Structures

Review

Hygrothermal ageing of composite structures. Part 1: Technical review

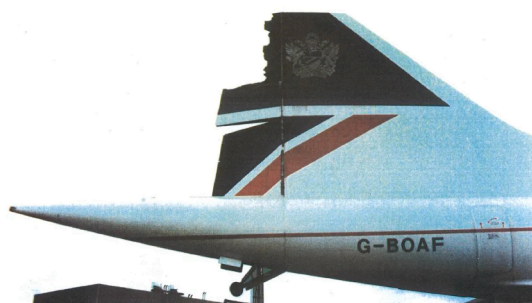
Fig. 1. Rudder failure, G-BOAF, 1989. Adapted from [10].

One of the most exemplar case study is that of the Concorde, with at least six rudder failures (in-flight separation of some portions, as can be seen in Fig. 1) during its operations over 14 years, from 1989 to 2003 [3]. The rudder used for the Concorde was produced as a honeycomb sandwich structure, formed by adhering two rigid thin sheets of composite with a low-density honeycomb core, which is made by empty cells to minimize the weight, but at the same time inducing the trapping of moisture inside them.

Investigation followed the accident and revealed that the rudder separation was determined by the presence of delamination of the honeycomb core and skin (composite layers detachment). Moreover, the adhesive bond strength was deteriorated and the surface between the honeycomb adhesive and skin was damaged by corrosion, both as a consequence of moisture penetration into the structure, with, in some cases, subsequent ice formation, which enhanced the deterioration of the structure [3]. Another possible cause and co-factor of the failure was the presence of pre-existent and un-repaired defects or micro-cracks not seen during previous maintenance check [3]. In addition, the installation of rivets after bond curing of the structure may have promoted cracks and adhesive strength reduction, leading to debonding and

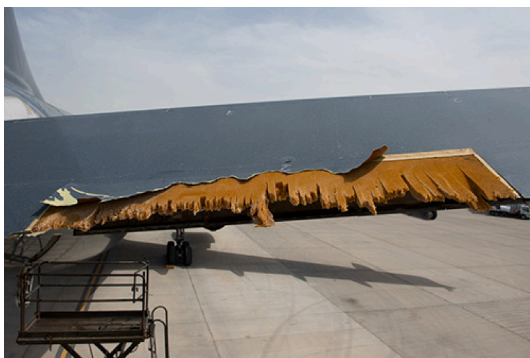
Fig. 2. View of damaged right elevator trailing edge of an A310 Polaris. Adapted from [18].

One of the most recent accidents linked to humidity absorption is dated 8 May 2015, when a Royal Canadian Air Force (RCAF) Airbus A310 (known as a CC-150 Polaris) reported an in-flight loss of part of an elevator [18]. After a safe landing, visual inspections were performed, showing debonding and loss of a part of the right elevator trailing edge, Fig. 2. The combination of high surface temperature, promoted by the dark paint scheme of the component, and moisture absorption, was considered responsible of the failure, affecting the properties of the structural adhesive located between the elevator skin and honeycomb core. The horizontal stabilizer was further analyzed, detecting an irregularity in the paint, not duplicated on the opposite elevator, and a delaminated length from 0.3 m to 1,5 m along stabilizer span [18]. The accident pushed the engineers to establish several preventive actions on the entire CC150 Polaris fleet, including the repaint of composite parts

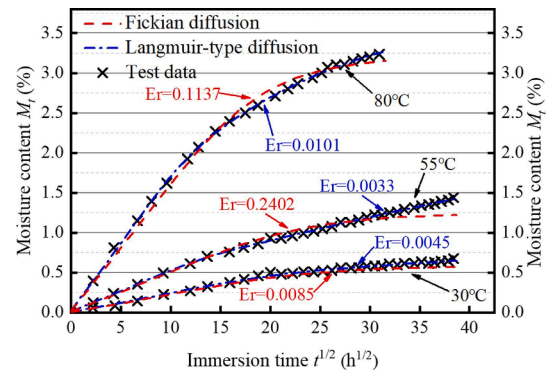
Fig. 3. Diffusion curves: numerical and experimental data of moisture content at 30 °C, 55 °C and 80 °C. Adapted from [37].

J Mei et al. [37] conducted accelerated moisture diffusion tests on a carbon fiber-reinforced polymer (CFRP) composite in the form of a sandwich panel with innovative core structures (like strut-based lattices, realized by additive manufacturing) to investigate the moisture absorption behaviour and hygrothermal ageing effects on the mechanical properties. Temperature had a significant influence on the moisture absorption behavior. The equilibrium moisture content and diffusion coefficient increased as temperature increased, following the Arrhenius equation. They obtained the total moisture content in the sandwich panel during immersion tests; the relation between the moisture content M_t and the square root of the specimen immersion time \sqrt{t} is shown in

Fig. 3, which compares the experimental results with the outcomes from two diffusion models (Fick's and Langmuir-type).

In the initial part of the curves of moisture diffusion, the moisture content increases linearly, and then gradually slows down until a plateau is reached, which is the saturation condition, at the maximum moisture content. Since the temperature influences the diffusivity, it has also an effect on the time to reach the saturation condition. High temperature levels mean high diffusion and so a reduced saturation time. The compressive properties were also tested after hygrothermal ageing, through uniaxial compression tests in the direction of the thickness of the panel, after exposure to different temperature and humidity. The experimental results indicated that the compressive modulus $E_{(t,T)}$ and strength $\sigma_{(t,T)}$ of each composite strut and that of the whole sandwich panel reduced due to the combined effect of temperature and humidity absorption: prolonged ageing time and higher temperature resulted in a sensible drop of mechanical properties [37].
