Experimental investigation on the use of Fabric-Reinforced Cementitious Mortars for the retrofitting of reinforced concrete dapped-end beams

Department of Civil and Environmental Engineering, Politecnico di Milano, Milan, Italy

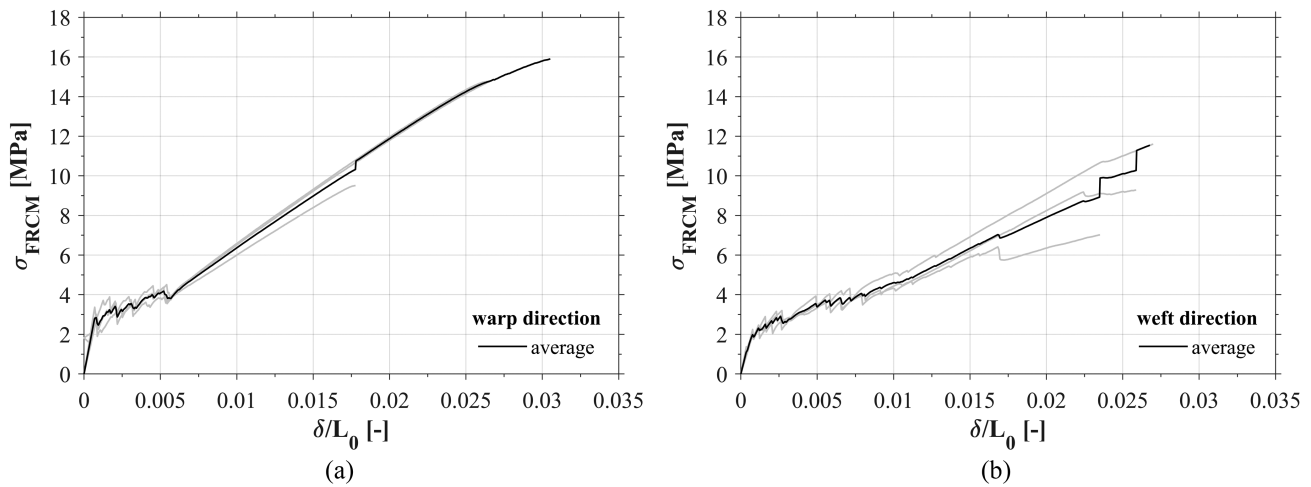
FIGURE 2 Tensile response of the FRCM system in terms of nominal stress σ_{FRCM} versus normalized displacement δ/L_0 ; in the warp (a) and weft directions (b). FRCM, Fabric-Reinforced Cementitious Matrix.

behavior of FRCM composites, which consists of a first linear-elastic branch, followed by a multi-cracking phase and a third region dominated by the fabric response. Relevant geometrical and mechanical quantities related to the uniaxial characterization of the FRCM system are collected in Table 7. In particular, the composite efficiency (EF_{FRCM}) corresponds to the ratio between the average maximum loads recorded in the composite and those of the fabric tensile tests.²³ In Figure 3, the comparison between the fabric and the composite tensile responses is reported. For the FRCM strips, the strain values (ϵ) are obtained starting from the COD measurements ($\epsilon = \text{COD}/L_G$). Please note that curves in which COD measurements were lost are not depicted in the graphs.

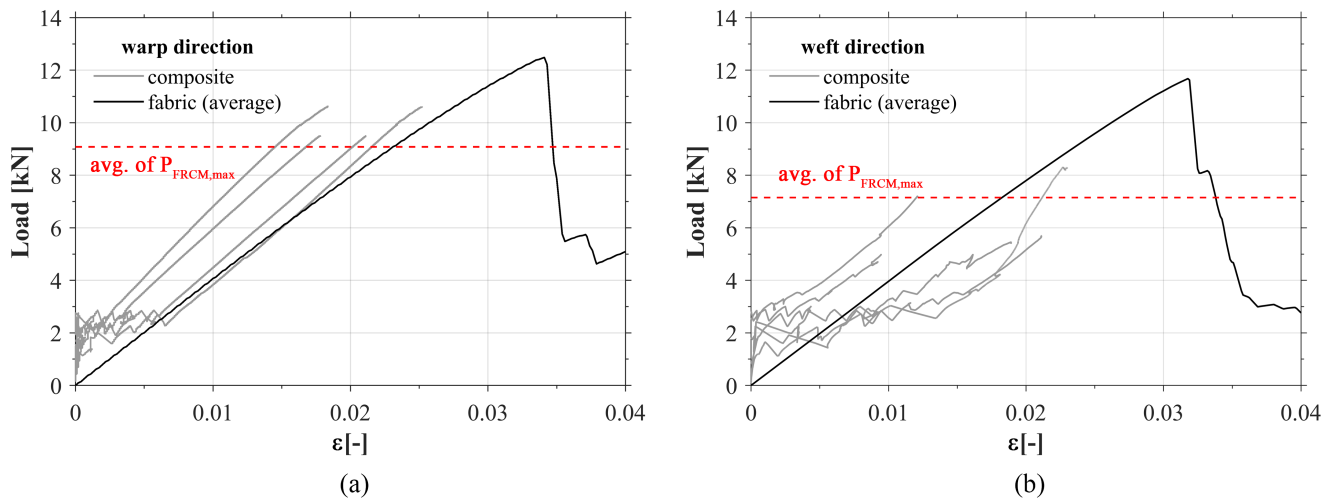
FIGURE 3 Comparison between the composite and the fabric tensile responses considering the same width of the samples (70 mm): load versus ϵ curves in (a) warp and (b) weft directions. Red dashed lines represent the average maximum tensile load of the composite.

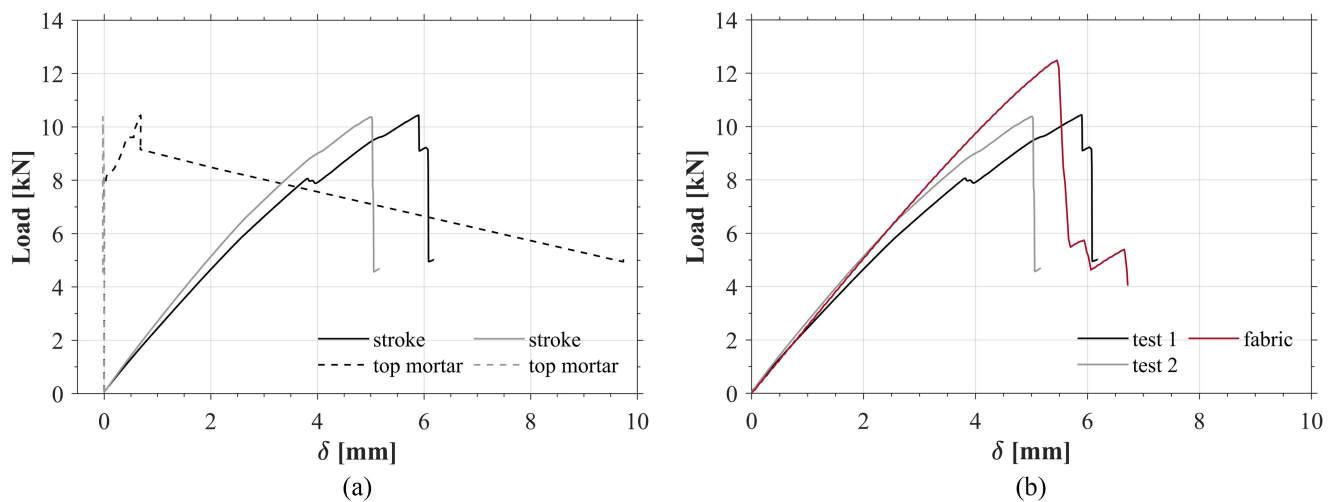
FIGURE 4 Single-lap shear tests: Load-stroke and Load-top mortar displacement (δ_{top}) curves (a), and comparison between Load-stroke curves and the fabric (warp direction) tensile response (b).

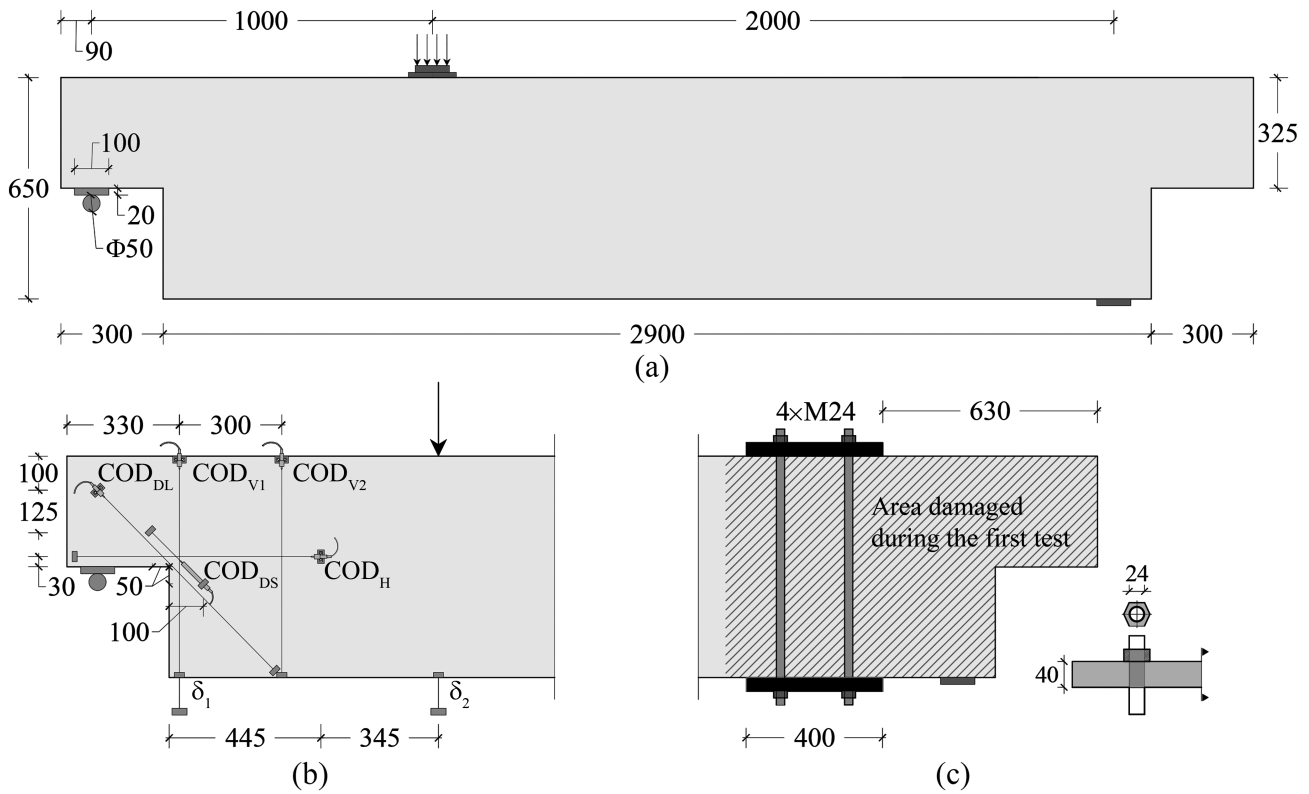
FIGURE 6 Geometry of specimens and test set-up (a), instruments layout (b), and detail of vertical reinforcing plates used after testing the first dapped-end (c). Measures in mm.

The tests were displacement-controlled at a constant stroke rate of 20 $\mu\text{m/s}$ and carried out according to the following sequence for each beam: (i) testing of the first dapped-end; (ii) unloading; (iii) reversing of the beam and vertical post-compressing of the already tested side of the beam by means of steel plates vertically connected with external post-tensioned steel bars (Figure 6c); (iv) testing of

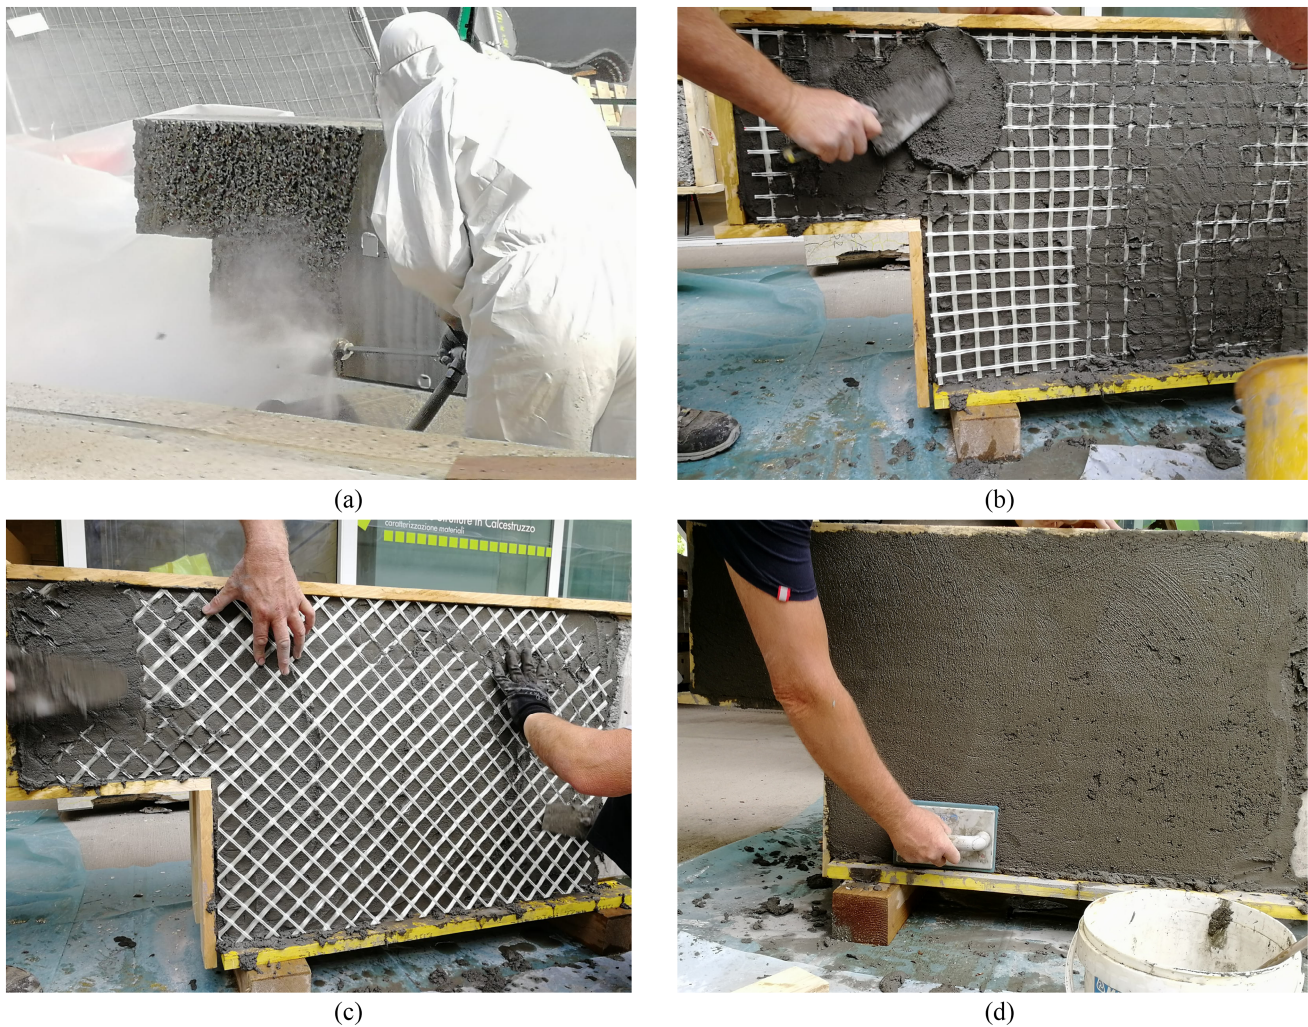
FIGURE 10 Application of the FRCM retrofitting system on the RC dapped-end beam: hydro-scarification of RC beam surface (a), placing of the fabric layer at 0° (b), placing of the fabric layer at 45° (c), and cast of the finishing layer (d). FRCM, Fabric-Reinforced Cementitious Matrix; RC, reinforced concrete.

(as for the single lap shear tests) to prevent the delamination of the reinforcement from the support (Figure 10a). Then, the FRCM composite was applied following a typical hand lay-up technique: (i) application of the first

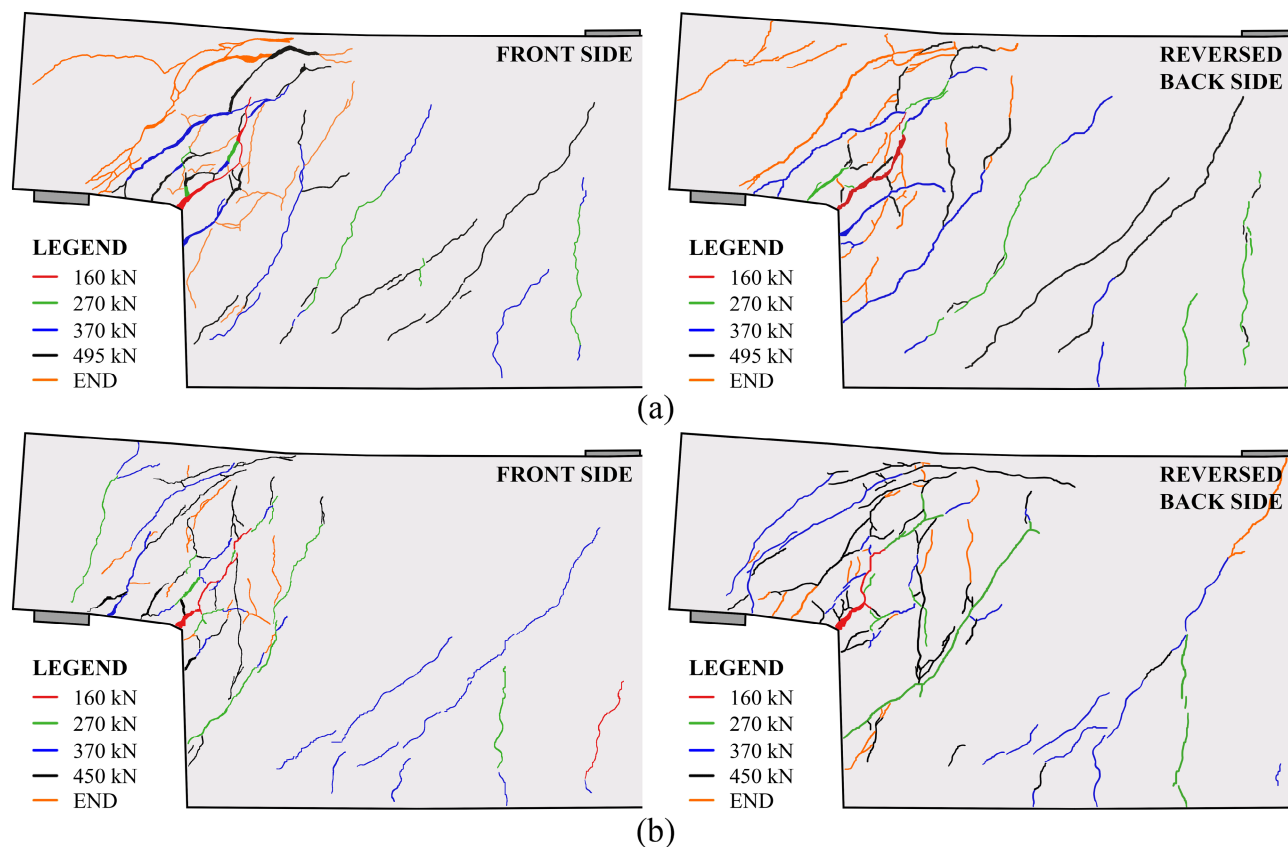
FIGURE 13 Crack pattern of reference specimens at different load stages: REF-01 (a) and REF-02 (b).

The evolutions of the crack patterns of reference and pre-damaged specimens are shown in Figure 13 and Figure 14, respectively. In all cases, the first crack occurred at the inner corner (red lines), followed by the

development of flexural cracks at the bottom section of the beam (green lines). As the applied load increased, shear cracks (blue-black-orange lines) gradually developed in the full-depth section up to the failure of the nib. Some differences between the front- and the back-crack patterns were visible only at loads larger than 370 kN (Figure 13). The obtained crack patterns were aligned with those reported by other authors considering orthogonal³⁰ and combined³¹ reinforcement. It is interesting to notice the fact that only inclined cracks developed in the nib area. This is an indicator that the dowel action contribution of the longitudinal reinforcement ($3\Phi 12$) was

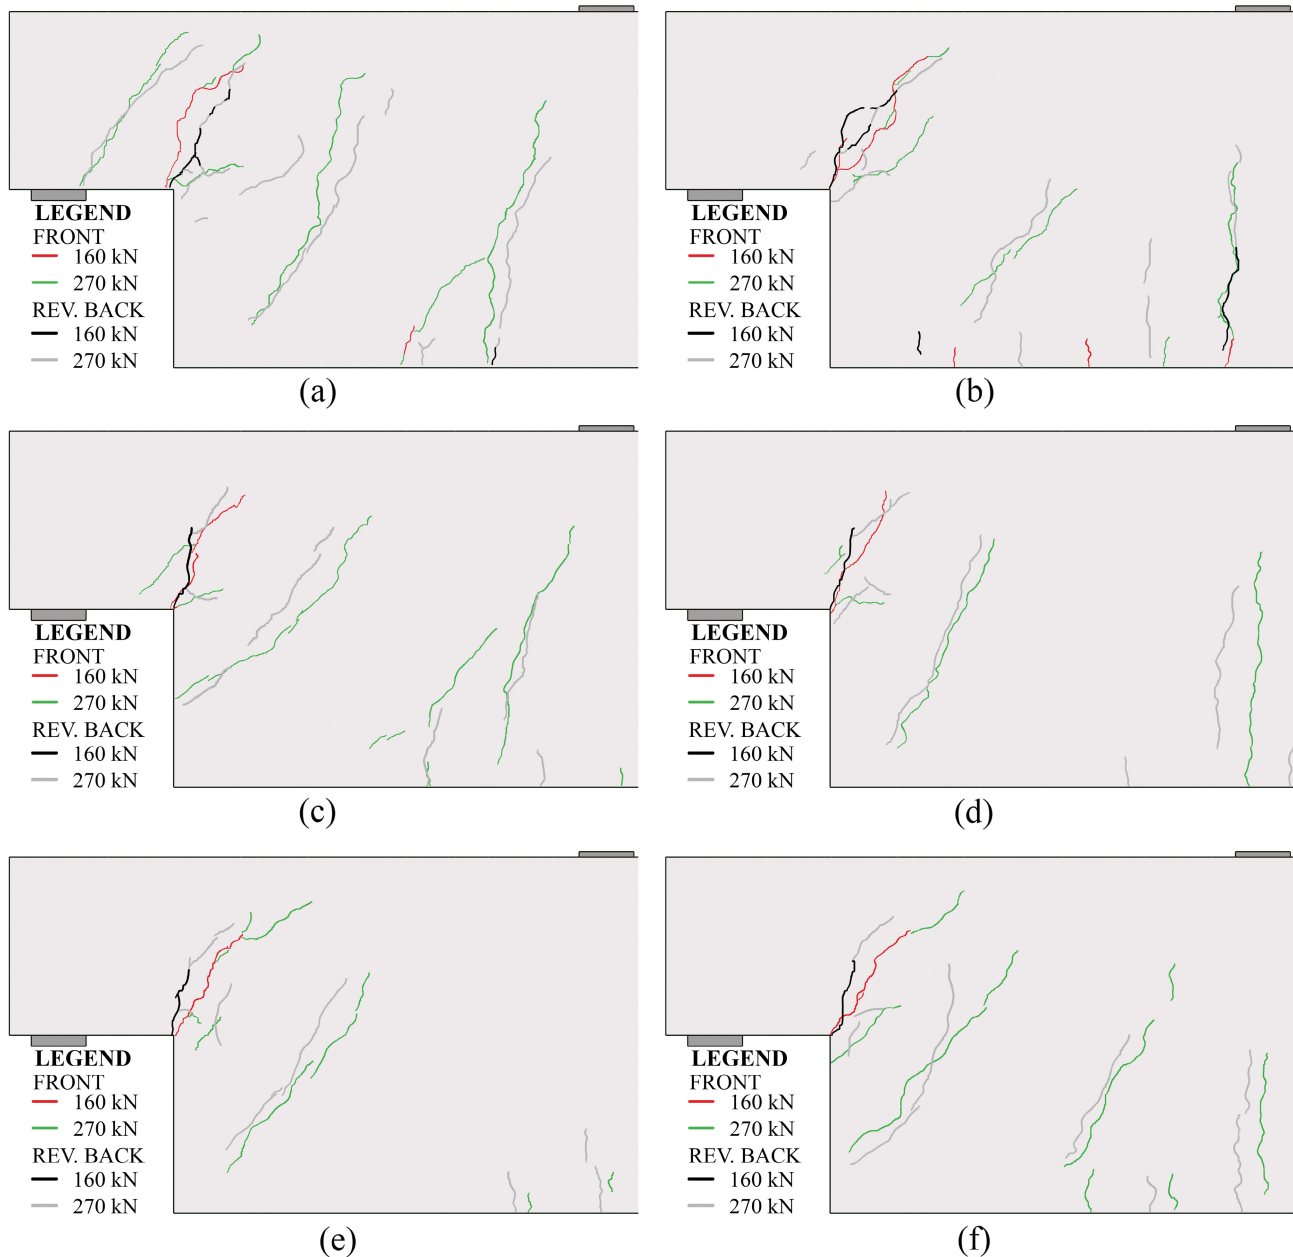
FIGURE 14 Crack pattern of pre-damaged specimens at different load stages: PRE-01 (a), PRE-02 (b), PRE-03 (c), PRE-04 (d), PRE-05 (e), and PRE-06 (f). Front and reversed back sides are depicted together.

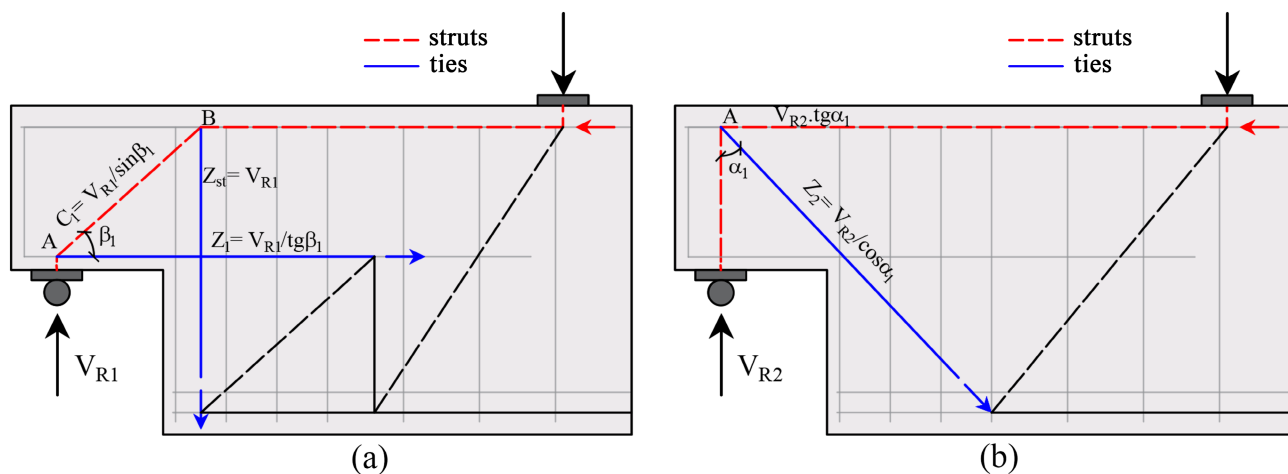
FIGURE 15 Strut-and-tie models adopted for the prediction of the load bearing capacity: first-orthogonal- (a) and second-diagonal- (b) resisting mechanisms.

(Figure 15a), the number of stirrups involved in the equilibrium may vary from a minimum of 1 to a maximum of 4 according to the reinforcement layout. As example, in Figure 15a the schematic representation of the equilibrium considering only two stirrups is shown. Under this assumption, the value of the maximum reaction of each mechanism ($V_{R,1}, V_{R,2}$) resulted to be associated with the tensile failure of a tie, provided the fulfillment of all the compression checks. The maximum load that can be applied to the beam specimen (P_R) was then determined according to Equation (1), based on the resisting load of the single dapped-end ($V_{R,1} + V_{R,2}$) and the static scheme of the test (see Figure 6a).

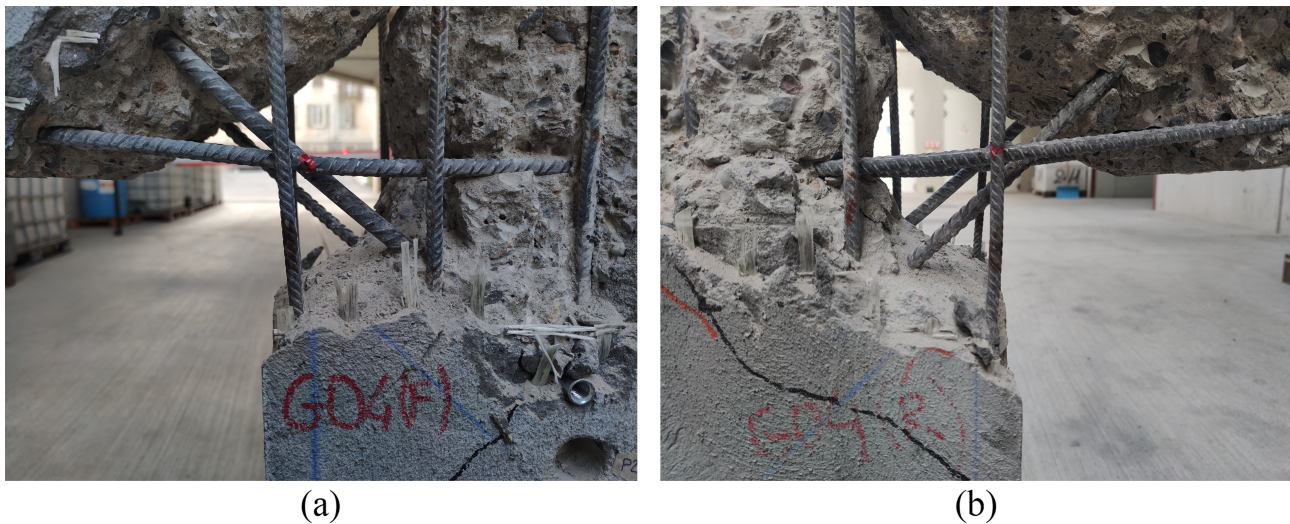
FIGURE 21 Detail of the rebar rupture in specimen RTF-(0°)-01 after concrete demolition: failure of the U-shaped horizontal bar on the front side (a), and of the first stirrup on the back one (b). Note that the latter view is reversed.

reference one (Figure 13), failed due to the crushing of the inclined concrete strut in correspondence to the top reinforcement, except for the case of specimen RTF-(0°)-01. In the latter the failure was governed by the rupture of the steel bars (one leg of the U-shaped horizontal bars on the front side, and one leg of the stirrup closer to the nib on the back side, see Figure 19a and Figure 21). The difference in the failure mode and the uneven behavior of the RTF-(0°)-01, as visible from the curves plotted in Figure 17 and Figure 18, are discussed in the following section.
