Assessing the potential application of bacteria-based self-healing cementitious materials for enhancing durability of wastewater treatment infrastructure

Wastewater treatment plants (WWTPs) around the world are mainly built using concrete. The continuous exposure to wastewater affects the durability of concrete structures and requires costly maintenance or replacement. Concrete production and repair represents ~8% of the global anthropogenic CO₂ emissions due to the use of cement, thus contributing to climate change. Developing a more sustainable cementitious material is therefore required for this vital health infrastructure. In this study, the feasibility of using bacteria-based self-healing (BBSH) cementitious materials for WWTPs is assessed by exposing BBSH mortar prisms to a continuous municipal wastewater flow and comparing their self-healing capacity to equivalent mortar prisms exposed to tap water. Microscopy imaging, water-flow tests and micro-CT analyses were performed to evaluate the self-healing efficiency of the mortar prisms, while SEM-EDX and Raman spectroscopy were used to characterise the healing products. Our work represents the first systematic study of the heal

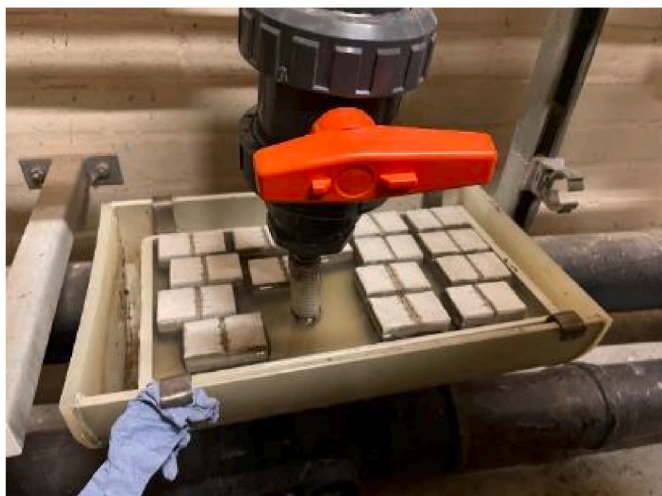
Fig. 1. Mortar prisms placement in the BEWISE pilot treatment plant. The inner tray of the hopper was subject to a continuous flow of municipal wastewater from the overhead tap. A small pipe extension was attached to the tap to prevent splashing. The inner tray, in which the samples were placed, had a height of 30 mm, allowing the top 10 mm of the mortar prisms to be exposed to air.

A duplicate set of mortar prisms (nominally identical to the ones kept in tap water) were tested at the BEWise pilot plant facility. The pilot plant is located inside the Northumbrian Water Ltd WWTP at Birtley (UK) which treats municipal wastewater (30,000 population equivalent). The mortar prisms were placed in a hopper within a tray of 30 mm height (Fig. 1), with the cracked side facing upwards. The hopper received a continuous flow of untreated municipal wastewater, identical to the one in the WWTP. The wastewater level was maintained 10 mm below the top of the mortar prisms, in a similar way to the tap-water-exposed mortar prisms. The mortar prisms were randomly distributed within the tray and their position was changed every week, to avoid any preferential healing due to the proximity of the prisms to the wastewater inlet.

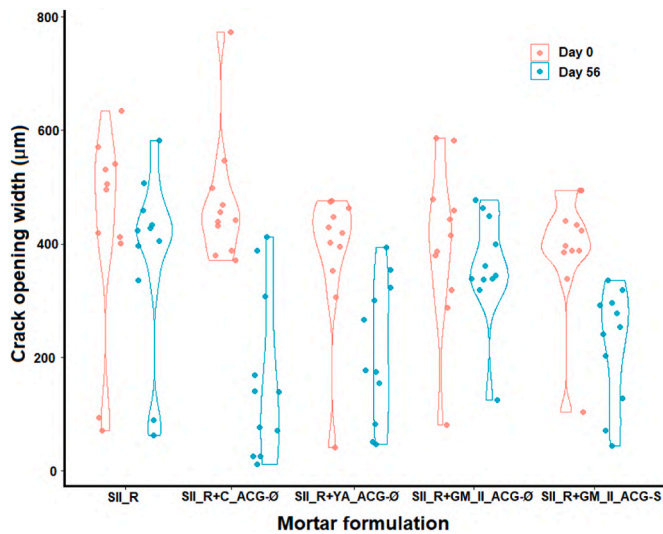
Fig. 8. The crack width changes from Day 0 to Day 56. The comparison is made for 11 points on reconstructed micro-CT images from wastewater-exposed Set II mortar prisms.

Micro-CT scanning was done on one mortar prism from Set II samples placed in wastewater to quantify the precipitation within the depth of the crack and analyse the crack closure for wastewater samples. The crack width was measured using ImageJ on reconstructed micro-CT images (see Appendix D). The measurement was made on 11 different points, 100 pixels apart, on the same slice of image for Day 0 and Day 56 scans. The distribution of the 11 points (as dots) is shown in the form of a violin plot and its probability density, see Fig. 8 (with red for the crack width on Day 0 and blue for the crack width on Day 56). In this representation, a better healing is considered if the points between Day 0 and Day 56 are further apart for the same sample. For most of the mortar prisms, the cumulative crack width was reduced in the two months they were exposed to wastewater. SII_R + C₂ ACG-Ø shows the maximum reduction in crack width, followed by SII_R + GM_II ACG-S. For SII_R + YA_ACG-Ø uneven amount of precipitate formation can be seen as all the points were distributed along the violin, whereas for SII_R + C₂ ACG-Ø most points were at the bottom of the violin showing a consistent reduction from ~400 µm to less than 200 µm. For SII_R, which is the

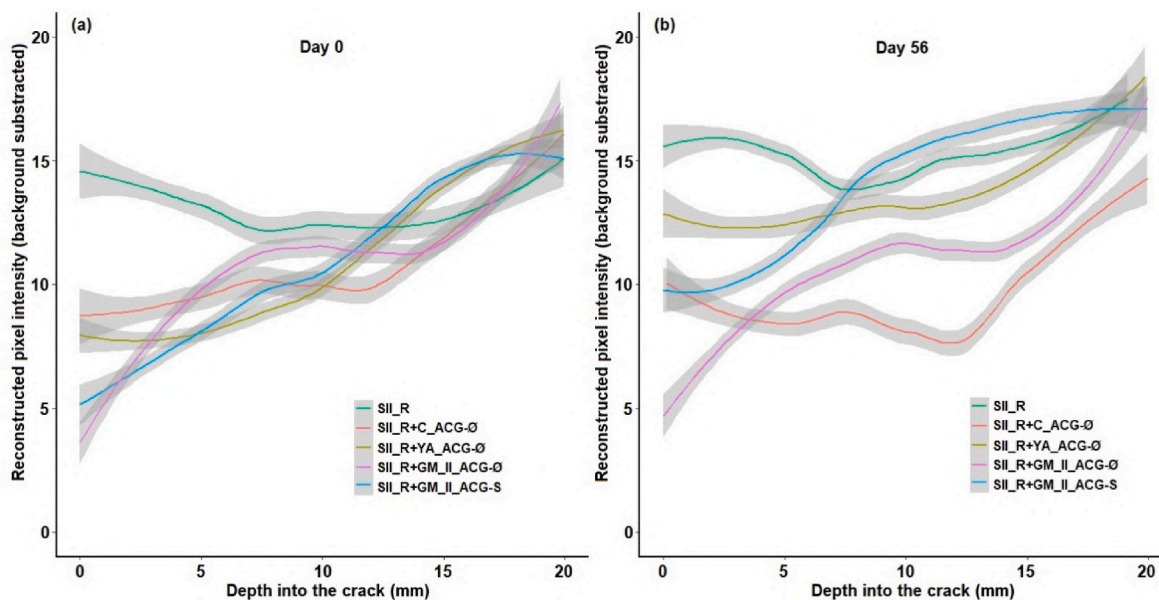
Fig. 9. Mean pixel intensity (from the surface up to 20 mm depth) measured at (a) Day 0 and (b) Day 56 on the micro-CT images for the wastewater-exposed mortar prisms.

To visualise the precipitation within the depth of the crack, pixel intensity was measured at 11 slices across the crack for up to 20 mm depth at Day 0 and Day 56 using micro-CT images (Fig. 9).

The pixel intensity for SII_R + GM_II_ACG-S, SII_R + YA_ACG-Ø and SII_R increased after 56 days, indicating the deposition of a denser material within the crack. For SII_R + C_ACG-Ø and SII_R + GM_II_ACG-Ø mortar prisms, the density increased slightly at the top surface while no increase was seen within the deeper regions of the cracks, which would correspond to the accumulation of precipitation only at the surface of the crack. Only one mortar prism from each set of triplicates was scanned on micro-CT, so no conclusive results can be made for the particular set of mortar prisms, but it has been shown that micro-CT can be a good method to visualise the crack healing at the surface as well as within the depth of the cracks.

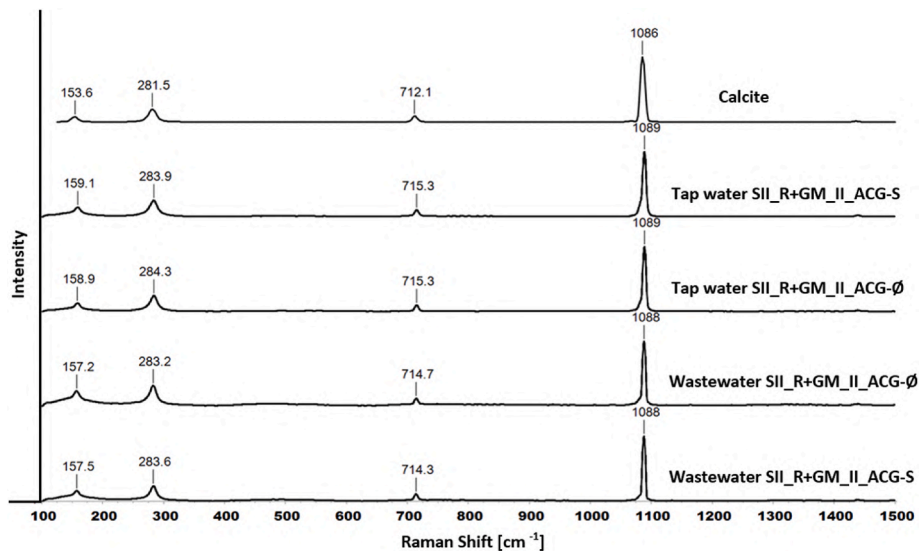
Fig. 13. Raman spectra of the healing precipitates formed within the cracks of SII_R + GM_II_ACG-Ø (without spores) and SII_R + GM_II_ACG-S (with spores) mortar prisms after being exposed to tap water or wastewater healing conditions. The four main peaks observed on the four mortar mixes correspond to the Raman spectra of pure calcite [40,41].

through Raman spectroscopy. Raman spectra of the healing product present in the healed cracks of the different mortar prisms presented the four bands that correspond to the Raman spectra of pure calcite [40,41]. Therefore, the healing product within these cracks were confirmed as calcium carbonate (CaCO_3) (Fig. 13).

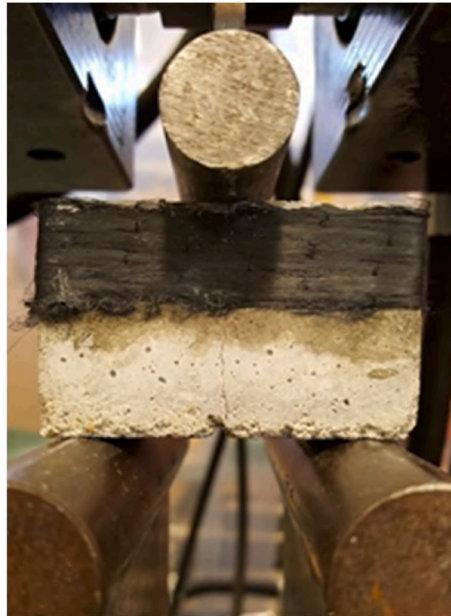
Cracking generation via three-point bending. Carbon fibre-reinforced polymer (CFRP) strips were affixed to guarantee the integrity of the mortar prisms after cracking.

After the curing period, all mortar prisms were dried at ambient laboratory conditions for 24 h. Following this, a notch of 1.5 mm depth was sawn at the centre of each mortar prism to induce crack formation. Then, carbon fibre-reinforced polymer (CFRP) strips were affixed to the top third of the mortar prisms using an EL2 epoxy laminating resin (Easy Composites, Stoke-on-Trent, UK) to guarantee the integrity of the samples after cracking (See Appendix A). Mortar prisms were cracked by

three-point bending using a 100 kN Dartec-Instron hydraulic loading frame. After the crack was formed and while maintaining the load, two 0.5 mm thick plastic spacers were placed at both ends of the formed crack, as fully described in Ref. [25]. Three selected crack locations (separated 10 mm from each other and the borders of the specimen) were marked with a permanent marker to enable monitoring of the crack at the same site. Immediately after cracking, the cracks were inspected using an optical microscope before placing the mortar prisms under healing conditions.
