Supporting the Diagnosis and Functioning of Historical Buildings through measuring

The paper explores various aspects of HBIM implementation, starting from a Scan-to-BIM process to create a customized model for static preservation analysis, leveraging laser measurements to assess the structural integrity of heritage buildings and mitigate potential damage during periods of high occupancy. The proposed method was applied to the case study of a convent located in the Merate, Lecco, in northern Italy. The case is developed from a digital survey and a produced accurate virtual model. The research starts with understanding the morphology of the convent, providing a theoretical understanding of its architectural evolution. Different modeling techniques and workflows are compared in the modeling phase, considering the challenges posed by the intricate shapes and unique characteristics of Cultural Heritage. After the modeling phase, the thesis investigates the structural analysis of the main structures within the church, particularly through verticality analysis and surface deformation measurements. This analysis provides insights into the historical building's structural integrity and po

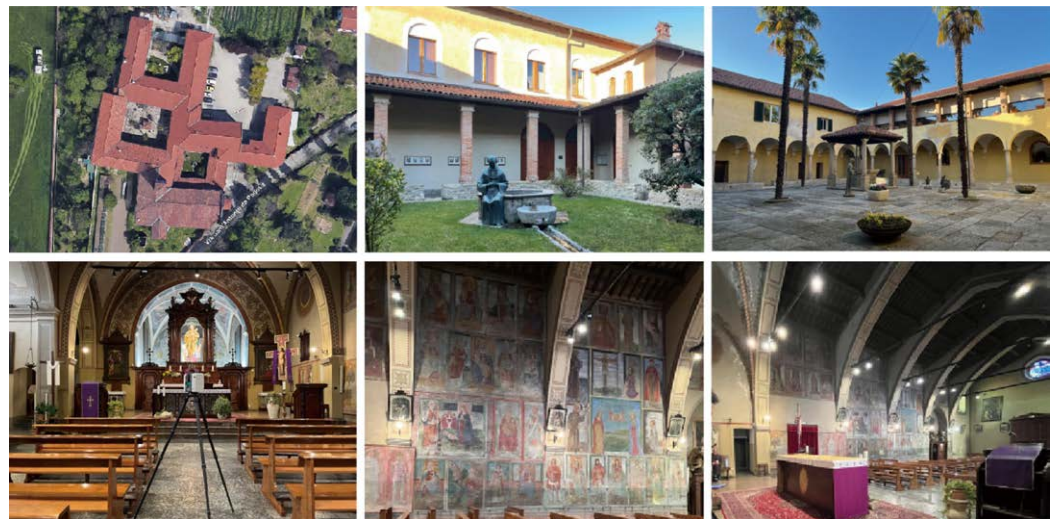
Fig. 2. Site plan (a) minor cloister (b), main cloister (c), church nave (d), frescoes (e), main structure (f). Elaborations by the authors.

The convent (fig. 2) is in the town of Merate, Lecco, in northern Italy. Over the following decades, the church underwent several renovation works, preserving its historical significance. In 1508, a new church in late Gothic style replaced the original structure; in 1540, a sacristy, refectory, kitchen, and bell tower were added. In 1588, a new presbytery was built. The convent faced suppression during Napoleon's reign in 1810 but was repurchased in 1884, becoming part of the Lombard province of the Friars Minor in 1898 [Europe in the XIX 2024]. The convent comprises multiple buildings arranged around two quadrangular cloisters, with wings opening onto two courtyards to the north.

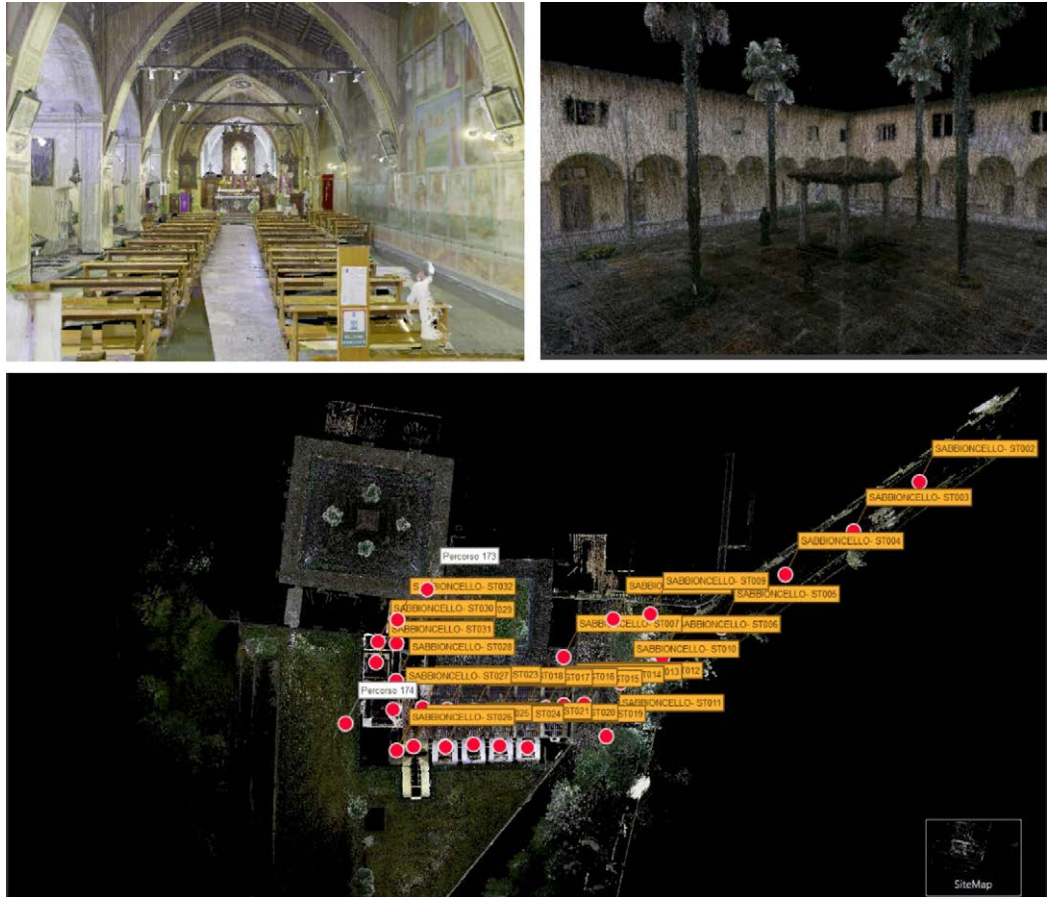
Fig. 3. First session point cloud of main church (a), second session point cloud of main. Elaborations by the authors.

To achieve a comprehensive representation of the church's structure, a two-stage point cloud scanning process was implemented. The first involved the utilization of a laser scanner structured with time-of-flight registration a Leica RCT360 [Leica RTC360 2024] whose VIS (Visual Inertial System) technology facilitated the placement of scans in a local reference system. The second session involved the use of a mobile scanner BLK2GO scanner [Leica BLK2GO 2024] to capture the courtyard on the southern side of the church as well as the two cloisters on the northern side [Del Duca et al. 2023].

The first scanning path originated from the northeastern road and seamlessly extended into the interior of the church (fig. 3). Cyclone REGISTER 360 [Leica Cyclone REGISTER 360] a 3D laser scanning point cloud registration software was used to import, align, clean and export project data collected by Leica Geosystems sensors.

The average error related to the scan alignment (Cloud-to-Cloud) was measured at 0.001 m, ranging from 0.000 m to 0.020 m.

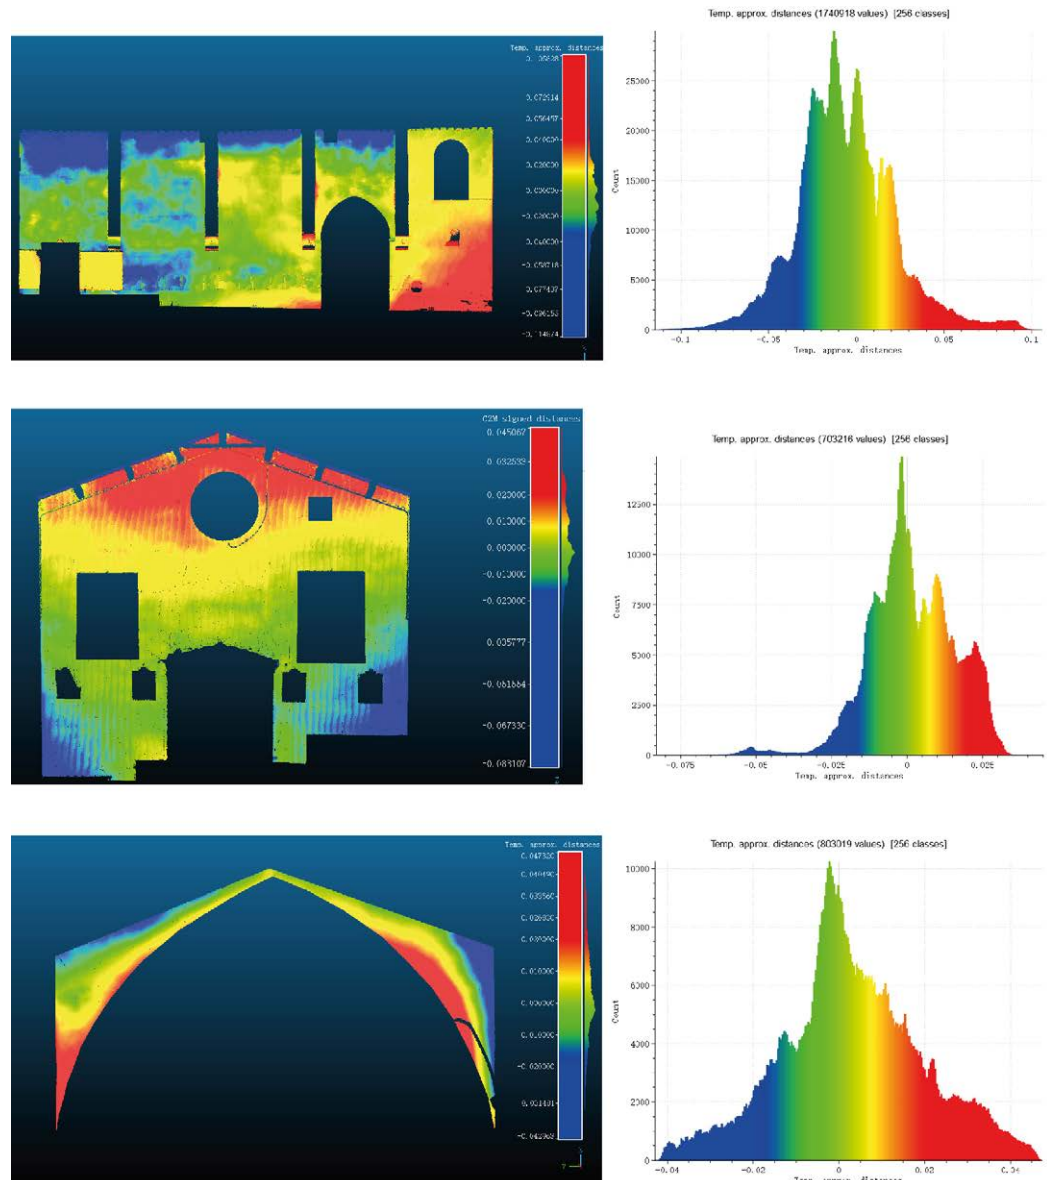
Fig. 8. The heat map and histogram of deformation. W1 wall (a), W2 wall (b), A1 arch (c). Elaboration by the authors.

In this research, the effectiveness of the employed methodology for evaluating structural surface deformation was assessed using the "RANSAC shape detection" plane on point cloud data in ".e57" format. The analysis focused on multiple locations, including W1, W2, A1, A2, A3, A4, and A5. The results obtained from this evaluation are visualized in the histogram and summarized in the following table (fig. 7).

The "Standard Deviation" column represents the measure of surface deformation, with lower values indicating less variation in the deformation. The "Min. Distance," "Max. Distance," and "Average Distance" columns provide information about the spatial extent of the deformation, with values reflecting the distances between the detected plane and the point cloud data. These distances were found to range from 0.00 to a maximum value depending on the location (fig. 8). Additionally, the "Max Error" column presents the maximum error observed in the deformation measurement. This value indicates the largest deviation between the actual structural surface and the plane created by the RANSAC shape detection algorithm.

The all-standard deviation values ranged from 0.0112 to 0.0586, indicating varying levels of deformation across the locations. This suggests that some areas exhibit more significant deformations than others. The minimum and maximum distance values provided insights into the extent of deformation, with each location having its own range of distances between the detected plane and the point cloud data. The average distance values ranged from 0.0042 to

0.0248, representing the overall magnitude of deformation observed. Furthermore, the maximum error values, ranging from 0.0382 to 0.0853, identified localized areas with substantial deviations from the actual wall surface.

possible to visually observe the inclination and deformations of the walls using heatmaps and bar charts. In this case, the walls exhibit some degree of flexibility rather than rigid bodies because of the masonry composition of the walls. The structural condition of the church is found to be in good shape, with the maximum inclination angle being approximately 1.1° and the largest deformation measuring around 0.2m. The analysis of this data enables the detection and recording of pathologies, which can then be incorporated into the inventory system.
