INTERNATIONAL JOURNAL OF WOOD CULTURE

Consolidation of the “Cassarini-Cavazza” Mansion Timber Floors: an Example of Minimal Conservation Intervention

This study presents an example of structural safety measures for old wooden and beaten earth floors. Accordingly, this study demonstrates that non-substitutive interventions can simultaneously save historical building materials and techniques, make quick interventions, and save money. Located in the province of Como in the Lombardy region of Italy, the ‘Cassarini-Cavazza’ mansion is a late 18th-century building where the floors are realised with a particular but heavy system of wood and earth mortar. Through its uses over the centuries, this system is now in a critical condition from a structural viewpoint and requires conservation. This study first cites the main international documents and guidelines that highlight the topic of minimum intervention. A step-by-step description of the case studio is then presented, as well as the problems identified and the solutions adopted.

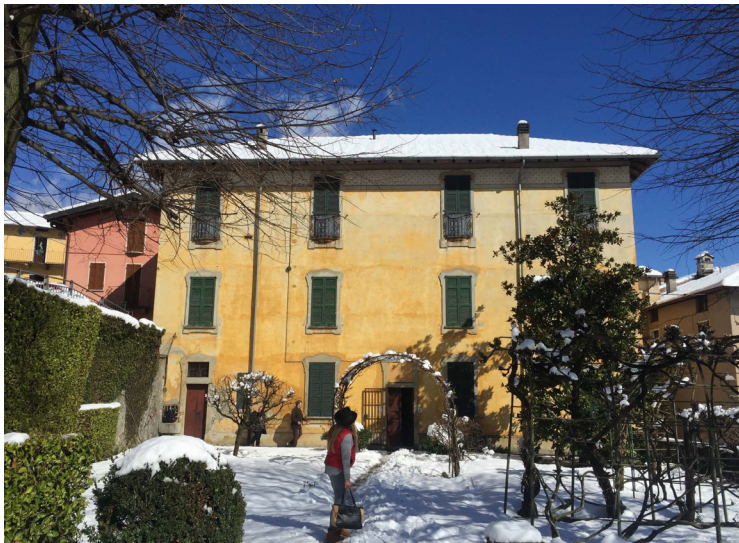
property borders, the plan of the house is trapezoidal (Fig. 3). A small, enclosed garden is located in front of the main façade (Fig. 4).

FIGURE 4 Main façade of the mansion and enclosed garden

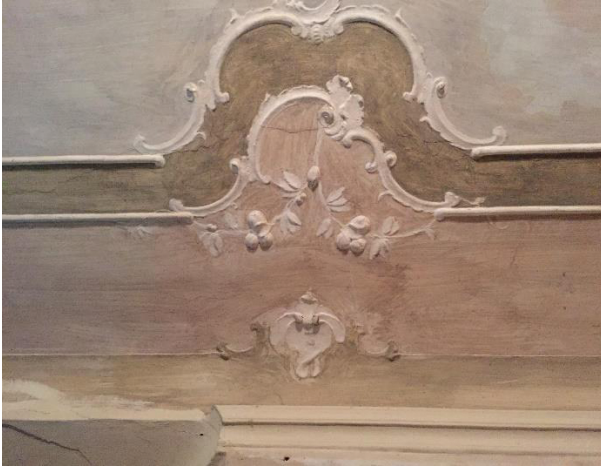
FIGURE 5 Example of stucco decoration on the vaults inside the mansion

20th century. Typical 18th–19th century style frames are visible around the openings on the outside. Gypsum frames that are clearly in the Rococo style are visible inside the mansion, mainly in a room on the ground floor (Fig. 5). The artisans of the Intelvi Valley were famous for being plasterers. In Cerano, a small museum is dedicated to stucco craftwork.

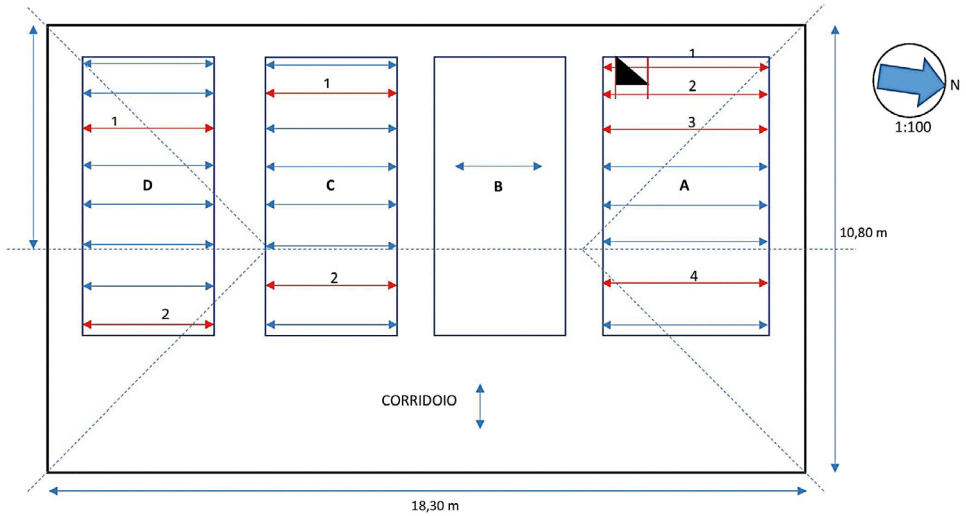
The three attic rooms occupy the entire building area (Fig. 6) and the floors are composed of wooden beams and beaten earth mortar with a small amount of lime. Interventions have been designed and performed on three of four floors because one was in reasonable condition. The distance between the beams, which vary in diameter between 15–25 cm, is approximately 70–80 cm.

FIGURE 6 Scheme of the three attic rooms (A to D). After the inspection phase, intervention in B was not considered necessary except for the removal of items and cleaning. The red arrows highlight the beams that need to be reinforced.

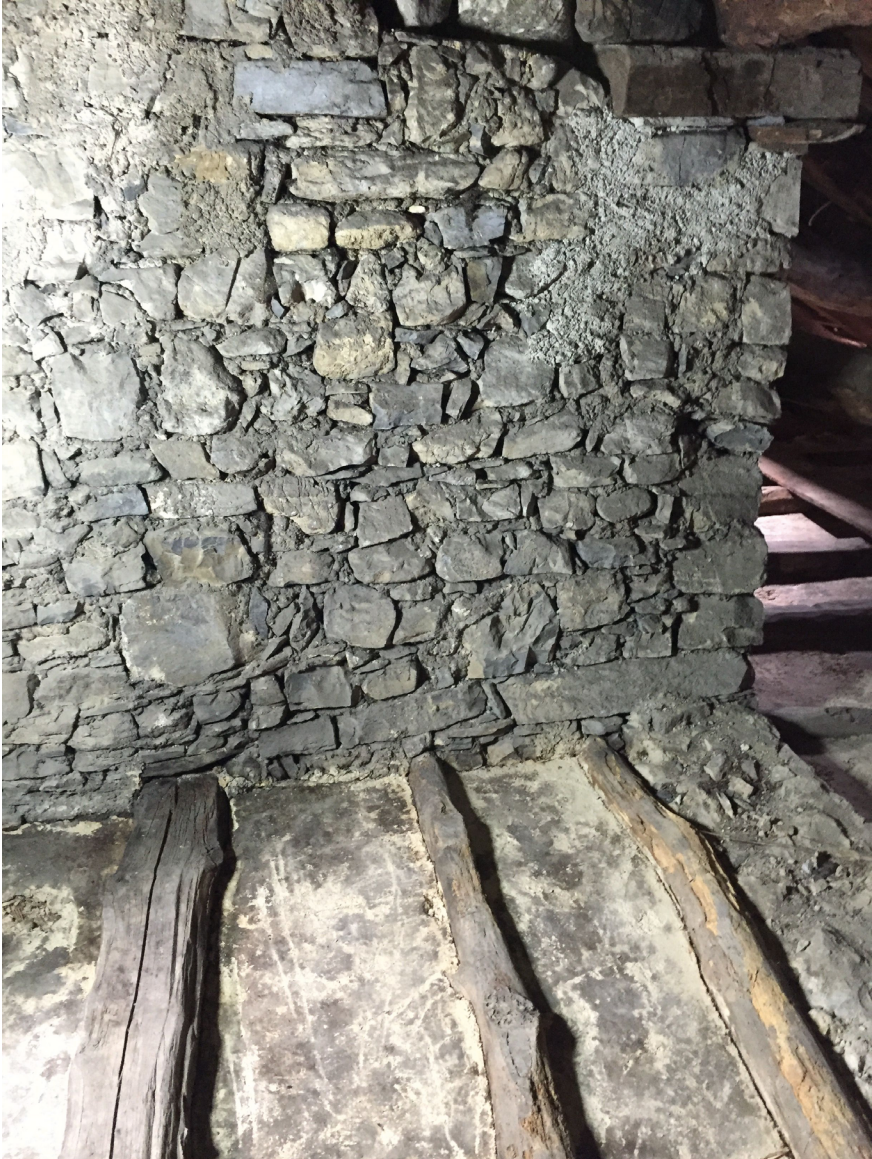
Beams, which are round or have been partially processed with an axe, are embedded into the rough stone walls (Fig. 7). Wooden laths are fastened at the intrados of the beams with nails. The distance between laths (thickness 4×2 cm) is approximately 10 cm. A layer of straw is placed on this lath net, and the space between the beams on the lath plus straw system is partially (50%) filled with hard earth mortar mixed with lime. The thickness of this mortar plus straw layer is approximately 6–7 cm (Fig. 8).

The quality of timbers is different sections and ranged from round timbers (the major part) to squared (a few elements). In between them are different shapes. Many beams have very different sections between one end and the

FIGURE 7 Extreme variability of spacing, processing, and diameter of timbers

other; the trend is frequently irregular, and knots are found in as much as 50% of the section.

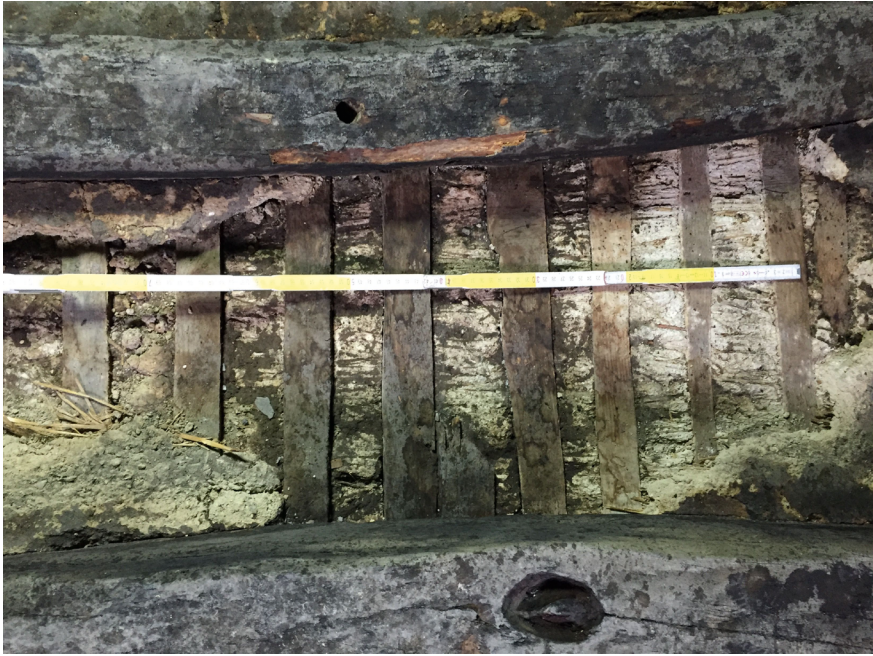
FIGURE 8 Partially removed upper part of mortar plus straw. The laths net between the beams and the top part of the plastered ceiling are visible.

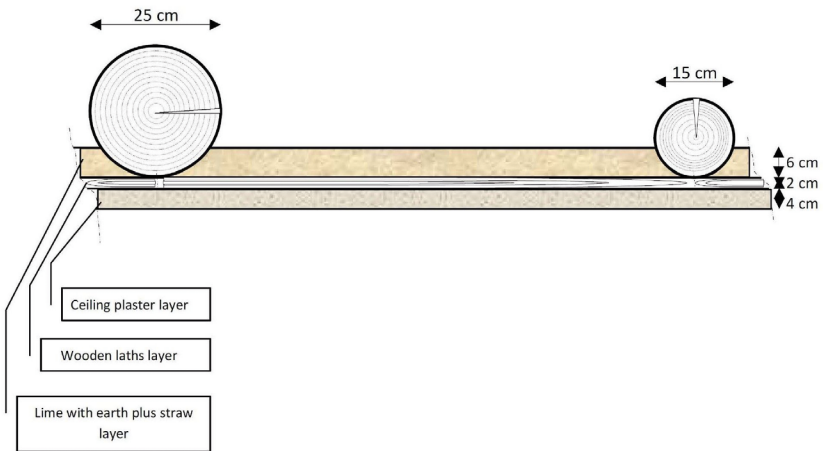
The extrados of the floor, which are composed of laths, are plastered and decorated with gypsum frames. Mixing the mortar with straw permits the

preservation of heating conditions in a site that experiences a cold in winter (Fig. 9).

FIGURE 9 Transversal section of the floor techniques and materials

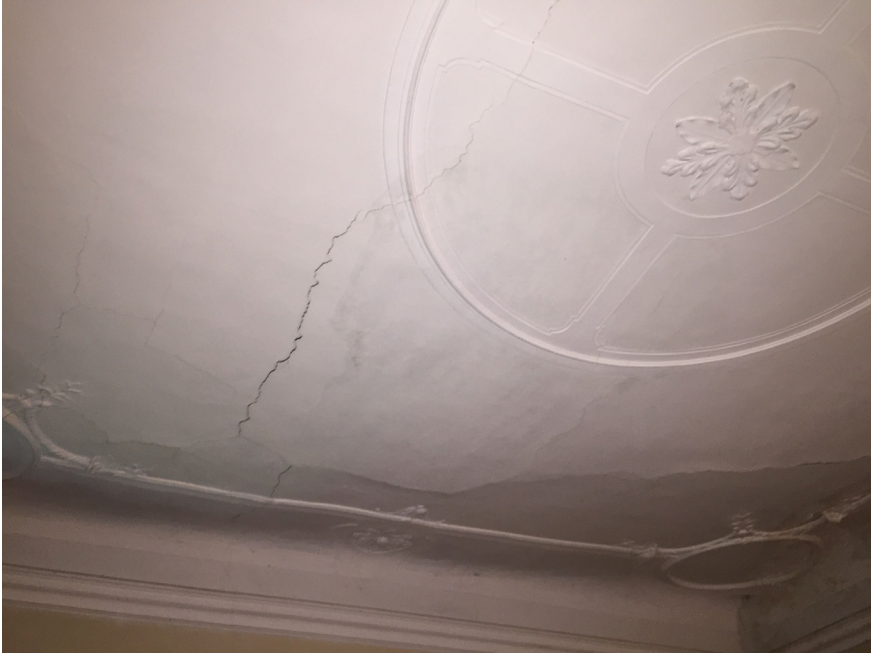
The third-floor ceilings showed significant bending, and the plaster was very cracked, with the risk of thick mortar falling on the owners (Figs 10 and 11).

FIGURE 10 View of the ceiling of a room with bending, cracks, and detachment of the ceiling plaster

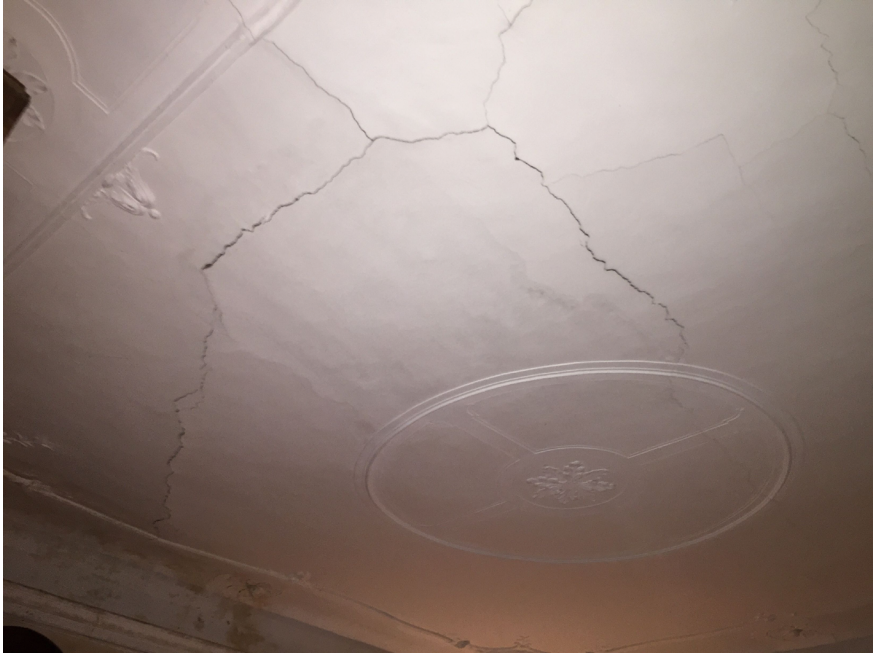
Generally, a large knot is present at the point of a small beam section or diffusely in the small section elements. Furthermore, timbers, mainly very small sections, are affected by wood-boring insects that cause deep (1–2 cm around the perimeter) decay that reduces the already small section of the beams. Fortunately, no rot attack has been observed.

The small section of the beams, even in a partial absence of deep decay and defects, provoked the bending in the middle of the floor.

Each floor has both conditions (deteriorations and defects). The result is that ceilings show many cracks due to the bends in different positions. (Fig. 11)

The heavy items accumulated in the attic over the centuries, the heavy technology system of the floors, the scarce section of timbers, the quality of the wood, and the wood-boring insect attacks have led to the current dangerous structural condition.

FIGURE 11 View of the ceiling of a room with bending, cracks, and detachment of the ceiling plaster

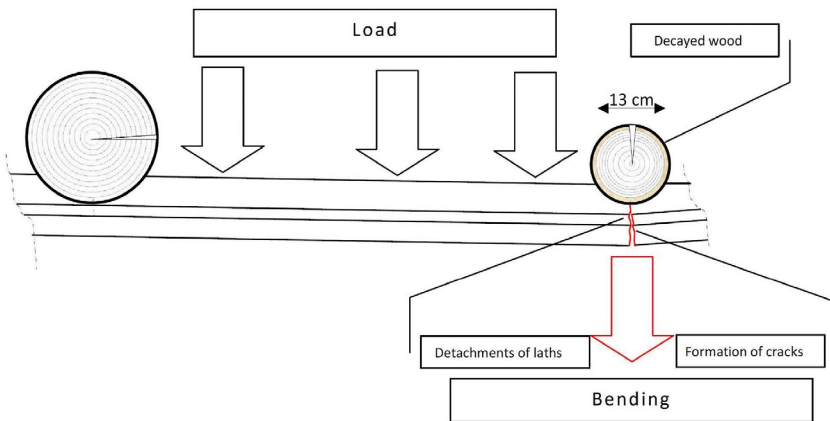
This bending has caused the detachment of some laths, as well as cracks and detachment of the ceiling plaster inside the rooms (Fig. 12).

FIGURE 12 Transversal section of the mechanism of ceiling cracks

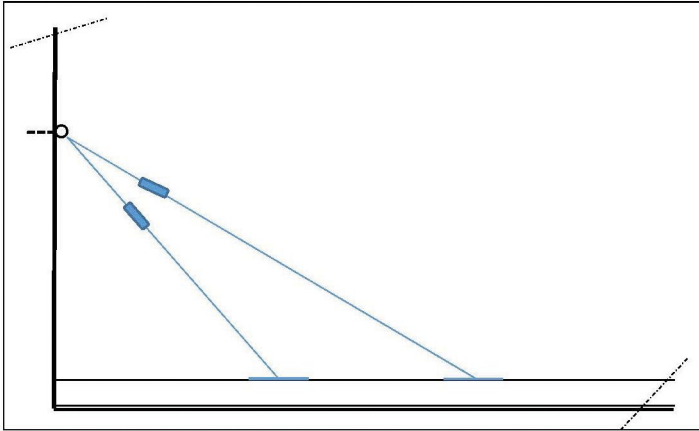
FIGURE 13 Scheme of the solution adopted using wall as point of anchorage for cables. The anchorage is performed using a long rawl plug embedded in the wall section.

Where possible, the walls were used as a point of anchorage for the cables. The anchorage has been performed using a long rawl plug embedded in the wall section (Figs 13 and 14). Sound timbers near problematic beams have frequently been used for anchorage (Figs 15 and 16). Large roof beams have sometimes been used to anchor the iron cables attached to the floor beams (Figs 17 and 18).

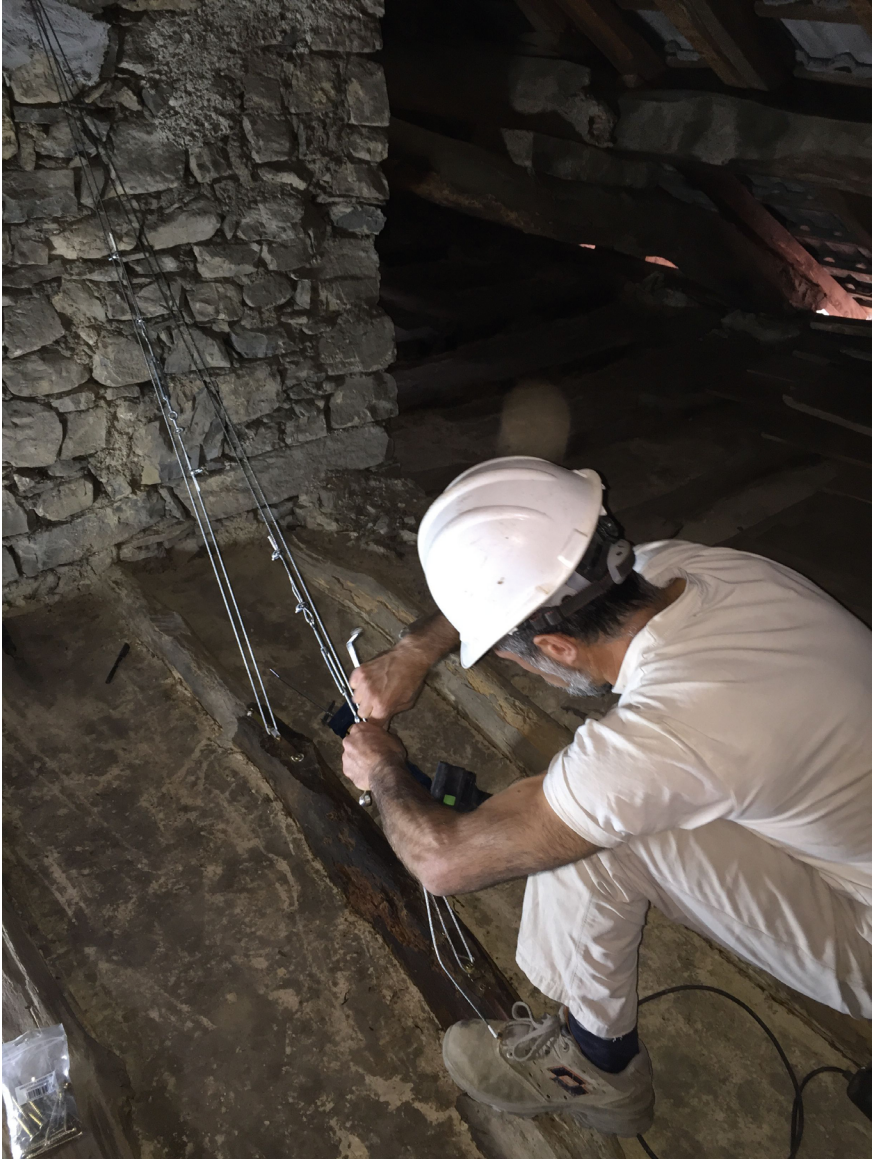
FIGURE 14 Execution phase described in Fig. 13

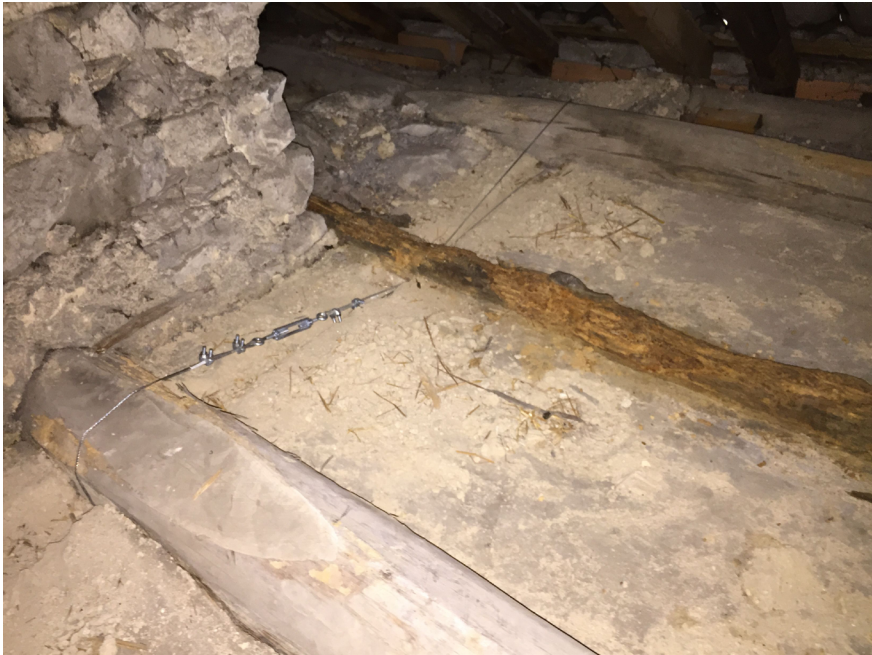
FIGURE 16 Execution phase described in Fig. 15

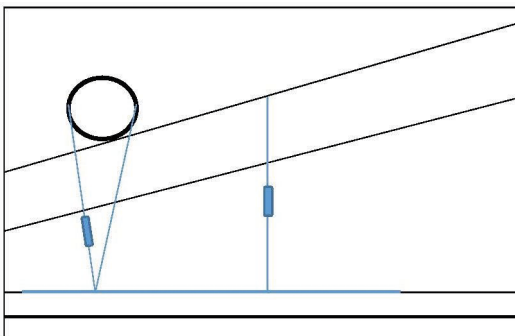
FIGURE 17 Scheme of solution with large roof beams used to hang anchor the iron cables attached to the floor beams

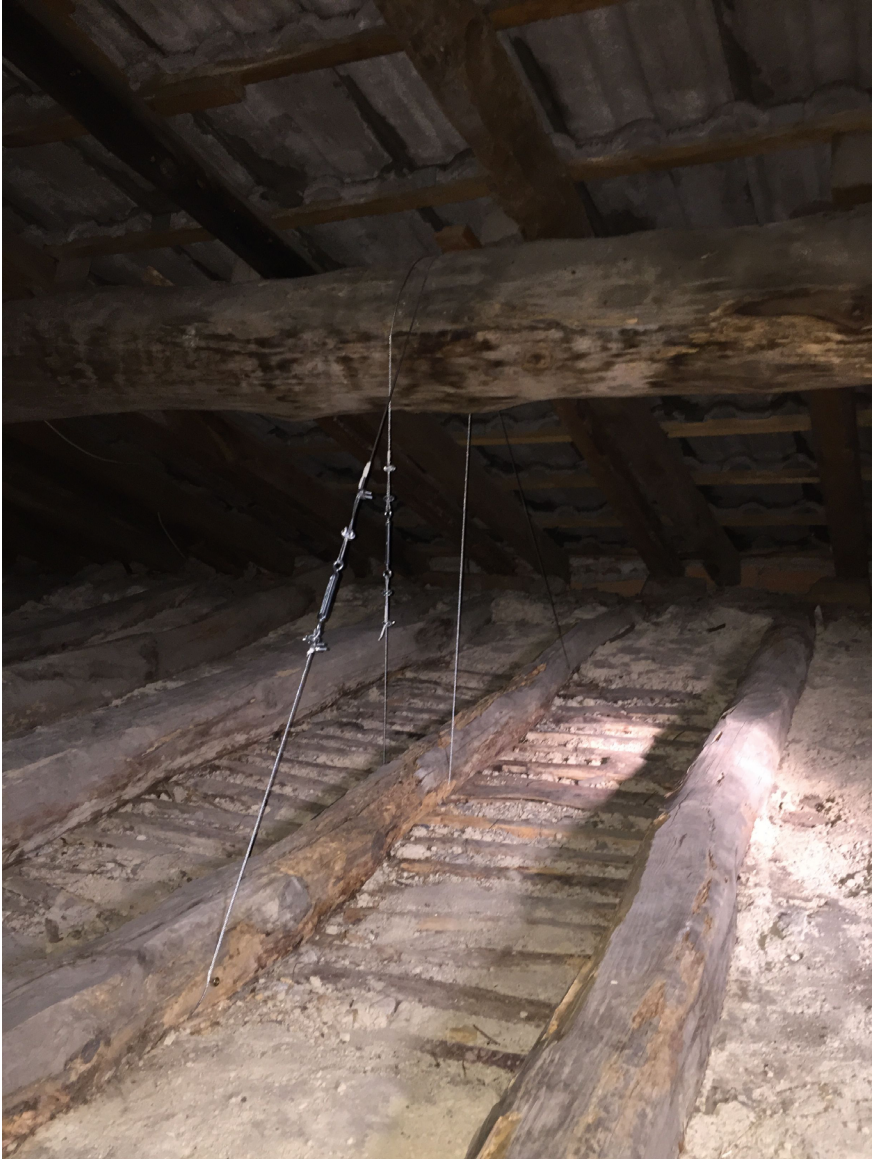
FIGURE 18 Execution phase described in Fig. 17

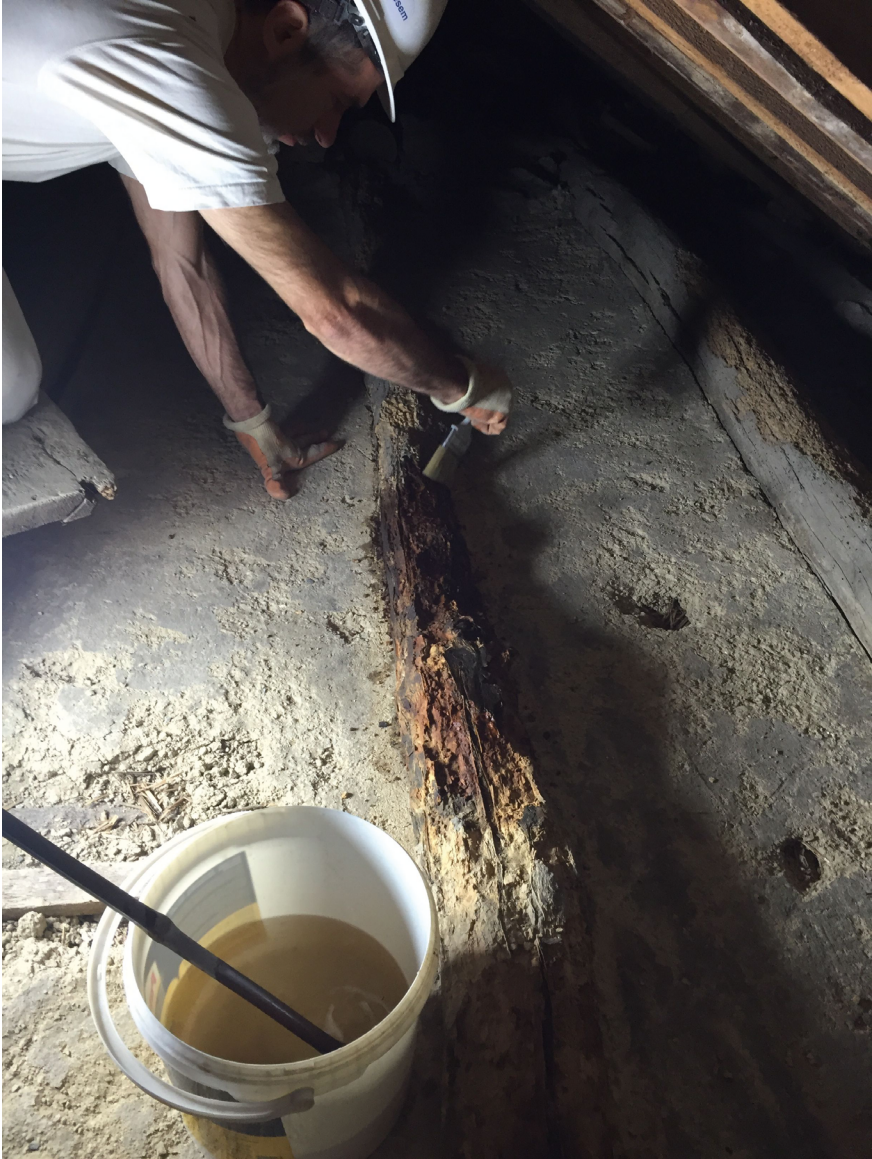
FIGURE 19 Punctual consolidation is done by brushing the deteriorated sapwood with liquid resin.

- (1) The punctual, where it was considered strictly necessary, consolidation of wood with brush application of liquid resin (epoxy) (Fig. 19).
- (2) Insert pilot holes for a screw for timber.
- (3) Inject adhesive inside the pilot holes when considered necessary (Fig. 20).
- (4) Fix an iron plaque on wood with wood screws (Fig. 21).

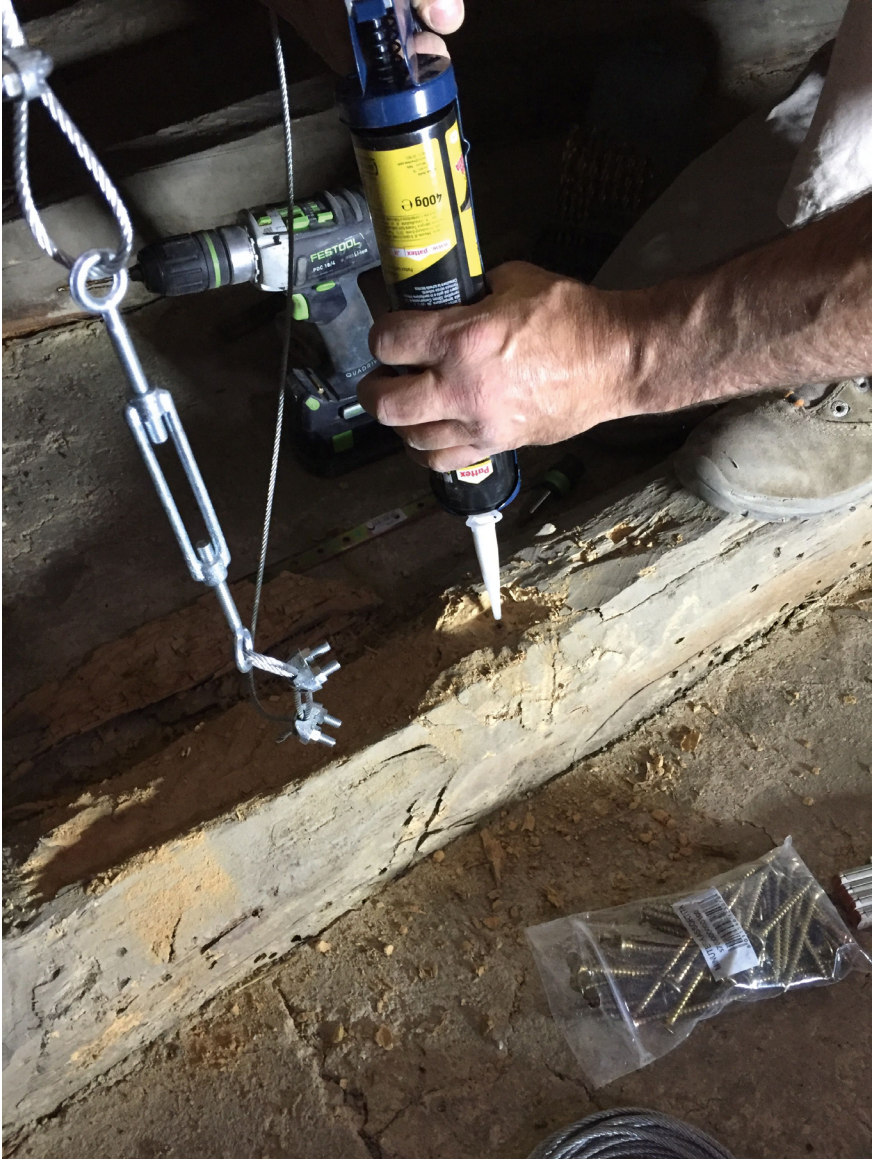
FIGURE 20 Injection of adhesive inside the pilot holes

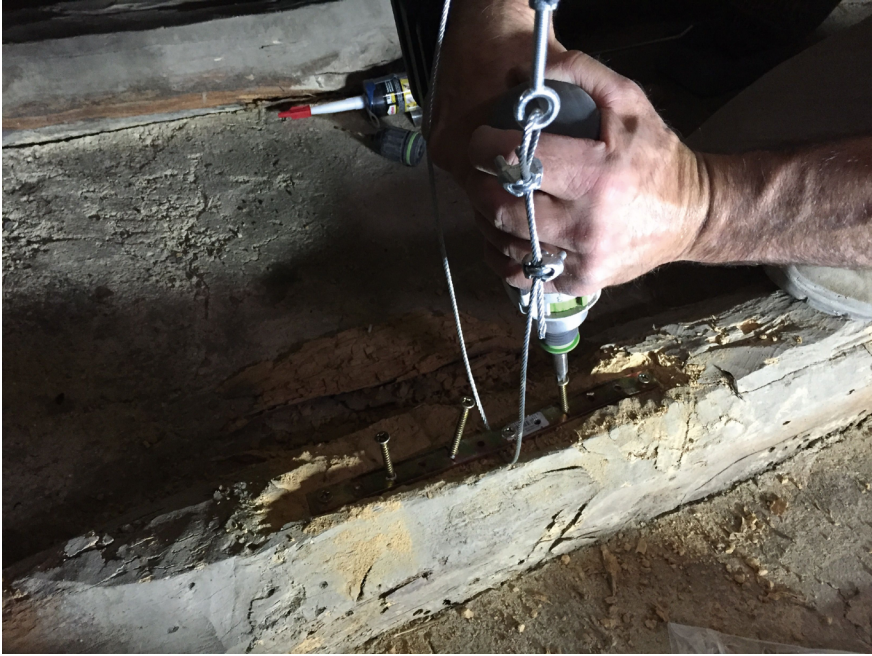
FIGURE 21 Fixing phase of the iron plaque with wood screws

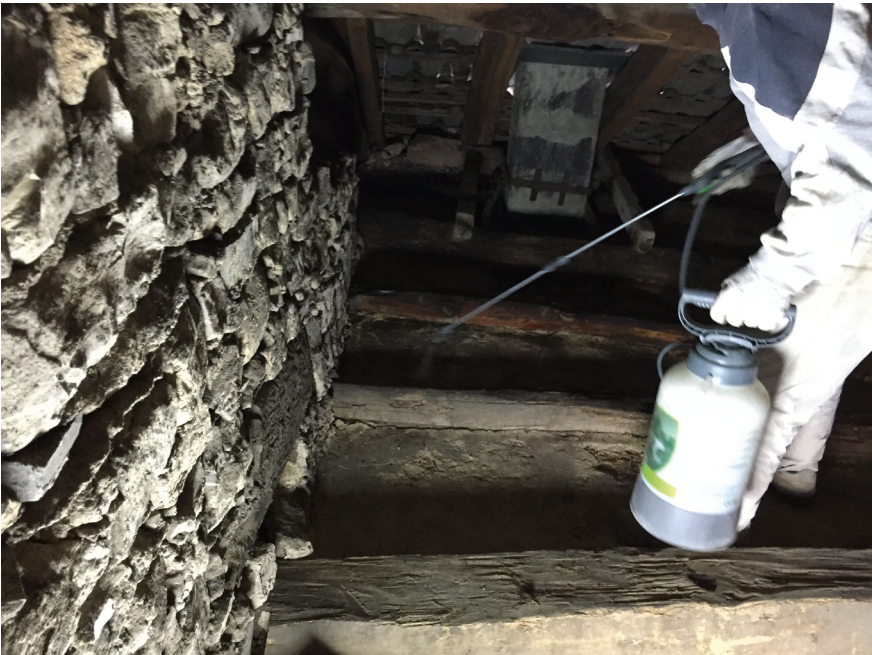
FIGURE 22 Spray treatment with a chemical preservative

After the reinforcement intervention, the last phase was the complete spray treatment of wood with a chemical preservative (natural pyrethroid) against wood-boring insects and fungi given the low durability of wood and the need to protect wood in the future (Fig. 22).
