ASSESSMENT ON FATIGUE BEHAVIOUR OF AL7475 T7351 SUBJECTED TO NATURAL CORROSION, ACCELERATED CORROSION AND ARTIFICIAL DAMAGES

Daniele Mezzanzanica^{1(*)}, Giuseppe Ratti¹, Andrea Baldi¹, Ugo Mariani¹
Marco Giglio², Andrea Manes², Marco Ormellese³, Andrea Brenna³

¹Leonardo Helicopter Division (LHD), via Giovanni Agusta 520, Cascina Costa (VA), Italy
(*)daniele.mezzanzanica@leonardo.com

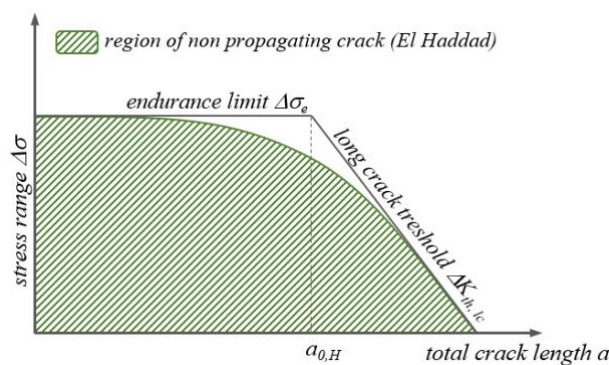
Figure 2 shows the crack size effect on $\Delta\sigma_{th}$; the horizontal straight line is the fatigue limit of pristine specimens $\Delta\sigma_e$, the slant straight line is the $\Delta\sigma_{th}$ for $\Delta K_{th,lc}$ constant (Eqn. 1) These two lines represent an ideal behaviour and are called Smith’s model [10], and they intersect at a crack size $a_{0,H}$ which is called the El-Haddad Parameter, expressed by Eqn. 2:

The smooth curve, known as the Kitagawa – Takahashi diagram, Kitagawa plot or Tanaka’s model, is the upper limit of micro-crack growth varying the applied stress.

Figure 2: Kitagawa–Takahashi Diagram

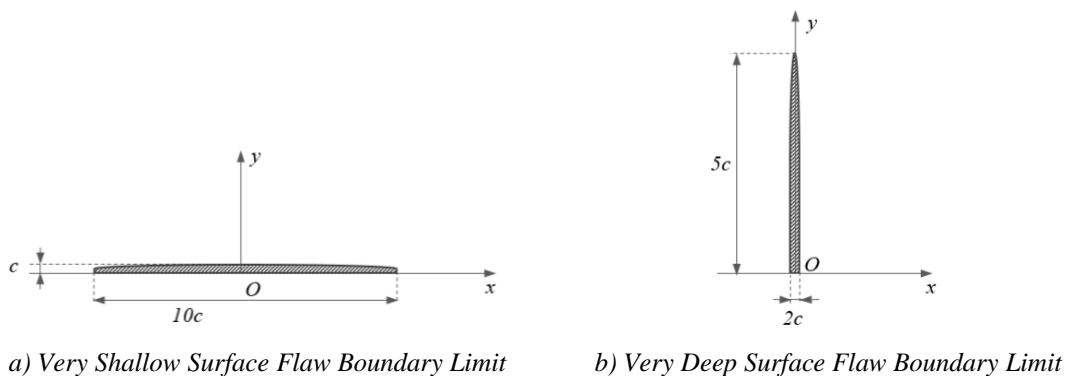
For very slender cracks, as shown in Figure 2-3, the effective $\sqrt{\text{area}}$ is evaluated by truncating the slender shape to a limiting length, since the stress intensity factor tends to a constant value as the crack length increases, even though the $\sqrt{\text{area}}$ increases without limit. The boundary limits used to estimate effective $\sqrt{\text{area}}$ for the very shallow cracks (length/depth ≥ 10) and the very deep crack (depth/length ≥ 2.5) are detailed in Figure 5.

Figure 5: Very Deep and Shallow Flaws Boundary Limits

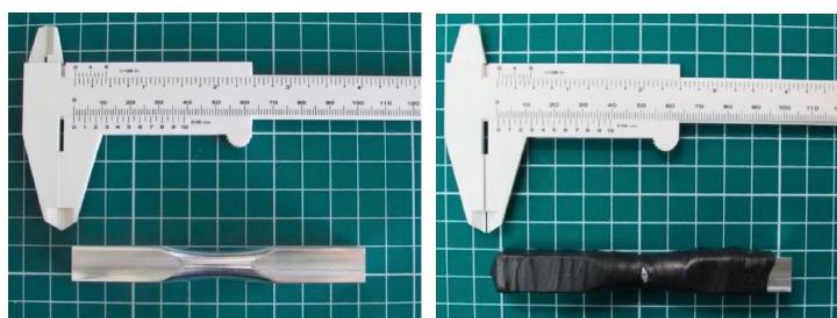
Two layers of different tapes were used: a transparent water-resistant polyethylene (PE) tape with a 1.4 diameter hole and a black self-amalgamating tape, or electrical insulating tape for salt fog tests, ref. Figure 10 and Figure 11.

Figure 11: Specimen Before and After Shielding

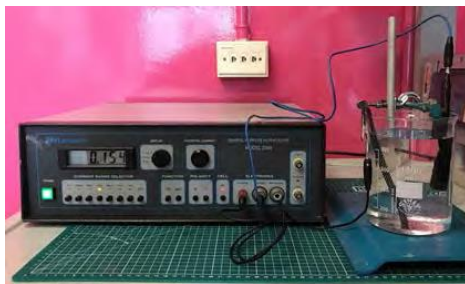
Galvanostatic tests are performed to generate an artificial well-defined localized corrosion attack [15]. The aluminium specimen is connected to the positive pole of the DC feeder (a galvanostat AMEL Instruments 2049), and a mixed-metal oxide covered titanium mesh (MMO-Ti), used as counter-electrode, is connected to the negative pole. The setup of the test is shown in Figure 12. The aluminium specimen works as anode and its corrosion rate has been controlled by the application of an external

Figure 12: Setup of the Galvanostatic Test

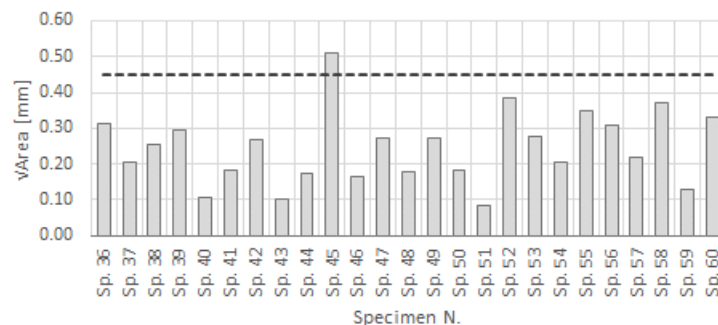
Figure 14 shows that the obtained corroded areas have very heterogeneous dimensions; the salt spray fog has not resulted in predictable and reproducible corrosion attacks.

Figure 14: Salt Spray Fog Test Damage $\sqrt{\text{area}}$ vs Target (dotted line: $\sqrt{\text{area}}=445\text{mm}$)

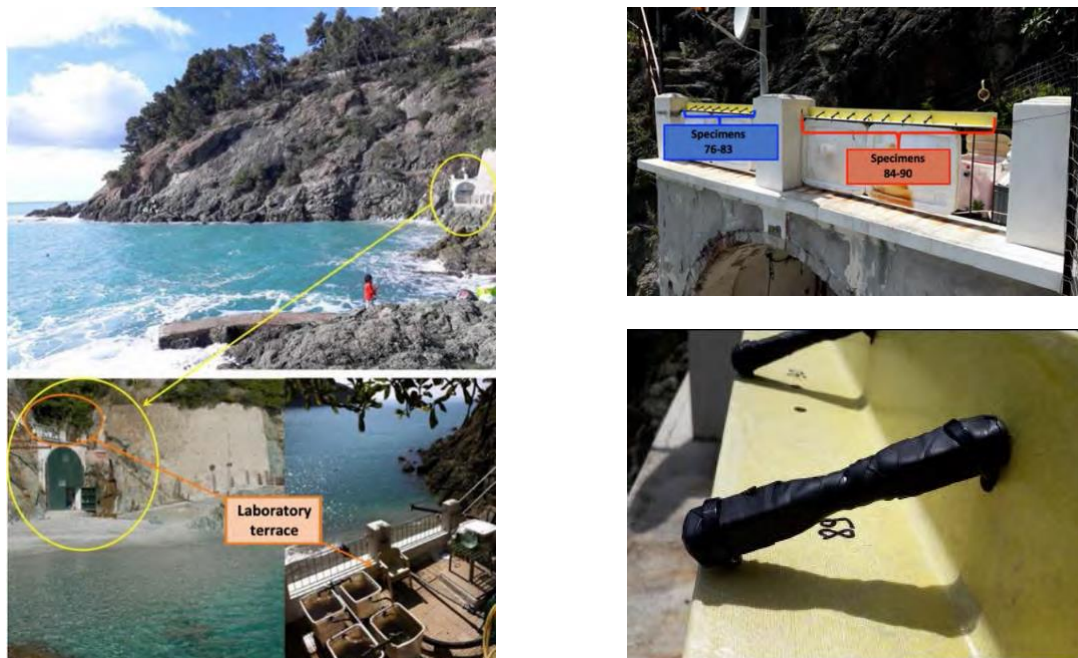
All specimens have been open-air, direct exposed in the direction of the sea for 1 year to all atmospheric conditions and atmospheric contaminants. Specimens have been placed on a rack, at a distance of 20 cm from each other, and exposed with an angle between 30° and 35° from the vertical. The elevation of the exposure point above the mean sea level is 6 m, the distance between exposure point and sea is about 15 m, and the exposure orientation is E-SE, as shown in Figure 16. A macroscopic weekly observation with a monthly report has been carried out.

Figure 16: Exposure Rack on the Terrace of MARECO CNR-ICMATE Laboratory

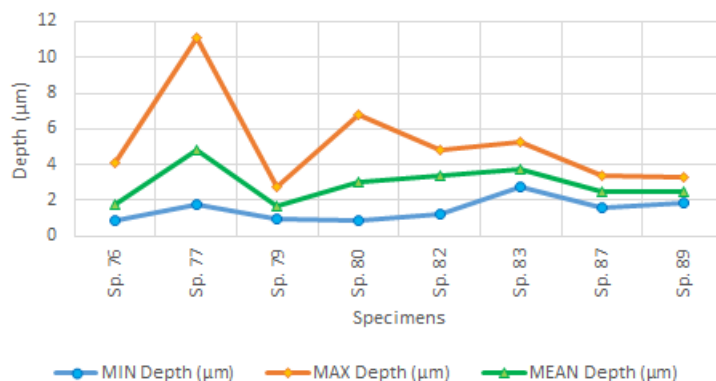
to an unsuccessful attempt to re-open the self-amalgamating tape (that has the tendency to close on itself). The results of laser profilometry are shown in Figure 17; the minimum, maximum and average depth of the attack is reported, measured on at least 6 profiles made on each specimen.

Figure 17: Natural Exposure to Marine Environment

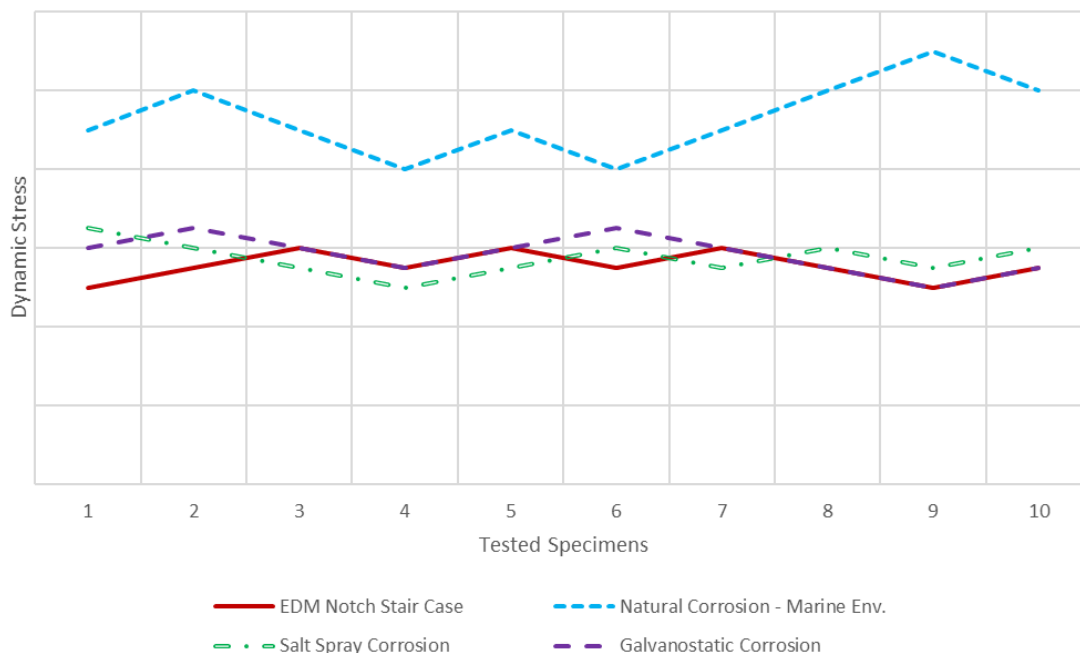
The results of the Hodge Rosenblatt sequences for the four types of tested damage types is shown in Figure 22; artificial corrosion and EDM defects, have the same fatigue strength.

Figure 22: Comparison of Stair Case Sequences
