Long-term monitoring of a masonry arch bridge to evaluate scour effects

Paolo Borlenghi^{a,1}, Carmelo Gentile^{a,*}, Manuel D'Angelo^{b,c}, Francesco Ballio^{b,3}

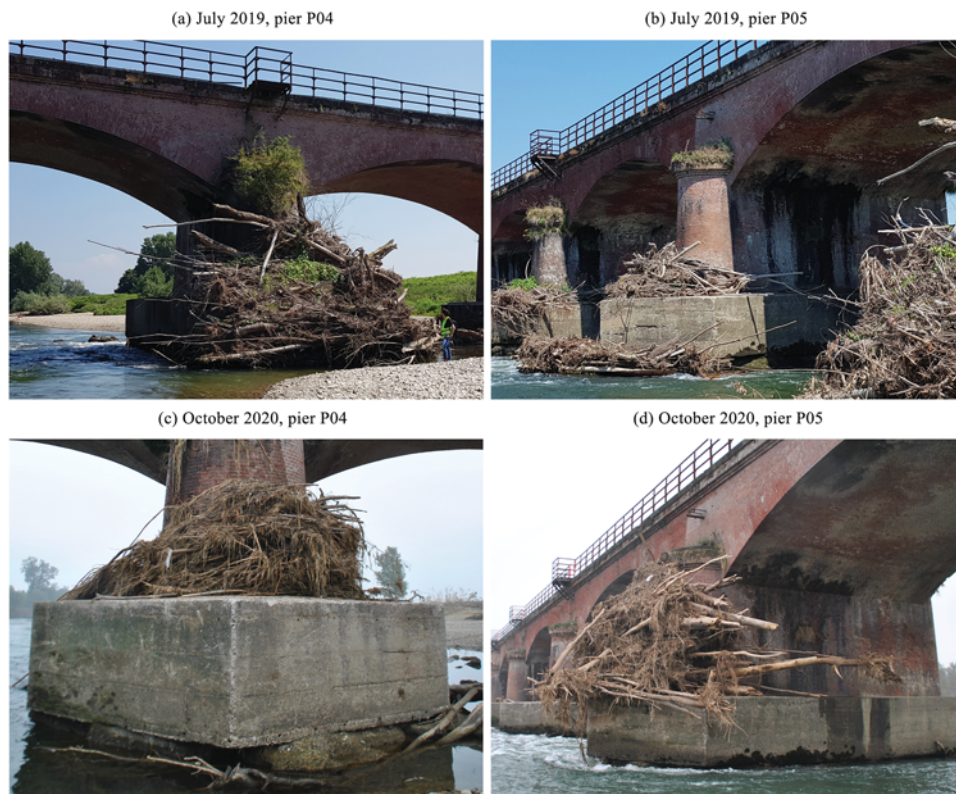
Fig. 2. Variations of debris accumulation on piers P04 and P05 before and after the flood of October 2020.

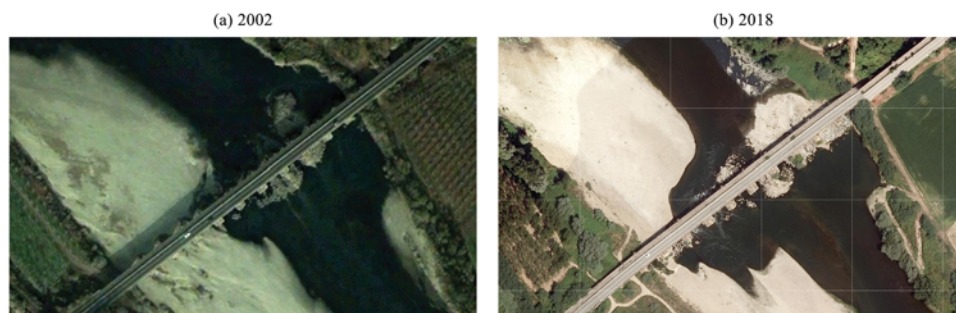
Fig. 3. Satellite images of the Sesia River (flow direction from top-left to bottom-right): before (a) and after (b) the rock armour installation around the piers of the left side channel.

Armouring interventions of the riverbed were performed at different times in the attempt to stabilise the sediments around the foundations (Fig. 1). To the authors' knowledge, the last intervention of riverbed stabilisation – before the installation of the monitoring system – was performed in 2003–2004 around the most eroded piers at the left side of the channel, where flow concentrated in normal conditions. This operation, however, modified the local morphology of the riverbed by deviating the main flux from the left-channel (looking downstream) to the central-channel piers, with consequent migration of the thalweg. Fig. 3 compares the satellite images of the Candia bridge of 2002 and

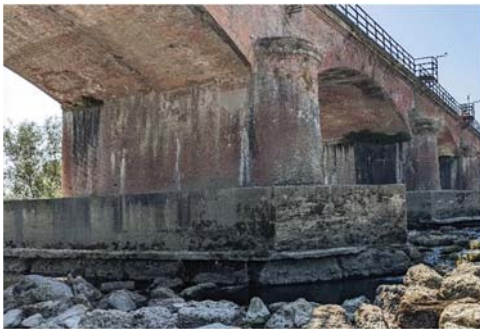
Fig. 5. Foundation scour at pier P08 (picture from the upstream side).

As known from past inspections, the most critical defect is the erosion of foundations from pier P09 to pier P04 (Fig. 5) caused by the sum of natural scour – estimated at approximately 3 m drop of riverbed level compared to the year of construction – added to contraction and local scour caused by flow obstruction due to the presence of the piers themselves.

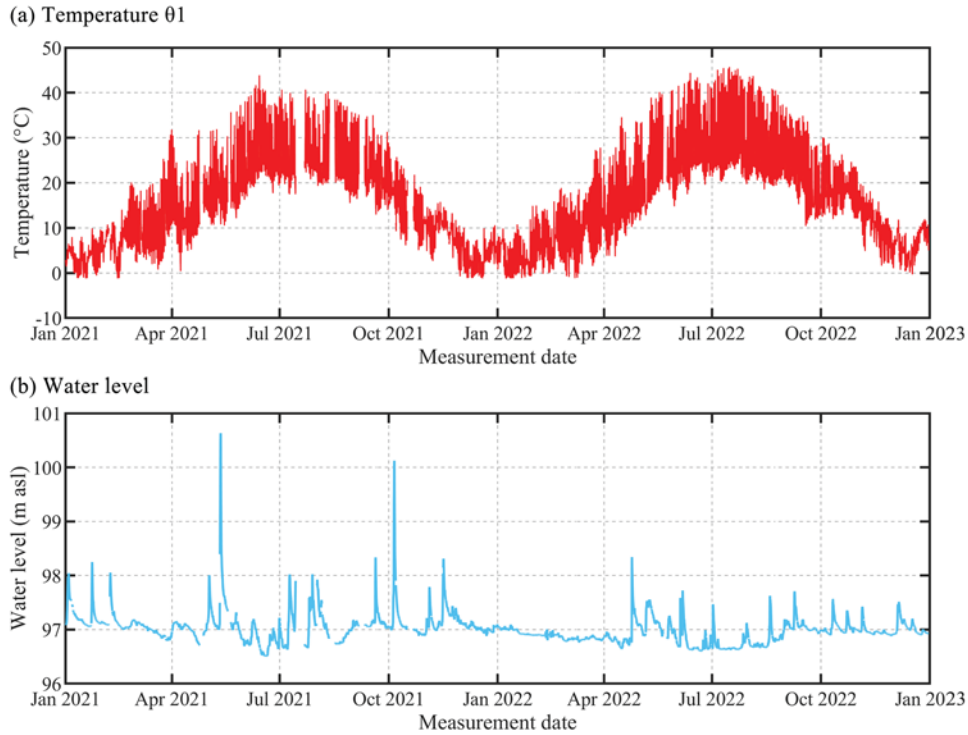
Fig. 13. Variation in time of temperature 01 (a) and water level (b) from 01/01/2021 to 31/12/2022.

The variation in time of temperature 01, turning out to be the main driver of the rotation changes, is shown in Fig. 13a and ranges between -1.2°C and 45.7°C . Fig. 13b presents the time evolution of the water level and shows an average level that is practically equal to the one of the training period (97.0 m, see Fig. 9d). It is further noticed that, during the first two years of monitoring, two high stage hydraulic events were observed, in May and October 2021: the corresponding water level (Fig. 13b) reached 100.6 m asl and 100.1 m asl, respectively. However, as previously stated, these events had a return period smaller than 2 years. Hence, during the two years of monitoring, the bridge has not encountered severe events like the one in 2020 mentioned in subsection 2.3.

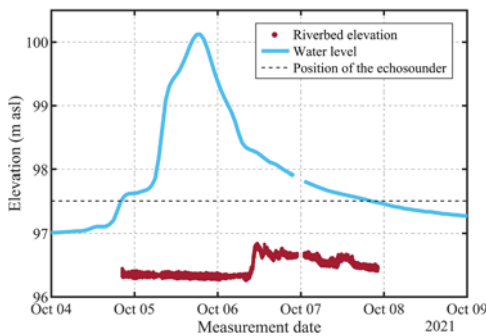
Fig. 14. Variation in time of the riverbed elevation during the hydraulic event of October 2021.

During the second event, the echosounder was active and Fig. 14 shows the evolution of the riverbed elevation measured by the echosounder installed in the foundation of pier P05 on the downstream side. It should be noticed (Fig. 14) that the riverbed elevation of 96.3 m asl did not increase during most of the event, whereas an aggradation process was observed during the descending phase, with an increase of 50 cm of the riverbed elevation. Hence, the measured data suggests that the downstream side of the bridge foundations is mainly subjected to the deposition of sediments during major hydraulic events rather than excavation. Of course, this conclusion should be confirmed by further measurements.

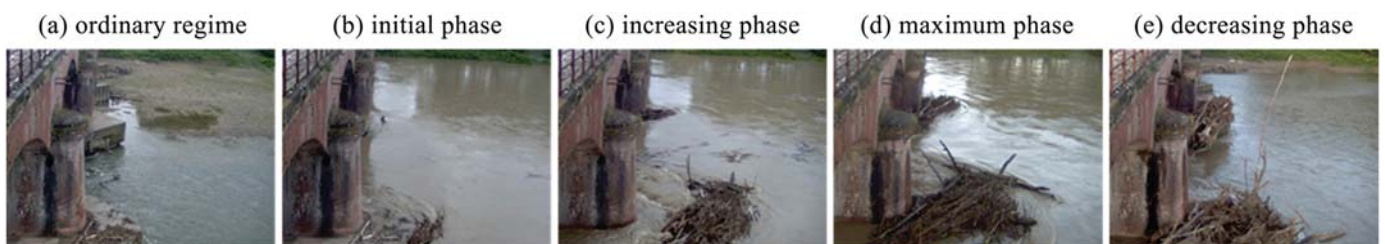
Fig. 15. Debris accumulation process at pier P05 on May 12th, 2021.

Accumulation of debris was observed in several events, typically when water reached the upper edge of the foundation plinth. Fig. 15 shows the accumulation process at pier P05 occurred in May 2021. It can be observed the debris mat increases in size, reaching its final configuration during the peak of the event.

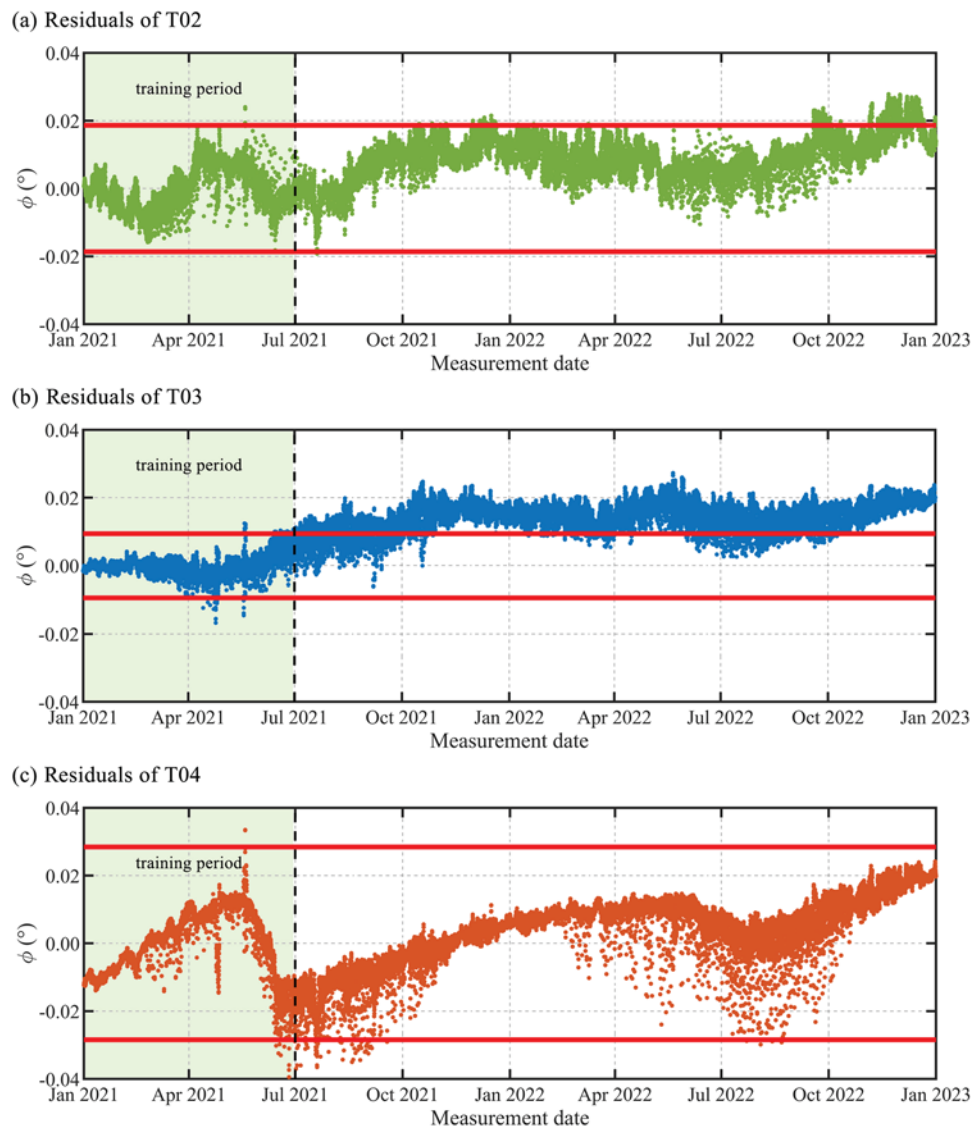
Fig. 21. Residuals of rotation T02, T03 and T04 with a $\pm 3\sigma_\phi$ confidence interval.
