Article

On the Safety of Implanted Breast Prostheses in Accidental Impacts

Citation: Janszen, G.; Arnoldi, M.; Vinci, V.; Klingner, M.; Di Landro, L. On the Safety of Implanted Breast Prostheses in Accidental Impacts. *Materials* **2023**, *16*, 4807. <https://doi.org/10.3390/ma16134807>

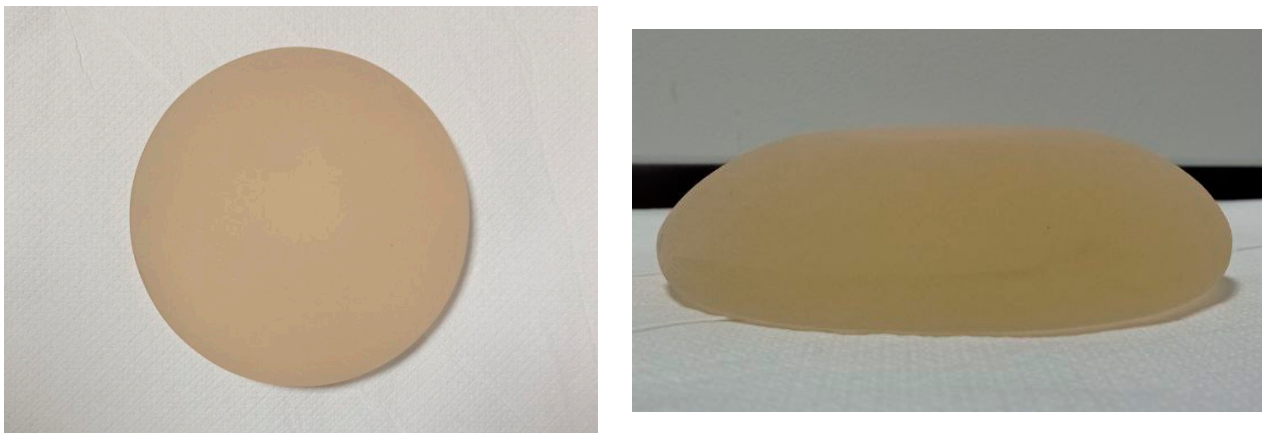
Figure 1. Compression-tested prostheses (volume: 275 cm³, diameter: 11.7 cm, projection: 3.7 cm).

Following a similar procedure previously set up with different used prostheses [19], squeezing tests were performed with new items. Two identical round prostheses of 275 cm³ volume (Figure 1) were compression tested between flat steel plates at a constant crosshead rate of 5 mm/min by an MTS858 Mini Bionix II (MTS Systems S.r.l., Torino, Italy) dynamometer. Compressive load, prostheses thickness and diameters were registered during the tests by a 15 kN load cell and video recording. The internal pressure was estimated as the ratio between load and contact area between prosthesis and compression plate. A first new, unaged item was pressed soon after the opening of the sterile, sealed packaging until rupture to estimate the rupture load and internal pressure. The second was pressed at 70% of the estimated failure load after aging at 37 °C in physiological saline solution (0.9%, NaCl). Results were determined for compression tests up to ten months of aging. Longer-term tests are underway.

Static tests were carried out on two equal round-shaped breast implants with a volume of 275 cc, a diameter of 11.7 cm and a nominal side projection of 3.7 cm. One of the specimens was compressed till rupture, while the second was compressed after an aging period at 70% of the measured rupture load.

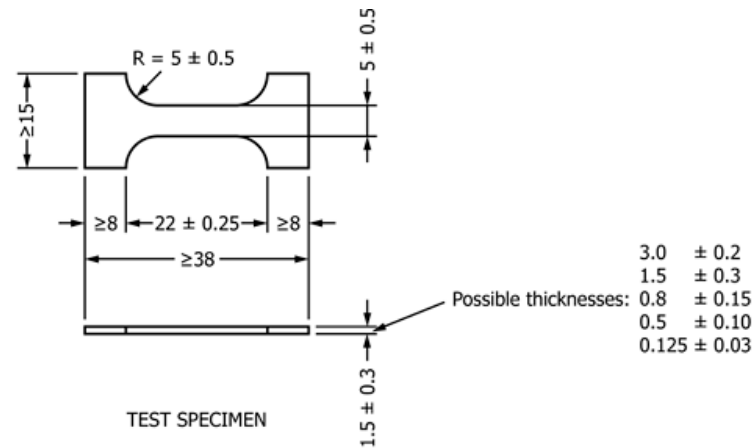
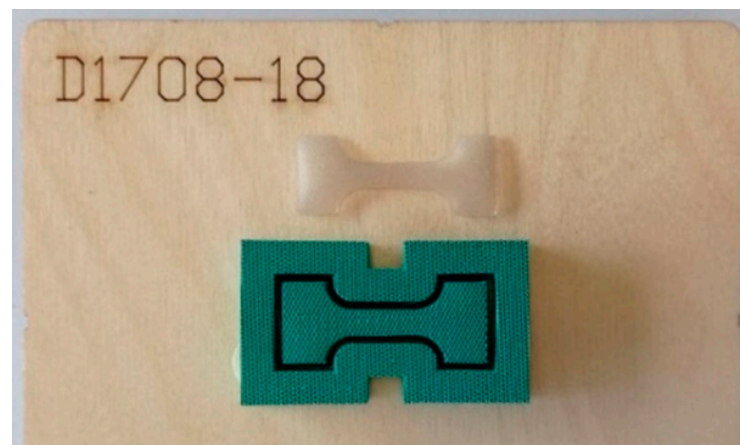
Figure 2. Microtensile specimen dimensions (in mm) and die-cutter for tensile tests.

gel. Microtensile specimens were cut from the upper part of the shell, with dimensions according to ASTM D1708 [22], by a die cutter (Figure 2). No specimens from the lower side of the prostheses were used since the thickness was consistently higher than the top side. Measurements were taken at different positions for each specimen with a micrometer gauge, indicating an average thickness of $0.521 \text{ mm} \pm 0.022 \text{ mm}$.

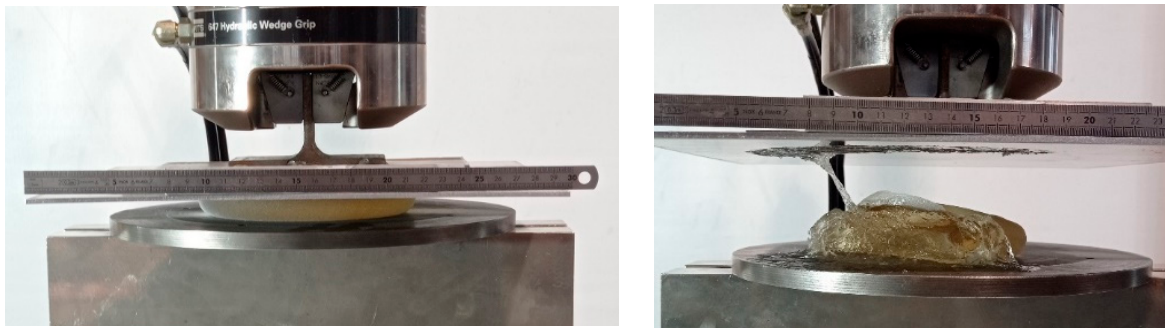
Figure 3. Compression test set-up.

Figure 3 shows the compression set-up during the tests and at the end when the prosthesis shows clear rupture. Throughout the tests, load and plate position were recorded. The contact area between the deformed prosthesis and the plates at maximum load was also estimated by measuring the footprint area of the specimen on the plates to evaluate the internal pressure and stress at rupture. In Figure 4, the load–displacement curves are reported for the test on a new prosthesis and on a prosthesis aged in saline solution at 37 °C for three months, six months and ten months compressed up to 70% of the previously measured rupture load. After each test, the aged prosthesis was again placed in the heated bath to continue the aging process. The compression test was periodically repeated, with the same loading condition (up to 70% of rupture load) until failure, to verify the possible influence of aging on the overall behavior of the prostheses, in particular, over shell rupture strength and elongation.

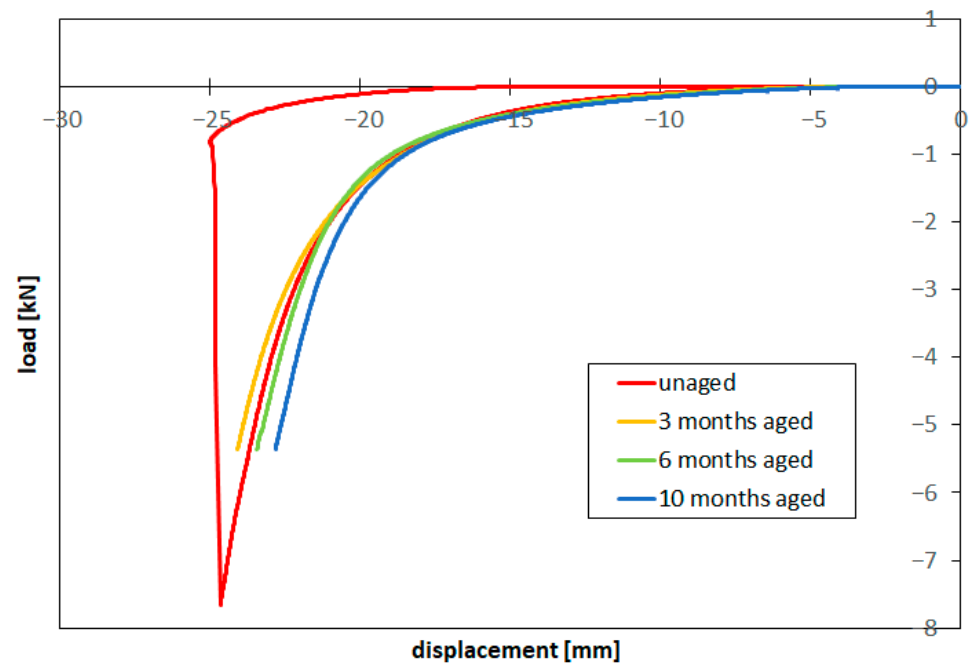
Figure 4. Uniaxial compression load–displacement curves for new (up to failure) and aged prostheses.

The measured rupture load for the new prosthesis was 7650 N, reached at a final prosthesis thickness of 8.44 mm. The internal pressure at rupture was about 2.35 bar. It is also to be noted that for the new prostheses, rupture was reached at an internal pressure that was similar, but somewhat higher, to that (about 2 bars) previously measured with prostheses explanted from living patients [19]. Although, for the latter, the implantation time period was not known, it is likely that such difference is a consequence of aging.

Compression tests performed with new prostheses after short aging times (3, 6 and 10 months) at 37 °C in saline solution at 70% of the estimated rupture force did not show signs of failure. In these tests, the prosthesis was pressed at 5359 N, corresponding to a maximum estimated internal pressure of 1.76 bar, i.e., about 75% of the rupture pressure. The same prosthesis will be tested after longer time periods in the same aging conditions. Figure 4 shows the compression load–displacement curves recorded for new and three, six and ten-month-aged prostheses. A significant increasing trend of the load-to-deformation ratio with aging time can be observed as a consequence of an increase in shell stiffness and/or an increase in the elasticity of the filler gel.

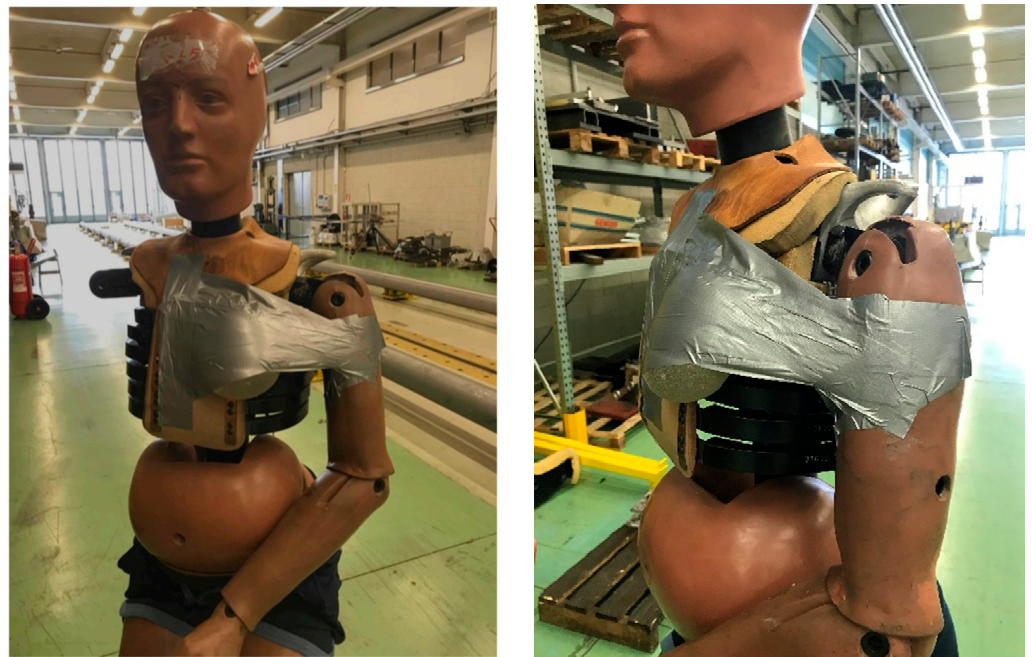
Figure 5. Assembly of prosthesis on Hybrid II dummy for crash tests.

Two dynamic tests were carried out on explanted round prostheses to reproduce car accident effects at different vehicle speeds. The prostheses with a volume of 330 cc were of the same producer and explanted from the same patient. The shell thickness, measured after the tests, corresponded (0.52 mm) to that of the new prostheses employed in static tests. The implants were fixed on an anthropomorphic dummy by adhesive tape in the exact location corresponding to actual implanted prostheses; of course, this arrangement is different but as similar as possible to that corresponding to a sub-glandular or sub-muscular insertion. A safety belt was positioned over the prosthesis. Figure 5 shows the prosthesis assembly on the dummy for the tests.

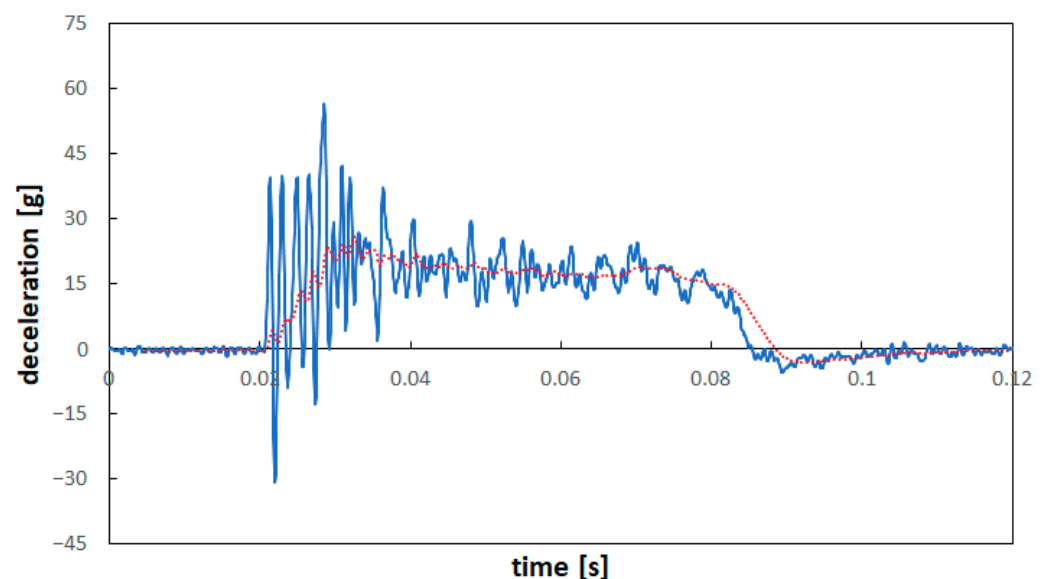
Figure 6. Deceleration vs. time of the crash event. Blue line: raw recording; red line: filtered results.

The recordings of the time history corresponding to the impact event for the two tests at 50 km/h and 90 km/h confirmed a maximum deceleration of about 25 g in both cases; this value is consistent with that experienced by a passenger in a vehicle during a frontal impact against a rigid barrier [24]. Figure 6 reports the deceleration vs. time results for the impact at 50 km/h; the blue line indicates the unfiltered signal from the accelerometer fixed on the sled, while the red line indicates the filtered result. It can be observed that after a peak corresponding to the onset of plastic deformation of the aluminum stopper, a fairly constant deceleration of about 20 g occurred during the whole pulse time. In case of impact at 90 km/h, as expected in consideration of the same stopper used, a quite similar deceleration peak was recorded, but with a longer pulse time.

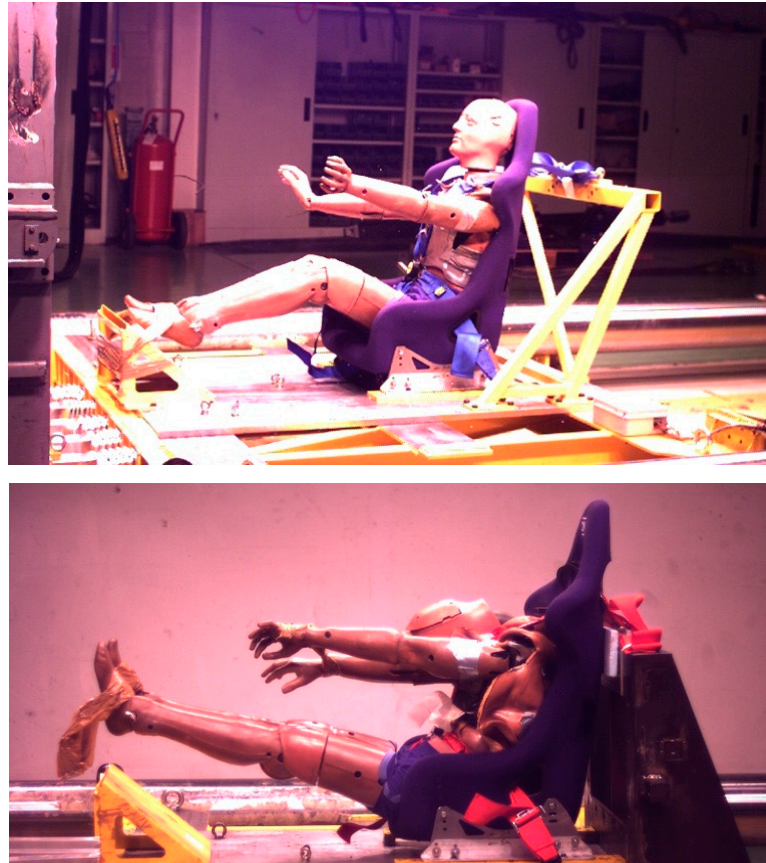
Figure 7. Instant frames of the sled/dummy during impact event.

Figure 7 shows two frames from the video recordings of the seat/dummy during the crash tests: a relevant compression of the prosthesis was evident. A visual inspection

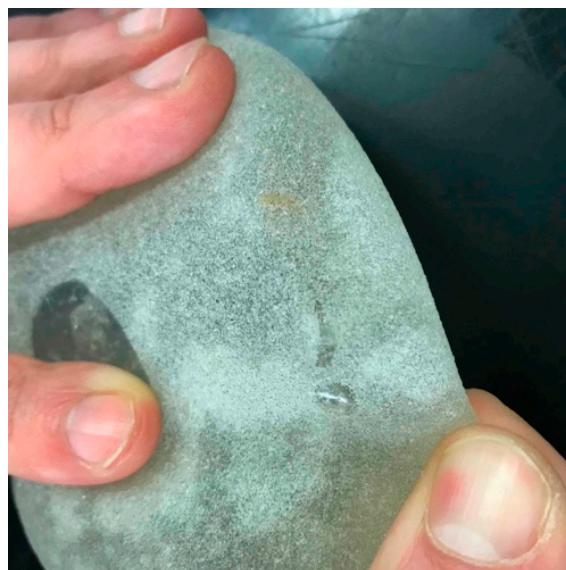
Figure 8. Rupture of the silicone shell and gel leakage after impact at 90 km/h.

after the impacts showed that at the lower speed, no clear damage of the prosthesis was observed; on the other hand, after impact at 90 km/h, a rupture with some, although limited, internal gel leakage was clearly evidenced (Figure 8). The limited loss after impact, compared to the extensive loss observed in compression tests (Figure 3), is related to the very short time of the crash event.

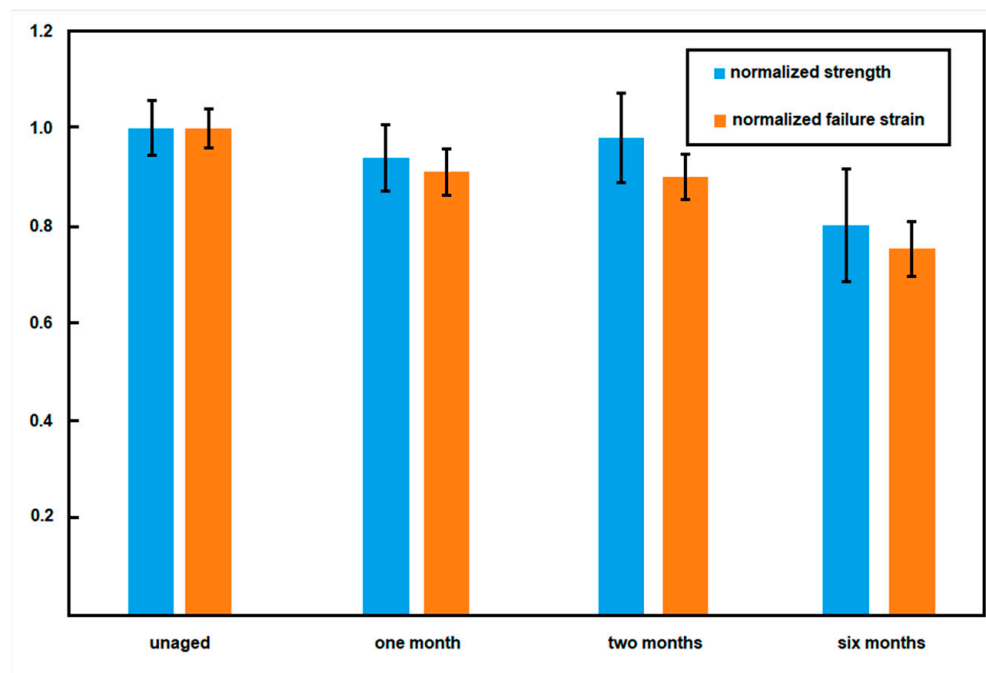
Figure 9. Decrease in strength and strain at failure during aging at 90 °C.

Preliminary tests of shell specimens after different aging conditions, i.e., new and after permanence at 90 °C in saline solution for one and two months, showed a significant reduction of failure elongation with aging and a corresponding variation of strength, notwithstanding the relatively limited exposure time. However, these results were later compared with those from specimens aged six months at 90 °C, which confirmed the decreasing trend of the material properties (Figure 9). Such variations suggest that high-temperature aging can produce physical changes in the polymeric elastomer, possibly with an increase in crosslinking density.

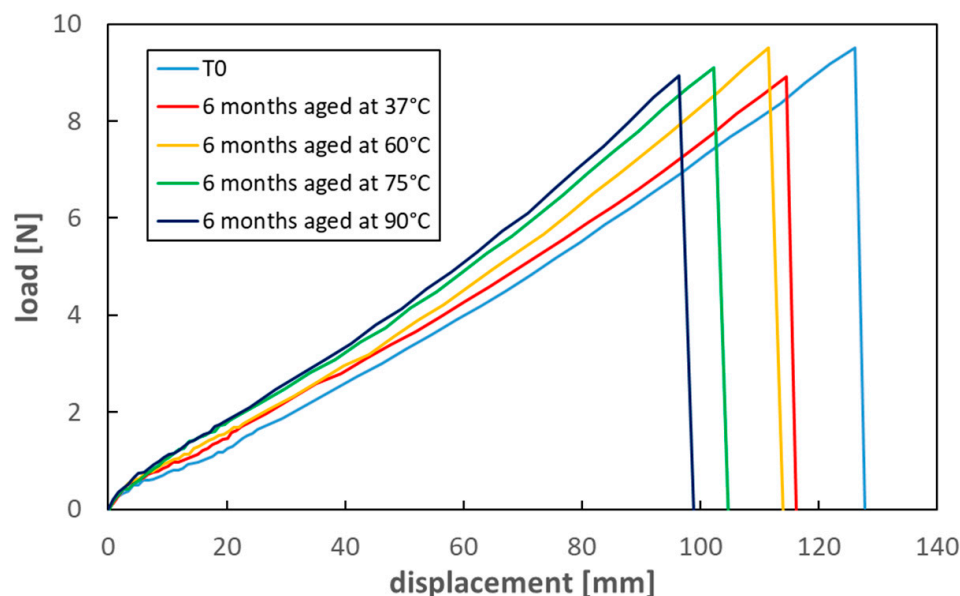
**Figure 10.** Tensile load–displacement curves for new and aged shell material.

A further confirmation of the mechanical response trend with time comes from the results of the six-month aging for the specimens maintained at four different temperatures: tensile tests showed an evident increase of silicone stiffness with aging time, which becomes more relevant the higher the temperature. Table 2 reports the strength and strain at failure values after six-month aging, while Figure 10 shows tensile load vs. displacement curves of aged silicone samples compared to unaged material.
