MS16: Assessment of existing masonry arch bridge infrastructure
Organizers: M. Gilbert, G. Cardani, T. Boothby & D. Coronelli

The role of history in the structural assessment of a multi-span masonry arch bridge

G. Zani, P. Martinelli, G. Cardani & M. di Prisco

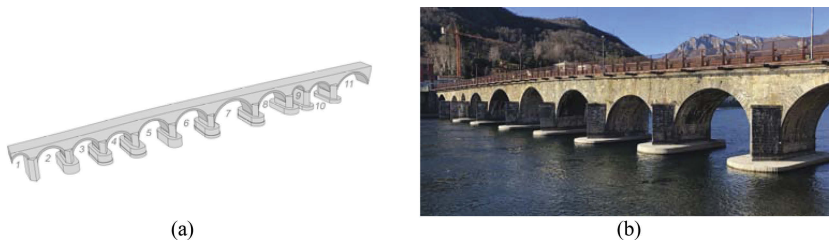
Figure 7. Azzone Visconti bridge: a) model representing the current shape (adapted from di Prisco et al. 2019) and b) current view.

Three arches damaged by the out-of-plumb of the piers were strengthened. External pedestrian footbridges were also added using cantilever steel beams and RC slabs resting on the aforementioned beams. Over the next 70 years, after this invasive intervention, no further work was carried out other than routine maintenance. Figure 7 shows a view of the bridge as it appears today.
