## **ARCHAEOSEISMOLOGY OF ARCHITECTURE: A NEW TOOL FOR SEISMIC RISK MITIGATION?**

### **Questions And Potential Of Archaeoseismological Research In Architectural Context**

Margherita GANZ<sup>1</sup>

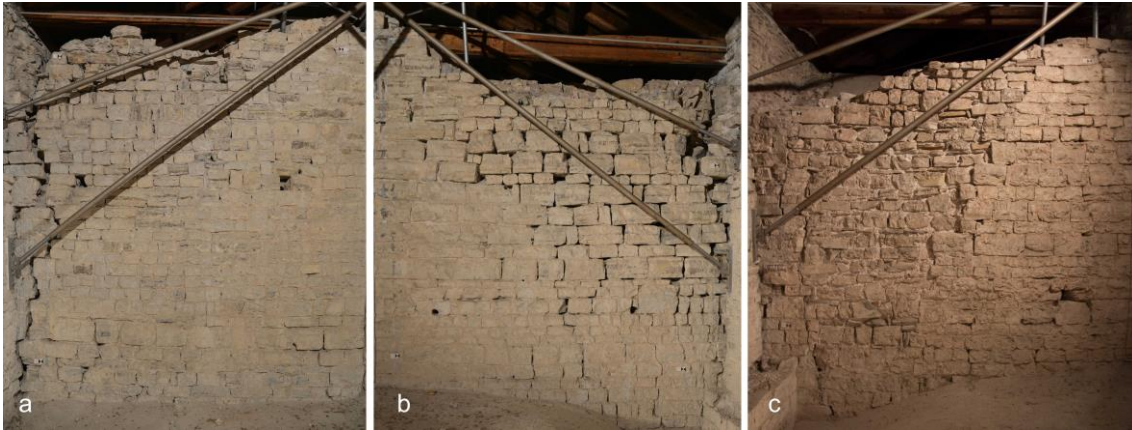
Fig. 1a, 1b, 1c, - Damage on the north and south facades of the transept. Please note in picture 1c the rebuilt part with a later crack on the left side (author).

If we adopt the validation criteria for the Church of Saints Vittore and Corona, regarding the damage (fig. 1a, 1b, 1c) affecting the Greek-cross structure we note that the cracks on the transept fronts:

- both display horizontal translation of the joints (Tab. 1, parameter A1b);
- are related to the activation and development of an overturning mechanism, with a hinge close to the point of wall thickness reduction (Tab. 1, parameter A2a);

- are substantially opposite and symmetrical (Tab.1, parameter B);
- have laminating effects on the lower external face of Romanesque masonry, a possible effect of the horizontal hinge that triggered the overturning of the transept facades (Tab. 1, parameter D1);

- in different ways both constitute sealed damage (the marked tilting of the southern façade—over 20cm—does not affect the double porticoes cloister built in 1494; while, on the northern façade, a large part of masonry reconstruction does not seem to have been damaged by subsequent events) (Tab. 1, parameter E1);

- can be compared with damage and mechanisms in similar buildings caused by more recent earthquakes (Tab. 1, parameter F).

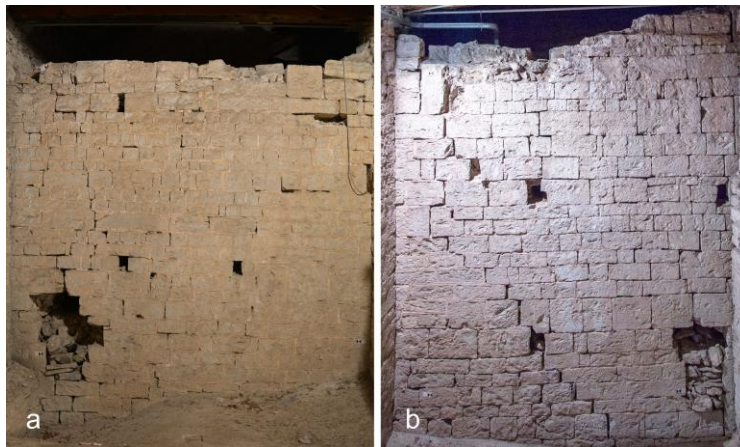
Fig. 2a 2b – The cracks observed on the surviving parts of the ancient bell towers(author).

The cracks observed on the surviving parts of the ancient bell towers (fig. 2a, 2b):

- both present horizontal translation of the joints (Tab. 1, parameter A1b);
- are both related to the activation and development of typical shear and bending stress (Tab. 1, parameter A) and they are attributable to the discordant oscillation of the bell towers in relation to the main body of the building. These cracks may be considered 'sealed' damage (Tab.1, parameter E1) because this configuration is only possible while the soaring bell towers were standing);

- are substantially opposite and symmetrical (Tab. 1, parameter B) even if there is a significant difference. In fact, on the southern bell tower seismic action insisted on an old construction phase which represents a weak point in the overall structural behaviour so the crack pattern for this façade consists just in a unique diagonal split (Fig. 2b), while on the northern bell tower the crack pattern is expressed by lots of minor cracks (Fig. 2a)
