FAUSTA FIORILLO¹, LUCA PERFETTI¹, GIULIANA CARDANI²

AERIAL-PHOTOGRAMMETRIC SURVEY FOR SUPERVISED CLASSIFICATION AND MAPPING OF ROOF DAMAGES

The selected case study is *Palazzo Littorio* in Caronno Pertusella (VA), a representative building that housed the local branch of the Italian National Fascist Party in Italy.

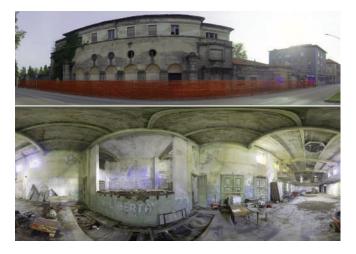
Figure 4. TLS panoramic images of the north facades and of theatre in the inner salon.

An integrated digital survey based on range-based and image-based techniques was designed to comprehensively document this heritage building. A TLS (Terrestrial Laser Scanner - Leica RTC3601) was used for the complete geometrical survey of the building exterior and interior. For creating 360° spherical panoramas, 3 HDR (High Dynamic Range) cameras allow for 5 bracketing exposures2. The VIS (Visual Inertial System) uses the other 5-cameras to track the laser scanner path. The integration of VIS and IMU platform enables real-time raw alignment between pairs of scans during on-site capturing. This raw registration ensures real-time control over the minimal needed overlap among scans and the completeness of surveyed areas. Therefore, the number and position of scans were planned ac-cording to a target-less acquisition mode. The survey consists of 84 scans (34 indoor) with a greater than 50% overlap to ensure proper cloud-tocloud alignment to optimize the raw registration. The TLS acquisitions were generally set with a spatial sampling

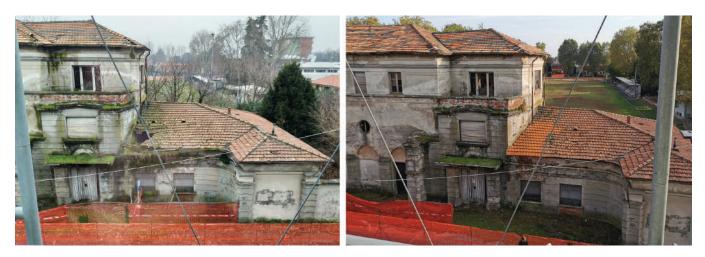
Figure 6. Roof photo of the north side towards the west corner before (left) and after (right) the urgent repair works in 2020. The 3-types of tiles are easily recognizable: the oldest dark ones, the new brilliant red ones and the other dull red ones.

The tiles found are all of the interlocking tile typologies (*Marseillaise* tiles) with approximately 24x42 cm. With UAV survey, it was possible to identify 3 main categories of roof tiles. The 30s original clay tiles are very dark/black. The faded red roof tiles belong to the early 60s when the major change of use from the House of the People to the police station took place and to the later years for maintenance, now covered by a very variable grey patina dirt and biological growth. Lastly, the newer ones used during the last urgent repair works in 2020 have an intense red color, partly because they are cleaner.
