II Fabre Conference – Existing bridges, viaducts and tunnels: research, innovation and applications (FABRE24)

Structural assessment of a stock of motorway viaducts located in north Italy: results, statistics, and intervention.

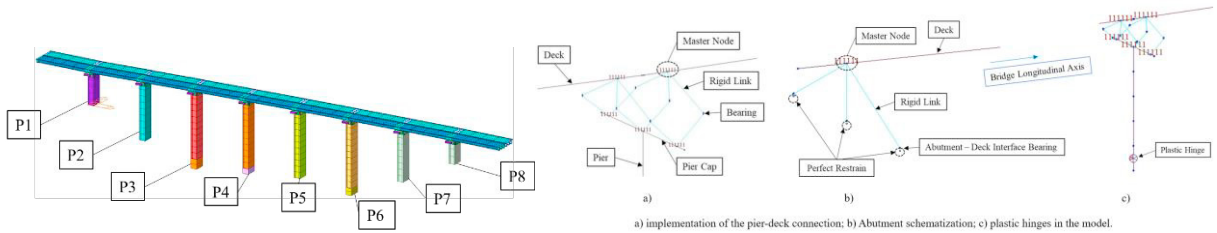
Fig. 1. FEM with details for the modelling of the viaduct for traffic and seismic analyses

For each viaduct, the safety evaluation is generally performed by adopting three different finite element models, with different levels of details, specifically developed for the verifications of piers and decks against traffic and seismic loads. For the safety verification of the deck under traffic loads, single or multiple span models FEMs of the deck only are developed. In this case, beam elements are used to represent longitudinal and transversal beams while the deck concrete slab is included in the cross section of the longitudinal beams. At the ends of the deck's beams, simple supports are generally applied to reproduce the translational constraints of the pier caps, whereas the connection between the deck longitudinal beams and the pier caps is implemented by means of a system of rigid links, to guarantee a simply supported static scheme and to account for the vertical eccentricity between the longitudinal axis of the beam and the bearing device. For the safety verification of the piers under traffic loads, a complete 3D finite element model of the bridge is adopted (Fig. 1). In this case, the piers are represented through beam elements with a fully restrained node at their intersection with the foundation plinth. In this finite element model, also the deck is modelled with Timoshenko's beam elements while the bearings are implemented through elastic links having their translational and rotational stiffness calculated according to the formulas reported in EN 1337-3 (2005). The connections between the elastic links representing the elastomeric bearings and the beam elements of the deck, on top, and the pier caps, on bottom, are modelled by means of rigid links. The abutments are considered in the FEM as perfect restraints applied at the base nodes of the bearings located in correspondence to the deck-abutment interface. This kind of mode is also used for the seismic analyses but nonlinear static analyses are executed considering nonlinear constitutive laws for

both steel and concrete (Kent et al. (1969), Park (1975)). Moreover, under the seismic action, two failure mechanisms are considered for the piers: ductile collapse mechanism and brittle collapse one as explained in Crespi et al. (2020), Zucca et al. (2023), FEMA 440. Also, the reduction of the piers bending stiffness is considered too, EN1337-3 (2005), Eurocode 8 (2005).

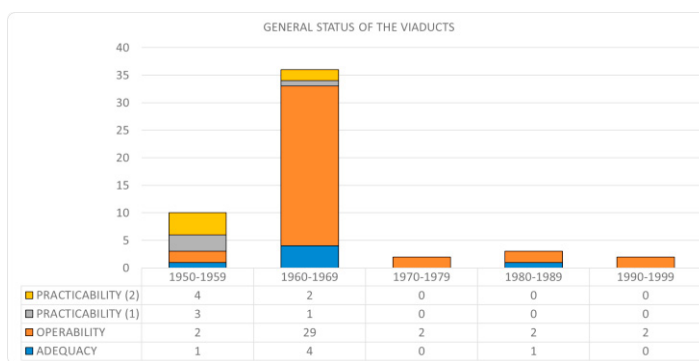
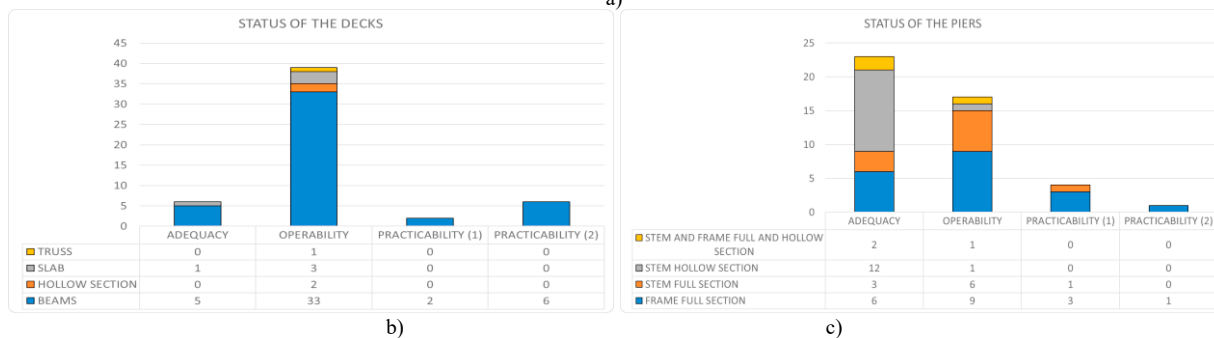
Fig. 2. a) General status of the 53 viaducts under the traffic loads (including the degradation status) b) Condition due to the status of the decks c) due to the status of the piers

The safety analyses presented in Sections 3 are applied to the viaducts described in Section 4. The results are statistically analyzed and illustrated in the present Section 5. The first investigation concerns the general status of the viaducts. The status is grouped by decades considering the design years (Fig. 2a). The histogram clearly shows that most of the viaducts are in the Operability condition, regardless of the decades, starting from about 1960. On the contrary, viaducts designed (and realized) in the 1950-1960 decade show a higher percentage in Practicability (2) condition. This means that the degradation effects are most evident for this last group of viaducts. It could also be noticed that, for each decade, the Adequacy condition is the minimum part of the histogram. The conditions of each viaduct are expressed in terms of status of the decks in Fig.2b and status of the piers in Fig.2c, where the conditions are grouped together by different typologies of elements. As previously mentioned, most of the considered viaducts have decks composed by longitudinal and transversal beams. These elements are seriously interested by the degradation effects acting on the reinforced concrete, therefore, the beams are very often in Operability condition. About 17% of the decks with beams is interested by strong degradation, leading to Practicability conditions. In the bridge stock here analyzed, there are only four slab decks, but also this typology has been resulted in Operability condition. About the piers, Adequacy and Operability conditions are the most frequent situations, regardless of the

piers’ typologies. Stem piers (full and hollow sections) show better results in terms of condition with respect to frame ones. Frame piers are characterized by safety conditions with greater variation than other types. The safety analyses, considering the viaducts with degradation and Adequacy condition, have shown several failure mechanisms occurring in the decks and piers with negative safety verifications. About the decks, the longitudinal external beams are the elements mostly affected by degradation. They represent the elements of the deck where the adequacy condition is not satisfied for bending or shear mechanisms with approximately the same percentage (22% and 26%, respectively). Vice-versa, the inner beams can be considered not really exposed to the degradation effects because only 4% of the viaducts do not satisfy the Adequacy condition in these elements. Moreover, the degradation effect is strongly present in the Gerber half-joint (if present). In 9% of the viaducts here considered, shear in Gerber half-joint represents the mechanism leading to negative safety verifications. About the piers’ mechanisms, the shear one is the worst one for different types of piers. The percentage of about 51% of the analyzed cases is not in Adequacy condition having verification index minor than one, with 18% for frames with full sections, 9% for stems with hollow sections, and 24% represented by the pier-caps. Therefore, the pier caps represent a part of the viaducts strongly affected by the degradation effects.

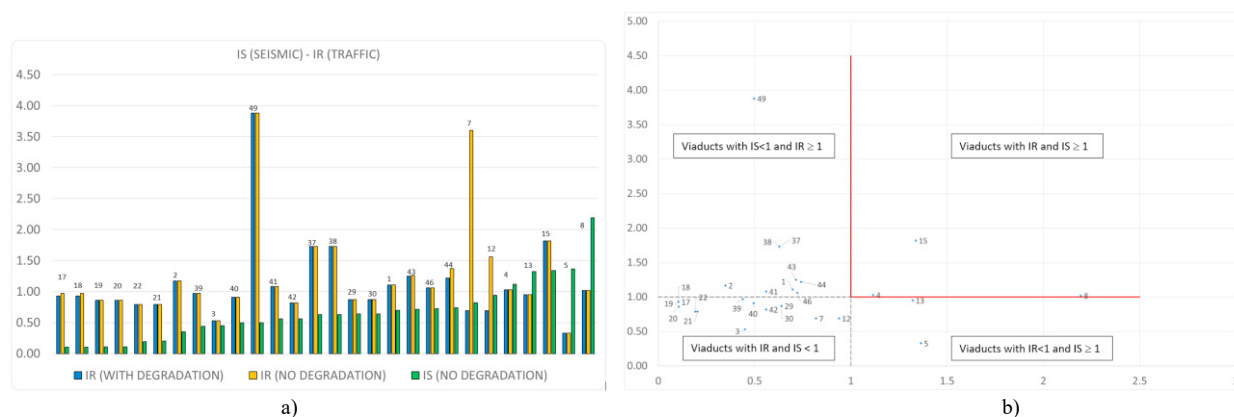
Fig. 3. a) Verification indexes for the traffic loads (IR, with and without degradation) in comparison to the Verification index under seismic action (without degradation) b) Representation of the status of the viaducts in terms of IR and IS

The analyses under the different traffic conditions, with the relevant partial factors in the load combinations, have been performed by considering or not the degradation effects. When degradation is included in the analyses, a reduction of rebars diameter or the elimination of a reinforcement level have been considered (as reported in Section 2). Moreover, for some viaducts of the considered stock (28 out of 53 viaducts), seismic analyses have been performed too, without considering any degradation. A comparison among the safety indexes for traffic loads (IR) and seismic loads (IS) is shown in Figure 3a (both in Fig. 3a and in the following Fig. 3b the labels with the identification number of the 53 viaducts here analyzed are shown). The comparison shows that the degradation effects are generally not significant on the safety index related to the traffic loads. In fact, most cases are characterized by the same value of the traffic safety indexes by considering (or not) the degradation. Only viaduct n.° 7 shows a very important difference between the traffic indexes (IR is five times higher if degradation is not considered). This is caused by the presence of exposed bars with corrosion on both piers and beams of the deck. Also, viaduct n.° 12 shows an important difference

between IR with or without degradation. In this case, the reason is the run-off with exposed bars and corrosion on the beams of the deck. Moreover, by comparing IR due to the traffic without degradation (yellow columns in Fig.3a) to IS due to the seismic action without degradation (green columns in Fig.3a), only 14% of the viaducts shows IS higher than IR. These viaducts are all designed between 1957 and 1962, and they are located very close themselves along the same motorway, but they are characterized by different features in terms of pier configurations (nn. 4, 5, 8 and 13 have piers respectively with frame with full section, frame with full section, stem with hollow section, and frame-stem with full and hollow section). Also, the material characteristics are in line with the other viaducts, therefore, local seismicity could be a possible cause of their vulnerability. Generally, a limited number of viaducts positively satisfies the safety verifications due to both earthquakes and traffic conditions simultaneously. In Figure 3b, this situation is represented in the top-right quadrant. The lower-right quadrant shows the viaducts that are safe only against seismic loads. Similarly, in the upper-left quadrant there are the viaducts satisfying only the traffic conditions. Finally, the lower-left quadrant represents the most dangerous situation containing the viaducts not verified for both seismic and traffic loads.
