SEISMIC INTERACTION OF TIMBER ROOFS AND SUPPORTING WALLS

ABSTRACT

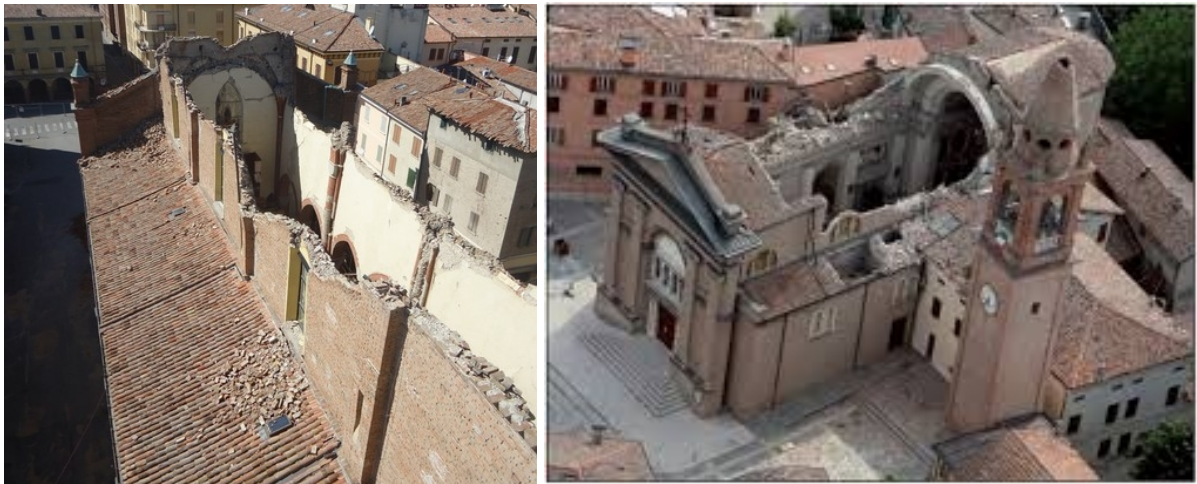
Fig. 1 Cathedral of Mirandola, Emilia, (left) and Church of S. Martino Secchia, Emilia (right)

In most instances, the roof collapsed over the nave area and drew along also the nave wall. Figure 1 shows two cases occurred in the Emilia earthquake: the cathedral of Mirandola and the Church of San Michele Secchia. In the former, the timber trusses on the central nave fell over the barrel vault underneath and drew it down, sparing the nave walls. Failure has concerned apparently the restraint condition at the interface. In the latter, the involvement of the nave wall is evident, with collapse reaching the base of the clerestory.

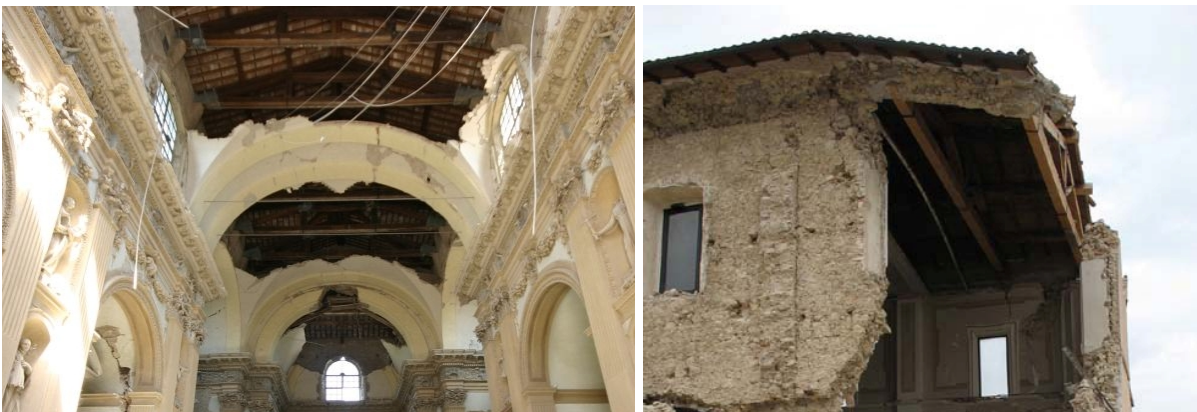
Fig. 2 Mirandola, Emilia, Chiesa del Gesù (left); damage from the L'Aquila earthquake (right)

In some cases, however, the truss-and-wall system has survived and clearly contributed to maintain the cohesion of the entire structural system. Figure 2 presents two cases: on the left side, a church of Mirandola, hit by the Emilia earthquake, where the trusses and the clerestory, with large windows, were preserved, as may be seen through the collapse of the barrel vault underneath; the right-hand-side picture is from the L'Aquila earthquake and shows a single nave where the roof structure survived and seems to have been active in maintaining connection between facing nave walls for an extended part of the nave length. The beneficial effect is partial here, but damage at the end wall and vicinity is probably due to local conditions.
