Climamed 2017 – Mediterranean Conference of HVAC; Historical buildings retrofit in the Mediterranean area, 12-13 May 2017, Matera, Italy

Keeping it modern, making it sustainable. Monitoring and energy retrofitting the Urbino University Colleges

Cesare M. Joppolo^a, Davide Del Curto^{a*}, Andrea Luciani^a, Luca P. Valisi^a, Mara Bellebono^a
^aCLIMATE AND ENERGY FOR CULTURAL HERITAGE (C.E.C.H.) LABORATORY, POLITECNICO DI MILANO,
PIAZZA L. DA VINCI, 26, 20133, MILANO

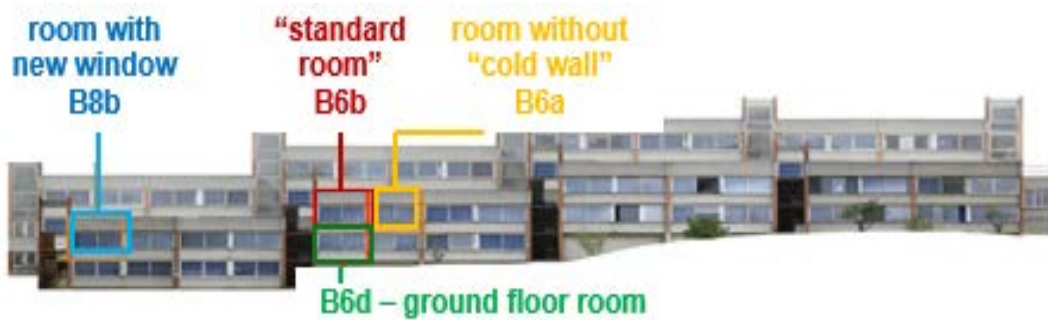
Fig. 2. Position of the monitored rooms on the South-West façade of the "Aquilone" building

Sensors were installed in a couple of overlapping rooms on different floors (Room B6B and B6D) with original windows. This is the most typical room disposition within the colleges. Sensors were also installed in other parts of the complex, with a different room configuration. Room B8B is similar in position while the original window was already substituted by a new one with aluminum frame without thermal break. Room B6A represents the case of a room not in touch with an external brickwall.

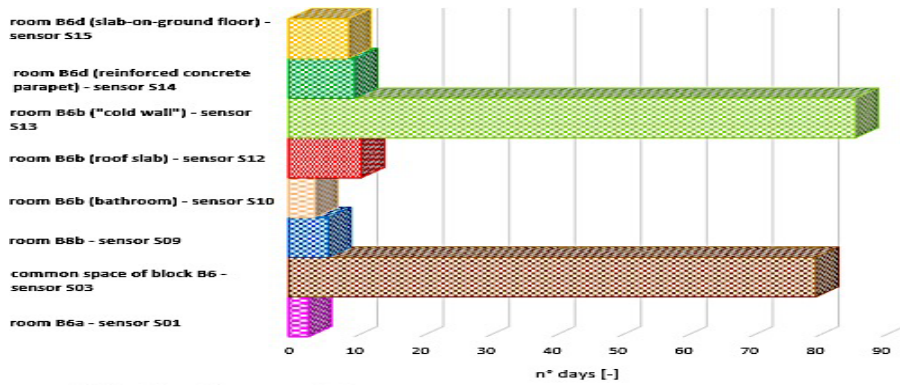
Fig. 5. Number of days with indoor temperature < 20° C from 8 am to 10 pm (159 total days of measurement, corresponding to the periods when the heating system was in operation: from 1/12/2015 to 21/12/2015, from 04/01/2016 to 14/04/2016, from 28/04/2016 to 07/05/2016)

Near the dispersant wall in room B6B, air temperature was $< 20^{\circ}\text{C}$ for the 54% of the days monitored. It highlights a possible local discomfort. The air operating temperature was thus considered beside the ambient air. Data show how the indoor climate and the internal comfort is influenced both by the low thermal inertia of the not-insulated building, both by the high thermal transmittance of the windows (see par. 4.2).

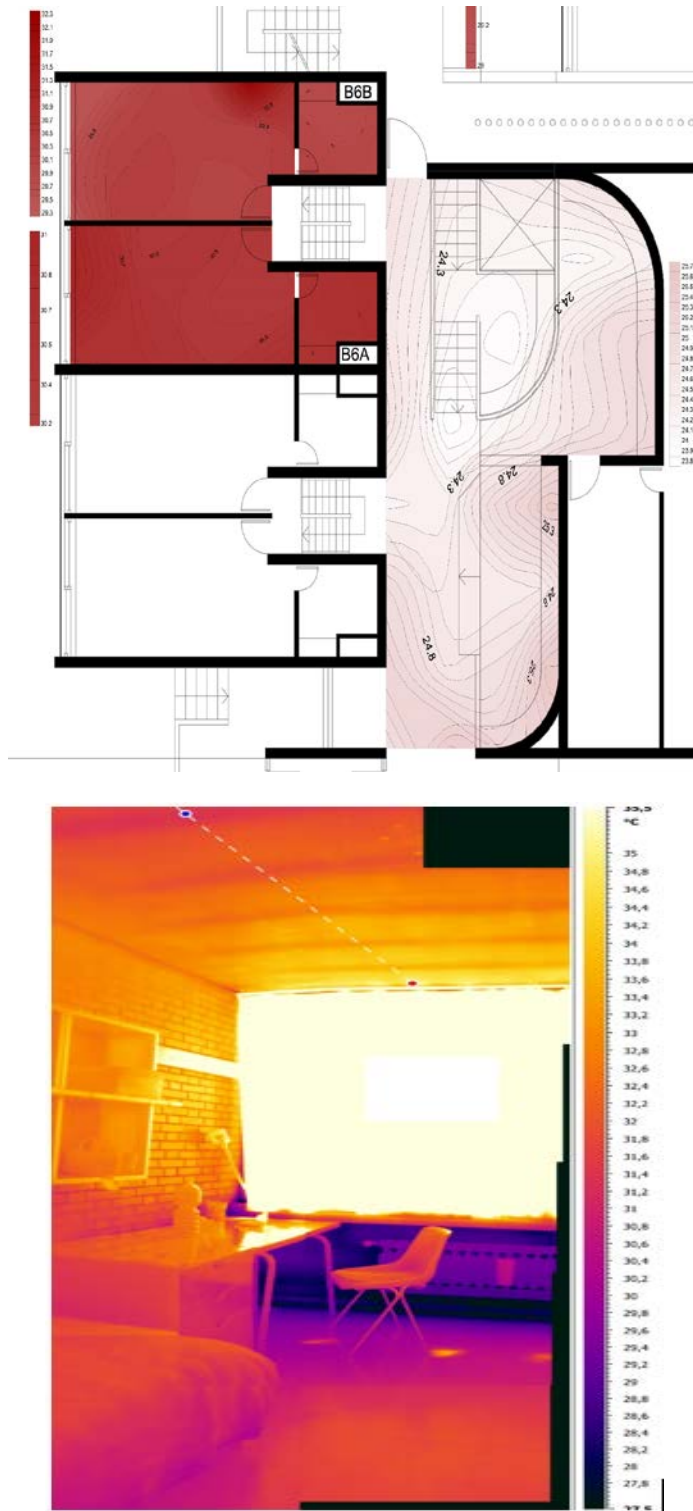
Fig. 9. Distribution of temperature (left) in B6b room (top) and B6a (bottom) compared with the common space (in the middle) of the “Aquilone” building– 14/07/2016. Thermal image of B6b room - 14/07/2016 (right).

The same rooms were analysed during summer (Fig. 9). On the left, the temperature in rooms B6b and B6a (around 30°C) is compared to the common space (24°C). In the corresponding thermal image, the ceiling's concrete joists are perfectly visible, just like all the non-insulated structures. The surface temperature of the inner side of the roof is 35°C , thus confirming the data mentioned in the previous paragraphs.

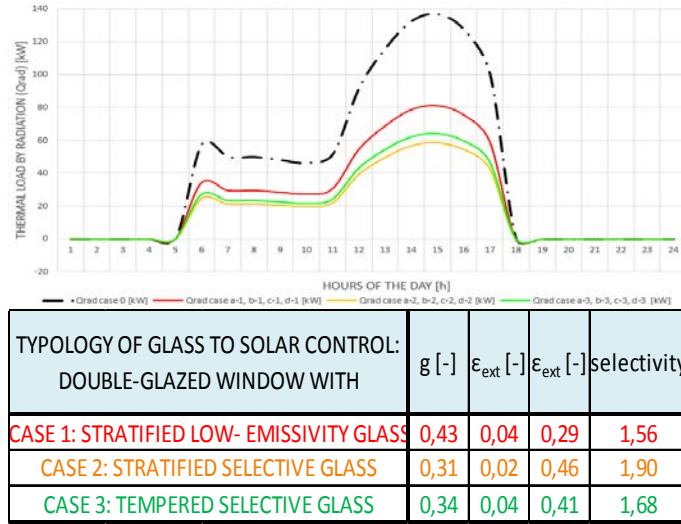
Fig. 10. Thermal load by radiation in the existing windows and after the substitution of the window glass

The preservation of room windows was a difficult task. Some results already acquired concerning the conservation of historic windows [16] proved to be useful when dealing with the windows of a wide XX century complex, e.g. the *Collegi*. A consistent decrease of the total summer thermal load may be obtained by replacing the transparent components with a solar control glass, since the thermal load by solar radiation is drastically reduced (Fig. 10). This is shown by the gap between the continuous colored lines (solar control glasses) and black dot-dashed line (existing glass). The reduction of the radiation heat output was evaluated considering the solar factor, the emissivity and the selectivity of three different types of solar controlled glass. Solution 1 (red curve) results in terms of thermal power by radiation, a lower reduction compared to the case 0 (black curve) because the low emissivity glass has a solar factor (g) greater than the other two cases. In addition, the low-emissivity glass of type 1 has a lower emissivity on the inner surface. This generally results in a significant reduction of magnitude if the room is air-conditioned in summer. The selective glass of type 2 (yellow curve) is the most powerful in terms of solar factor, of emissivity of the outer surface and especially in terms of selectivity. This window allows the greatest reduction of the heat load in summer conditions given that the high selectivity (1.9) allows an increased light transmittance. The solar factor is the ratio between the solar incident energy on the total glazed incoming surface. The energy expenditure of an air conditioned room can be controlled by keeping this factor as low as possible in the summer. In fact the second type has the lower solar factor (0.31).
