Reducing the Loss of Built Heritage in Seismic Areas

Giuliana Cardani * and Paola Belluco

Department of Civil and Environmental Engineering, Politecnico di Milano, Piazza L. da Vinci 32 instead of P.za L. da Vinci 32, 20133 Milano, Italy; pao.belluco@gmail.com

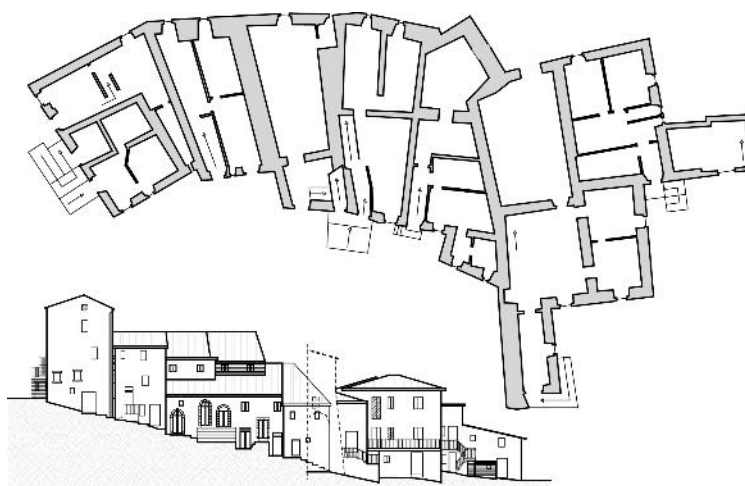
Figure 1. Example of a map and elevation of a complex civil building in a historic centre [3].

All strengthening intervention against seism should take into account the history and constructive evolution of the building, with all the modifications made over the centuries, right up to the recent ones. As already reported above, the presence of such discontinuities makes a historic building much weaker than a similar one, but homogenous and compact, and often concurs to add irregularities both in the plane and in the height, as shown in Figures 1 and 2.

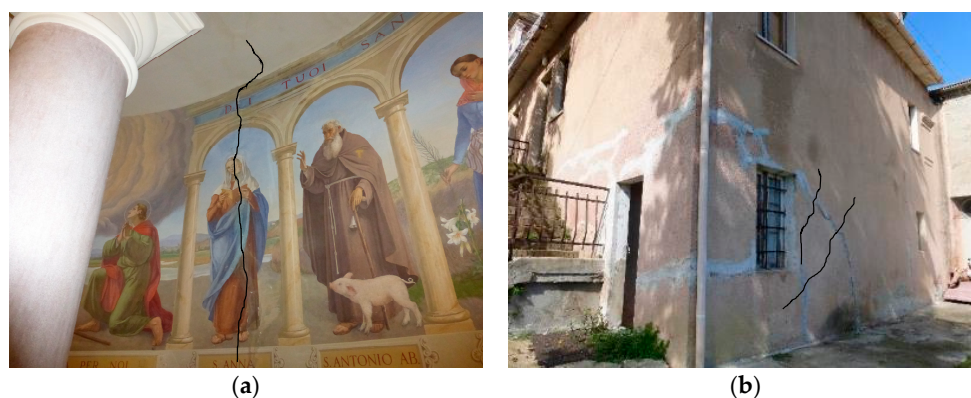
Figure 2. Cont.

Figure 2. Example of a damage survey of a church struck by the 2016 seismic event: (a) vertical crack in the apse in correspondence to a perpendicular wall situated at the back; (b) diagonal cracks in the sacristy corner; and (c) the church survey form reporting the volumetric stratigraphy and the crack pattern sketches.

In Figure 2 we have an example of the damage survey of a church struck by the 2016 earthquake and reported in the forms Model A-DC, covering the aforementioned issues.

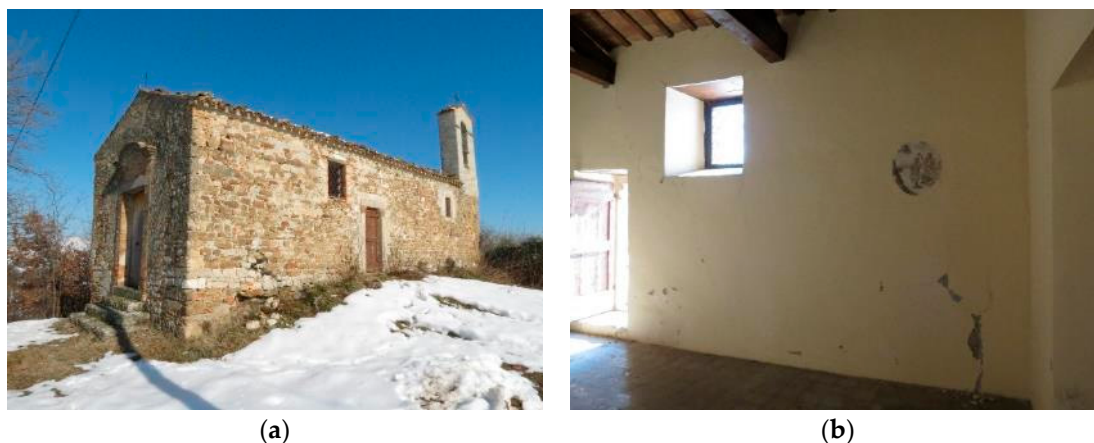
Figure 7. Example of damage due to soil settlement occurring after a seismic event: (a) visible outside a church; and (b) inside a church.

The already-cited Italian damage survey forms of churches and palaces need to be reviewed periodically in order to be more efficacious on site, for instance, by taking into consideration the presence of landslide or soil settlement provoked by the earthquake, causing damage to the buildings above. This damage is not linked to the collapse mechanism currently listed in the survey form (Figure 7).
