# Evaluation of Moisture Transfer to Improve the Conservation of Tiles Finishing Facades

Silvia Erba, Bruno Daniotti, Elisabetta Rosina, Antonio Sansonetti  
and Riccardo Paolini

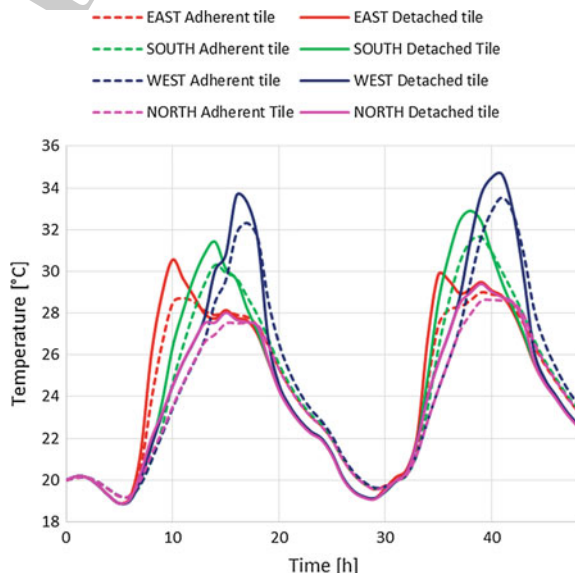
**Fig. 2** Distribution of the characteristic thermal gradient due to detachment in tiles cladding systems as a function of the orientation

139 The use of IRT can be at transient or steady-state conditions: in the case of  
 140 adhesion problems, it is fundamental to create a temperature transitory to visualize  
 141 the map of the state of adhesion on the façade (Caglio et al. 2011; Ludwig et al.  
 142 2012). With this procedure, it is possible to evaluate a thermal gradient between  
 143 sound and detached areas. Natural or artificial sources of heating successfully  
 144 generate the proper thermal gradient for detecting the delamination. The researchers  
 145 validated the results also by numerical simulation through WUFI® software (De  
 146 Freitas et al. 2014) (Fig. 2).

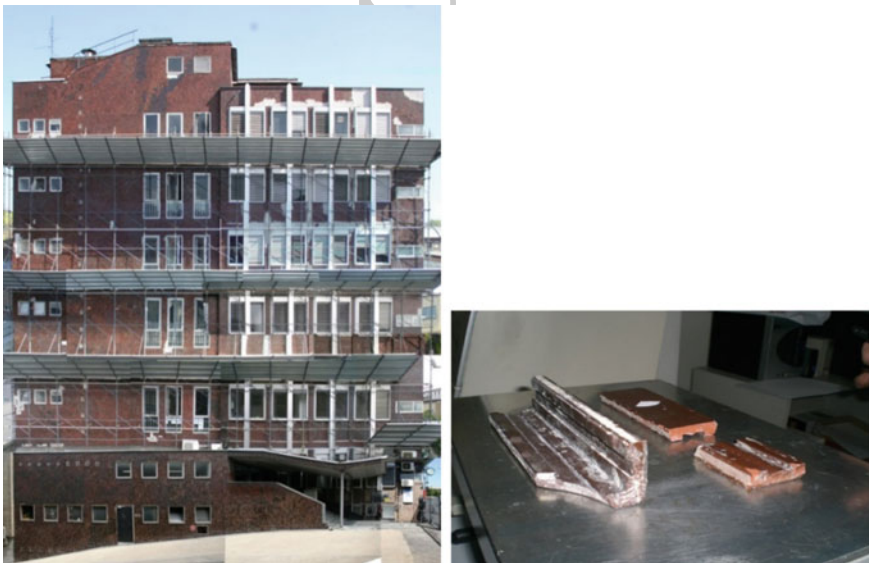
**Fig. 3** Building 12 in Campus Leonardo (left); details of the tiles of Building 12 (right)

Building 12 has an exterior stoneware tiles cladding (Fig. 3, left). The ceramic elements, flamed at high temperature (producer Italian Society of Grès, now Italcementi s.p.a.), are no longer under production. The body of the material is compact, and the superficial layer presents the typical glaze obtained through a vitrification while firing; the glaze thickness is around 50  $\mu\text{m}$ , except for the corner tiles where it is enhanced at 150  $\mu\text{m}$  (Fig. 3, right). The underneath layer is a cement mortar bedding 4 cm thick.

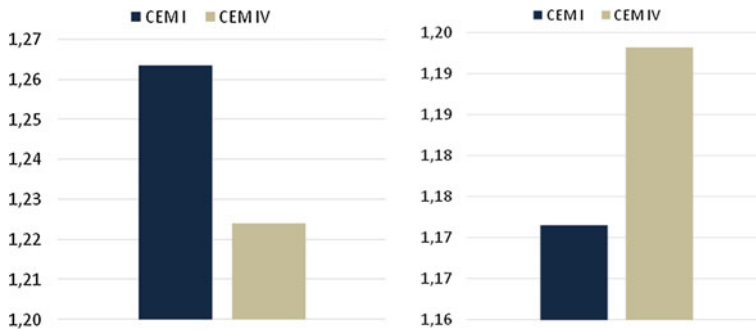
**Fig. 12** Total color difference  $\Delta E$  (left) and total shade difference  $\Delta H$  (right) between the two cement types

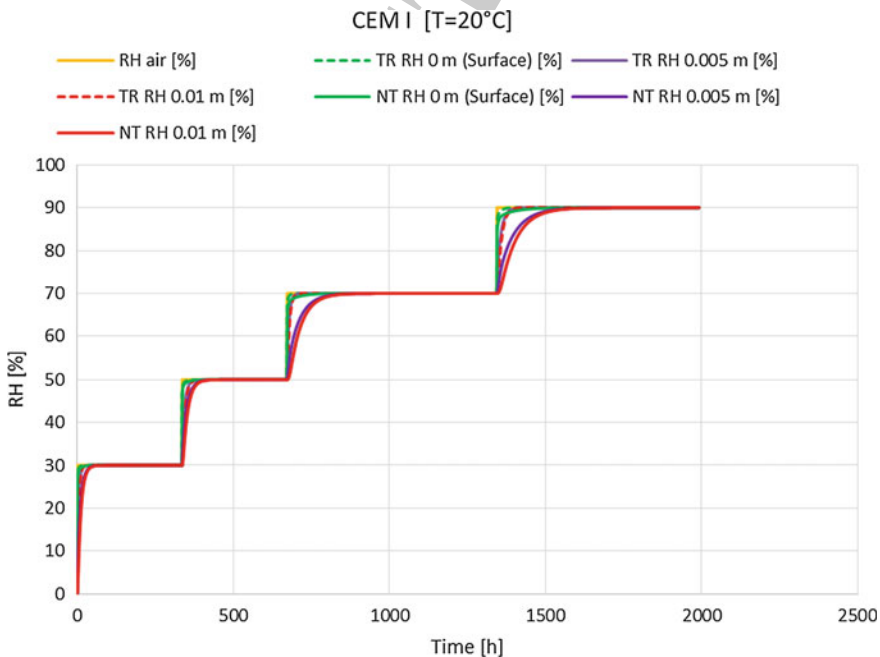
**Fig. 14** Comparison of the RH trends for untreated/treated cement (CEM I) specimens
