A DATABASE CONSTRUCTION TOOL FOR SEISMIC VULNERABILITY ASSESSMENT OF TIMBER ROOF STRUCTURES

Keywords: Timber roofs, Seismic Vulnerability, Assessment, Inspection database

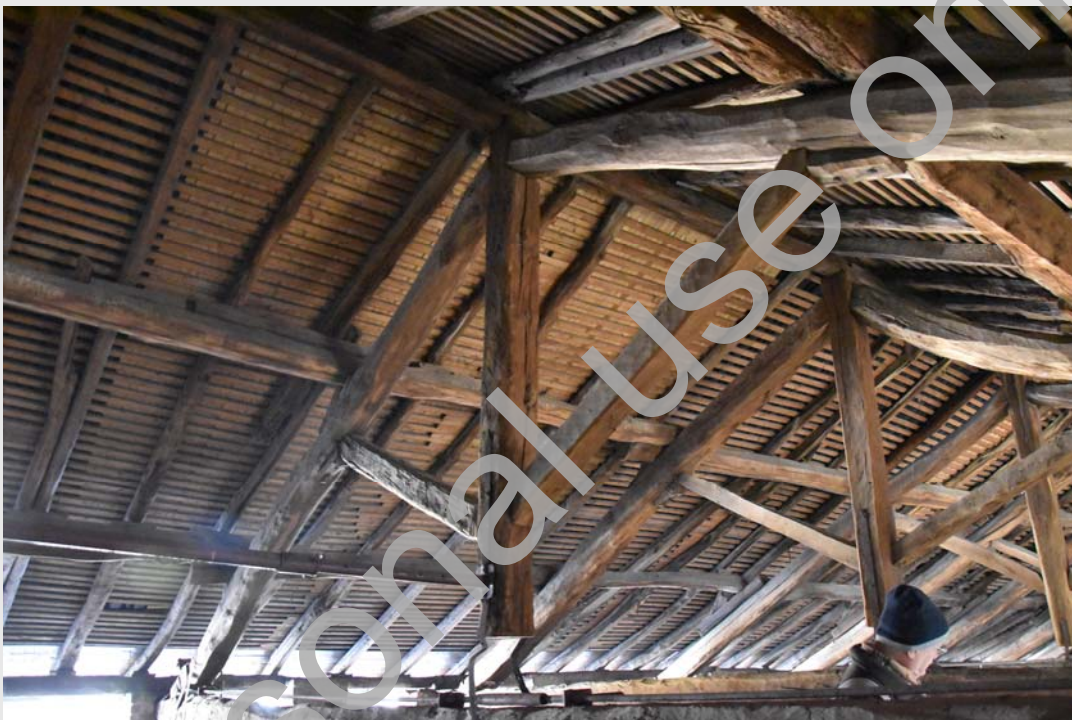
Figure 4: View of the roof trusses

The roof covers the central nave of the church and has a typical configuration of 11 parallel trusses ending in a semi-cylindrical roof over the apse. The trusses are interconnected simply with purlins and a ridge beam, as in fig. 4. The roof structure is not visible from below, because it covers a barrel vault that masks it. Not being considered part of the church architecture but only a functional element to support the roof pents, its construction and detailing are not sophisticated. Roof structures of this type have often been considered an artisan element of secondary importance, not understanding their role in some conditions like seismic actions. Figure 5 shows a detail where rudimental manufacturing is evident.

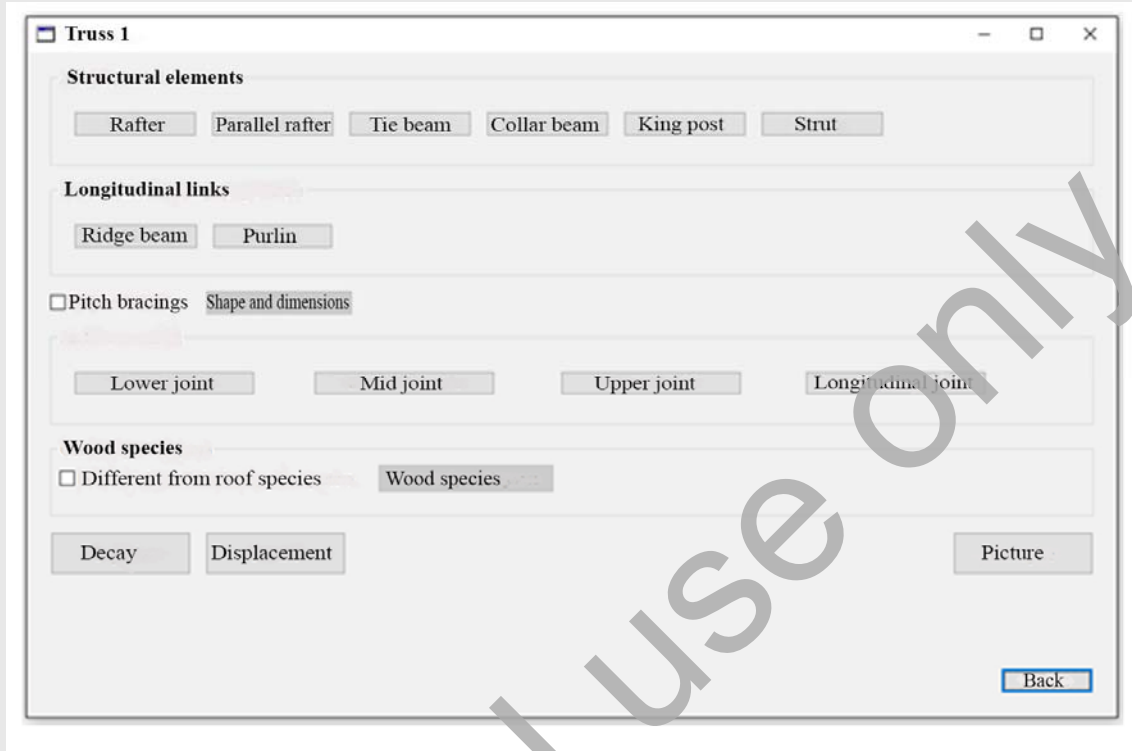
Figure 7: The truss specification with links to its elements

Figure 7 concerns the first truss, used as master for the others. Some information like the type of wood remains at this level, others, like the structural elements, branch down. The rafter menu describing the left and right rafter is in fig. 8; space for notes and comments is available, because some observations cannot be condensed in numbers and measures.
