Water and Cultural Heritage

7TH INTERNATIONAL SYMPOSIUM ON THE CONSERVATION OF MONUMENTS IN THE MEDITERRANEAN BASIN

KARST SOIL AND RISING DAMP IN SASSARI: GUIDE LINES FOR RESTORATION OF CANOPOLENO COMPLEX

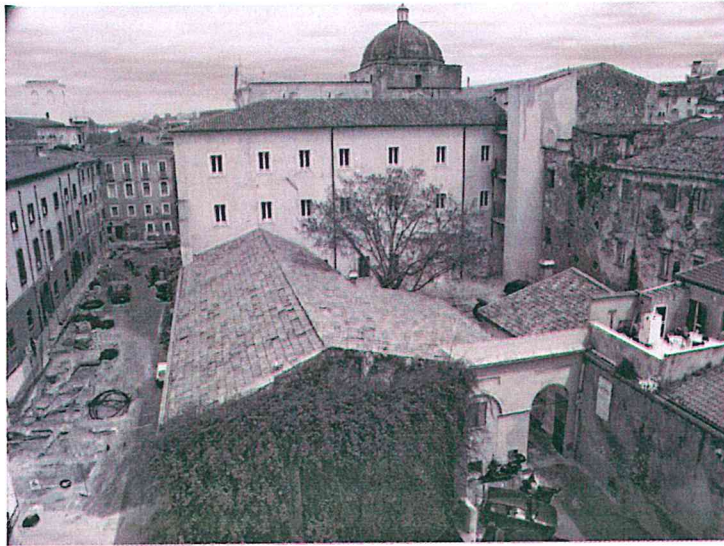
Figure 1 - Canopoleno complex in Sassari, 2005

Leaving aside modifications, nowadays we can clearly distinguish original plant: a “C”-shaped plant, in which vaulted halls are set along a central aisle, and an elegant facade.

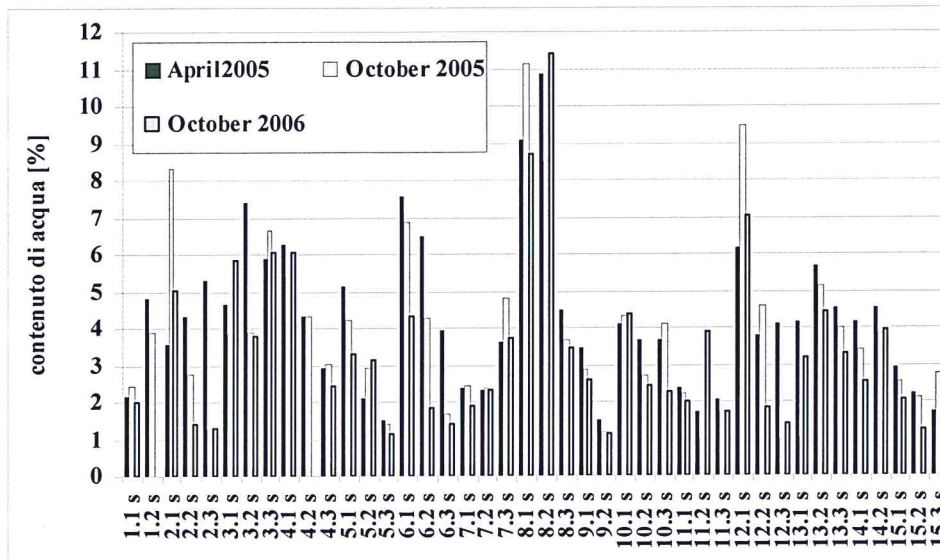
Following graphics show in details variation of average water content of surface and samples collected at 15-20 cm inside.

Figure 6 - Water content of samples 1.1/ 15.3. Samples are numbered with two figures: first means row, and second means height (around 20 cm, 60 and 80 from the floor)

October 2006 measurements have lower values of average water content, especially at the basis of masonry, but it is anyway high.

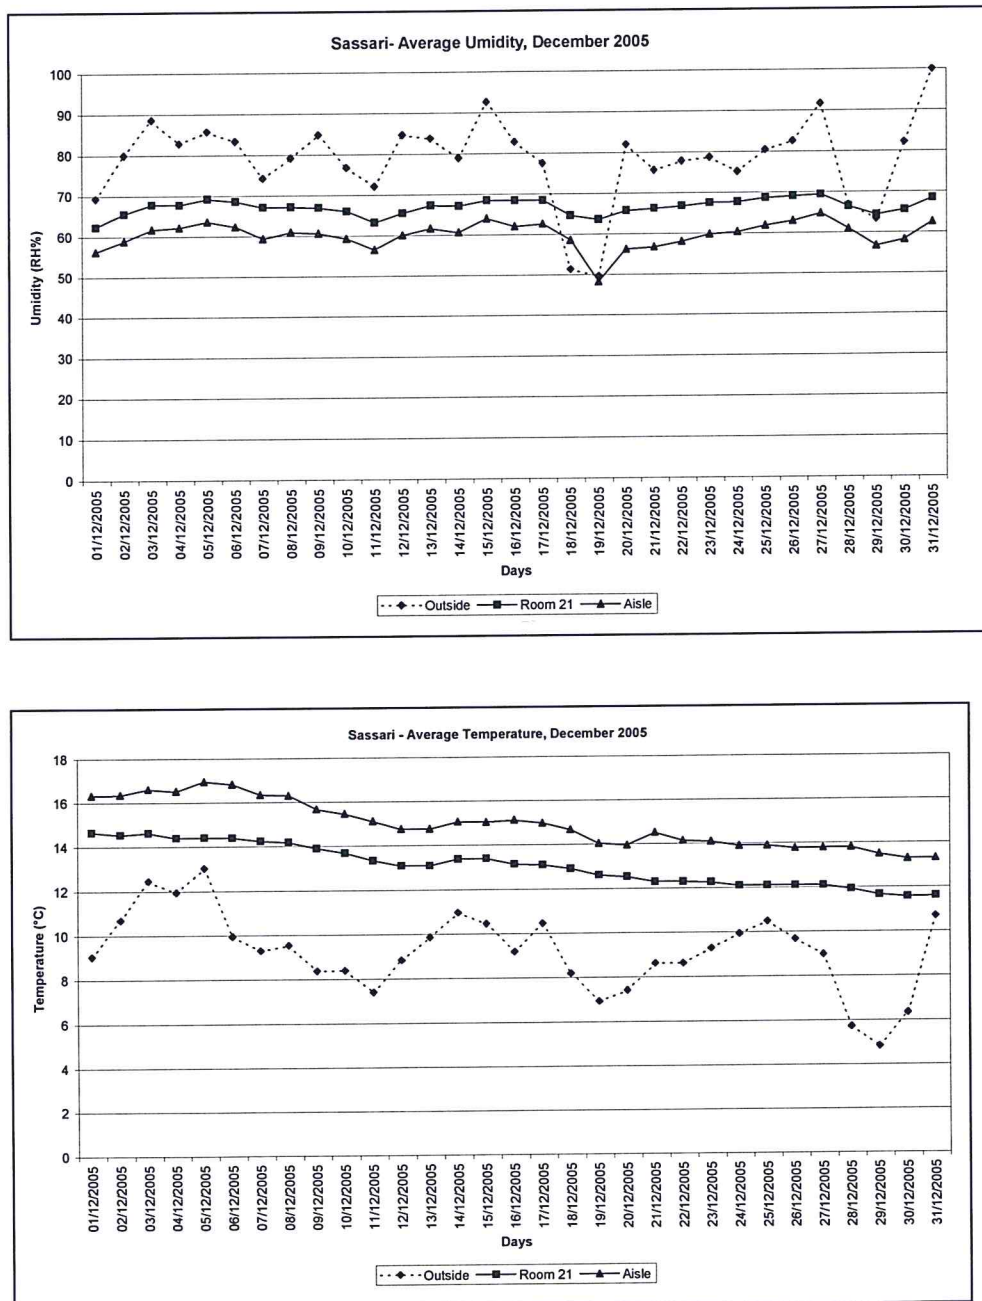
2) Operators installed four probes to monitor thermo.hygrometrical variation of microclimate in cellar and ground floor (rate of registration is one/hour). Moreover, a fifth probe has been placed in Palazzo Ducale cellar. The historic building is set in front of Canopoleno; it has similar building techniques, and same materials. Rising damp was one of major cause of its damage. It already went under restoration and professionals restored plaster of cellar and ground floor by white washing. Moreover they ensures a continuos ventilation in the cellar, in order to decrease RH. Therefore, Palazzo Ducale's microclimate monitoring constituted a study case for intervention and gave reference values for ambient condition.

Figure 8 - Graphics of average daily values of $T^{\circ}\text{C}$ and RH on December 2005
