International Energy Agency

Shining Examples of Cost-Effective Energy and Carbon Emissions Optimization in Building Renovation (Annex 56)

Energy in Buildings and Communities Programme

March 2017

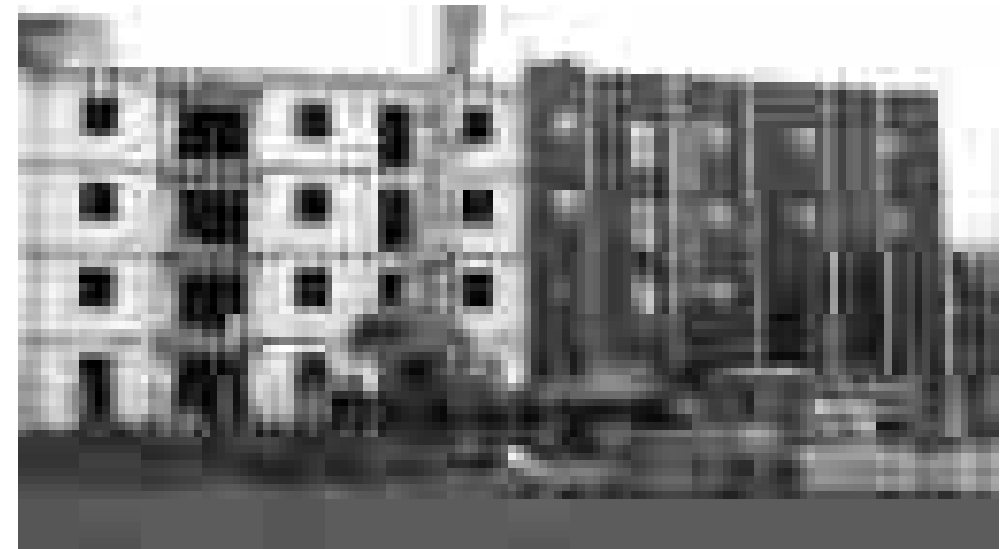
Assembling of the prefabricated façade modules on the west facade

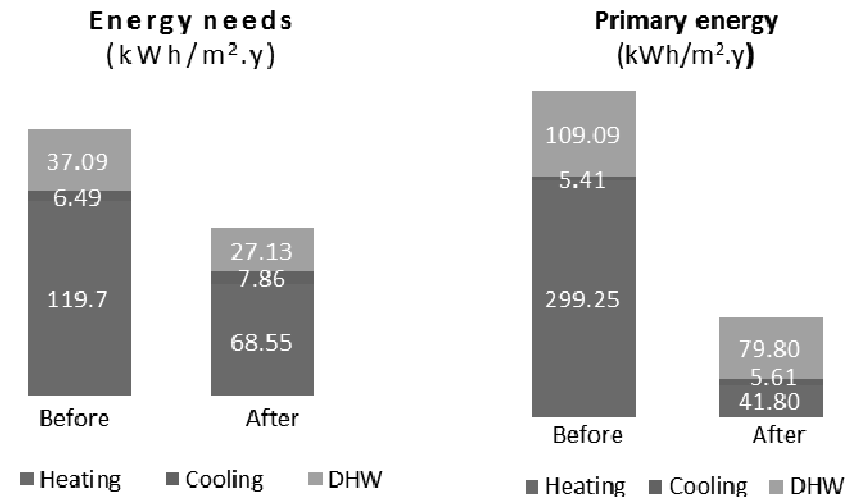
Figure above on the left shows the energy needs for heating, cooling and DHW before and after the renovation works calculated in accordance with the Portuguese thermal codes, which consider the comfort indoor temperatures of 20°C in winter and 25°C in summer.

Figure on the right shows the carbon emissions before and after the building renovation related to the non renewable primary energy use.

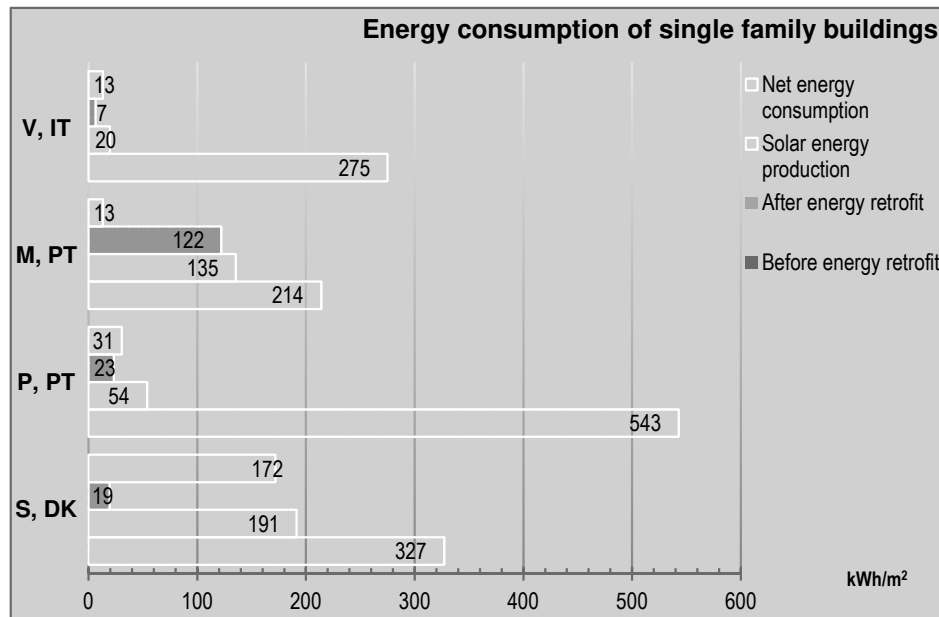
Overview of the Energy consumption before and after energy retrofit for the four single-family buildings.

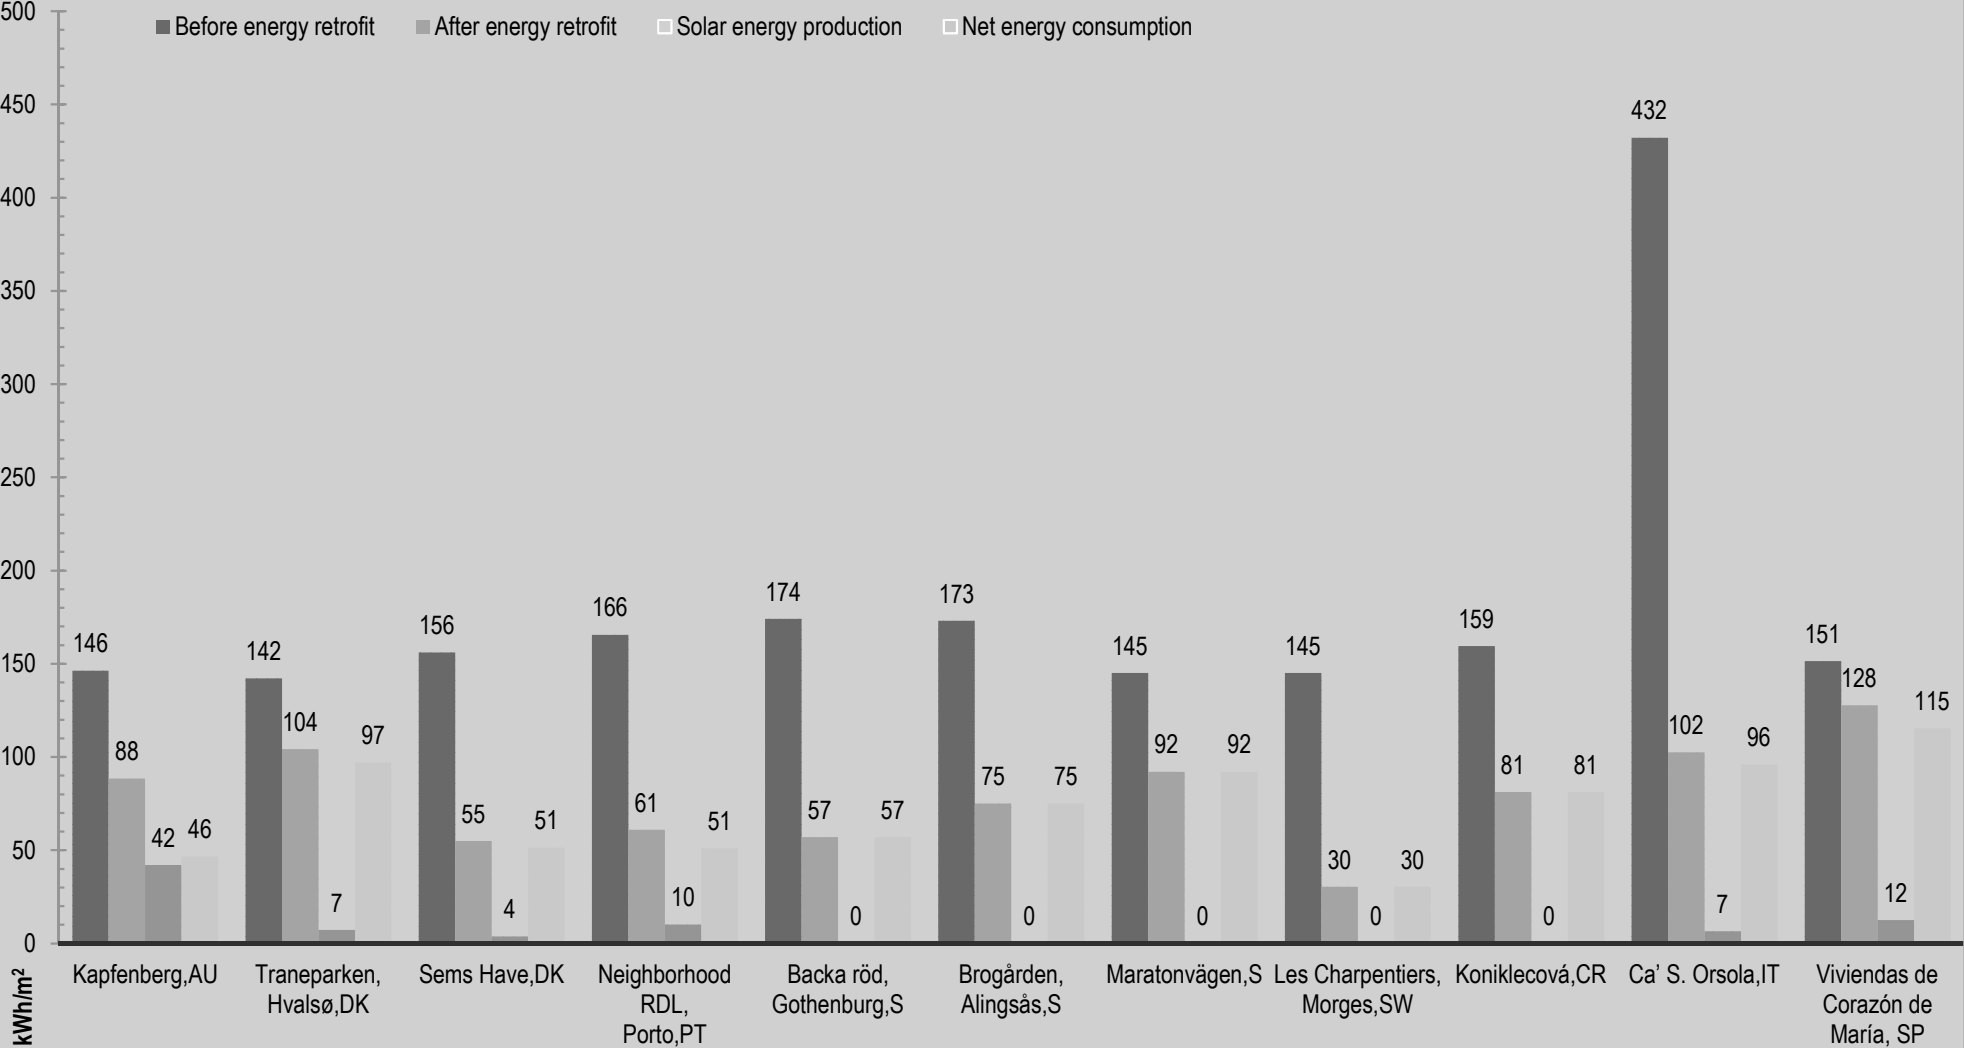
Overview of the Energy consumption before and after energy retrofit of multifamily buildings.
