# Understanding of historical masonry for conservation approaches: the contribution of Prof. Luigia Binda to research advancement

Anna Anzani · Giuliana Cardani · Paola Condoleo · Elsa Garavaglia · Antonella Saisi · Cristina Tedeschi · Claudia Tiraboschi · Maria Rosa Valluzzi

**Keywords** Masonry · Vulnerability · Creep · NDT · Grout injection · Durability

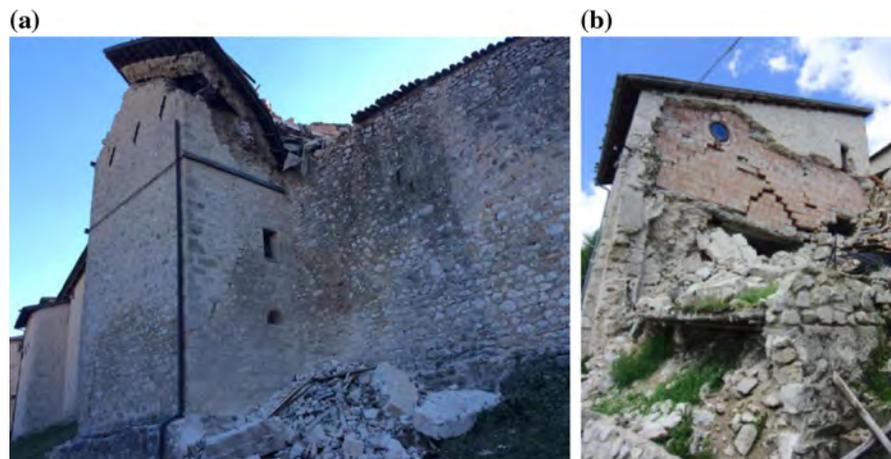
**Fig. 1** Damage due to irregular interventions on masonry walls: **a** damage of stone masonry bearing modern r.c. roof; **b** collapse of stone masonry bearing new floor made with modern technique and detachment of external leaf in composite walls

The extreme varieties of constructive solutions adopted in historic masonry buildings did not help in the choice of the techniques for their repair and strengthening in the XX century. In Italy, first the 1997 earthquake (which struck the Umbria and Marche regions), then the one of 2009 (Abruzzo region) and the last in 2016–2017 (wide part of central Italy), gave the occasion to learn about the effectiveness of the repair and retrofitting techniques applied to existing buildings in the 1970s and 1980s. Those interventions were mainly based on the use of the common modern materials (e.g., concrete and steel). Most retrofitting interventions caused unforeseen effects due to the "hybrid" behavior activated between the new and the old structures (Fig. 1).

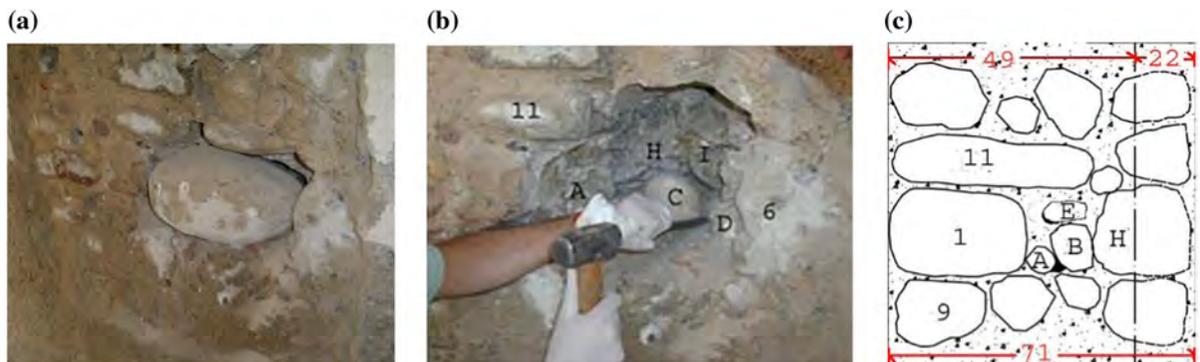
**Fig. 2** Analysis of wall cross-section: **a** masonry texture and starting of first stone extraction; **b** hole after masonry disassembling; **c** drawing of left vertical face of cross-section (without reaching other side) [12]

There is a real difficulty in applying some intervention techniques to certain types of stone masonry, made of not manufactured stones [9]. The presence of defects or the low quality of the constructive techniques can alter the load-bearing capacity of a wall and can be the cause of a local mechanism. The observation of the facing masonry texture only is not enough to reveal how the masonry is made in each parts. When it is not possible to observe the masonry sections directly and in the absence of large visible cracks or collapsed parts, a wall can be slightly dismantled (with hammer and chisel), in a portion not larger than  $40 \times 40/50$  cm (depending on the average stones dimension) and of the cross-section thickness. This should be realized in the same wall portion after carrying out diagnostic investigations with Nondestructive (ND) tests, so that the cross-check can be made between direct survey and experimental results. As an example, a high value of sonic pulse velocity can be related with the possible presence of the transverse connecting elements (i.e., stones especially oriented to connect horizontally the masonry layers) (Fig. 2).

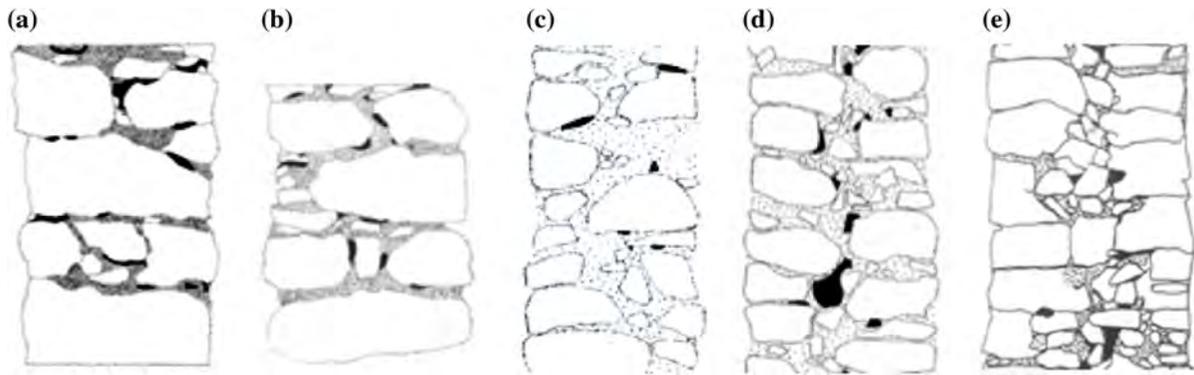
**Fig. 3** Examples of masonry cross sections: **a** one single leaf; **b** two leaves well interlocked (with transverse connecting stone); **c** two leaves partially interlocked; **d** two leaves not interlocked; **e** three leaves or multiple leaf [12]

non-respected), presence of wedges and levelling of different materials; (f) cross-section type of the masonry wall (Fig. 3), e.g., single or multiple leaf, well interlocked or not, the presence of transverse connecting elements [10, 11].

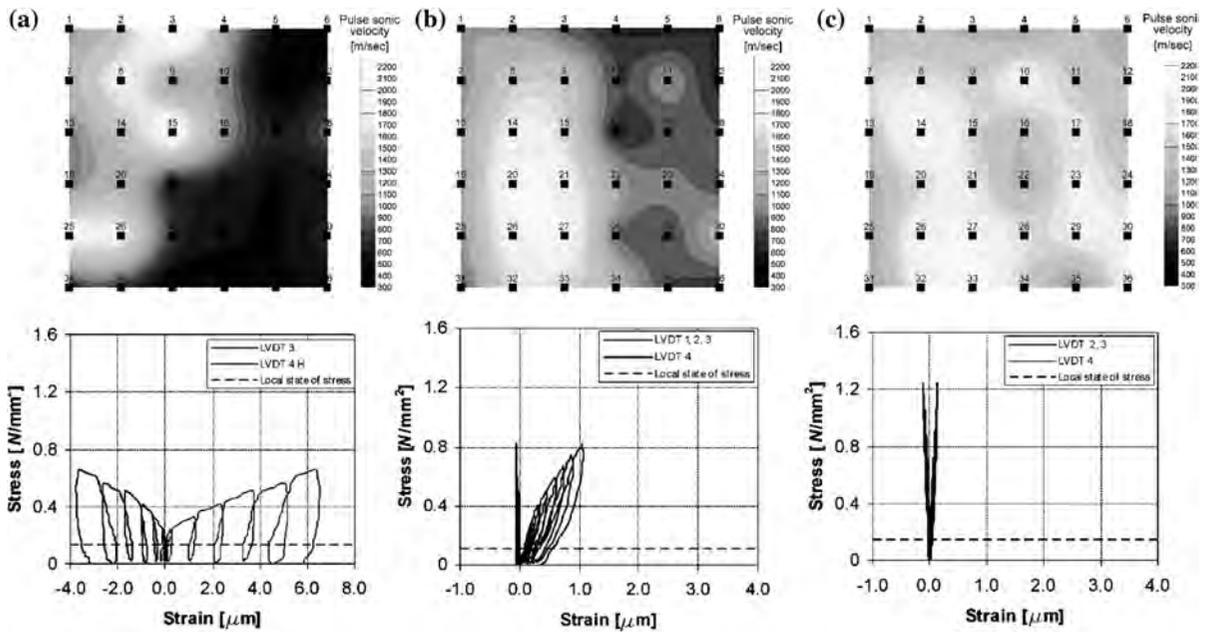
Fig. 4 Results of pulse sonic tests and single/double flatjack tests carried out to evaluate masonry quality

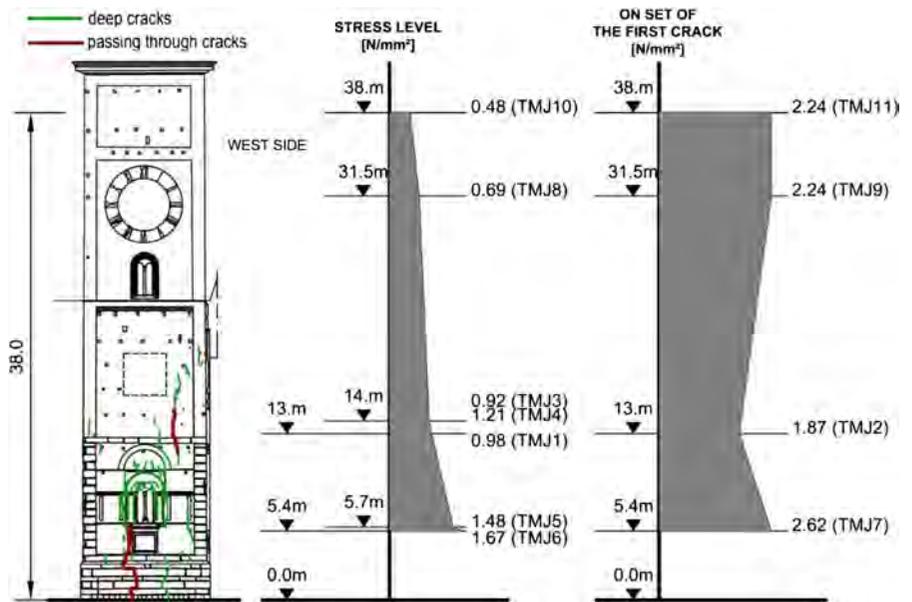
Fig. 5 Stress distribution by single flatjack and values of cracking onset by double flatjack

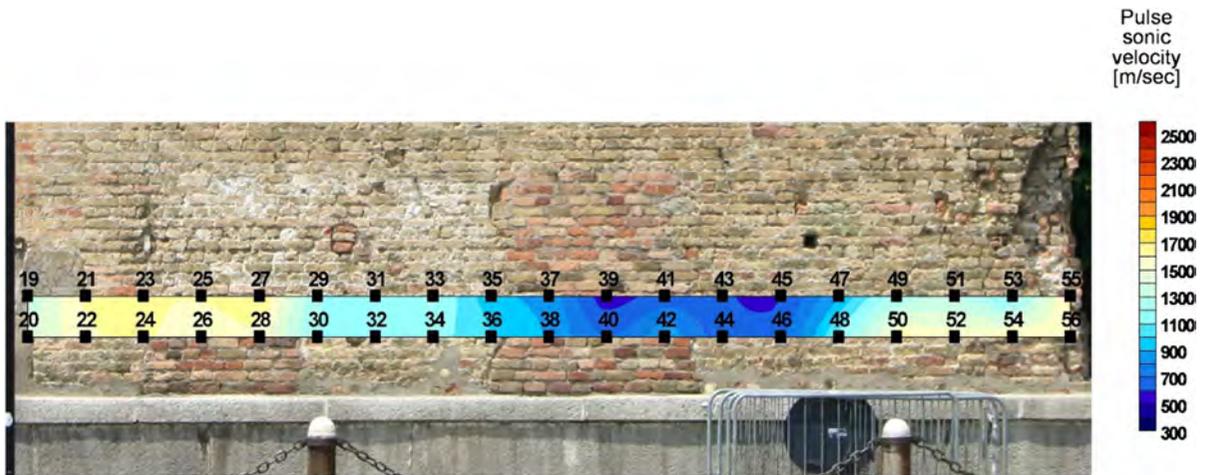
**Fig. 6** Distribution of pulse sonic velocity measured by transmission at base of Isso Tower at Castelleone showing presence of infilled opening

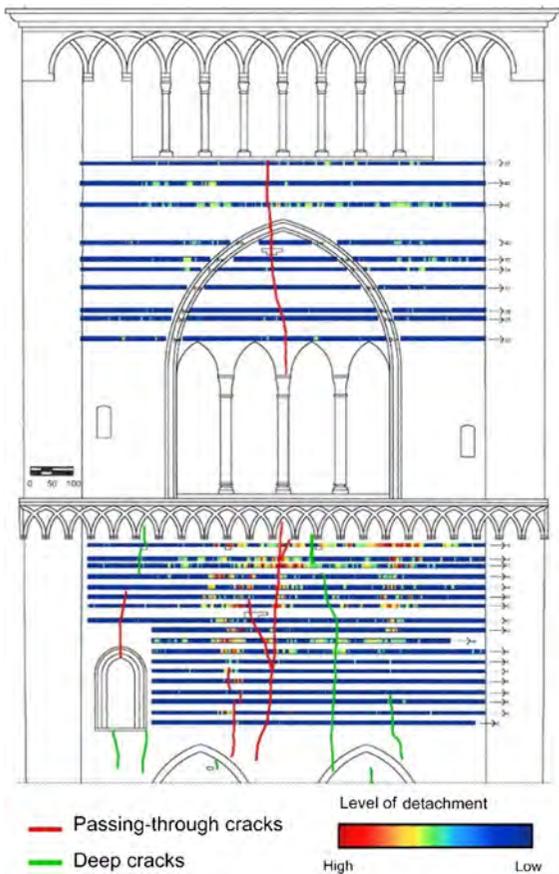
**Fig. 7** GPR used in Cremona Torrazzo to map detachment of large part of cladding

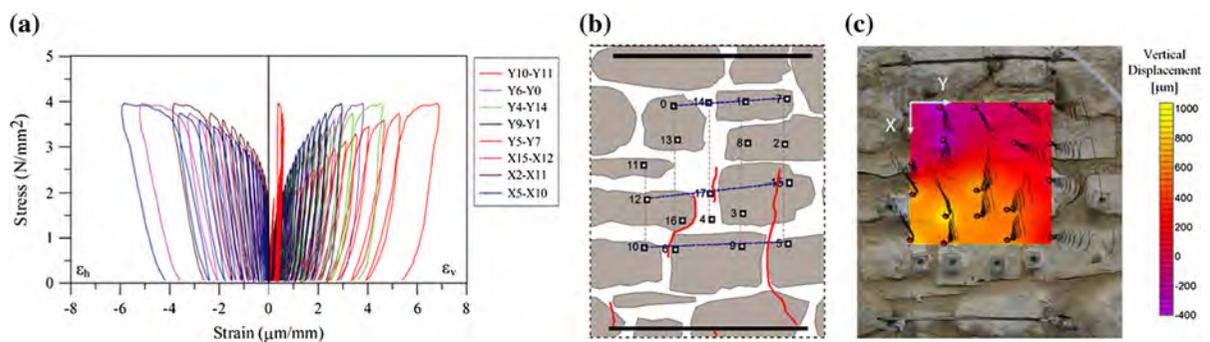
**Fig. 8** **a** Typical stress–strain diagram obtained from different couples of markers on masonry; **b** markers fixed on wall and evidence of vertical crack; **c** amplified trajectories of markers

and map of final displacements acquired by optical system during double flat jack tests

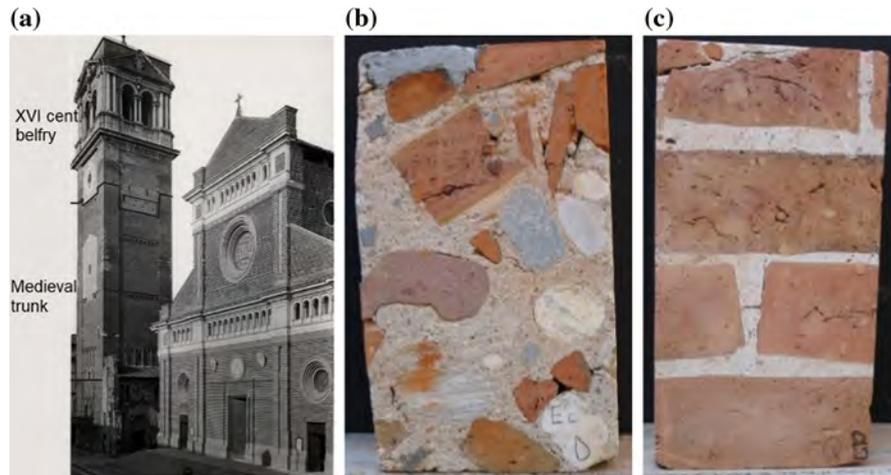
**Fig. 9** a View of Civic tower of Pavia before collapse; b medieval rubble inner leaf; c XVI cent. plain masonry

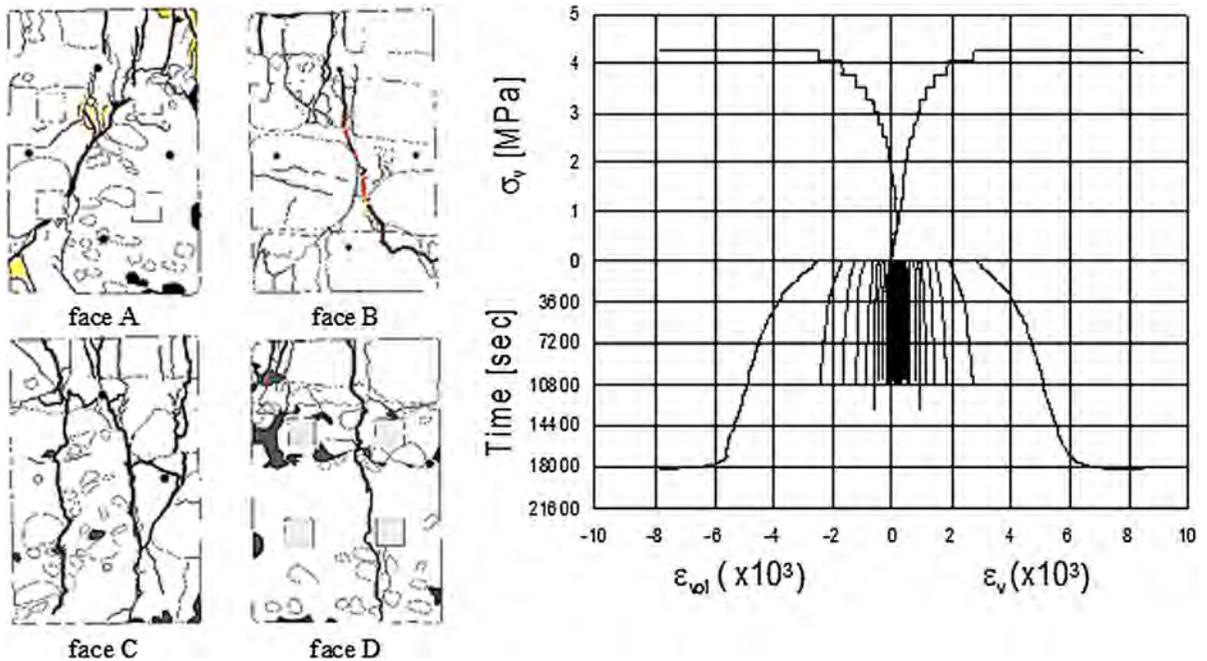
**Fig. 10** Pseudo creep test on masonry of Monza crypt: crack pattern (left) and stress–strain–time diagram (right)

increase of material damage. Figure 10 also shows the crack pattern across the specimen at the end of the test. It can be seen from the drawings that the prism was characterized by the presence of a large stone, occupying most of its face D and large parts of faces A and C. Basically, the crack pattern developed in sub-vertical direction, with fissures opening mostly along discontinuities which were already present at start of the test, whereas bricks were not cracked.

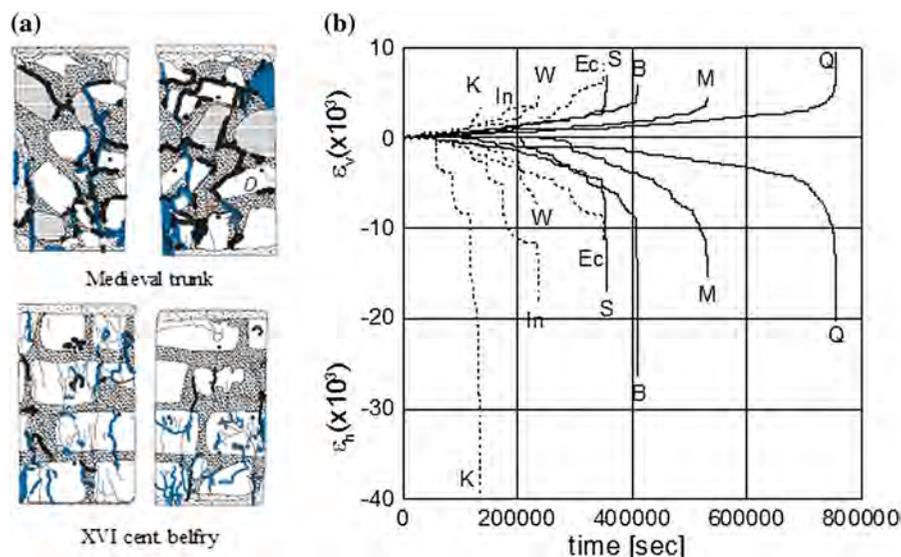
**Fig. 11** Results of pseudo creep test on masonry of Pavia tower: **a** crack pattern; **b** strain versus time diagrams: (dashed line) Medieval trunk and (solid line) XVI cent. belfry

In Fig. 11, the results of pseudo creep tests carried out on the medieval inner leaf rubble masonry and on the XVI century belfry plain masonry of the Pavia Tower are compared. Initially, primary creep develops, then secondary creep and eventually tertiary creep shows for both materials. As expected, the prisms of the inner leaf (less regular and less homogeneous) reached failure well before the prisms of the plain masonry. Horizontal strain takes higher absolute values than vertical strain, indicating that at failure dilation takes place.

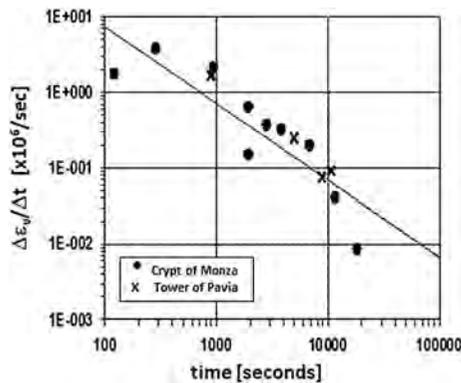
**Fig. 12** Secondary creep strain rate before failure versus duration of last load step

When studying the long term behaviour of ancient structures, a crucial issue is finding a way of predicting the residual life of a building. Based on the experimental results of pseudo-creep tests, a relationship was searched between the secondary creep strain rate and the residual life. The representative parameters were obtained from the last load step of every test and, particularly, the duration of the last load step was assumed as the residual life of the material. This was put in relationship with the secondary creep rate calculated before collapse. Figure 12 shows the comparison between the values obtained on the masonry of Monza crypt and those obtained on the ruins of the tower of Pavia: the strong correlation between creep time to failure and secondary creep rate is evident for both materials.

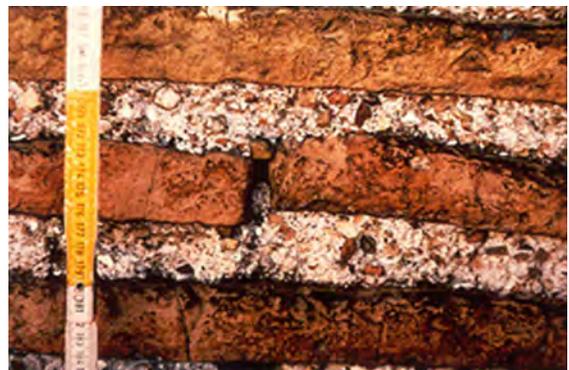
**Fig. 13** View of thick mortar joints of St. Vitale basilica in Ravenna (Italy)

At the end of the 1990s L. Binda and G. Baronio’s interest was attracted by the study of Byzantine churches (S. Vitale basilica in Ravenna, Italy, 5th cent. AD) and particularly by the use of thick mortar joints (Fig. 13). The feature of that masonry, similar to that of other Byzantine buildings, is represented by the joints thickness, which is approximately the same height of the bricks (40–50 mm) [51]. The use of thick mortar joints was very frequent during the Byzantine Empire, although it was already adopted in the late Roman Empire. Currently, a thick mortar joint is considered a weaknesses affecting the strength of the masonry. Historians gave several explanations for this use; the most diffused among them referred to economic reasons, as thick mortar joints in a wall required less bricks. Nevertheless, due to the fact that the size of the aggregates was carefully increased according to the thickness of the joint, L. Binda was also convinced that the technique had certainly to be reliable from a mechanical point

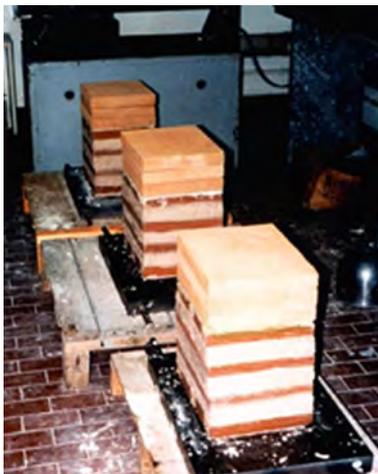
**Fig. 14** View of some specimens in pre-loading phase

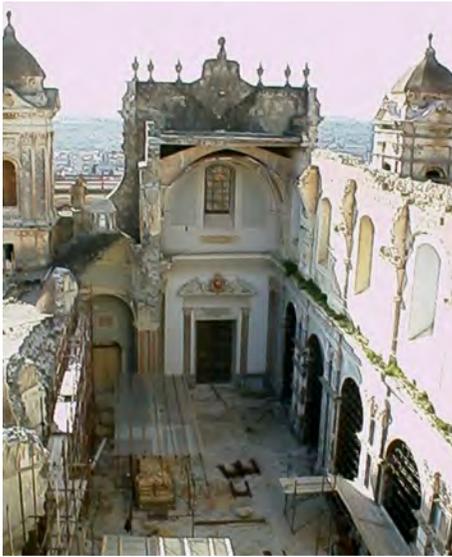
**Fig. 15** View of entrance of Noto cathedral after removal of ruins

After the terrible collapse of the pillars of the Noto cathedral (Italy) in 1996 and the consequent decision to demolish the remains of the survived pillars (Fig. 15), an extensive on-site investigation was carried out by L. Binda and G. Baronio aimed at identifying the cause of the collapse to avoid new damages in the future [57]. A parallel work was done in the laboratory and on-site, to identify and characterize the materials used in the construction. On-site investigation was aimed at studying the morphology of wall and pillars and the state of damage of the remaining pillars to evaluate the possibility of consolidation by the grout injection technique. Mortars and stones were characterized in the laboratory to

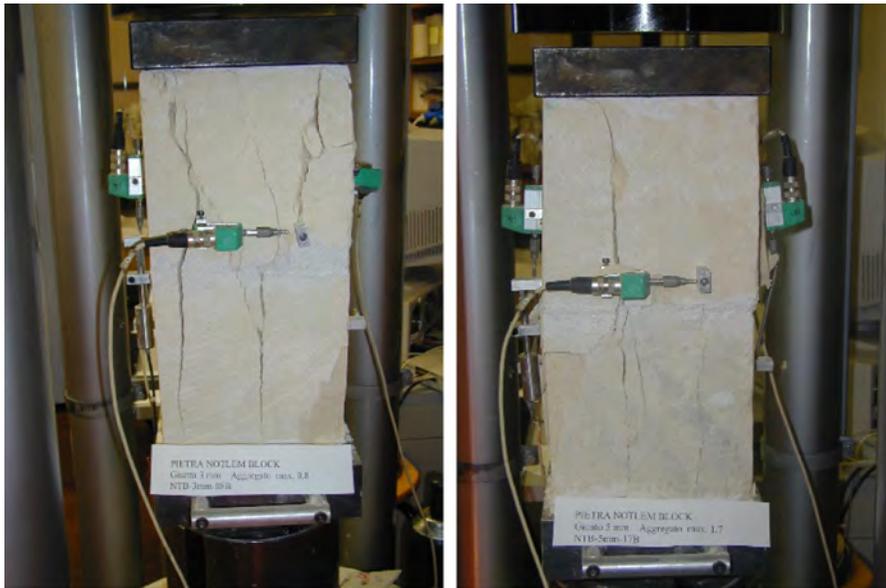
**Fig. 16** Couple of limestone specimens after compression tests

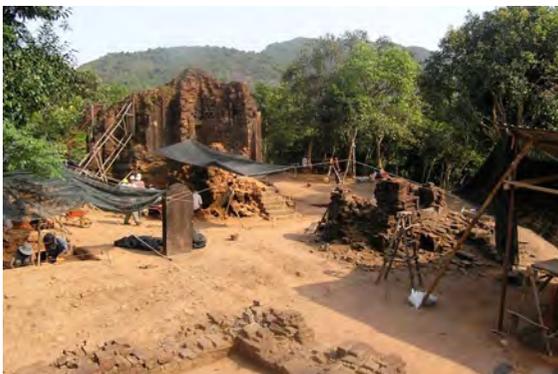
**Fig. 17** Group G before intervention

Since 2003, thanks to another agreement between UNESCO, Vietnam Ministry of Culture and Information and the Lerici Foundation, a pilot project started in Mỹ Sơn. The study concerned the excavation and conservation of a group of religious buildings built between the eleventh and thirteenth century, partially in ruin conditions (Fig. 17). These buildings were classified by Parmentier with the letter G [67]. Results achieved up to now contributed to answer to numerous open questions of historical and scientific nature, and to give the site a new value through the correct conservation of some of the buildings. Before this project, there were many doubts concerning the construction techniques and the materials used for the erection of buildings. It was widely believed that these architectures were made of raw bricks, afterwards cooked. Furthermore, it was possible to identify the structural problems emerging from the buildings leaning, their crack pattern and the physical, chemical and biological decay of their materials.

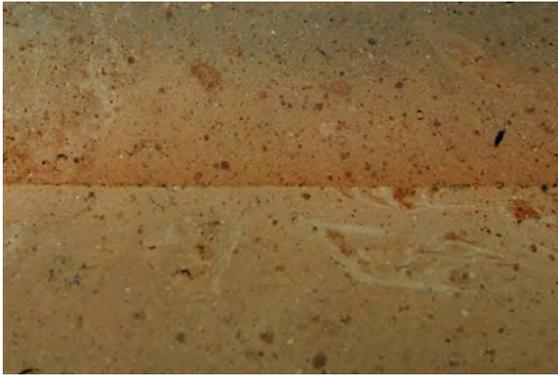
**Fig. 18** Couple of bricks with original joint

The most important results concerned the material used for the binder. The joint appearing on the external face of the brick masonry was so thin that it was impossible to recognize it as a real joint (Fig. 18). The chemical analyses demonstrated that the joints were not made of lime, but included many organic components, among which *Dammarenediol*. It is a component of the Dammar resin, widespread in the Southeast and East Asia, which can be extracted from some families of conifers, including *Araucariaceae* and *Dipterocarpaceae*. The same material was found in two commercial resins from the area of Mỹ Sơn:

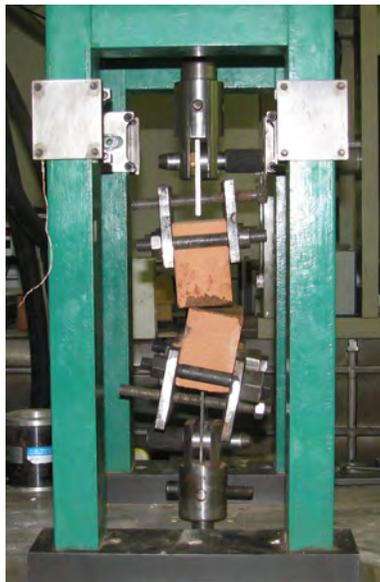
**Fig. 19** Couple of bricks specimen bond with new natural resin after tensile test

Several mechanical tests were carried out before deciding how to use the resin for the restoration, whether it had to be mixed with brick powder or lime or used alone, cold or hot (Fig. 19). The best results were obtained by using the natural resin after heating and eliminating all the contained impurities as burned bark.

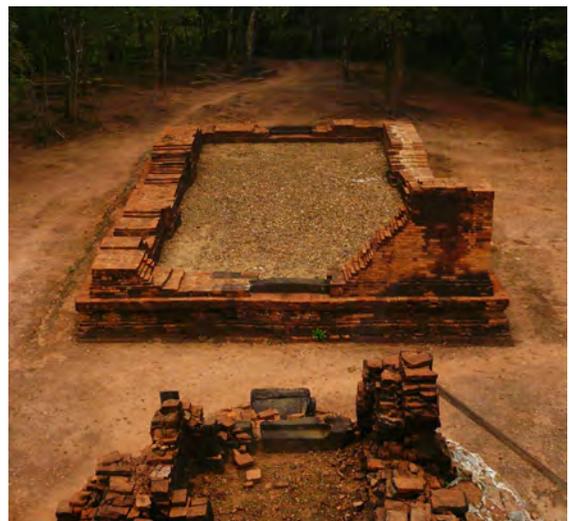
**Fig. 20** Part of group G after intervention

The intervention on the first building started in 2004. In 2005, after some good results had been obtained, the same procedure was applied to the other buildings (Fig. 20).

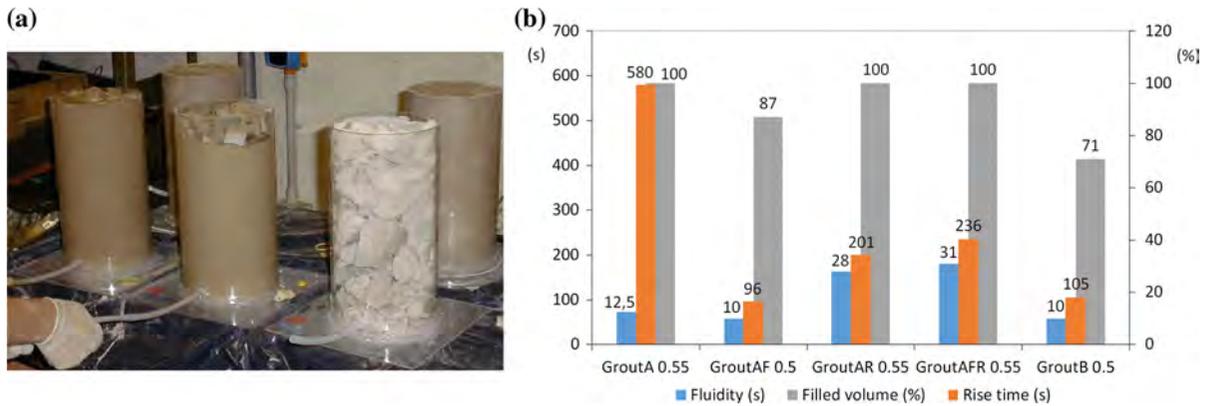
**Fig. 21** Results of rheological properties: phase of injection of cylinders (a); comparison between fluidity of grouts and injectability of cylinders (average of three cylinders for condition) (b)

The results confirmed the high injection capability of such coarse cores, as all cylinders were fully permeated by grouts (Fig. 21a). Times to cover the whole height vary according to the fluidity of the grouts (measured as efflux time at the ASTM cone

[95]), especially for the additive-added admixtures. In particular, GroutB and GroutAF (both with  $w/b=0,5$ ) referred to the lowest rise times, whereas the grouts including water retainer, even with higher  $w/b$  ratio, were highly slowed down (more than 100% compared to the previous ones). However, the positive effect of additives is clear, as the simple GroutA, even with high  $w/b$  ratio, had a quite difficult migration to fill the whole cylinders. By comparing the volume of grout introduced through the injection (computed as the weight of the consolidated cylinder divided by the density of the fresh grout) with the volume of voids (quantified as the amount of saturating water before injection) the high effectiveness of the injection was estimated, varying those ratios from 86% to 100% (Fig. 21b).

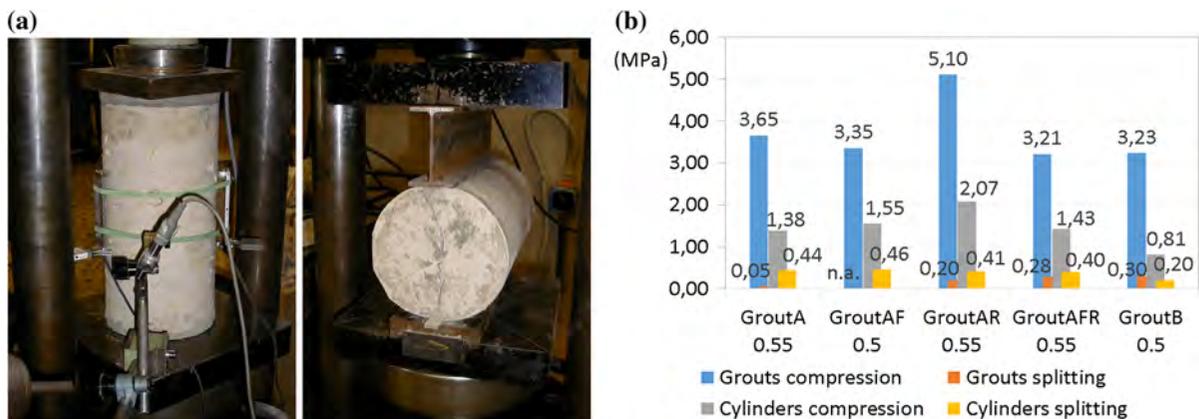
**Fig. 22** Results of mechanical properties (hardened specimens): compression and splitting tests on cylinders (a); comparison between grouts and cylinders strengths (b)

Experimental results on hardened cylinders (for both compression and splitting tests) (Fig. 22a) showed a very low variability in comparison with the mechanical strength of grouts (particularly the compressive strength) (Fig. 22b). Inspection after test pointed out the good bond between grout and mortar (better than with stone surface); this was due to the higher roughness of the mortar compared to the stone pieces but also to the higher absorption coefficient (12.7%, compared to 0.4%). The research demonstrated the feasibility of the injection intervention technique and the control of its effectiveness by the preventive optimization of the grout composition, also taking into account compatibility requirements.
