SEISMIC PROTECTION OF EXISTING BUILDINGS IN THE ITALIAN EXPERIENCE

Maria Adelaide Parisi, Chiara Tardini

Politecnico di Milano, Department of Architecture, Built Environment and Construction Engineering

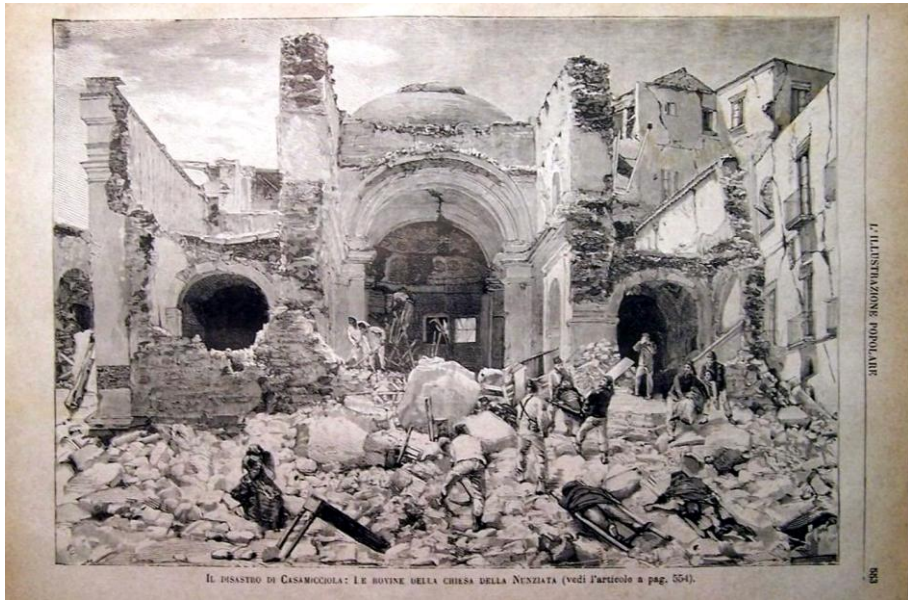
Fig. 1 - Ruins of the Church of the Annunziata, Casamicciola - E. Matania.

Short after national unification was reached, in 1861, Italy had to face a highly damaging earthquake that occurred on July 28, 1883 at Casamicciola, in the island of Ischia, gulf of Naples (Fig. 1). The earthquake occurred in the evening causing over 2300 victims, out of which almost 700 tourists. The site was a well appreciated resort for northern Europeans seeking milder winters. In the aftermath, the Government issued building regulations to be applied in the reconstruction.

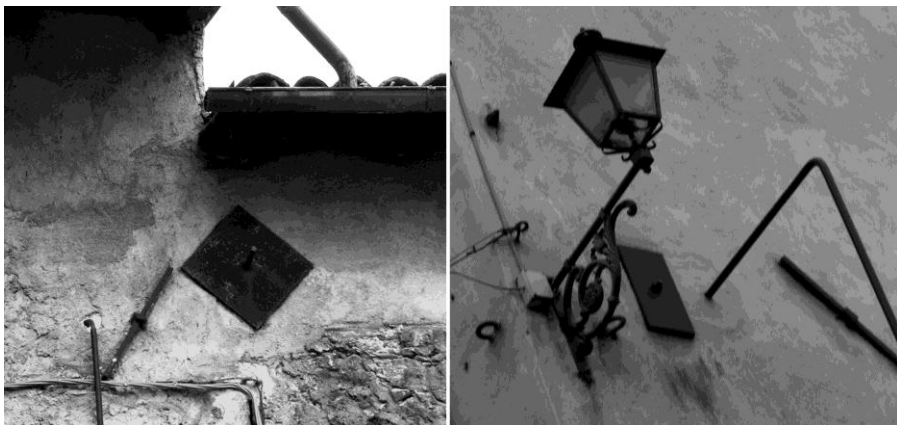
Fig. 4 - Different tie rod restraints.

The many seismic events that hit the Country in the first half of the 20th century were usually followed by decrees regulating funds and technical indications for reconstruction. The insertion of metal ties to relieve thrusts and improve connectivity of buildings has been, and still is, indicated as an effective and simple intervention. Figure 4 shows the presence of tie rods with different restraint systems on the outer wall of a building in the Abruzzo region, each representing a different period. The bar-shaped restraint could date back to the 1915 Avezzano earthquake, while the plate is typical of much later times, like the earthquakes of the 1970's or 1980's. The arrow-tip restraint indicates the presence of an old timber tie.

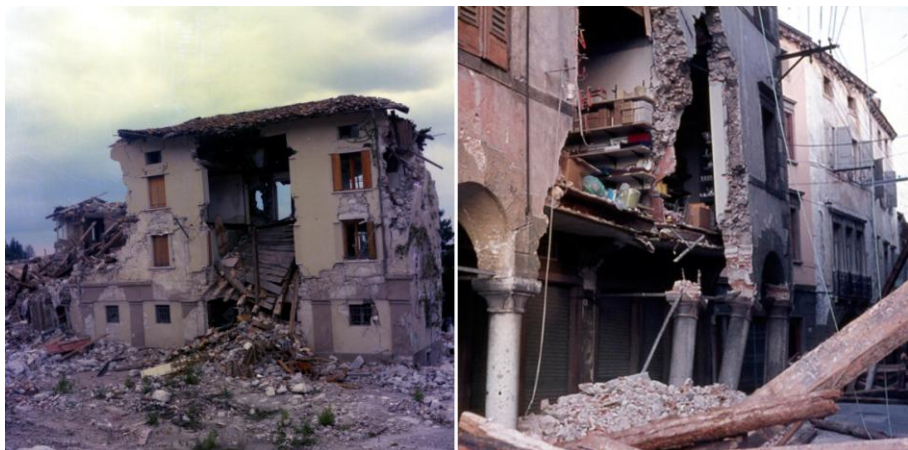
Fig. 5 - Damage in the Friuli 1976 earthquake.
