A STRUCTURAL PARADOX IN THE CHURCH OF THE NATIVITY: FE STATIC ANALYSES

Keywords: masonry church, collapse of a column, vertical loads, static non-linear analyses, arches.

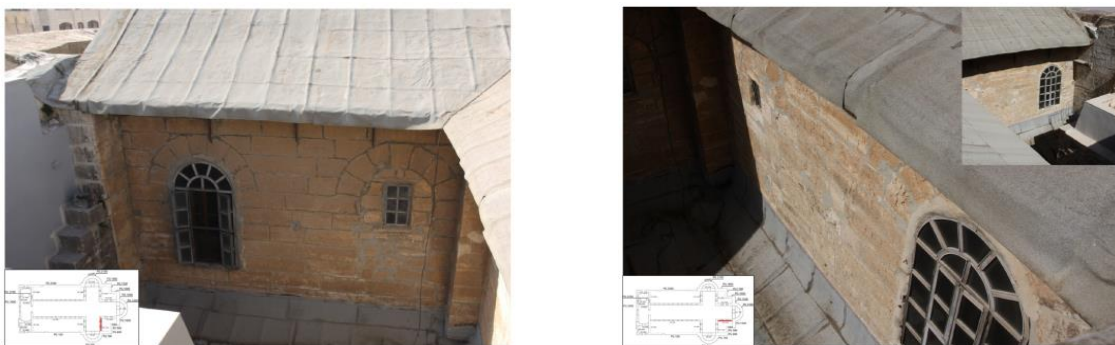
Figure 5: Walls of the corners.

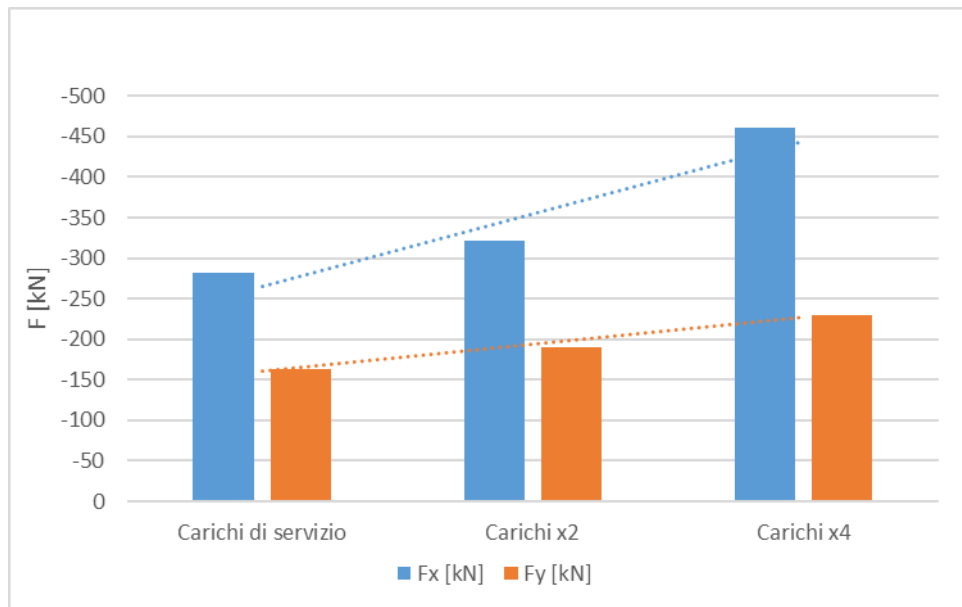
Figure 12: Thrust components in the arch along the nave. Constant basic friction coefficients.

The thrust components in the nave direction are greater than those in the transept direction because the arches along the nave cover a longer span. Moreover, both these components are much greater than the vertical components because exerted by lowered arches. Obviously, both horizontal and vertical components increase with increasing external loads. The load values obtained by multiplying by 2 the basic loads are very close to those indicated by the Technical Norms for incipient collapse (Ultimate Limit State - ULS). The resultant of the horizontal components corresponding to such loads is 400 kN approximately.

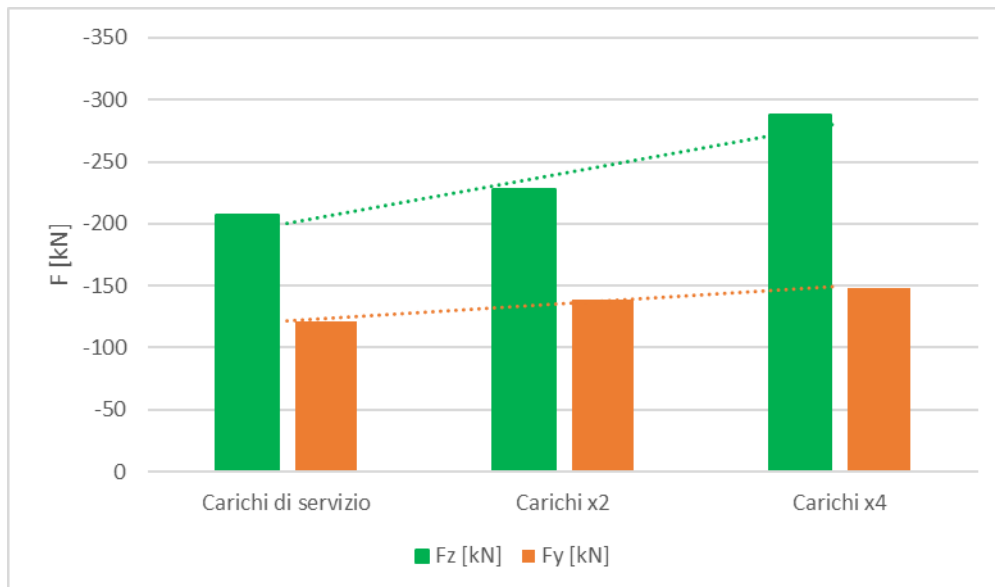
Figure 13: Thrust components in the arch along the transept. Constant basic friction coefficient.

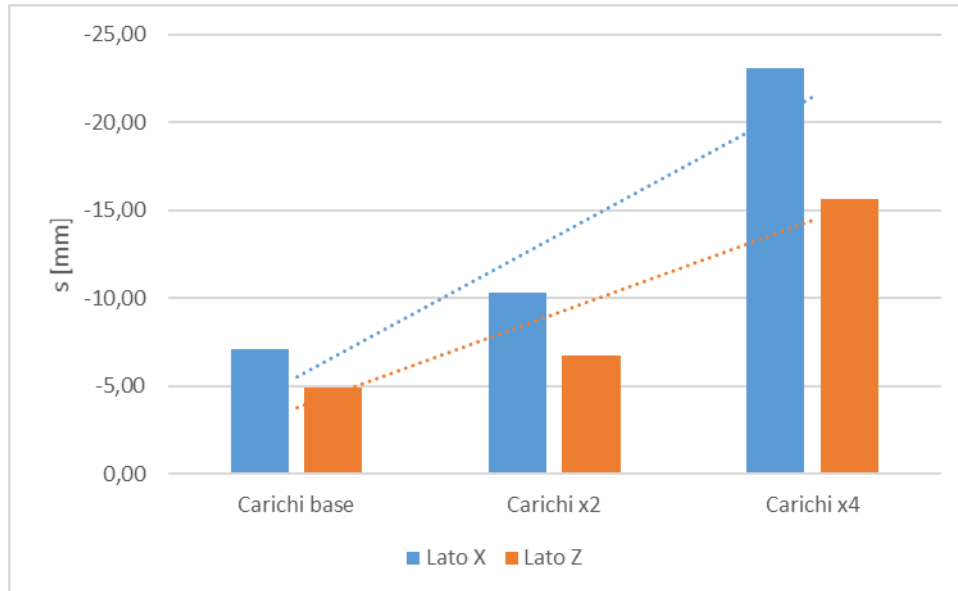
Figure 16: Maximum displacements with increasing loads and constant basic friction coefficients.

It is worth noting that these displacements vary considerably by increasing the loads, i.e from 5.4 mm to nearly 23 mm in the arch along the nave and from 5 mm to nearly 16 mm in the arch along the transept. Such values might seem too high at a first sight but they correspond to a progressive damage of the above masonry walls, as shown in the following Section. Moreover, they probably occurred in reality because of the low quality of the filling material between arch and lintel, as shown in Figure 18.

Moreover, passing from the 2nd to the 3rd load condition the vertical displacement increases abruptly, more than the double in both nave and transept direction. That means that the 2nd load condition, or other load conditions between the 2nd and the 3rd, can be considered as corresponding to an incipient collapse. That also means that with these loads the masonry walls above the lintels undergo a considerable damage before finding a new state of equilibrium, as will be shown in the following.

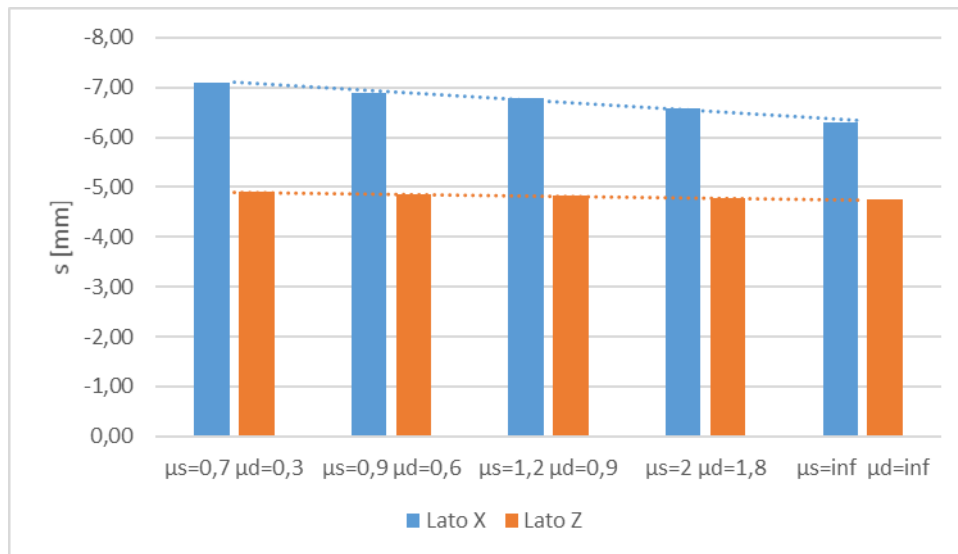
Figure 17: Maximum displacements with increasing friction coefficients and constant basic loads.

On the contrary, the increase of the friction coefficients causes a decrease of the maximum vertical displacements, as was expected, and this decrease is very small, less than 1 mm in the arch along the nave and nearly 0.1 mm in the arch along the transept.

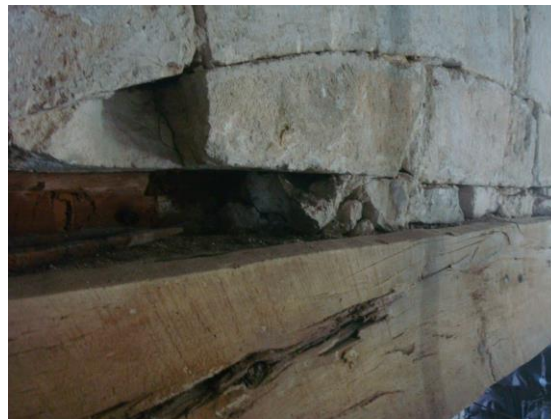
Figure 18: Filling material between relieving arch and lintel.

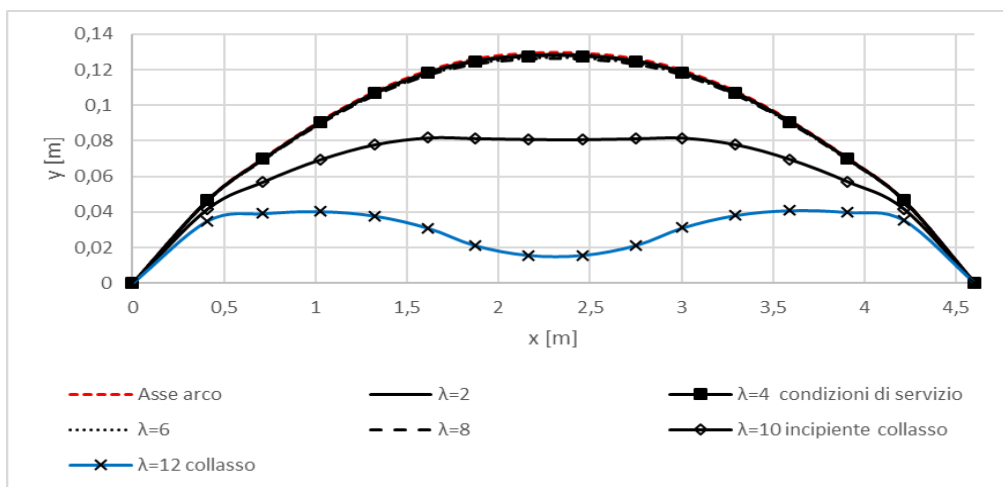
Figure 22: Deformed arch at variable values of λ multipliers

Figure 22 shows the deformation of the centre line of the arch at increasing values of the λ multipliers. For $\lambda = 8$, the double of the basic loads, i.e. the loads corresponding approximately to the Ultimate Limit State according to the Technical Norms, the arch is very close to the incipient collapse which occurs for $\lambda=10$ or for λ values slightly lower. It is worth noting that a displacement $U=10$ mm is here achieved for $\lambda=12$, far beyond the ULS load condition and when the clamped arch has already collapsed, whereas the same displacement in the global model with one sliding support and basic friction coefficients is already achieved with loads approximately close to the ULS condition. Therefore, it is possible to state that with the 2nd load condition in the global model, i.e. loads multiplied by 2 and corresponding to the ULS

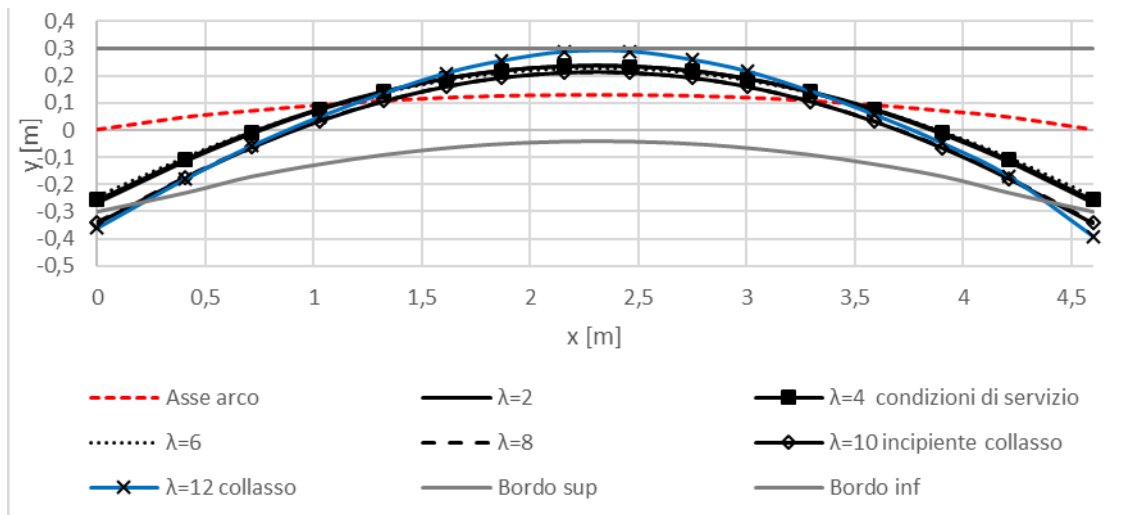
Figure 24: Lines of thrust for variable λ .

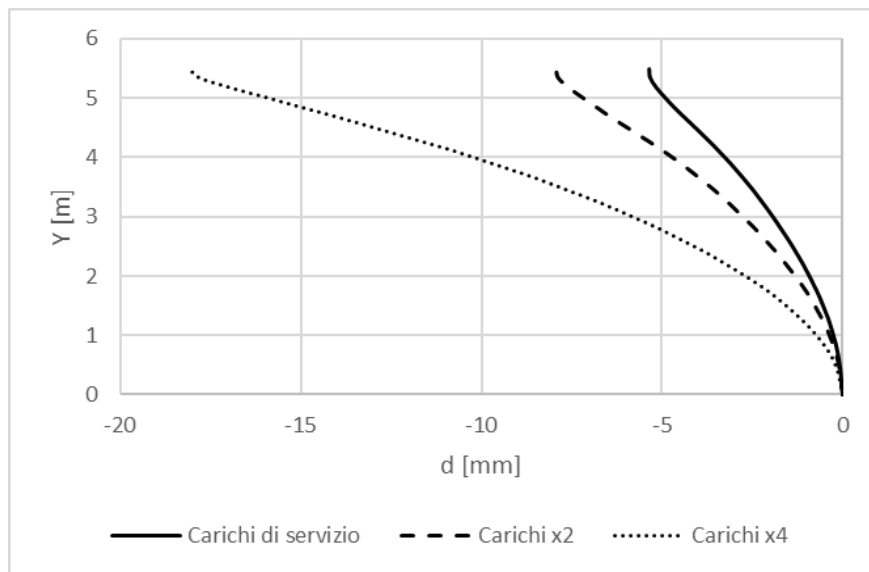
Figure 28: Resultant horizontal displacements along the axis of the column.

Figure 28 shows the resultant displacements of the vertical axis of the column obtained by the composition of X and Z displacement components and referred to basic friction coefficients and increasing loads.

It is worth noting that for loads multiplied by 2, i.e. ULS load condition, the resultant horizontal displacement on the top of the column is just over 5 mm, whereas it increases considerably for greater loads. On the contrary, such displacements do not change a lot with increasing values of the friction coefficients, as shown in Figure 29 where the resultant horizontal displacements are computed for constant basic load conditions and variable friction coefficients. The difference between the maximum displacements referred to basic friction and infinite friction is less than 1 mm. It means that the particular conditions at the interfaces do not affect considerably the behaviour of the column and that, in the end, the maximum horizontal displacements of the column are contained within a very small range of values.
