Energy efficiency and preservation of 20th century architecture

The case of the Urbino University Colleges

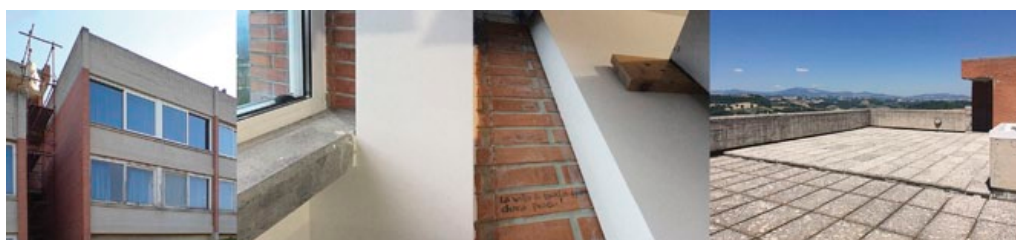
Figure 8. After the pilot site, from left to right: new window, “cold wall” insulation, slab cover.

A pilot site (12/2016–1/2017) implemented the best combination: scenario D (wall and roof slab) + scenario 2 (windows) in rooms B6a and B6b (Figure 7). However, during the pilot site some decisions were reconsidered. The concrete parapet on the top of the building could not be raised up and consequently, for safety reasons, the new slab insulation could not be thicker than 8 cm. An insulating panel was applied to the inner side of the perimeter wall but the panels had to be cut 20 cm before the window, in order to not have them visible from the outside. These limitations clearly resulted into weaknesses in terms of energy efficiency (Figure 8).
