# Fatigue life and damage tolerance of postbuckled composite stiffened structures with indentation damage

Journal of Composite Materials

The fatigue life and damage tolerance of composite stiffened panels with indentation damage are investigated experimentally using single-stringer compression specimens. The indentation damage was induced to one of the two flanges of the stringer of every panel. The advantages of indentation compared to impact are the simplicity of application, less dependence on boundary conditions, better controllability, and repeatability of the imparted damage. The tests were conducted using advanced instrumentation, including digital image correlation, passive thermography, and in situ ultrasonic scanning. Specimens with initial indentation damage ranging between 32 and 56 mm in length were tested quasi-statically and in fatigue, and the effects of cyclic load amplitude and damage size were studied. A means of comparison of the damage propagation rates and collapse loads based on a stress intensity measure and the Paris law is proposed. The stress intensity measure provides the means to compare the collapse loads of specimens with different damage types and

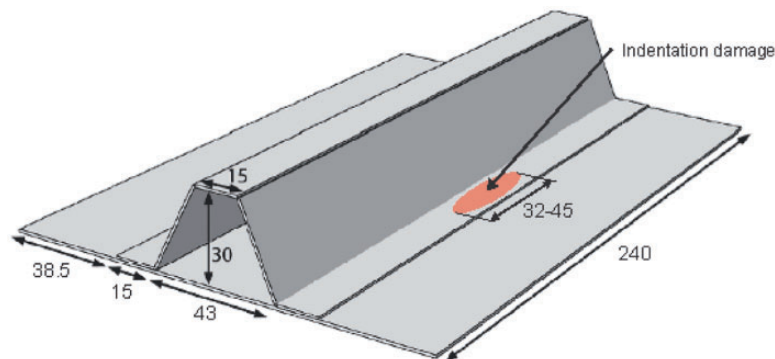
**Figure 1.** Single-stringer compression specimen (all dimensions in millimeter).

The SSC specimen is composed of a skin and a hat-shaped stringer. The dimensions of the test section of the specimen are shown in Figure 1. The skin consists of an eight-ply quasi-isotropic laminate with a stacking sequence of  $[45^\circ/90^\circ/-45^\circ/0^\circ]_S$  and a total thickness of 1 mm. The stringer consists of a seven-ply laminate with a symmetric stacking sequence of  $[-45^\circ/0^\circ/45^\circ/0^\circ/45^\circ/0^\circ/-45^\circ]$ , which results in a nominal thickness of 0.875 mm. The skin and stringer are cocured in an autoclave and the material is IM7/8552 prepreg tape. Tabs for load introduction are potted and machined at the ends of the specimen after the curing cycle. A more detailed description of the SSC specimen can be found in the literature.<sup>12–16</sup>

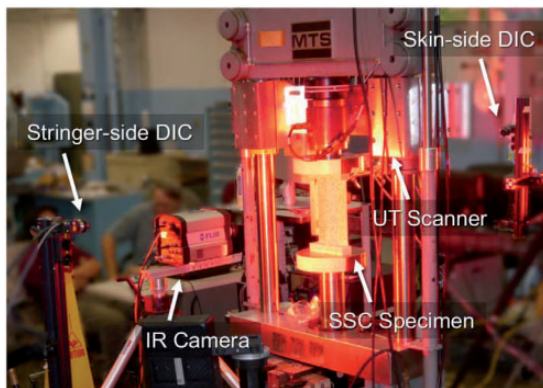
**Figure 8.** SSC specimen, load frame, and test instrumentation.

The tests were conducted using a uniaxial test frame and with instrumentation that allows a precise evaluation of the postbuckling response and damage. The test frame and the instrumentation shown in Figure 8 is the same as used in the previous test campaign conducted on SSC specimens with Teflon films and described in Dávila and Bisagni.<sup>16</sup> The primary instrumentation consists of (i) two three-dimensional digital image correlation (VIC-3D) systems<sup>18</sup> that are used to measure the postbuckling full-field deformations and strains on the skin and stringer sides of the specimen, (ii) an infrared camera for the passive thermal monitoring<sup>19</sup> with a frame rate of 60 Hz that can track the position of a delamination front during fatigue cycling, and (iii) an in situ UT scanner<sup>20</sup> mounted on the load frame which is used to obtain detailed measurements of the damage. The digital image correlation system acquired images at a rate of 0.2 Hz, the infrared camera at 60 Hz,

and the UT scanner at selected intervals. Finally, two back-to-back pairs of strain gauges placed on the skin near the top of the specimen were used to ensure that the load introduction platen was properly aligned.

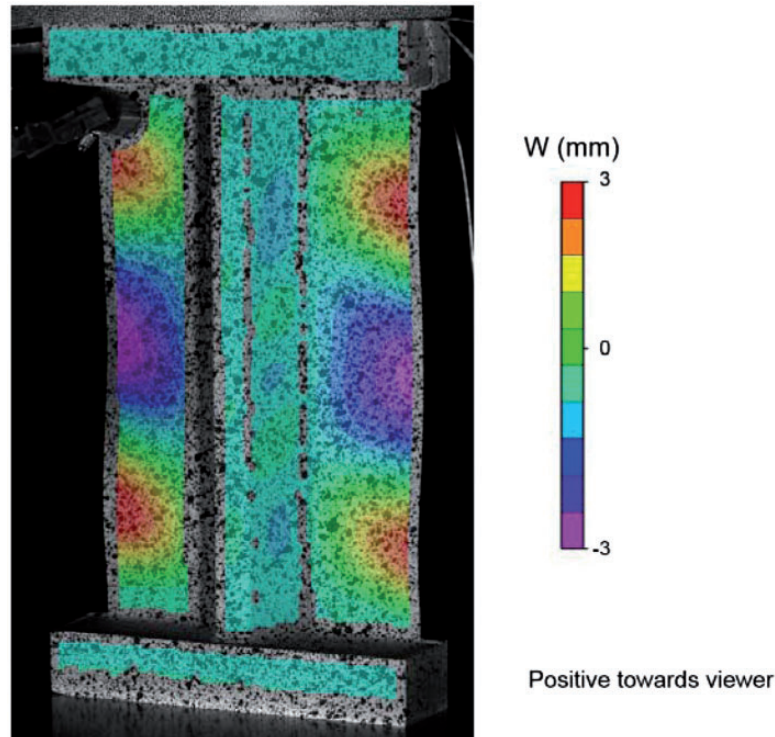
**Figure 9.** Out-of-plane displacement during quasi-static test of specimen SSCS-2 taken with VIC-3D from stiffener side immediately before collapse (34.5 kN).

The postbuckling deformation was characterized by a mode composed of three half waves along the length in the skin on both sides of the stiffener. The deformation at a load of 34.5 kN immediately before collapse is shown in Figure 9 using the out-of-plane displacements measured by the digital image correlation system. The deformation was symmetric with respect to two orthogonal planes and no damage was detected. The maximum amplitudes of the out-of-plane displacements at the center of the free edges were approximately 3 mm in the direction opposite to the viewer. The specimen collapsed suddenly, and the failure was characterized by a separation of the stringer from the

skin at the mid-length. The collapse load magnitude of 34.5 kN was used as an upper bound when determining the loads at which the fatigue tests were run.

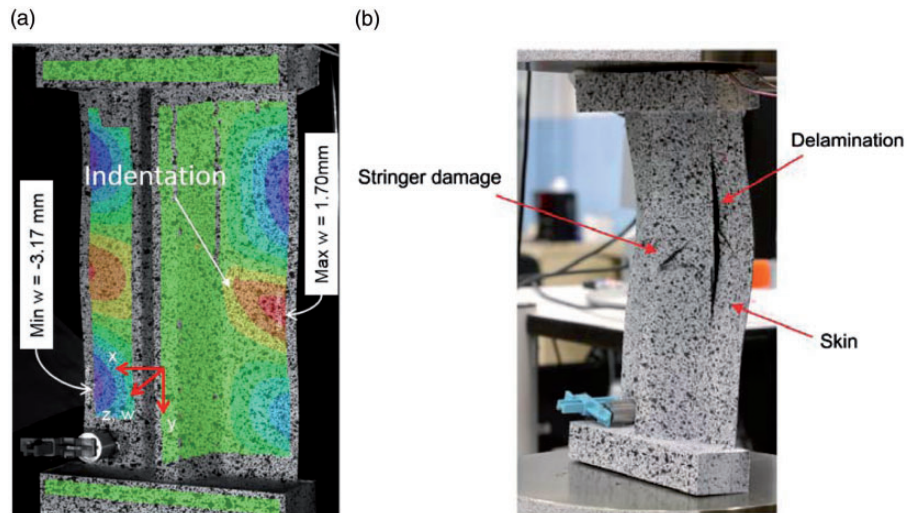
**Figure 10.** Fatigue and posttest assessment of specimen SSCS-1: (a) deformation at 96,000 cycles and (b) after collapse.

An image captured by the digital image correlation system on the skin side of a typical panel (SSCS-1) after 96,000 load cycles is shown in Figure 10(a). When subjected to a load of 31.1 kN, the maximum out-of-plane displacement is equal to 3.42 mm in the direction opposite to the stringer and 1.79 mm in the direction of the stringer. It can be observed that the deformation is similar to that for panel SSCS-2 but of opposite amplitude. Differences in the postbuckling response of two nominally identical specimens are common and attributable to small differences in the initial imperfections of the panels and, possibly, to minute differences in the alignment of the specimen in the test platens. Therefore, it is extremely difficult to predict the mode that will develop in a particular panel.

Specimen SSCS-1 failed suddenly at 117,506 cycles as a consequence of an unstable delamination between the skin and both stringer flanges. The posttest deformation is shown in Figure 10(b), where it can be observed that there is separation at the skin-stringer interface and crippling damage in the stringer.

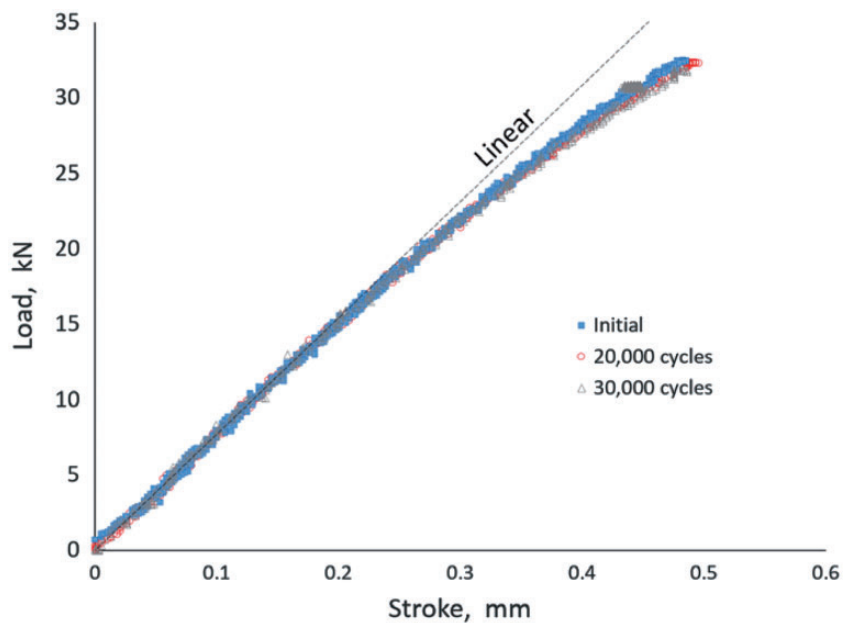
**Figure 11.** Quasi-static load-stroke curves at three stages of the fatigue life of specimen SSCS-5.

Quasi-static load-shortening curves for specimen SSCS-5 are shown in Figure 11, which is representative of what was observed for all specimens. It can be seen that the initial response is nearly identical to that at

20,000 and 30,000 cycles. Clearly, the global response of the SSC specimens retains a constant nonlinearity and is only mildly affected by the progression of fatigue damage. The specimen collapsed at 33,623 cycles.
