DIAGNOSTIC INVESTIGATIONS AND STRUCTURAL HEALTH STATE ASSESSMENT OF SAN PIETRO BELL TOWER IN PERUGIA

P.F. Giordano¹, F. Ubertini², N. Cavalagli², A. Kita², L.F. Ramos³, M.G. Masciotta³

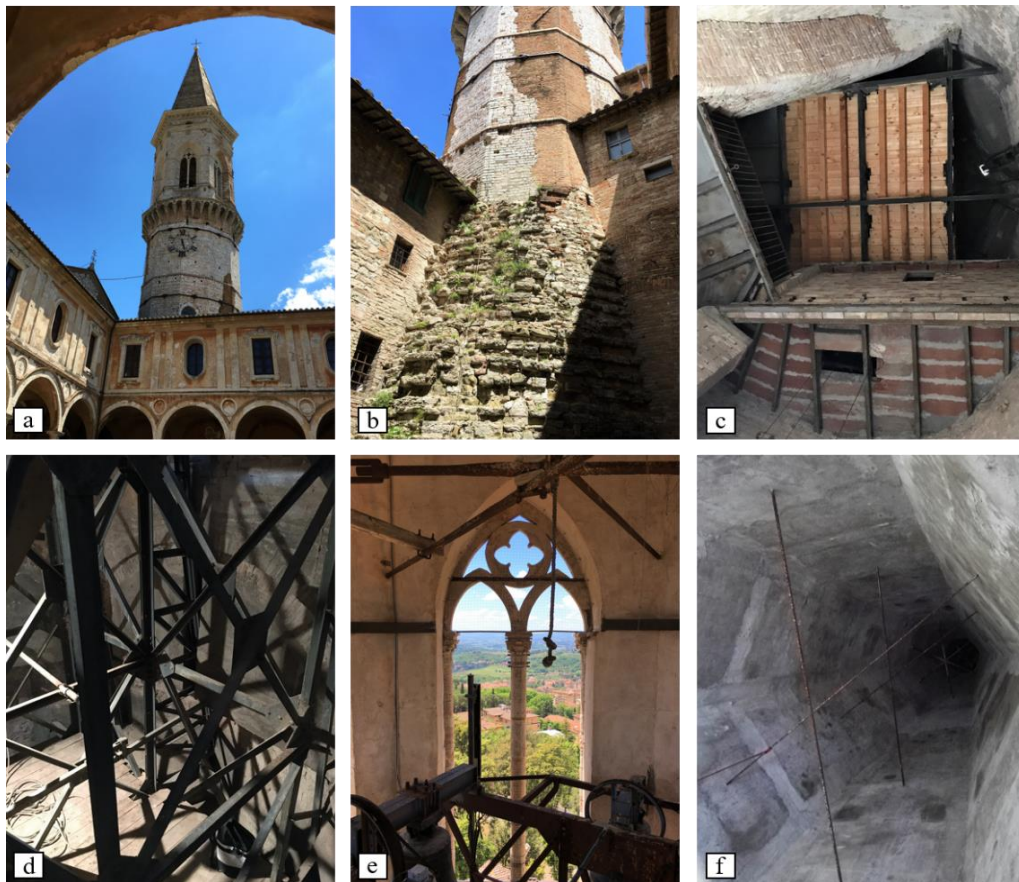
The tower is 61.45 m high and can be subdivided in four main parts, namely (1) basement; (2) shaft; (3) belfry; and (4) cusp, see Figure 2. The basement has a truncated dodecagonal pyramid shape and a height of 8 m. It is characterized by massive stone walls, with thickness ranging roughly from 2 m to 3.5 m. Inside, the basement consists of a semispherical dome of 6 m diameter. The external leaves of the basement are made of irregular travertine blocks. The shaft rests on the basement, at a height of 4.5 m from the ground, has a dodecagonal cross section and reaches a height of 27 m. The average thickness of the walls is 1.8 m. The outer leaf is made of limestone blocks and brick insertions. Inside, the structure is particularly complex, but it can be subdivided into two spaces. The lower room consists of a second hemispherical vault. The second room is located at a height of 11.6 m and occupies the remaining volume of the shaft. Here, the metal structure supporting the bells rises. The materials used for the internal structure are strongly inhomogeneous. The walls are mostly made of limestone masonry, while arches and vaults are made of bricks. Some concrete elements are present as well. A concrete floor separates the shaft from the belfry. The belfry has a hexagonal shape and rises up to a height of 41 m. The thickness of the walls decreases to 1.2 m. The lower part of the belfry is pierced by six openings. Likewise, large mullioned windows characterize the upper part. Here, the materials are travertine and brick masonry. The cusp completes the bell tower on top, reaching a total height of 61.5 m. It has the shape of a hexagonal pyramid and thickness of 1 m. Concerning the materials, the last 6 m are composed by a solid masonry block, featuring a cusp mainly made of travertine with an external brick layer.

Figure 2: San Pietro bell tower: a) North-West side of the tower; b) Basement; c) Interior of the tower; d) Metal structure supporting the bells; e) One of the mullioned window; f) Interior of the cusp.

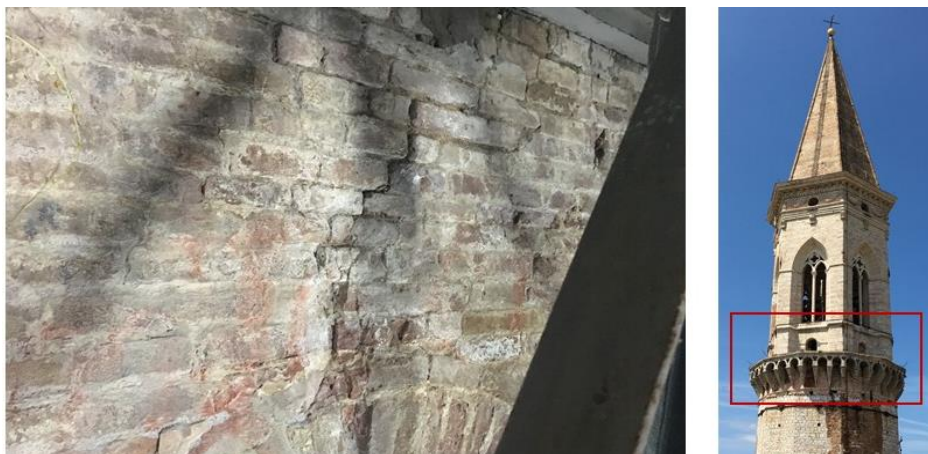
Globally, the bell tower appears to be in good state of conservation from the structural point of view. Major damages due to the last earthquakes are not clearly recognizable. Nevertheless, some thin cracks can be found in the lower portion of the belfry, in correspondence to the masonry arches above the lower windows, as shown in Figure 3, that are consistent with the diffused damaging expected from numerical simulations [2]. The good seismic behavior may be attributed to the extensive insertions of FRP materials executed during the last restoration works [4].

Figure 3: Cracks in the lower part of the belfry.

- Concerning the visual survey, the monument appears in good state of conservation. However, some thin cracks are found in the lower portion of the belfry. The geometrical survey of the metal structure supporting the bells was carried out.

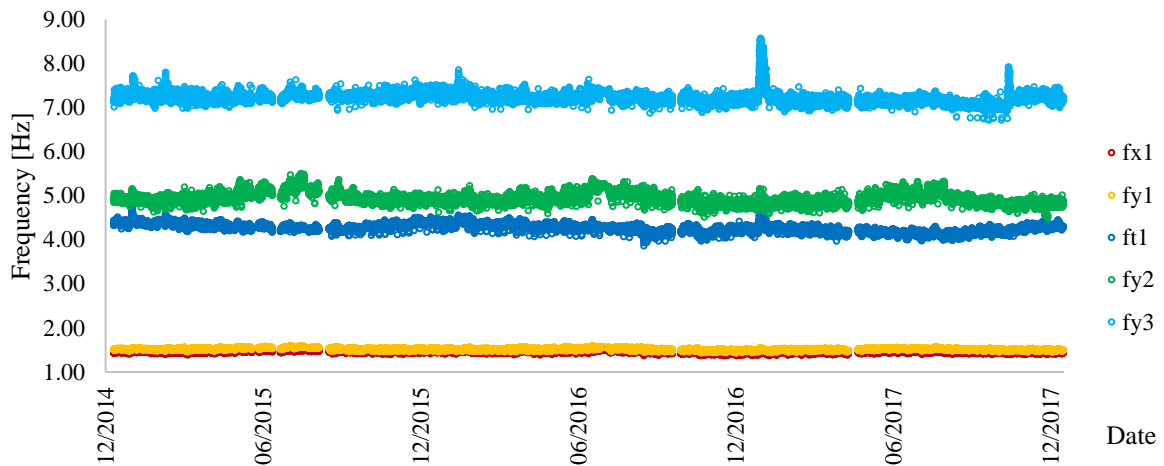
The long-term monitoring data concern natural frequencies, air and surface temperatures, and air humidity. Five modes are continuously tracked in operational conditions by means of a fully automated SSI technique: the first two bending modes f_{x1} and f_{y1} , the third torsional mode f_{t1} and the other two modes in the Y direction, f_{y2} and f_{y3} . Data related to frequencies are available since December 2014 while environmental data are available since March 2015. The plot of the identified frequencies over time is presented in Figure 8. The reader is referred to [12] for an exhaustive analysis of hygrothermal effects on natural frequencies. In this paper, sensors T_2 , T_3 , T_5 , T_7 , T_8 , H_5 are taken into account. Long-term records are subdivided

Figure 8: Identified natural frequencies over time.

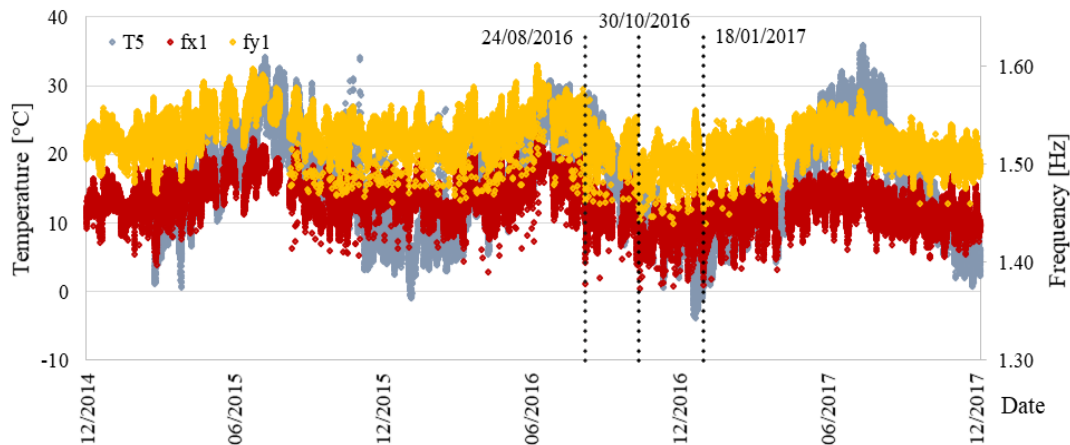
Figure 9: Time history plots of temperature T₅ and frequencies f_{x1} and f_{y1}.

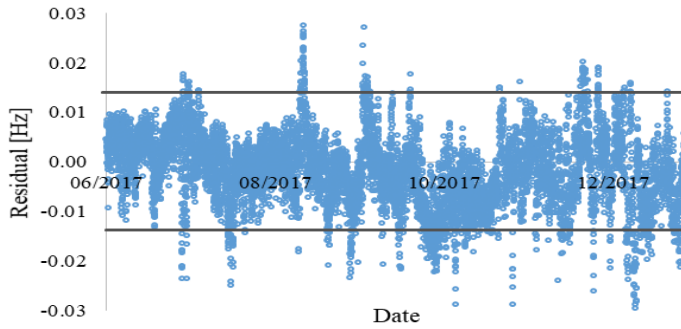
Figure 15: Time plot of identified and predicted frequency f_{y1} .

Figure 16: Plot of residuals between identified and predicted frequency f_{y1} .

Figure 17: Experimental frequency f_{y1} versus the simulated one.
