Seismic Structural Health Monitoring in some European countries

This paper compiles and describes the national initiatives and projects on seismic Structural Health Monitoring (SHM) active in a number of European countries. Sensors networks and typical layouts, data processing techniques and policies adopted for the management of alerts are described for the different national programs. The different policies adopted for the access to data are also described. For the different countries applications to buildings, bridges or cultural heritage constructions are used to describe in detail the SHM systems installed in Italy, France, Greece and Portugal.

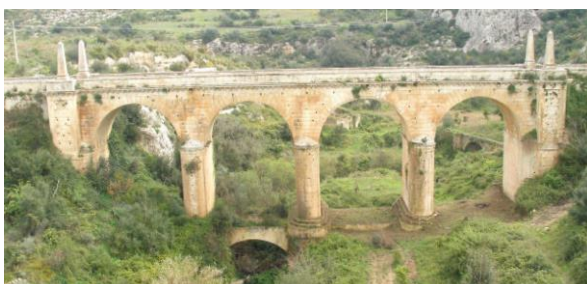
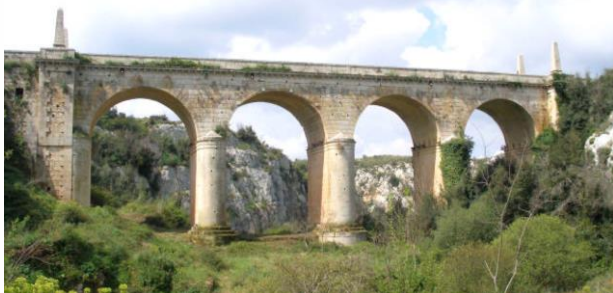
Figure 2- Santa Chiara bridge: general view (left) - sensor layout (right)

Each of the civil structures belonging to OSS is equipped with a number of Force-Balance Accelerometers (FBA) for measuring and recording the seismic dynamic response of that structure to both weak and strong earthquakes. The working range of accelerometers is set according to local seismic hazard. Typically either ± 0.5 g (g is the gravity acceleration) or ± 1.0 g range is chosen for accelerometers on the ground and, correspondingly, either ± 1.0 g or ± 2.0 g range for accelerometers on the structure, to account for structural dynamic amplification. All systems acquire continuous data and store it in a temporary memory. When at least 70% of the signals exceeds a predetermined amplitude threshold, generally 0.001 g, the data are copied to a permanent memory and immediately sent to the DPC server through a dedicated internet connection. The typical sample rates for digitizing is 200 and 250 Hz. Regarding the number and position of the sensors installed, for buildings it is possible to identify some general criteria underlying the choices made in the system design, so that well defined types of systems can be identified. For bridges and dams the design of the accelerometers' layout is performed ad hoc for each specific case. In Figure 2 (left side) a general view of the "Santa Chiara" arch masonry bridge (Noto - Sicily) is shown and the sensor layout is presented on the right side of the same figure. The sensor layout (represented as black arrows) has been designed for monitoring both the lateral vibration of the piers and the vertical and lateral vibrations of the arches.

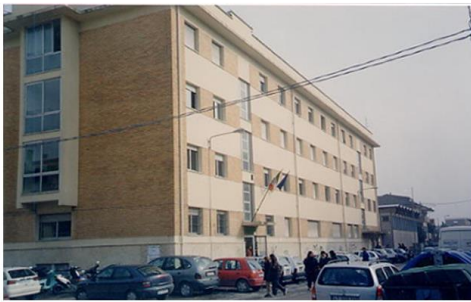
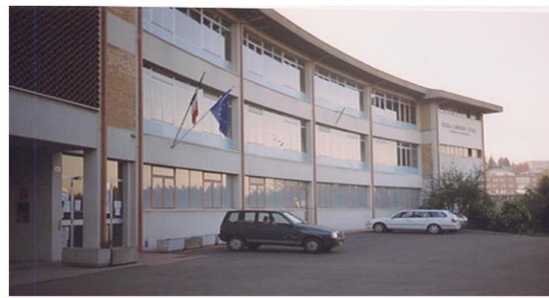
Figure 3 – Sensor system configuration and general view of a regular RC building (Industrial Technical Institute of Rimini, on the left side) and of an irregular one (Elementary school of Cesena, on the right side).

In the case of buildings, two different types of monitoring systems can be fundamentally distinguished: the "complete" and the "simplified" system. The complete systems, deployed in 129 buildings, are equipped with a three-axis accelerometer installed at the ground level plus a number of uniaxial accelerometers per floor sufficient to completely describe its seismic behavior, according to some rational reasonable kinematic assumptions. In the case of regular reinforced concrete buildings, as the one shown in Figure 3 on the left side, the rigid floor assumption allows to measure only three components of acceleration per floor (black arrows in the figure). For complex buildings, (e.g. the one in Figure 3 on the right), more components for floor are needed in order to properly represent the dynamic behavior.

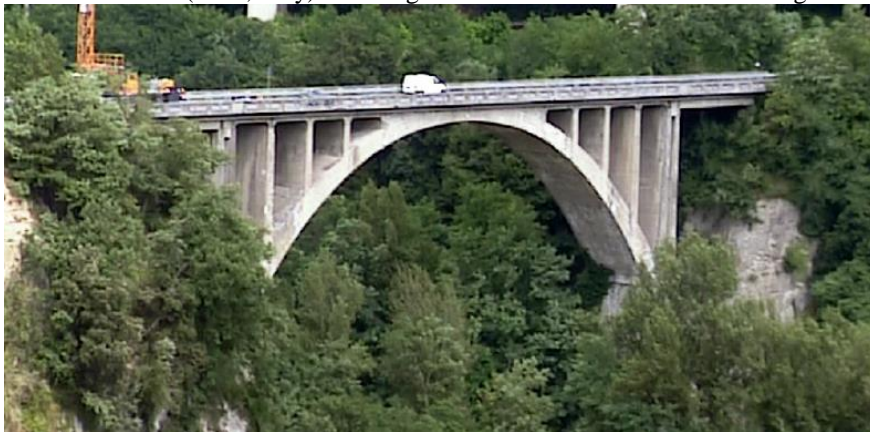
Figure 7. The Zingone bridge

Data recorded by the OSS are available on request and can be used for scientific purposes. In the following are reported some examples. The first one concerns data recorded on the Zingone Bridge (Figure 7), a fixed arch reinforced concrete bridge located in Mercato Saraceno (Forli, Italy) featuring a reinforced concrete of 54.9m length with a rise of 15.6m.

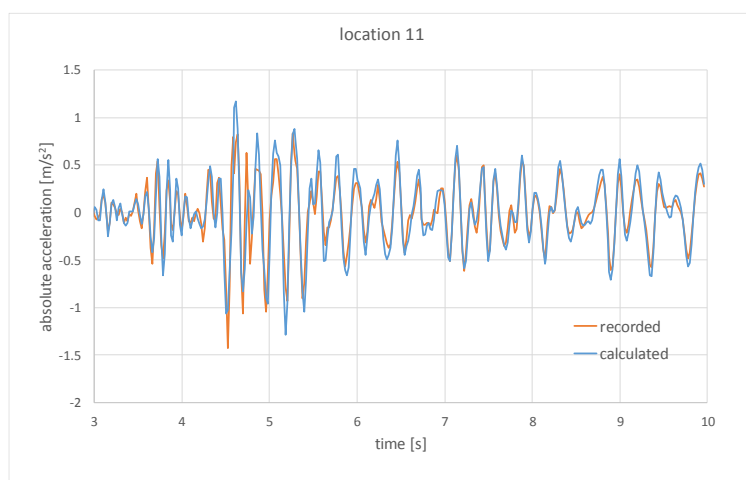
Figure 9. Zingone bridge: comparison of recorded and calculated accelerations

In reference (Limongelli 2004) earthquake data recorded during the San Leo-Novafeltria earthquake (August 1, 2000) on the Zingone bridge were used to check a technique to reconstruct seismic responses at locations not equipped with sensors. The technique is used, jointly with a criteria based on modal filtering (Limongelli 2003), to optimally locate a limited number of recording sensors for damage detection purposes. In

Figure 9 is reported the comparison between the recorded accelerations and the accelerations calculated using responses of a limited number of sensors at the optimal locations.

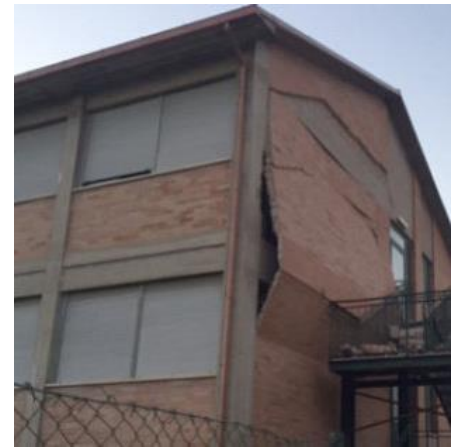
Figure 10. a) Norcia school. Sensor's layout; b) damages after August 2016 earthquake

The second example is the Norcia School that, since 2002 is monitored by the OSS with the network of accelerometers shown in Figure 10. In 2010, was strengthened with dissipative braces in the longitudinal and transversal directions and in August 2016 was struck by the Central Italy earthquake. Between 2002 and 2017 several earthquakes have been recorded by the OSS sensors. In Figure 10b and Figure 11a and b are reported some of the damages to non structural elements after the 2016 earthquakes.

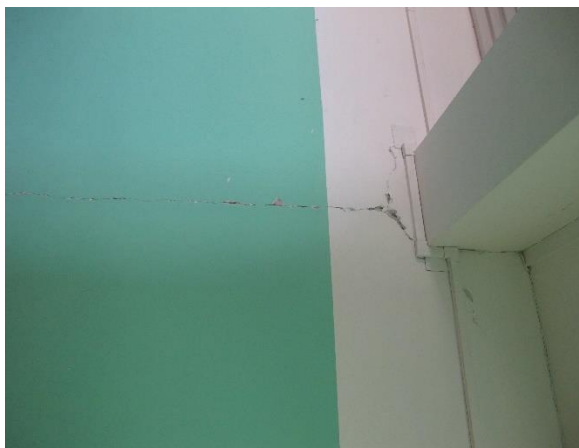
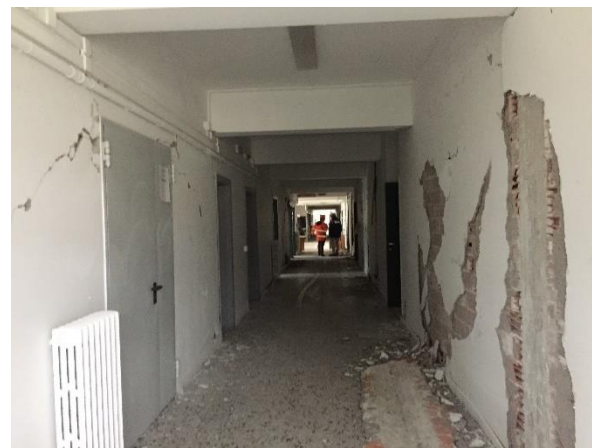
a) August 24, 2016

b) November 3, 2016

Figure 11. Damages to non structural elements during the earthquakes in 2016

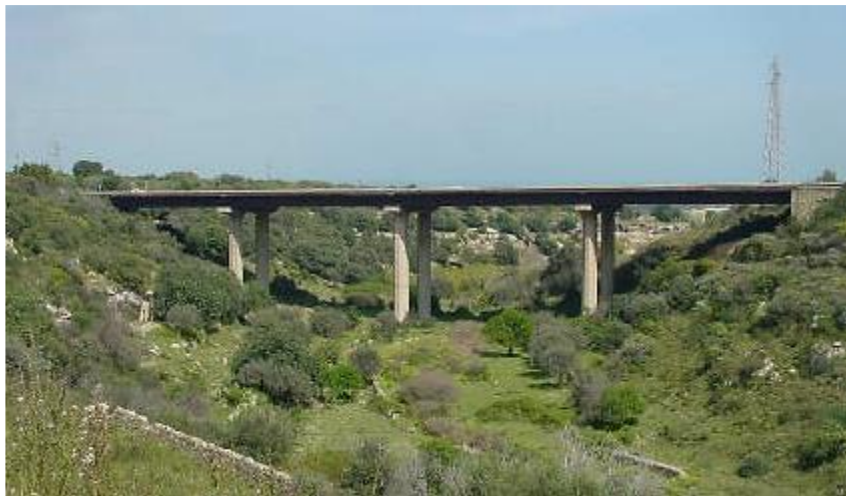
Figure 13. West side elevation of the Cusumano bridge

A further example is relevant to the Cusumano bridge (Figure 13), located near Prioro Gargallo, in Sicily. Data recorded by the OSS enabled the calibration of a numerical model of the bridge. This model has been used to apply a pre-posterior Bayesian analyses for the computation of the Value of the Information retrieved by the network of sensors for the seismic emergency management of the bridge (Giordano et al.).

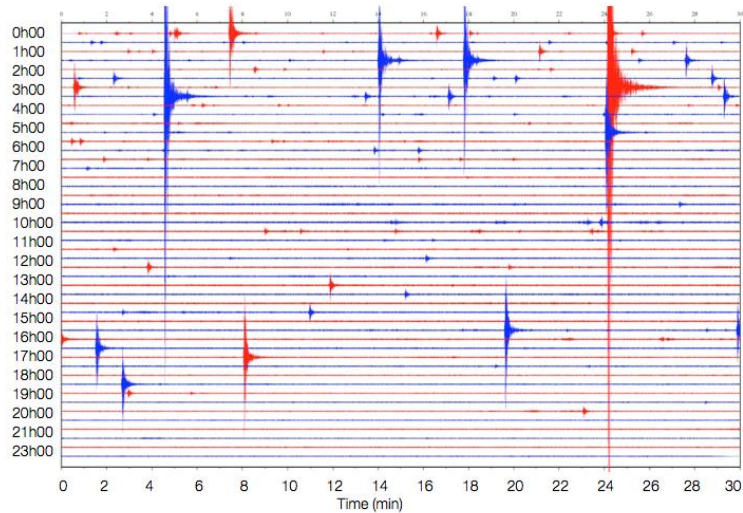
Figure 16. 24-hours recording at the bottom of Ophite tower during a seismic sequence in 2012.

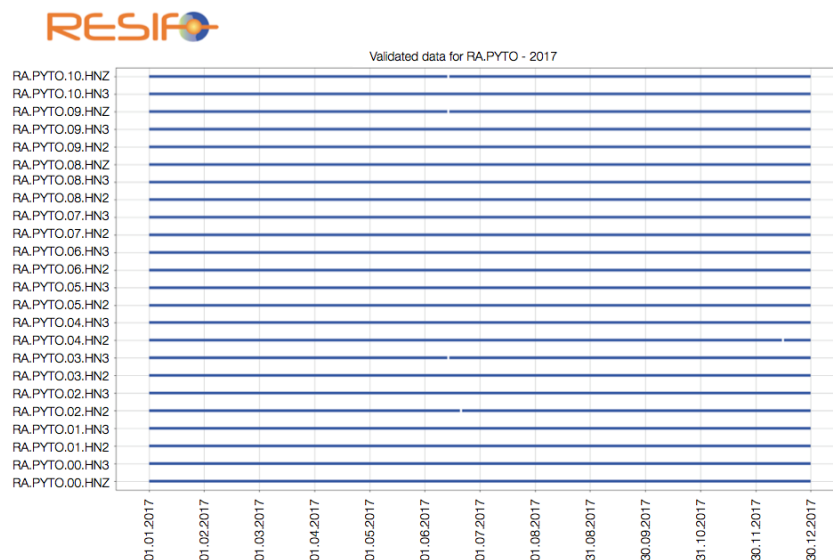
Figure 18. Example of data continuity from the 24 acquisition channels of the PYTO building for 2017.

Each station transfers its data in real time directly to the RAP-DC via a SEEDLINK protocol on a ring buffer. The data are then pushed to the RESIF-DC after verification and a first level quality control. Some data quality (such as noise level) is processed automatically and can be viewed on-line on the RESIF portal. Figure 18 shows an example of data continuity from the PYTO station after this quality check.

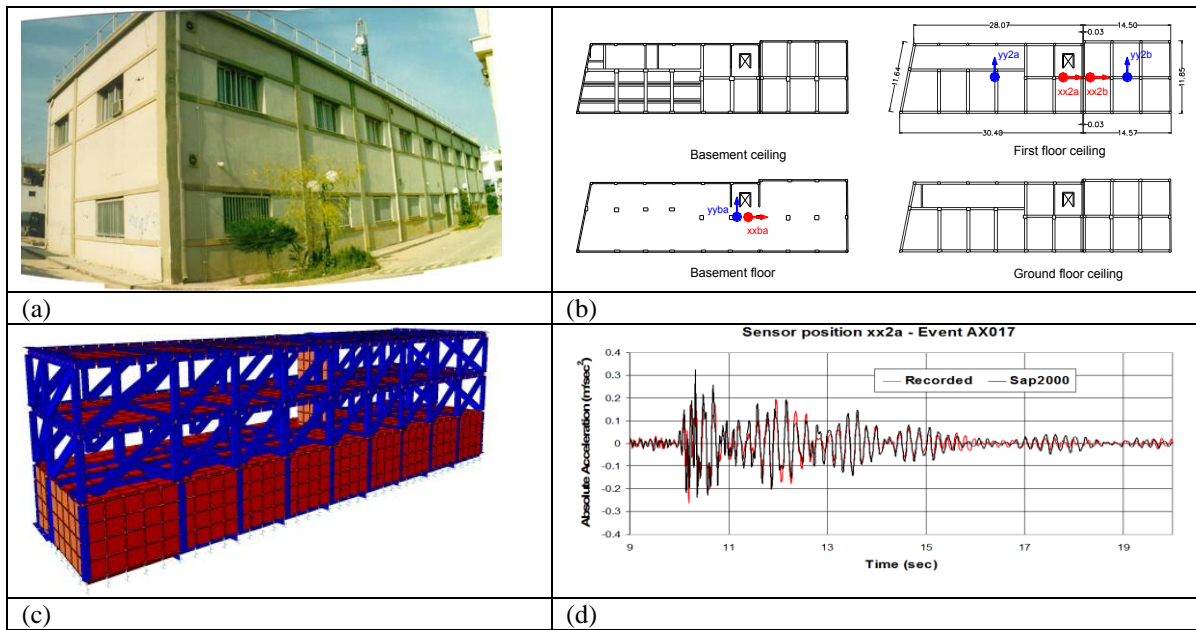
Figure 19. (a) OTE building at Ano Liosia (b) instrumentation layout (c) F.E. model (d) predicted vs recorded response (updated model, longitudinal direction).

Two of the most intense recorded aftershock (of the order of 20-40 mg) were used to identify the dynamic properties of the building, using a custom software developed by the Department of Mechanical and Industrial Engineering of the University of Thessaly, Greece. The experimental results were used to properly calibrate the finite element model of the building (Figure 19c). The soil compliance was modelled through Winkler springs, with values of the spring constants corresponding to a dynamic behavior (i.e. almost an order of magnitude bigger than the static value). The values of the Winkler springs constants, recovered through a parametric investigation, allowed to obtain a good match between recorded and calculated accelerations, especially in the longitudinal direction. In Figure 19d is reported the comparison at the location of one of the sensors. For either parts of the building, the peak relative displacement computed from recorded accelerations exhibited values far lower than the dimension of the existing expansion joint. This is a strong indication that no pounding took place, at least for the examined events. A further indication towards this conclusion is the fact that the calibrated analytical model, in which no pounding simulation capabilities were provided, accurately described the recorded response.

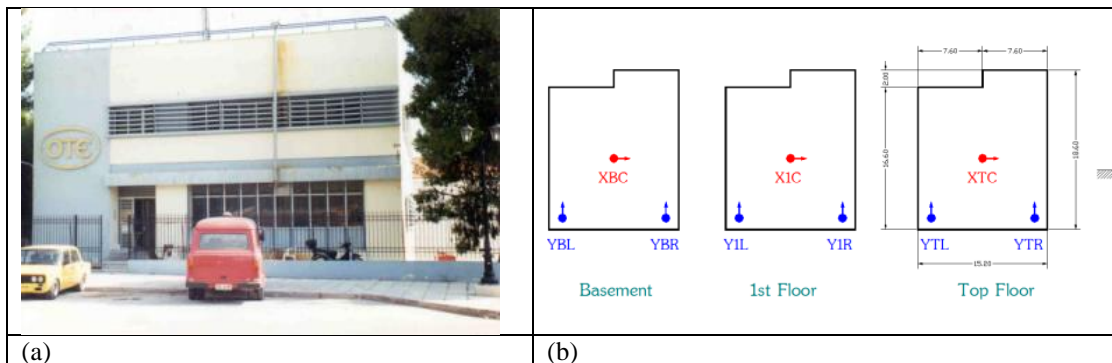
Figure 20. (a) OTE building at Thrakonakedones (b) instrumentation layout

OTE building, Thrakomakedones, Athens. For two weeks after the Ano Liosia earthquake, ITSAK monitored the seismic behavior of a respective (OTE) building (Figure 20a) in the municipality of Thrakomakedones, in the meizoseismal area. Damage due to the mainshock was limited to cracking at some of the interior infill brick walls, whereas the R/C load bearing system was unharmed. The same structural array was used, with nine sensors and 200sps sampling rate (Figure 20b). The selection of the particular configuration of the sensors aimed at the detection of the higher modes of the building, as well as at the detection of possible differentiations between the recordings of the two parallel sensors YBL and YBR at the basement (Karakostas et al., 2002).

As in the case of Ano Liosia, the identified dynamic parameters were used to update a Finite Element F.E. model of the building. An additional finding was the observable difference between the recordings at the two parallel sensors YBL and YBR deployed at the basement level. Given the small dimensions of the building, a possible cause may be a soil-structure interaction effect between the torsional response of the building superstructure and its foundation. This explanation was partly confirmed by the analytical investigations carried out on the calibrated FE model of the building. A detailed presentation of the experimental and analytical investigations of the two buildings can be found in Karakostas et al., 2002 and Karakostas et al., 2003.

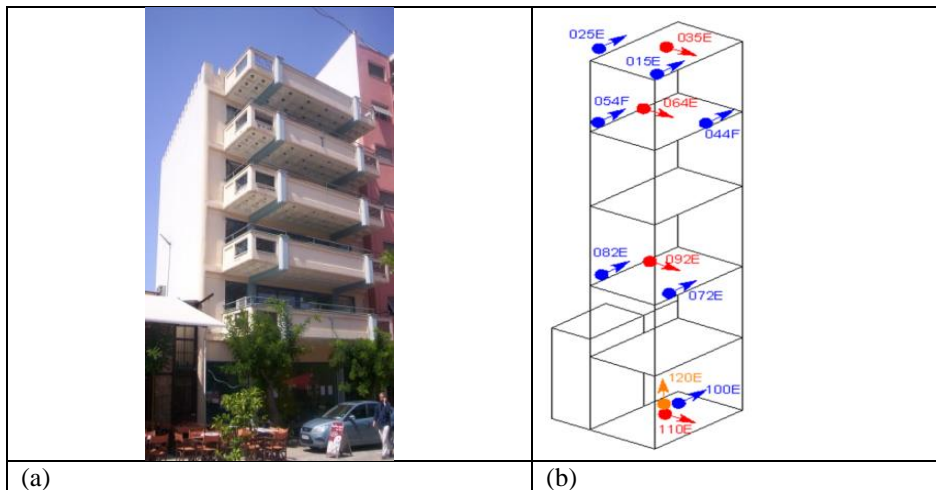
Figure 22. (a) The Technical Chamber of Greece building at Patras (b) instrumentation layout

Technical Chamber of Greece building, Patras. After a M6.5 mainshock on June 6, 2008 at a distance of approximately 35 km southeast of the city of Patras, ITSAK researchers instrumented the five-story R/C building of the Technical Chamber of Greece (Figure 22a). A 19-bit special array was used, together with 12 uniaxial accelerometers and a 200sps sampling rate (Figure 22b).

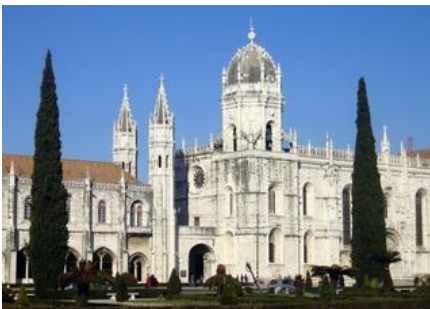
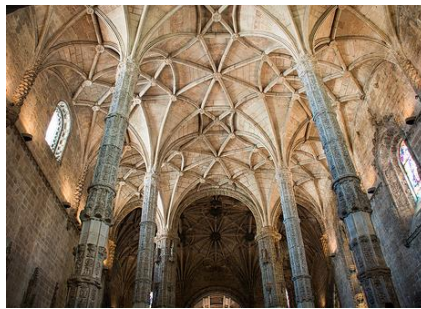
Figure 32 – Church of Jerónimos Monastery: (a) exterior view; (b) nave ribbed vault.

The Church of “*Santa Maria de Belém*” is a limestone masonry structure built during the XVI century and located inside the majestic Monastery of Jerónimos in Lisbon, one of the regions with the highest seismic hazard in Portugal. The church features a cruciform shape with a single nave of 70 m length crossed by a transept of 40 m width, and an average height of 24 m. A single bell tower of 50 m height rises in the corner between south and west façades. Two rows of slender octagonal columns with a free height of 16 m and a radius ranging from 1.04 m to 1.88 m provide support to the barrel vault of the longitudinal limb, allowing to reduce the large free span of the nave (Figure 32) The seismic performance of the structure during the strong earthquake of 1755 was impressive. No severe damage was registered in that occasion in the whole compound. On the contrary, the subsequent shake of 1756 caused the collapse of one of the columns supporting the vaults of the church (with subsequent ruin of the nave) and also the partial collapse of the vault of the higher choir (Lourenço et al. 2007, Masciotta et al., 2016). Following these events, during the XIX century changes were made in the structure of the two towers and in the roof. The effect of these changes on the seismic performance of the structure remained an open issue (Lourenço et al. 2007). Hence, several studies and numerical simulations have been performed in the last decades to investigate the structural behaviour of this church (Lourenço et al. 2007, Oliveira et al. 2005). In addition, to keep under control the health state of the monument and mitigate the seismic risk, a simplified monitoring system has been installed in the church since 2005. The type and location of sensors have been chosen according to the features to be extracted and in conformity with the directions of IGESPAR, former IPPAR (Portuguese Authority for the Architectural Heritage), with the purpose of minimizing the visual impact of the systems in the church (Masciotta et al. 2016).

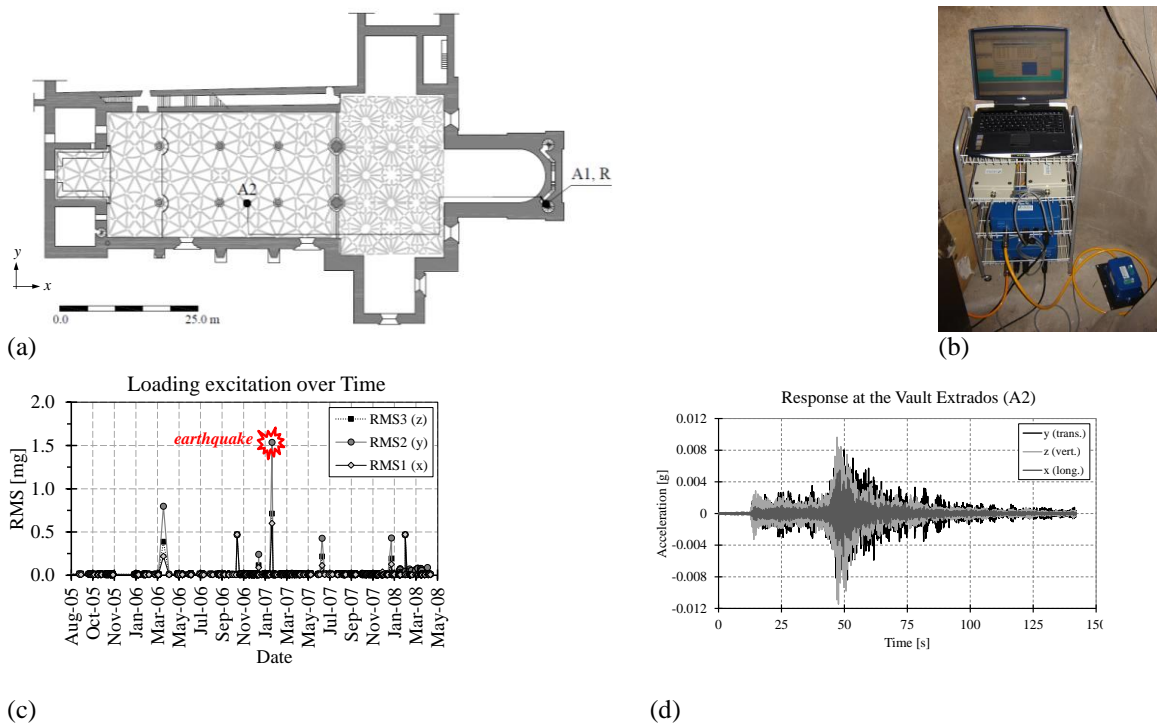
Figure 33 SHM system of the Church of Jerónimos Monastery: (a) sensors location; (b) battery of recorders and accelerometer at the base level; (c) ambient excitation before, during and after the earthquake of 12/02/2007; (d) response of the church at the vault extrados during the seismic event.

The SHM system is composed of two strong motion recorders and two tri-axial force balance accelerometers (Figure 33a-b), one (A1) located at the base of the structure near the chancel and connected to the master recorder, and the other one (A2) installed on the nave extrados and connected to the slave recorder. The recorders are mutually interconnected and synchronized for both triggered and programmed events. A predefined amplitude threshold of 0.5 mg is set in all 3 directions for the sensor at the base. As for the sensor at the nave extrados, thresholds of 1 mg and 5 mg are assigned in x (longitudinal) and y/z (transversal/vertical) directions, respectively. Anytime the amplitude level of the signals exceeds the predefined thresholds, data are recorded and stored to a permanent memory. Besides, monthly and seasonal programmed events of 10 minutes are registered to follow frequency trends over time and separate possible environmental fluctuations. According to the results of previous Operational Modal Analysis (OMA), the sampling rate adopted for digitizing the signals is 100 Hz for all events. On 12 February 2007 at 10:35 am, a moderate earthquake of magnitude $M_w = 6.1$ and with epicentre offshore Southwest Iberia occurred. The Monastery felt the ground shaking and its response was acquired by the strong motion recorders installed in the church (Figure 33c-d). No severe damage took place, but a slight drop in the modal frequencies as well as a change of the frequency-temperature correlation were observed after the occurrence of the seismic event.
