Delamination tests on CFRP-reinforced masonry pillars: Optical monitoring and mechanical modeling

R. Fedele^{a,*}, M. Scaioni^c, L. Barazzetti^b, G. Rosati^a, L. Biolzi^b

^a Department of Civil and Environmental Engineering (DICA), Politecnico di Milano, Piazza Leonardo da Vinci 32, 20133 Milan, Italy

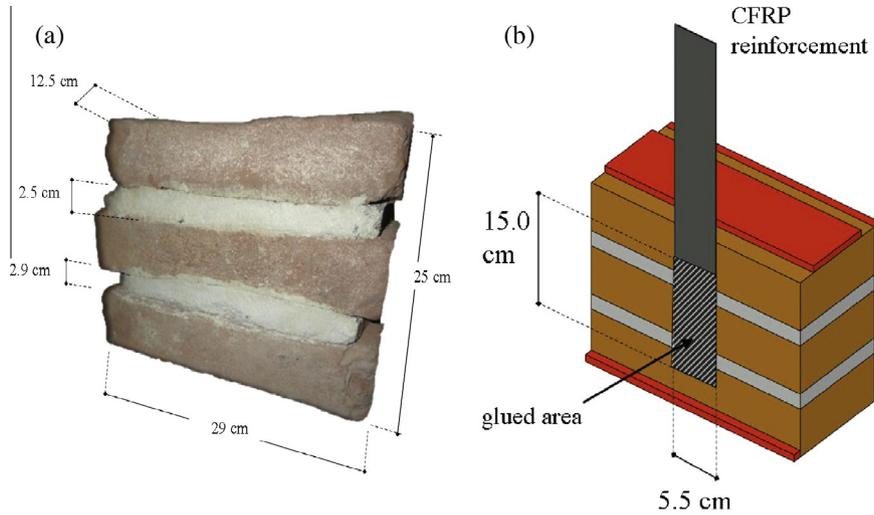
Fig. 1. Masonry pillar constituted of three historical clay bricks (XVII century), bonded by two joints of high strength mortar: main quotes are shown in (a), while idealized geometry with the external CFRP reinforcement in (b).

The masonry pillar considered in this study was made of three historical clay bricks derived from a XVII century rural building. Each one of them had slightly irregular sides of size approximately $29 \times 6.7 \times 12.5$ cm (width \times height \times depth), and were connected by two mortar joints, with 2.7 cm average thickness (see Fig. 1). The resulting anchor length of the CFRP strip (5.5 cm wide) amounted to 15 cm, and an initial notch (not glued) of 5 cm was present.

For the experimental tests, an electro-mechanical testing machine (Instron 8562) with 100 kN maximum capacity was used. Figs. 1 and 2 provide pictures and a simplified scheme of the tested sample and the adopted experimental set-up, respectively. The masonry pillar was fixed by means of a stiffened steel frame, designed to reduce as much as possible rigid body motions. The free end of the CFRP strip was clamped within two bolted steel plates (Fig. 2), and fixed above to the testing machine frame through pinned connections. During the shear test, the relative displacement between the CFRP reinforcement and the masonry pillar, usually referred to as (overall) tangential slip, was enforced by the actuator stroke at the frame basis (see Fig. 2).

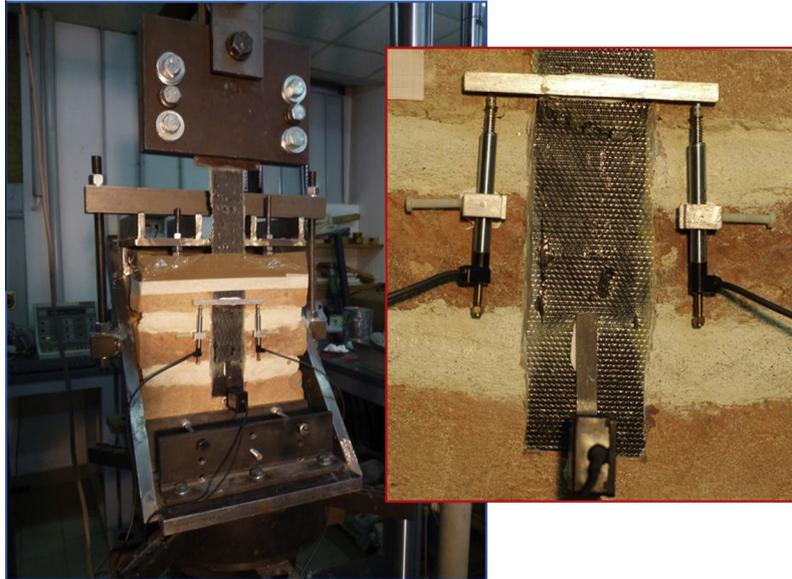
Fig. 2. The testing frame stiffened by diagonal connecting rods, including the reinforced masonry pillar. In the close-up window a detail of the monitored surface is shown, equipped with two LVDTs and a clip gauge.

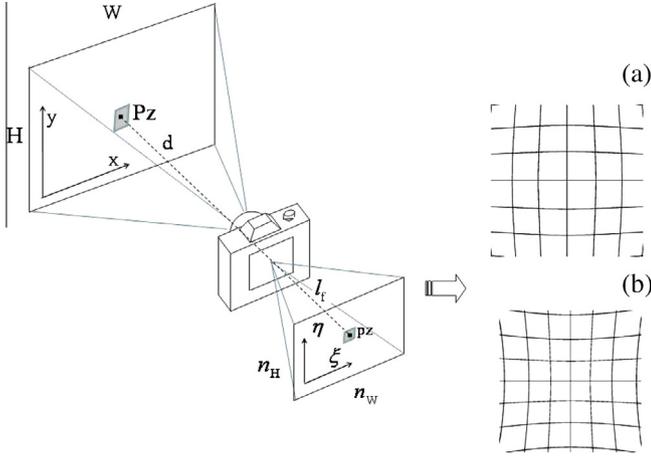
Fig. 3. Projective map between the image space and the object space: under coplanarity assumption, it is governed by parameters d , l_f and p_z ; in the general case, by a complete 8-term homography. Main types of lens distortions are schematically indicated at the right side, namely barrel in (a) and pincushion in (b).

If the coplanarity condition between the sensor and object surface is roughly met, some basic rules can be adopted to assess the acquisition set-up. Indeed, under such assumption only three parameters govern the acquisition stage: the pixel size of the sensor (or pitch, p_z), the focal length of the lens (l_f), and the average distance from camera to object (d). These parameters turn out to vary significantly from case to case, since they depend on the adopted camera, the selected lens, and the optical set-up, respectively. The average pixel footprint on the object (P_z) and the image coverage ($W \times H$) can be consistently reckoned by looking at the scheme in Fig. 3, as follows:

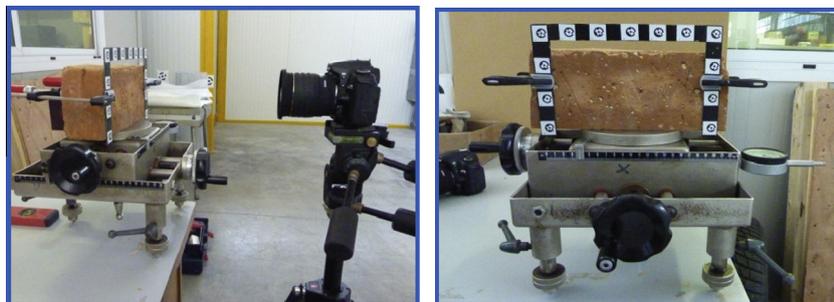
Fig. 4. Validation of optical monitoring system in the laboratory, by means of a dual-axis slide (with accuracy $\pm 10 \mu\text{m}$) and a registration frame with control points.

A preliminary assessment of the optical monitoring procedure was accomplished by the strategy proposed in [2]. As shown in Fig. 4, a masonry brick with a rough natural texture was located on a dual-axes slide. Here (rigid body) displacements with accuracy of $\pm 10 \mu\text{m}$ can be independently prescribed along two directions. As shown in Fig. 4, a registration frame was carefully placed onto the specimen (the same to be adopted later for shear tests). The aim of these tests was to assess the overall system precision also by estimating out-of-plane scale factor λ through Eq. (4), disregarding approximations to be done later in a more complex scenario. Six independent sets of displacements were prescribed to the masonry brick, then the average trajectory of points tracked with DIC was compared to the given steps and discrepancies worked out. Generally, the mean value of discrepancies in each series was not statistically significant. The Root Mean Square Error (RMSE) of all tests was purely based on the standard deviation of measurements, i.e. on their random scatter, and the residuals resulted approximately Gaussian with a vanishing bias. A value of $\text{RMSE} = 15.9 \mu\text{m}$ was found, i.e. equal to $0.19 P_z$ when compared to the footprint of the pixel size on the object. This outcome included both the uncertainty of the homography estimation and the unresolved residuals in the image matching process, and it was affected also by the intrinsic uncertainty of the slide positioning. By extrapolating these estimates to the real experiment set-up,

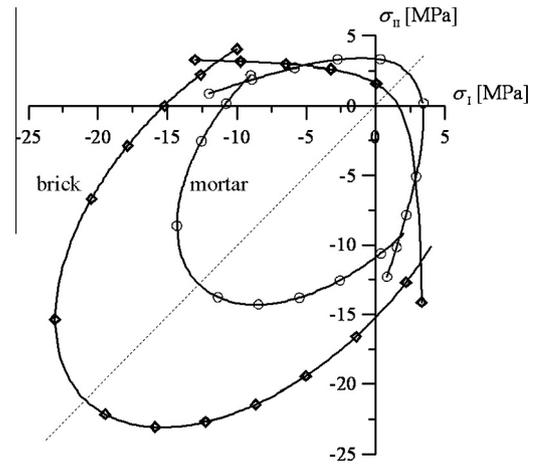
Fig. 5. Initial elastic domain under plane stress conditions, in the Haigh-Westergaard principal stress space, adopted for computer simulations: historical brick (line marked by rhombs) and high strength mortar (marked by circles).

The above parameters entering Eqs. (7)–(8) were estimated on the basis of additional experimental tests performed by the authors on historical bricks, and of the producer information for mortar and CFRP strips. However, these information were further integrated by literature data (see e.g. [4]). Rigorous mathematical formulae provided in [6] allow one to relate the material strengths for the engineering practice to the model parameters which do not possess a clear physical meaning. Model parameters assumed for computer simulations are outlined in Table 1, and relevant elastic domains under plane stress conditions are drawn in the Haigh-Westergaard principal stress space in Fig. 5, for both brick and mortar materials.

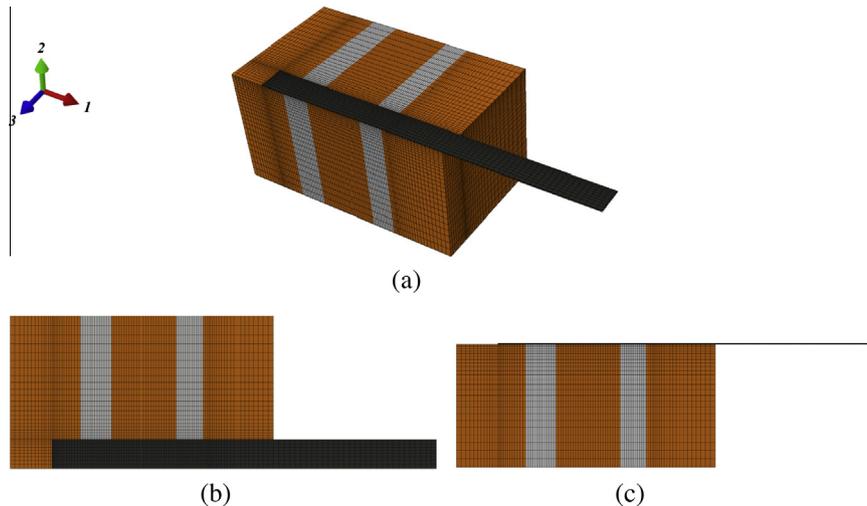
Fig. 6. Three-dimensional finite element model of the reinforced pillar (due to the symmetry, only one half of the specimen was discretized): (a) axonometric view; (b) upside view of the plane (1,3); (c) lateral view of the plane (1,2).

The adopted finite element discretization of the tested pillar is shown in Fig. 6. This model includes ideal (i.e. non-compliant) constraints to prevent rigid body motions, consistently with the experimental set-up: the simulation was driven by a monotonically increasing displacement (referred to as overall tangential slip), prescribed to the reinforcement free end as boundary condition. As a simplified hypothesis, perfect adhesion was assumed between the elastic reinforcement and the damageable masonry support: in fact, damage processes occurring inside the bulk material were expected to be predominant with respect to the elastic slips of intermediate layers constituting the final reinforcement.

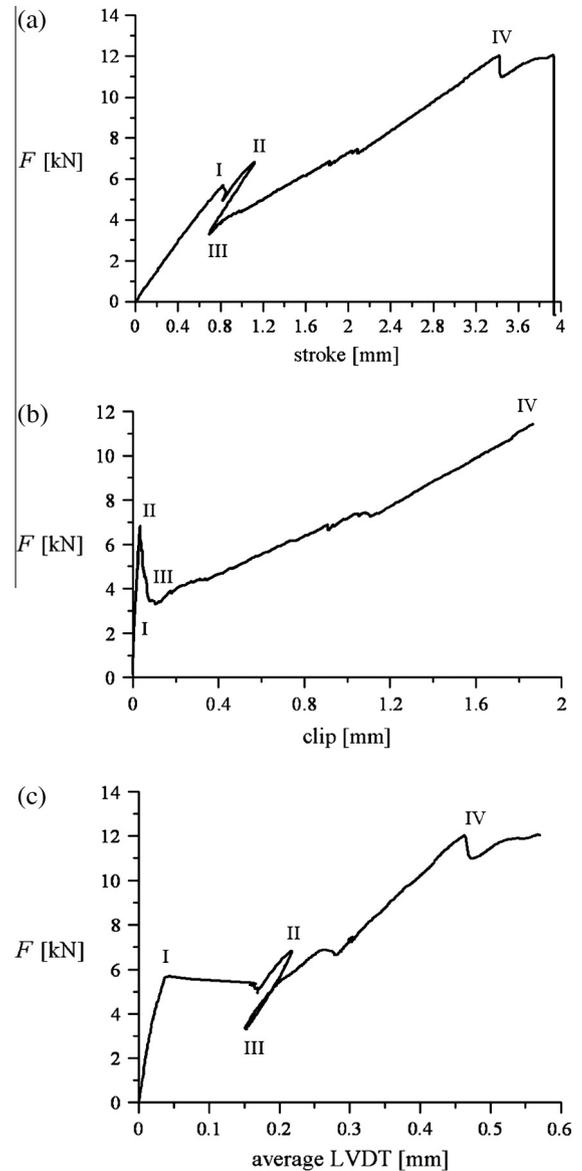
Fig. 7. Reaction force F during the single-lap shear test as a function of: (a) actuator stroke; (b) relative displacement provided by the clip gauge, at the CFRP strip attachment, adopted as feed-back signal for the test control; (c) mean value of two LVDTs at the notch, symmetrically located with respect to the reinforcement axis. Snap-back response can be observed not only in (a), but even in (c). Main phases of the test are also schematized: I, delamination onset; I \rightarrow II, debonding along the first mortar joint; II \rightarrow III, sudden unloading due to last brick cracking; III \rightarrow IV, debonding propagation along the second brick and mortar joint; IV, onset of the spoon-shaped bulk mechanism closely to the CFRP anchorage.

A marked snap-back behavior can be observed in Fig. 7(a) (between instants II and III), where the variable running along the abscissae axis is the actuator stroke. In principle, this behavior might be considered not so unusual, due to the elastic energy released by the specimen after strain localization and by the testing machine frame. Obviously, the clip displacement, selected as feedback signal for the test control, monotonically increases during the experiment and no snap-back is observed along the force versus clip plot Fig. 7(b). Surprisingly, in Fig. 7(c) where the LVDT signal is considered, snap-back behavior appears again (for clarity, the average of the two gauges is plotted).

Actually, the snap-back phenomenon in Fig. 7(c) (between instants II and III) has to be regarded as a consequence of an in-depth crack opening inside the lowest brick, closely to the CFRP attachment (see Fig. 8). This is probably due to pre-existing flaws in the historical clay material. Accordingly, also the snap-back behavior resulting in Fig. 7(a) was presumably emphasized. Due to such unexpected crack, with a typical wedge shape, the relative displacement detected by the clip exceeds significantly the LVDT measurements (of about 1 mm). In particular, when the reaction force decreases to about 3.5 kN (Fig. 7), the clip displacement

In Fig. 7(c) it is rather interesting to observe the presence of a wide plateau, along which the reaction force is almost constant with respect to the LVDT displacement (between instants I and II). Such plateau corresponds to a small jump along the force versus stroke plot, see Fig. 7(a), localized at the end of the initial linear branch, before the above mentioned snap-back ring. An analogous phenomenon is repeated closely to the force peak in Fig. 7(a) and (c).

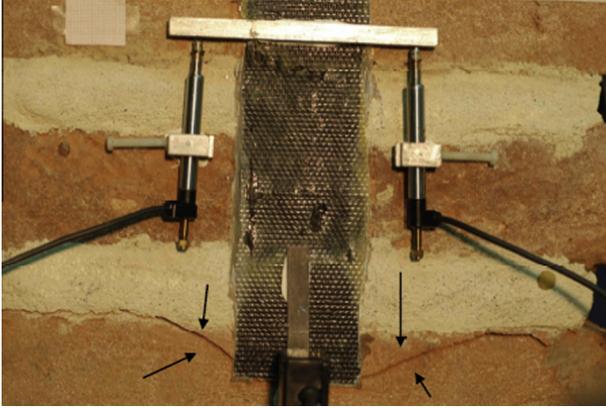
Fig. 8. In-depth crack emerging at the monitored surface during the test, favored by pre-existing flaws in the historical bricks.

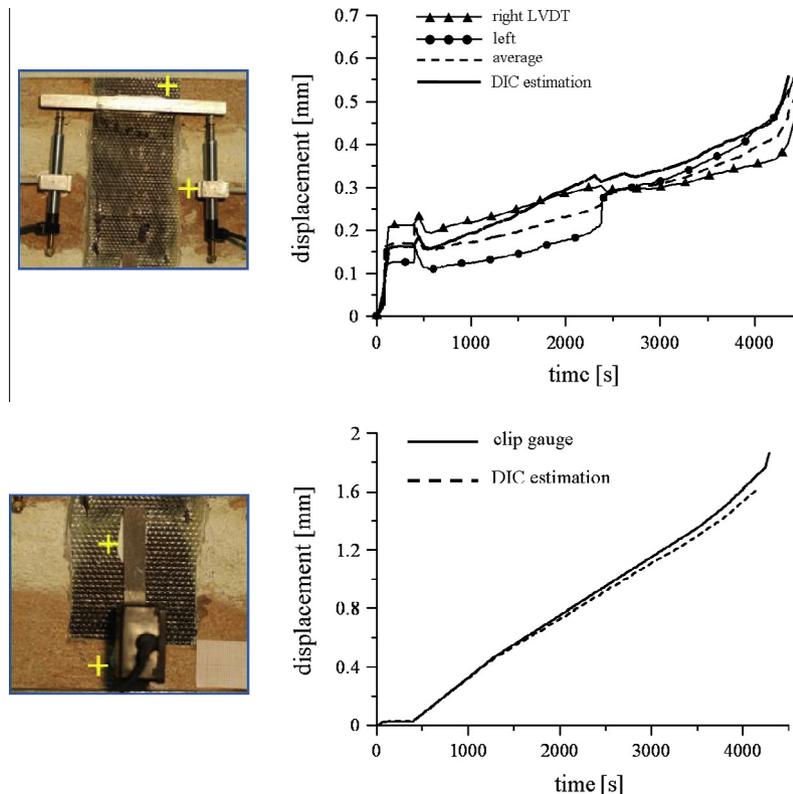
Fig. 9. Measurements provided by contact point sensors (LVDTs and clip gauge) and relevant DIC estimates, versus the experiment time. Inside the picture column at the left side, crosses indicate centroids of regions over which absolute displacements were detected by DIC and averaged.

As a first step, a cross validation between full-field measurements and point sensor data is considered. The agreement observed in Fig. 9 between point data (clip gauge and LVDTs) and the relevant DIC estimates is indeed noteworthy, also at the light of some circumstances outlined in what follows. To perform a comparison between punctual and ‘diffuse’ sensors, DIC displacements were averaged over small regions closely to the reference points of LVDT bases but not exactly at the same locations (which obviously

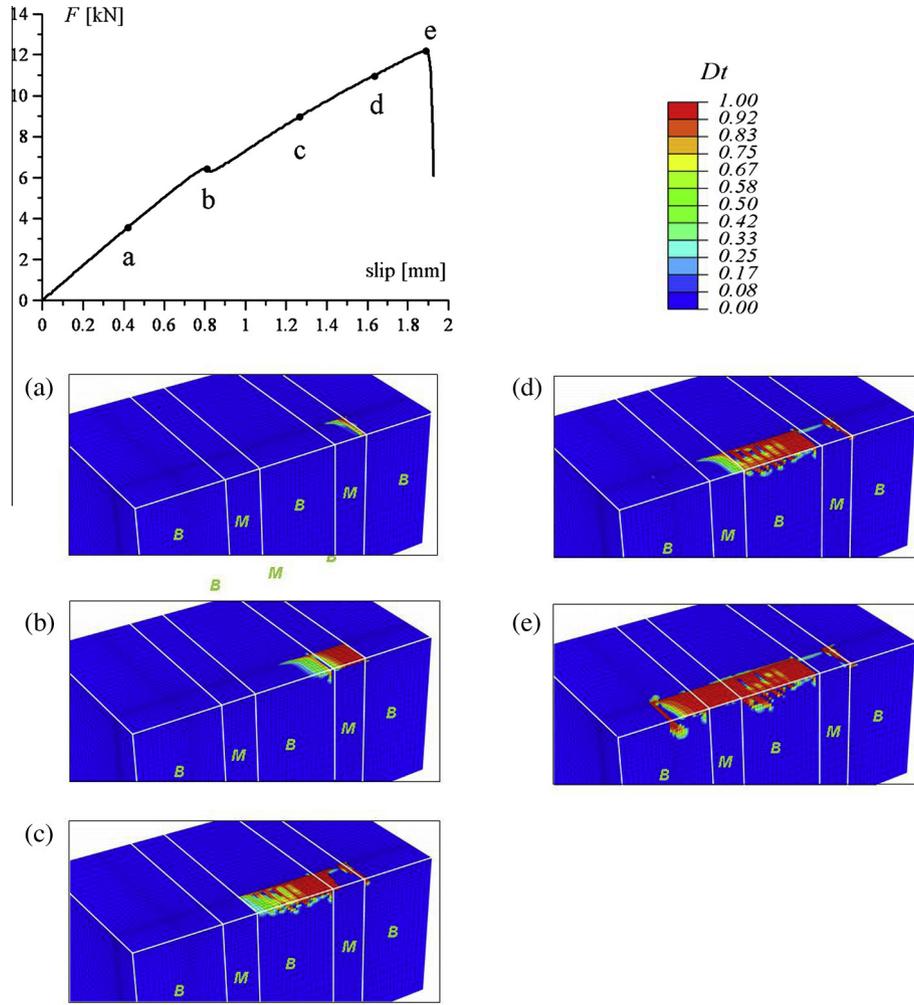
Fig. 10. Finite element simulation of the shear test: evolution of damage in tension D_t inside the pillar, at measurement instants a–e. Symbols B and M denote brick and mortar materials, respectively, whilst CFRP strip has been removed from the plot.

curved branch at the reinforcement attachment appears. The initiation of a bulb-shaped mechanism can be observed in Fig. 10(e): it occurs as soon as the current delamination front approaches the FRP attachment, at a distance of one half of the entire reinforcement width (about 3 cm). Under such scenario the applied force acting on the outer reinforcement, no longer balanced by bonding tractions over the first part of the joint, induces stress concentration at the FRP anchorage (in the last brick), and rapidly tensile damage begins to develop inside. This circumstance clearly demonstrates that the mechanical interaction at the masonry–reinforcement interface cannot be described by means of point springs with no mutual coupling.

From a mechanical standpoint, due to the presence of quasi-brittle constituents inside the pillar, these phenomena can be interpreted as bifurcations along the loading path. At the beginning, the direction of this secondary crack branch developing at the FRP attachment is approximately orthogonal to the interface: therefore, locally mode I (peel) loading conditions are met. Under a further increment of the overall tangential slip, mixed mode conditions cause the crack to deviate along a curved trajectory. Simultaneously, also at the second brick damage propagates inside the bulk material.

During the transition from d to e , a significant enlargement of the bulb can be noticed, with damage developing in-depth and also laterally inside the last brick. Unfortunately, the adopted explicit simulation does not allow one to follow in a stable way the entire

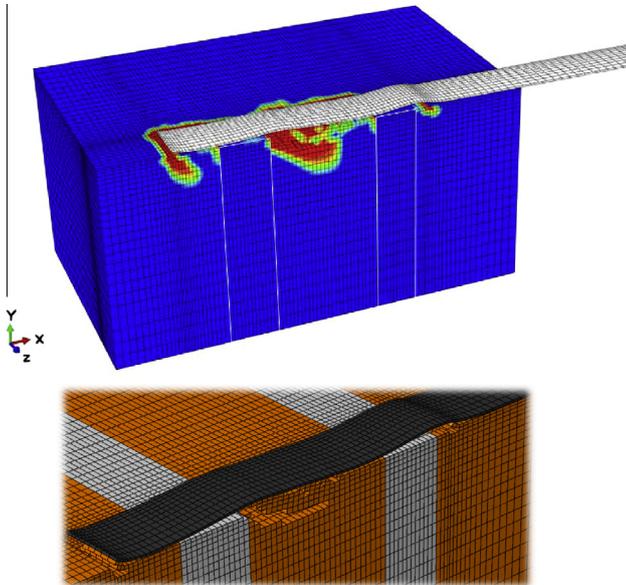
Fig. 11. Predictions of finite element analysis at collapse: distribution of damage in tension D_i inside the masonry pillar, drawn on the magnified deformed shape, and a detail closely to the reinforcement, illustrating the collapse mechanism. Finite elements in which damage variable exceeded a suitable threshold (close to unity), were eliminated from the analysis and eroded in the plot. Deformed shape is magnified ten times.

Fig. 11 shows the distribution of tensile damage computed by the finite element model at collapse, drawn on the deformed configuration of the masonry pillar. Post-mortem analysis of the detached reinforcement (see Fig. 12) confirmed the presence of bulb-shaped material glued to the reinforcement, markedly thicker over the second brick (in the middle): the outer contour turns out to be in excellent agreement with the numerical predictions, as showed in the lower detail of Fig. 11. The mortar layers (white colored) still glued to the reinforcement are almost negligible: also this circumstance is in agreement with the finite element analyses, predicting damage along the mortar joints almost exclusively limited to the interface.

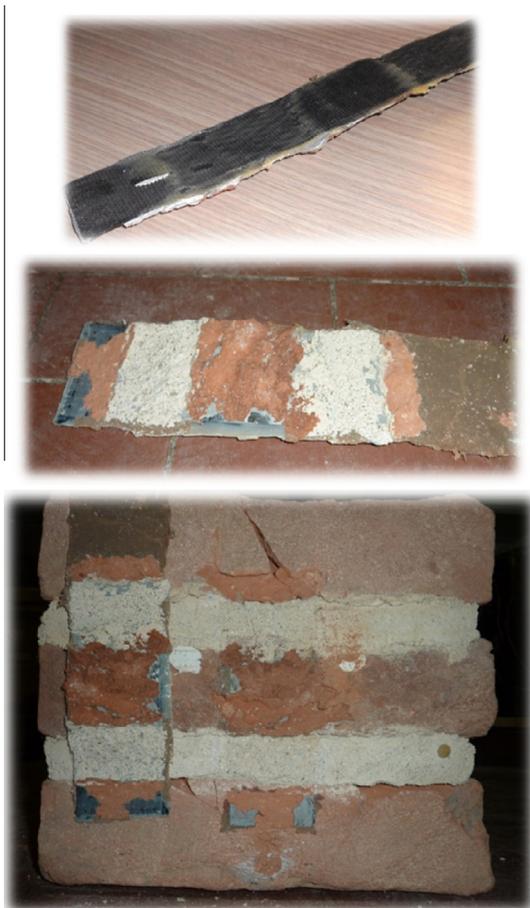
Fig. 12. Post-mortem pictures of masonry pillar and detached reinforcement. Part of the support is still glued to the CFRP strip, thicker in the middle (over the second brick), and indicates the bulk collapse mechanism.

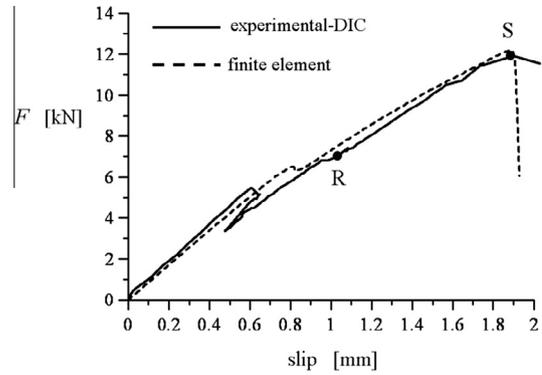
Fig. 13. Response of the single-lap shear test in terms of overall reaction force F as a function of the 'actual' tangential slip reconstructed through DIC (thick line), and its counterpart computed by means of the finite element analysis (dashed line). In the simulations the actual slip is prescribed as boundary condition to the CFRP free end, whilst rigid body motions of the pillar are prevented by ideal constraints.

machine frame, the relative slip was approximated by displacements in the upper part of the masonry support, estimated by DIC over two regions symmetrically located with respect to the reinforcement and then averaged. Such displacement history was prescribed as boundary condition to the finite element model (at the reinforcement free end), whilst rigid body motions of the modeled pillar are prevented by ideal (i.e. non-compliant) constraints. Explicit finite element simulations of single-lap experiment are therefore slip-driven. In Fig. 13, the reaction force provided by the load cell as a function of the reconstructed slip appears in a rather satisfactory agreement with its computed counterpart, which does not include the wedge crack occurred inside the last brick. The experimental plot still exhibits a pronounced snap-back phenomenon, and the final collapse appears less brittle than in the numerical predictions.

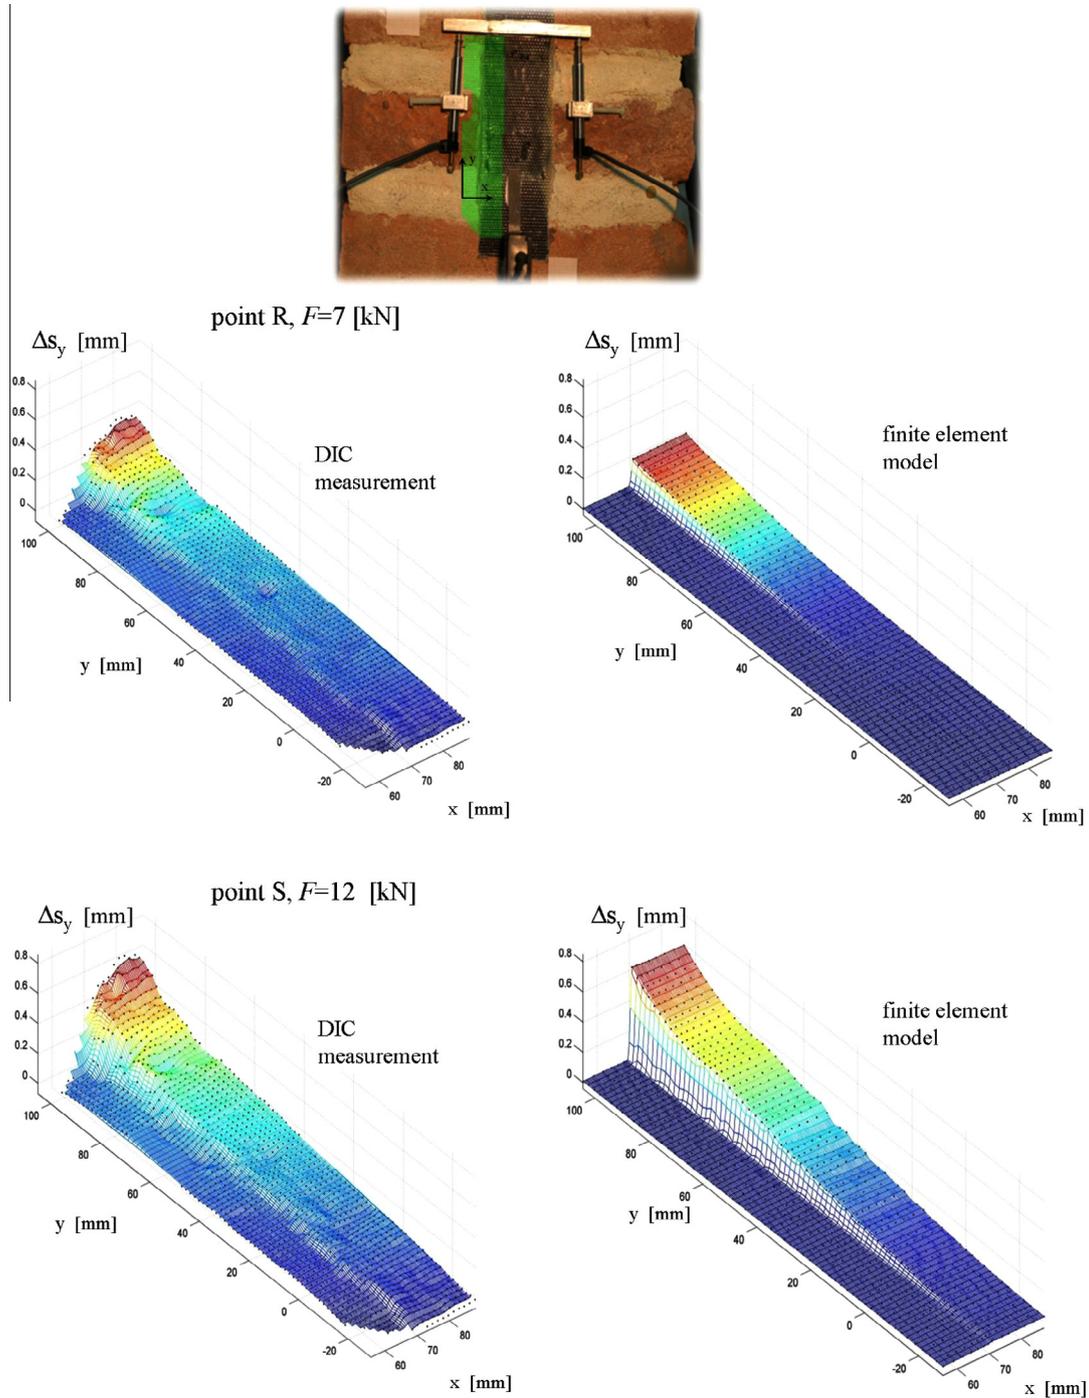
Fig. 14. Relative tangential displacements between the CFRP reinforcement and the masonry support, estimated by 2D DIC at different loading phases during the shear test (points labeled as R and S are indicated in Fig. 13), and their counterparts computed by the finite element model. The upper picture shows the wide field-of-view covered by the camera, and the ROI (green-colored) selected for these analyses. (For interpretation of the references to color in this figure legend, the reader is referred to the web version of this article.)
