Effect of thermal ageing and salt decay on bond between FRP and masonry

C. Tedeschi · A. Kwiecień · M. R. Valluzzi ·
B. Zajac · E. Garbin · L. Binda

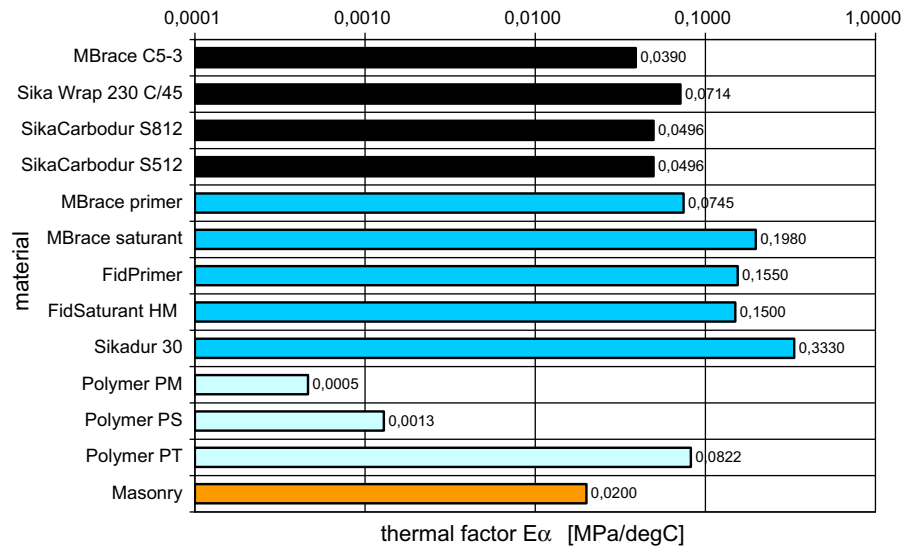
Fig. 1 Comparison of thermal factors $E \cdot \alpha$ obtained for the analyzed materials

Increase of uniaxial stress $\Delta\sigma$, caused by increase of temperature ΔT , in perfectly constrained conditions can be computed through the thermal factor $E \cdot \alpha$, according to Eq. (1), for any material characterised by the elastic modulus E and thermal expansion coefficient α . More details about values of E and α of materials using in FRP systems in civil engineering can be found in Zajac and Kwiecień [27], where values of the thermal factor $E \cdot \alpha$ of using strengthening materials are presented (Fig. 1).

This shear stress generates tensile stress in the material which has lower value of the thermal factor $E \cdot \alpha$ (Fig. 1).

the thermal factors of the soft mud brick and that of the layer of epoxy penetrated into the brick (thin layer of the brick impregnated by the primer). In such a case, the brick of low strength does not withstand the shear stress level causing failure, generated by different deformation of both layers. In real applications on masonry structures exposed to sunlight, the CFRP strengthening system reaches high temperature faster than the masonry substrate, thus the temperature gradient between both materials is higher, generating bigger differences in deformation as presented in Fig. 1.

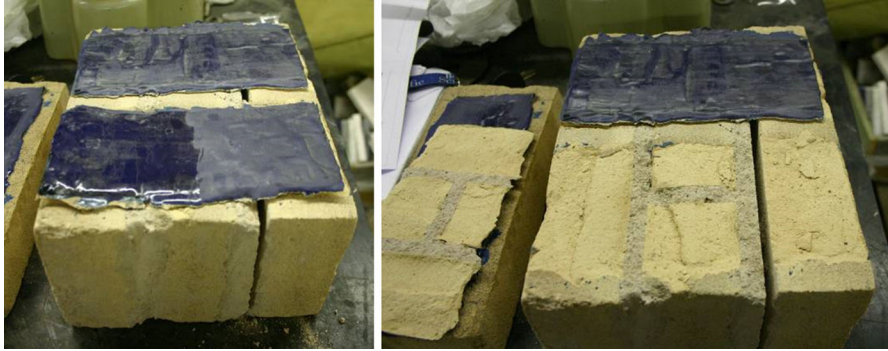
Fig. 5 Damage observed in the specimens after 40 thermal cycles; detail of the trimmed section

The number of thermal cycles applied amounted to 40 cycles and caused a deep delamination in the case of the Italian soft mud bricks. The delaminated layer was trimmed and the section was observed under the stereomicroscope (Fig. 5).

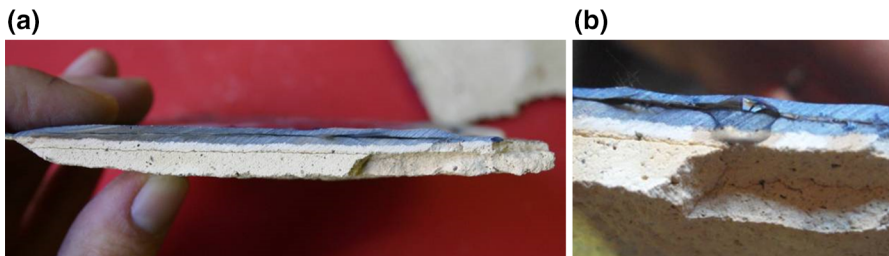
Fig. 6 Visual inspection: **a** delamination on the porous brick after 40 thermal cycles, and **b** presence of a *border* below the fibers at the limit of the impregnated layer

The different layers of FRP, as well as the zone in the brick impregnated by the primer and the resin are presented in Fig. 6a. The figure also shows the delaminated layer with a clear horizontal crack of 1 or 2 cm under the fiber. There was a clear penetration of the primer into the brick (1–2 mm), as it is clear that the impregnated brick is more compact and probably stronger.

On the contrary, the deeper zone which has not been impregnated remained porous and weak. The delamination was observed to have occurred at this point. The contact angle test confirms the penetration zone of the primer (Fig. 6b). The reason why this phenomenon happened can be connected with differences between

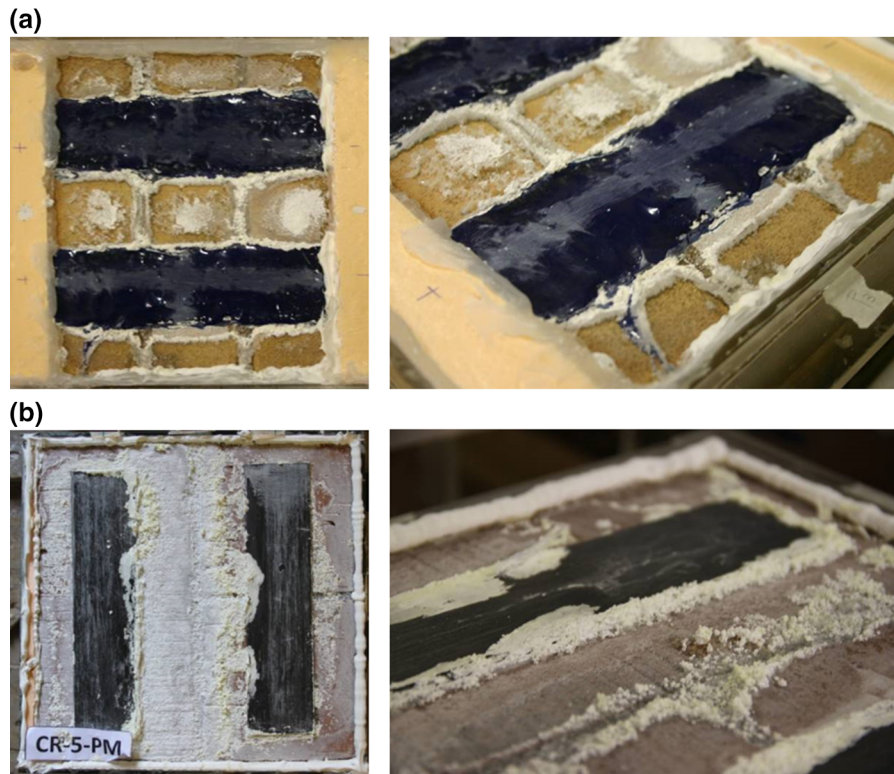
Fig. 7 Damage after 11 cycles of crystallization: **a** general view and detail of concentration of stresses underneath the fibres in Italian specimens, and **b** general view and detail of concentration of stresses underneath the fibres in Polish specimens

Furthermore; in these cases it seems that a different damage is induced by the presence of FRP which are partially covering the specimen on the upper surface. Figure 7 indicates that salts are concentrated at the interface between the brick and the fibre, in the zone where most damage occurs due to microcracking.

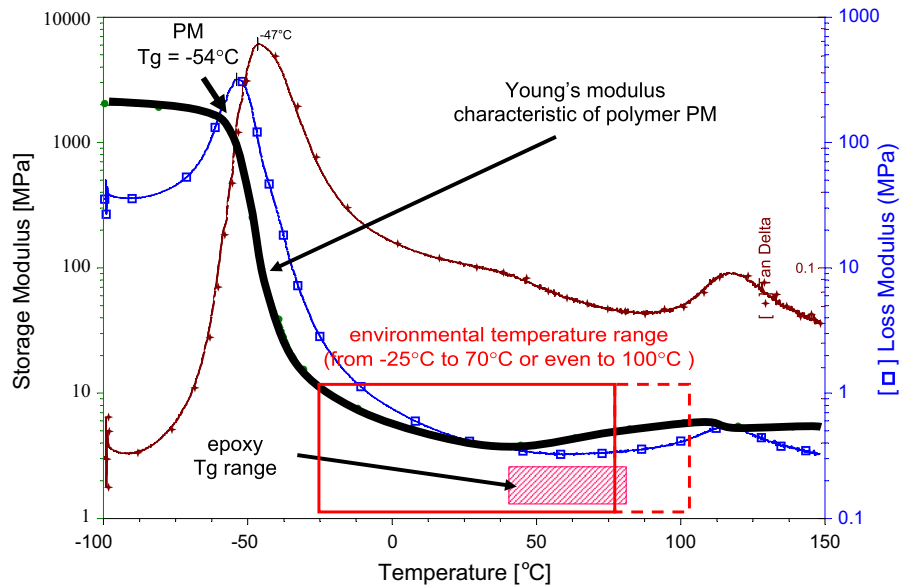
Fig. 8 DMA results for polymer PM performed at excitation frequency of 1 Hz

On the other hand, polyurethane adhesives (polymers PM, PS, PT) work in the environmental temperature range (-25 to $+70$ °C or even to $+100$ °C—Fig. 8) beyond their characteristic glass transition temperature T_g , and are therefore safer in practical applications, when considering thermal aspects. An example dynamic mechanical analysis (DMA) results, for the polymer PM—[13], confirms that this polyurethane works in stable conditions beyond $T_g = -50$ °C in the environmental temperature range (visible in Fig. 8, presenting characteristic of Young's modulus, also named "storage modulus", in the wide temperature range).

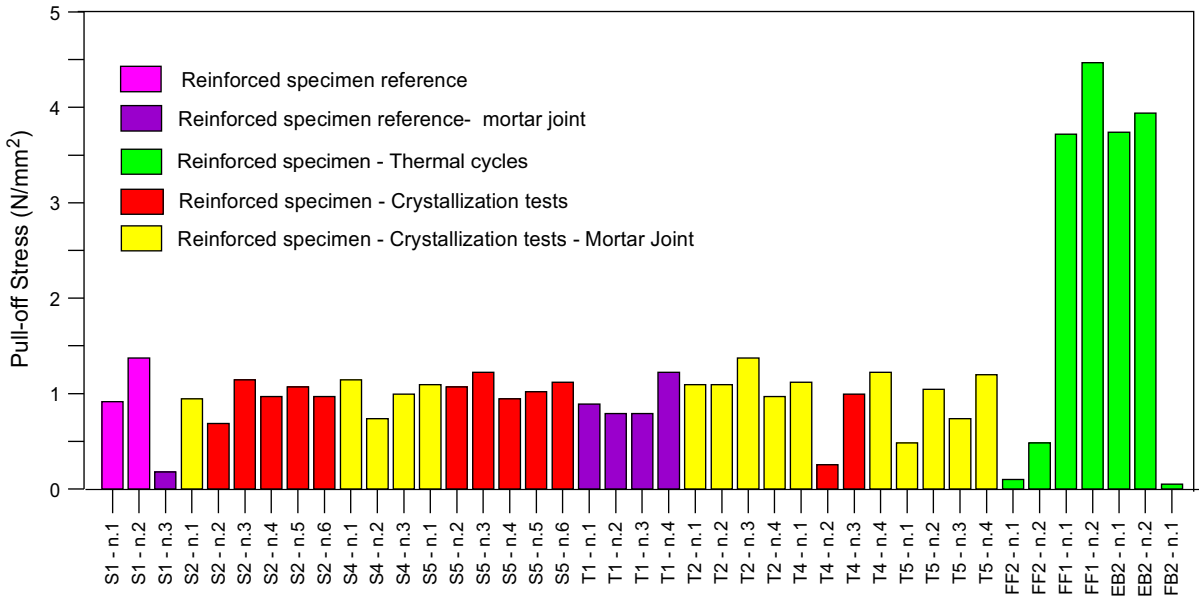
Fig. 10 Result of pull-off test after crystallization and thermal tests for Italian specimens

The results of the pull-off tests obtained on specimens subjected to thermal ageing tests are shown in Figs. 9, 10 and 11.

The results of the pull-off tests obtained on specimens subjected to crystallisation cycles are shown in Figs. 9, 10 and 11. The reference pull-off test results on brick specimens (without fibres) are represented by mean values 2.10 MPa for the Polish brick [16] and 1.14 MPa for Italian soft mud brick (S1 type) and 0.92 MPa for Italian extruded brick (T1 type).

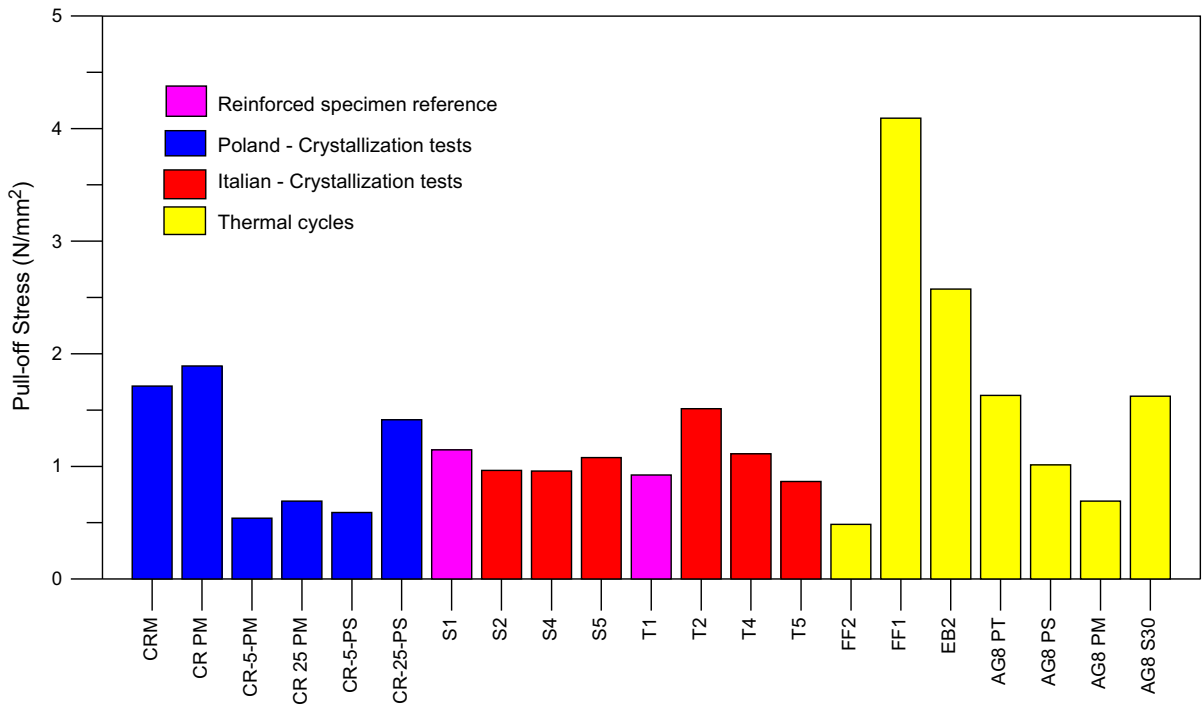
Fig. 11 Mean result of pull-off test after crystallization and thermal tests for Italian and Polish specimens

Results presented in Fig. 11 indicate that in the case of Polish bricks the applied thermal ageing caused pull-off strength reduction: of about 18 % up to value 1.62 MPa for epoxy S30 adhesive, of about 30 % up to value 1.63 MPa for polymer PT adhesive, of about 31 % up to value 1.01 MPa for polymer PS adhesive and pull-off strength increase of about 9 % up to value 0.69 MPa for polymer PM adhesive. In the case of Italian bricks with epoxy adhesive the reduction was:

very high 89 % up to value 0.17 MPa for soft mud bricks and very low 5 % up to value 2.96 MPa for extruded ones.

In the case of Polish specimens (only brick—Fig. 11), the crystallisation cycles led to reduction of

about 18 % up to value 1.71 MPa for CR_M and of about 9 % up to value 1.91 MPa for CR_PM. The same crystallisation cycles affected specimens with fibres—Fig. 11. Obtained results (according to references presented for the thermal ageing test) were as follows: about 14 % reduction up to value 0.54 MPa for CR_5_PM, about 6 % increase up to value 0.69 MPa for CR_25_PM, about 61 % reduction up to value 0.58 MPa for CR_5_PS and about 3 % reduction up to value 1.43 MPa for CR_25_PS.

In the case of Italian specimens (with fibres—Fig. 11), the crystallisation cycles resulted in: about 15 % reduction up to value 0.96 MPa for S2, about 15 % reduction up to value 0.96 MPa for S4, about 5 % reduction up to value 1.08 MPa for S5, about 23 % increase up to value 1.13 MPa for T2, about 3 % reduction up to value 0.89 MPa for T4 and about 6 % reduction up to value 0.86 MPa for T5.
