STRATEGY FOR INTEGRATED SURVEYING TECHNIQUES FINALIZED TO INTERPRETIVE MODELS IN A BYZANTINE CHURCH, MESOPOTAM, ALBANIA

**Raffaella Brumana,¹ Daniela Oreni,¹ Branka Cuca,¹
Luigia Binda,² Paola Condoleo,² and Maurizio Triggiani³**

*¹Building Environment Sciences and Technology, Politecnico di Milano, Milan, Italy ²Department of
Structural Engineering, Politecnico di Milano, Milan, Italy ³Dept. of Studi Classici e Cristiani,
Università di Bari, Bari, Italy*

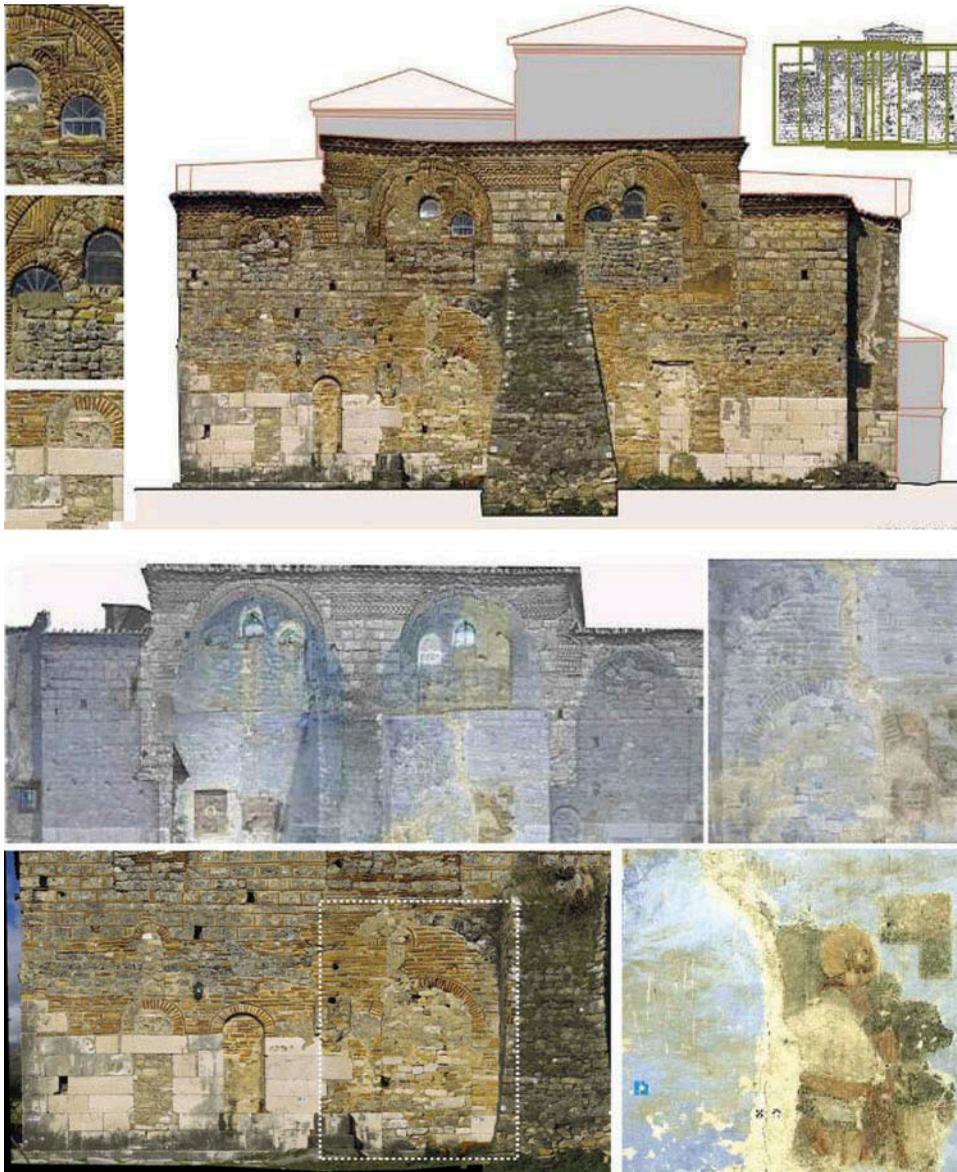
Figure 4. Orthoimages of the Southern façade. The photogrammetric orthoimages of the external (top) can be overlapped to the internal front (center), within a unique geographic system. Thanks to the GeoDB it allows to identify the surface correspondences and to connect them within the Irregular Wall Object Family sequences, generated by reading, georeferencing and mapping the stratigraphic analysis and the transformations to occur. (bottom right) Here a detail of the fresco along the right side of the arch probably representing the ancient entrance to the church successively closed.

On the Southern prospect (Figures 4 and 5), the occluded openings were identified.¹² Inside the church there is a fragment of fresco,¹³ where in the past there was an entrance to the church.¹⁴ Only two occluded openings can be considered real entrances to the church, while the others¹⁵ are arched doors already found in the Western and Northern external facade of the wall (Figures 6 and 7). In the upper part, there are three openings, all occluded,¹⁶ and these windows are also visible from the internal side.

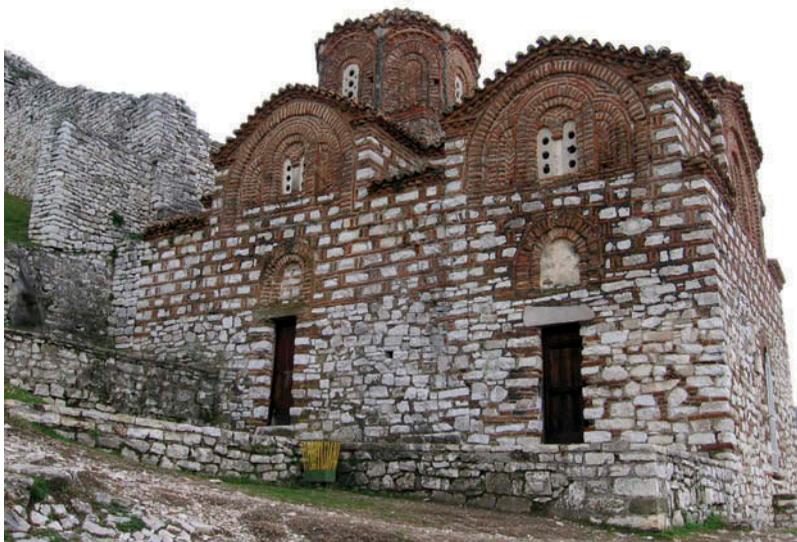
Figure 8. Photograph of SS. Trinity of Berat.

It is worth noting that there are many examples in the Byzantine architecture of carved *cotto* ornaments and brick frames used for narrow windows and doors, mostly in the 12th and 14th centuries (Osterhout 1999). These elements were present in the Northern Greek and Epirus area. Similarly, there are many examples in Byzantine architecture of Type C. Comparisons can be made with the Greek churches of Paregoretissa in Arta, Katholikon in Dafni, and Nesebar in the Bulgarian region. This solution, however, was mostly present in Albania. Near Mesopotam, in the district of Butrint, the ruins of a medieval church were identified of which only the apse, that shows a “brick cage” masonry, survived. This type of masonry (Type C), and also Type B (brick masonry with thick mortar joints) can be found in other churches, such as the great medieval basilica of Butrint, or in the Holy Trinity of Berat, which is the most outstanding example of this architecture (Figure 8).
