Continuous dynamic monitoring of a centenary iron bridge for structural modification assessment

Carmelo GENTILE*, Antonella SAISI

2 The iron arch bridge at Paderno d'Adda

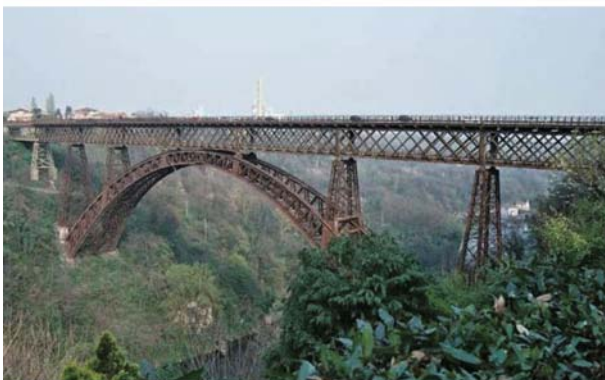
Fig. 2 (a) Historic and (b) present view of the San Michele bridge

The San Michele bridge (Figs. 12), better known as Paderno bridge, was designed in 1886 by the head of SNOS technical division, the Swiss engineer Julius R othlisberger (1851–1911), and its construction was completed on March 1889.

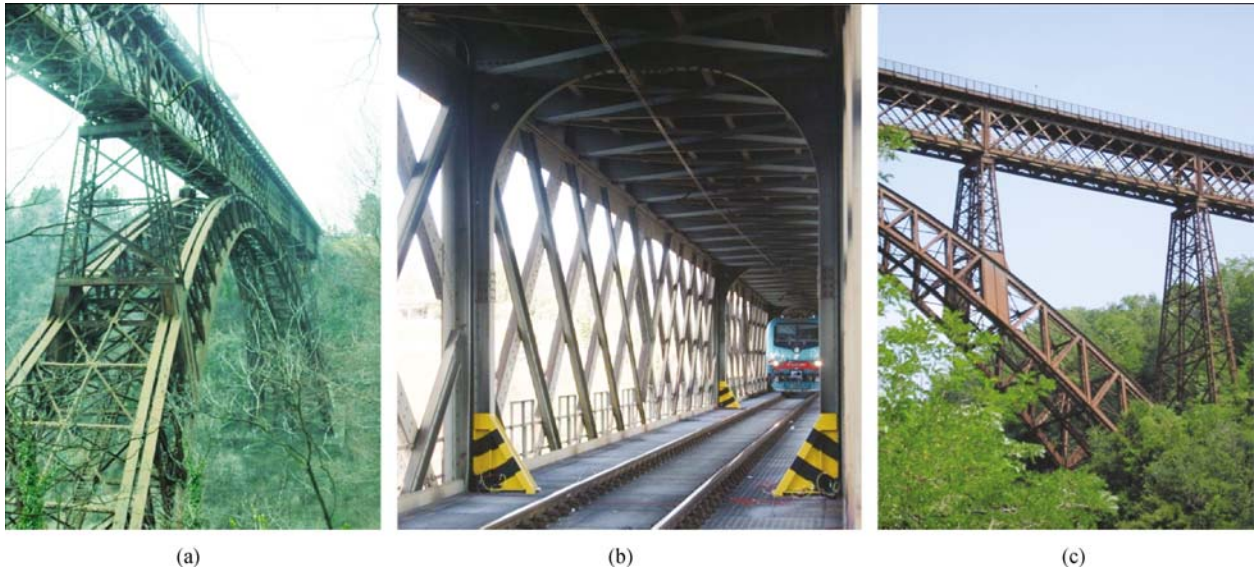
Fig. 3 Structural details of the bridge

The total length of the bridge is 266.0 m and the trussed arch (consisting of two ribs composed of double members 1.0 m apart, Fig. 3(a)) has the following dimensions [10,11]:

The upper girder is 266.0 m long and is supported by 9 bearings, equally spaced every 33.25 m, so that the girder behaves as a beam bridge defined between abutments and with equally spaced elastic supports. The girder vertical trusses (6.25 m high and 5.0 m apart) consist of T-shaped chords connected by multiple lattices and support two decks: the upper one for roadway and pedestrian traffic, and the lower one for a single line of railroad (Fig. 3(b)).

The piers, shaped like truncated pyramids, are composed by 2 truss-box inclined posts, connected by horizontal and bracing elements (Fig. 3(c)); each inclined post consists of 4 angular elements connected by transversal and diagonal members in the 4 main planes.

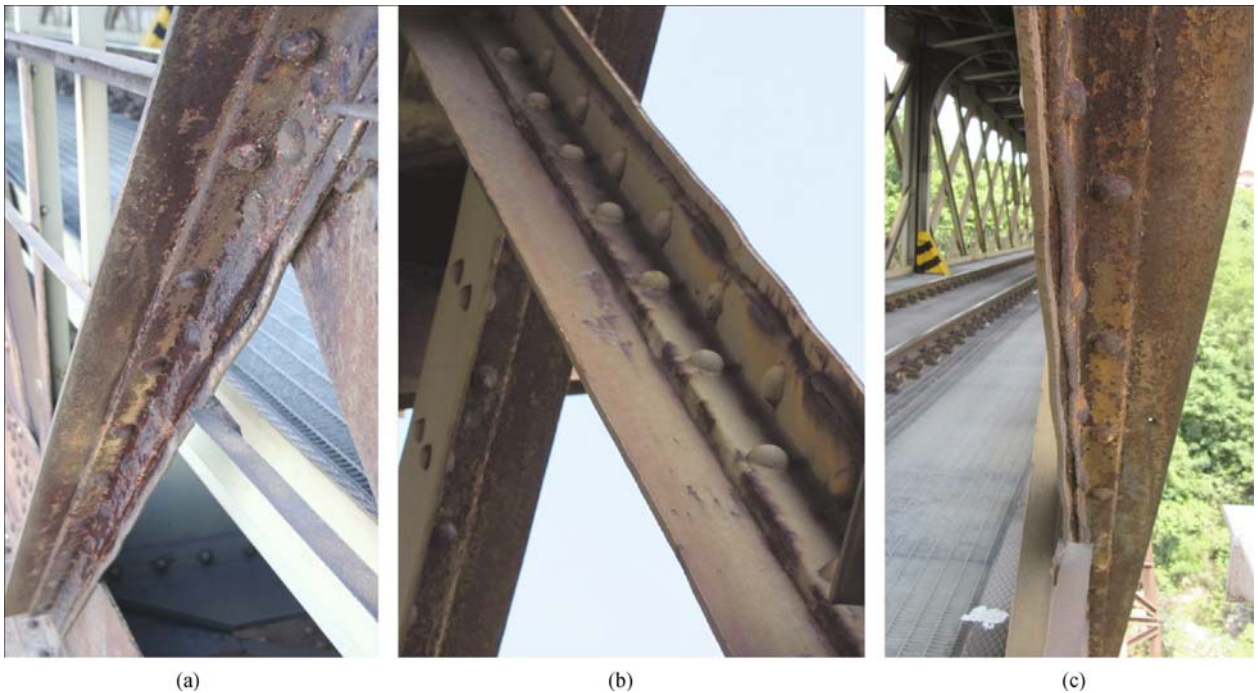
Fig. 4 Examples of the damage inflicted by the corrosion to the bridge members

As previously stated, the state of preservation of the bridge is rather poor; Fig. 4 exemplifies typical damages induced by the corrosion, observed on a huge number of structural members on both downstream and upstream sides. It should be noticed that the large spacing of the rivets, not adequate to the thickness of the iron plates, easily allows the penetration of moisture between the contact planes so that the subsequent oxide expansion induces deformations of the iron plates and sections at the connections of the composite struts.

sections (Fig. 4). Consequently, temperature and load variations induce slight variations of the truss axial loads, that might lead to slight changes of the second-order stiffness.

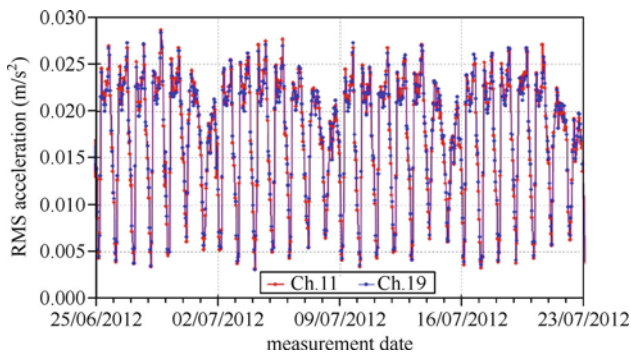
Fig. 11 Typical variation of the RMS value of vertical (red line) and transversal (blue line) acceleration

Figure 11 shows the variation over 4 weeks of the RMS

of the accelerations recorded in the vertical (red line) and lateral (blue line) channel, that are characterized by the largest RMS values, averaged over the entire day. It should be noticed that two rush hours of road traffic typically occur around 07:00 and 17:00; furthermore, the level of road traffic is quite high between the rush hours, whereas the traffic intensity significantly decreases at late evening and during the night. It is further noticed (Fig. 11) that, as it has to be expected, the road traffic decreases during the weekends (or in holidays) and the first rush hour moves around 12:00–13:00.

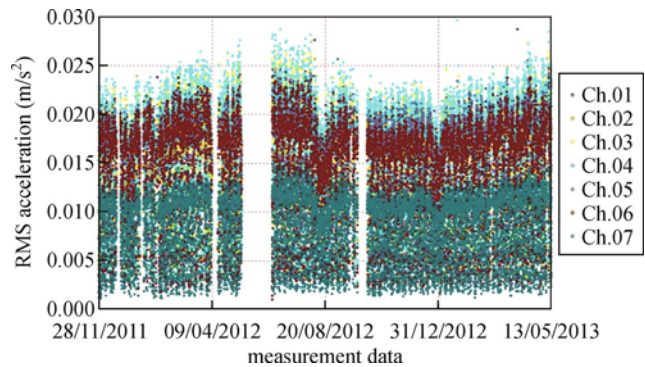
Fig. 12 RMS values of the vertical acceleration recorded by sensors 1–7 (Fig. 5) in the period from 28/11/2011 to 12/05/2013

The variation of the RMS value of vertical accelerations recorded at channels 1–7 (Fig. 5) in the period between 28/

11/2011 and 12/05/2013 is illustrated in Fig. 12, highlighting a similar evolution in each point of the bridge deck; furthermore Fig. 12 shows that the RMS of vertical accelerations (i.e., the road traffic intensity) tends to significantly increase in Spring and Summer and to decrease after the end of August.

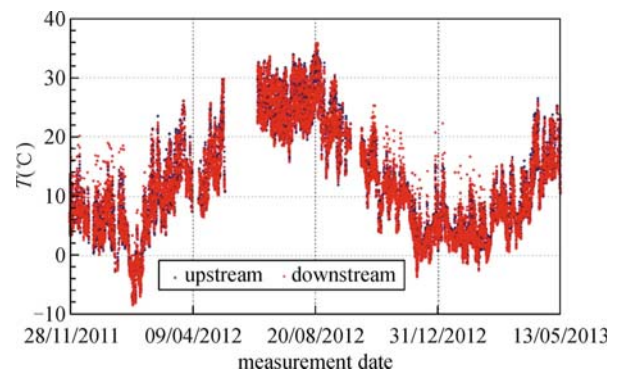
Fig. 13 Measured temperature in the period from 28/11/2011 to 12/05/2013

Figure 13 displays the temperature records from the two sensors installed in the upstream (blue line) and downstream side of the bridge between 28/11/2011 and 12/05/2013. It can be observed that the two temperature series are very similar, except in winter afternoons (i.e., between 13:00 and 16:00) when the temperature on downstream side of the bridge is few °C higher.

It is worth mentioning that the average temperature between the two sides was used to investigate the effects of temperature on the dynamic characteristics of the bridge.

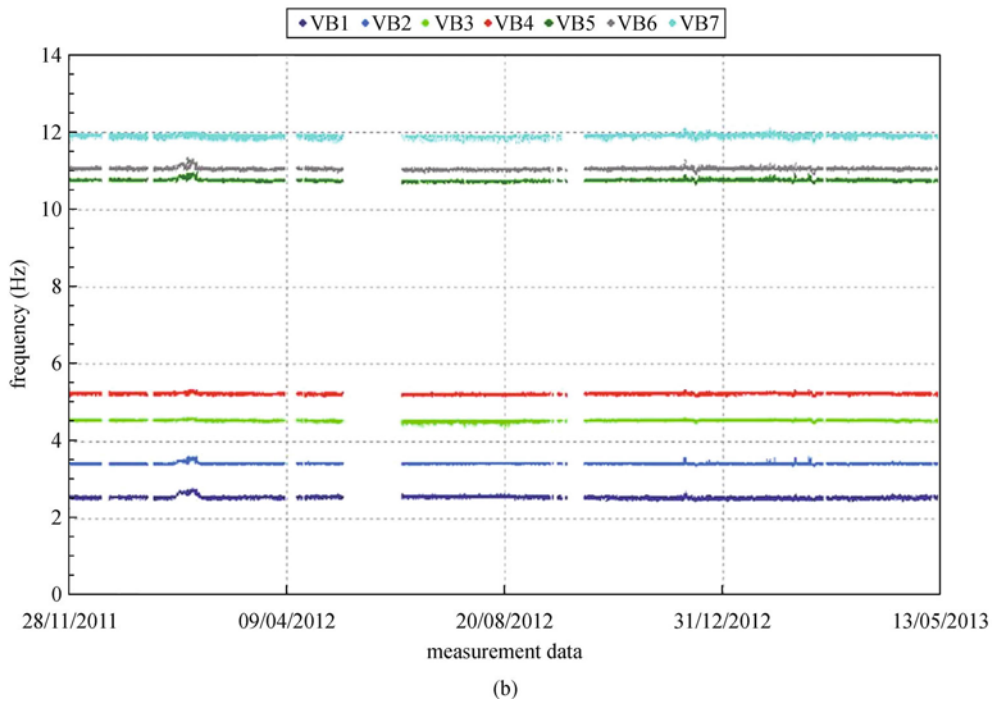
Fig. 14 Time evolution of the natural frequencies automatically identified with the FDD method, from 28/11/2011 to 12/05/2013. (a) Transversal modes; (b) vertical modes

Automated identification of the modal frequencies from the data sets collected during the period from 28/11/2011 to 12/05/2013 provided the frequency tracking shown in Figs. 14(a) (transversal modes) and 14(b) (vertical modes). The inspection of Figs. 14(a)–(b) suggests the following comments:

1) The algorithm for automatic modal identification exhibits good and robust performance, as all the expected modes (including the closely spaced modes) are clearly identified with high occurrence.

2) The natural frequencies exhibit relatively small but clear variations.

3) During the period under analysis, some interruptions of the monitoring occurred due to maintenance operations in the electric cabin providing power to the monitoring system and owned by the municipality of Paderno. The longest interruption occurred between 14/05/2012 and 17/06/2012 and conceivably allowed to solve the related issues.

4) Figures 14(a) and 14(b) (as well as Figs. 17(a)–(d)) show obvious abnormal increase of all modal frequencies in winter time. This phenomenon was almost constantly observed in the first two weeks of February 2012 and, more frequently but involving shorter time periods, between December 2012 and February 2013. In the corresponding periods, no clear change of the structural condition was observed but significant changes of the environmental conditions occurred. More specifically, heavy snowfalls occurred in the first half of February 2012 and several structural elements of the bridge’s trussed girder and arches were covered with ice, since the temperature ranged between 0°C and – 8°C for more than two weeks (Fig. 13); between December 2012 and February 2013, snowfalls occurred almost every weeks, with the temperature being below 0°C for several hours (in correspondence with each snowfall). Hence, the temporary and anomalous increase of modal frequencies has to be associated to low temperatures, snowfalls and the observed presence of ice on the bridge members. On one hand, frequency peaks are due to the locking of the iron bearing of the girder, that is induced by low temperatures (and the possible ice formation); on the other hand, the presence of ice on the

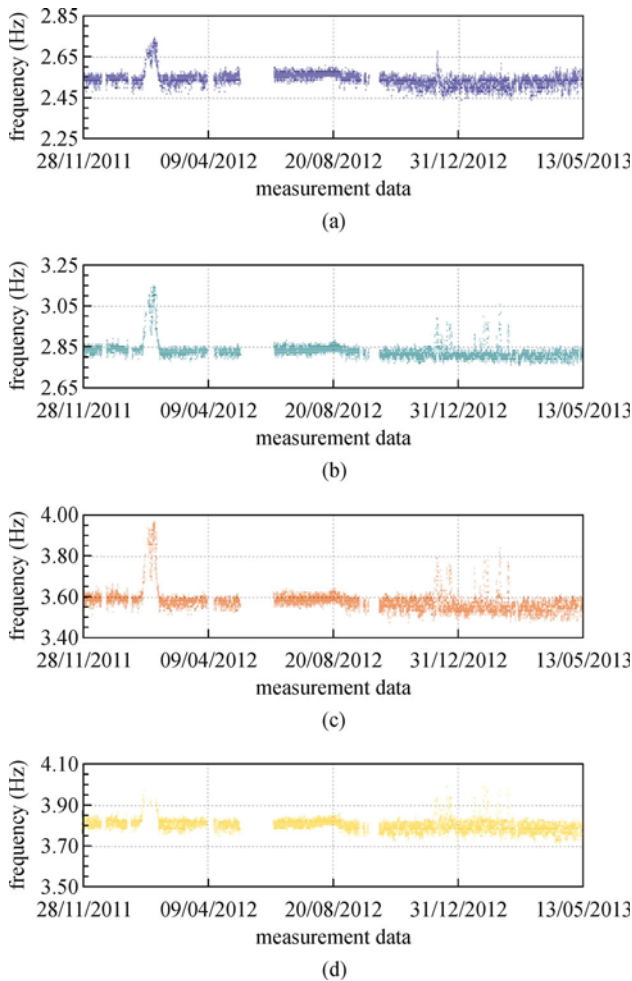
Fig. 17 Time evolution of the natural frequency of modes. (a) VB1; (b) TB7; (c) TB9; (d) TB10

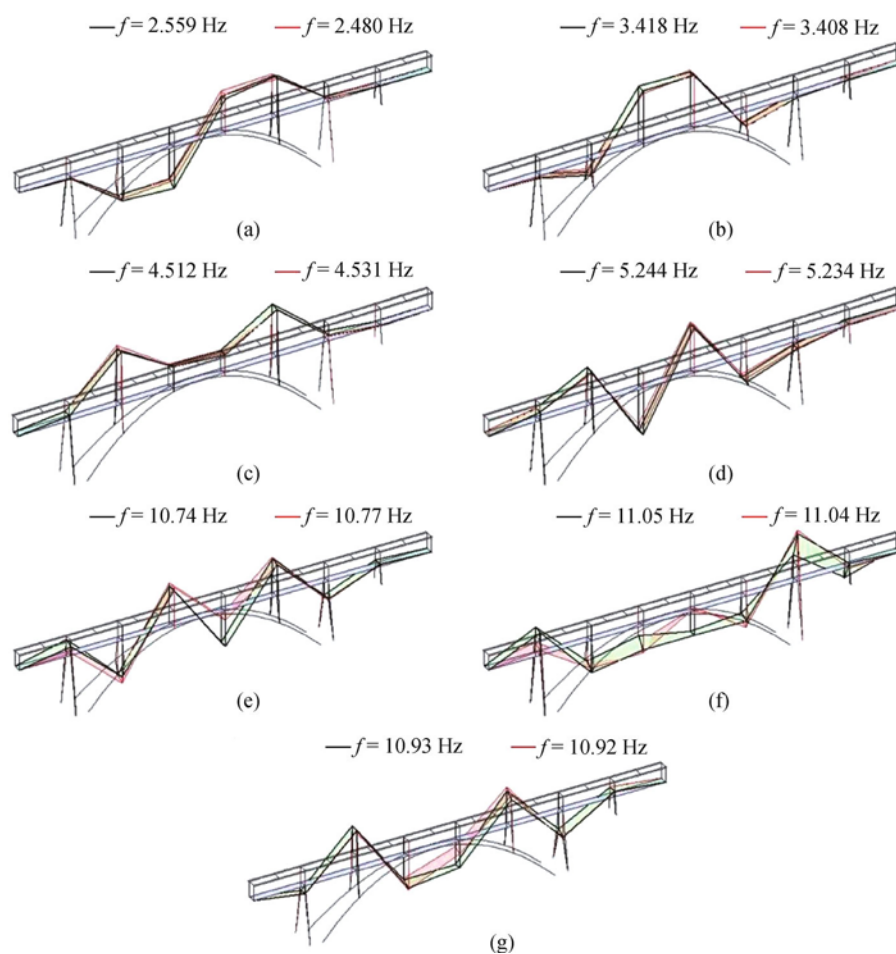
Fig. 18 Vertical bending modes: comparison between the mode shapes identified on 09/03/2012 (black line) and 30/11/2012 (red line). (a) VB1; (b) VB2; (c) VB3; (d) VB4; (e) VB5; (f) VB6; (g) VB7

Figures 18(e)–(f) shows that the region mainly involved in the changes correspond to the crown of the arch on the Calusco side of the bridge (i.e., the region neighboring the cross-section where the Sensors 4, 11 and 18 are installed, see Fig. 5). Indeed, visual inspection of this region did not reveal any concentrated damage but highlighted that the arch crown exhibits a state of preservation worse than neighboring regions, with higher corrosion of the structural members. The higher corrosion, detected in the zones affected by the major changes of modes VB5–VB7 (Fig. 18), was conceivably determined by less accurate carrying out the last protective re-painting of those regions, dating back to the late 50s.
