Structural vulnerability of old precast building stock: case studies from the period 1940s-1970s

ABSTRACT: This work aims at evaluating the structural performance indexes of different typologies of reinforced concrete precast industrial buildings built in the 40-70s of last century. Precast industrial buildings belonging to the pioneer era of this technology are quite common all over Italy and were mostly devoted to house industrial activities. As a matter of fact, they were designed according to criteria which are now obsolete, mainly for lower static actions as compared to current codes and without any concept for seismic or fire resistance. As such, they potentially feature strong vulnerability. With reference to two industrial complexes located in Brianza (Northern Italy), both built with successive expansions from the '40s to the '70s, the structural performances of 10 different typologies representative of the Italian precast building stock of this period are evaluated under static, seismic and fire actions. These typologies include vault roofs with truss systems, restrained arches, tapered beams, and moment-resisting portal frames. A preliminary assessment of the vulnerabil

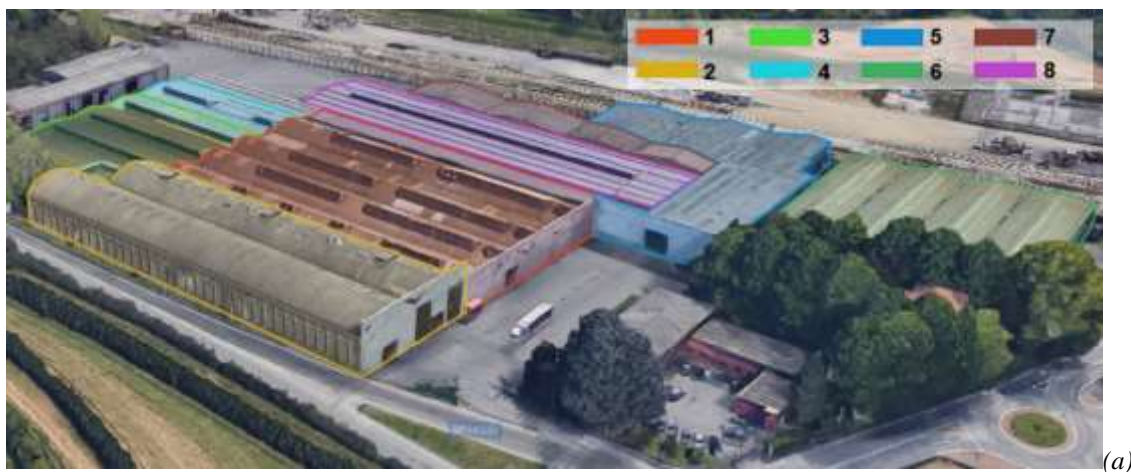
Figure 1. Case study industrial complexes: (a) with 8 considered structural typologies and (b) with 2 considered structural typologies.

study concerned the possible conversion of a nowadays abandoned large industrial complex covering over 30000 m² to commercial functions. This industrial complex was built with successive expansions from the late '40s to the late '70s by several contractors. 8 different building typologies can be highlighted (Figure 1a).

The second pilot study concerned the possible retrofitting of part of the complex of about 10000 m² which hosted the production factory of the precast concrete industry ELP (ELeменти Prefabbricati), operating since the early '60s to the late '80s. The complex was self-built by the precast company in the '60s. The investigated structures are 2 typologies, highlighted in Figure 1b. The same complex contains one of the first examples of application of prestressing to roof elements with a tapered beam system built in 1965 employing the technology of draped post-tensioning of centrally epoxy-glued symmetric segments (Dal Lago, 1969). Unfortunately, this part of the complex was not required to be investigated. Additional information about the work carried out can be found in Berretta (2018) and Dal Lago *et al.* (2018).

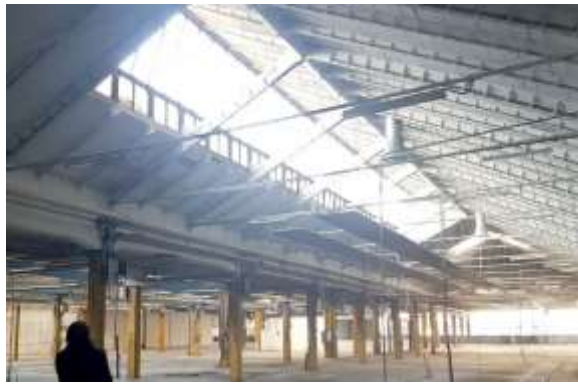
Figure 2. Typology 1.

Typology 1 (Figure 2) is the oldest of the complex, dating back to 1948. It is made with a triangular trussed roof with 150x400 mm struts spanning 12.5 m made of diaphragmed X-shaped precast concrete elements completed with a cast-in-situ topping and with a lower steel bar acting as tie. The vertical frame structure consists of square 35x35 cm 4 m tall columns and T-shaped 60(35)x80 cm 7.5 m long beams was fully cast-in-situ. The roof slab is mixed concrete-masonry.

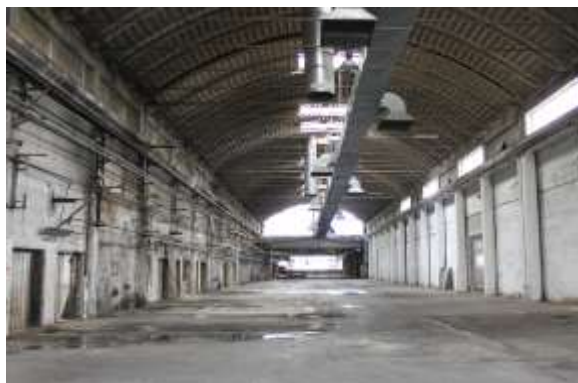
Figure 3. Typology 2.

Typology 2 (Figure 3), completed in 1958, is made by a precast reticular 10x34 cm arch system spanning 16.2 m completed with a cast-in-situ topping and with a lower steel bar acting as tie. Precast ribbed roof elements cover the span of 2 m in between adjacent arches. The vertical frame of the structure, characterised by a double layer of L-shaped 5 m long beams (75(50)x50 cm crane and 75(50)x70 cm top) over 35x50 cm 8.8 m tall columns, was fully cast-in-situ.

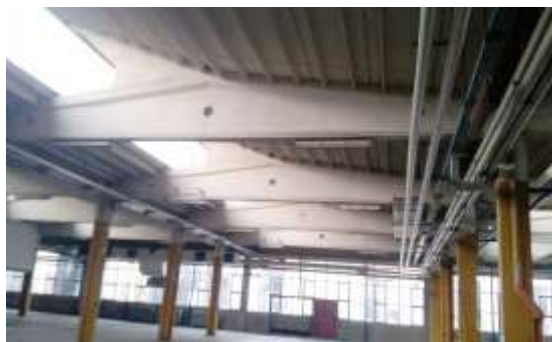
Figure 4. Typology 3.

Typology 3 (Figure 4) dating back to 1970 has been the first fully made with precast concrete elements: foundation footings, 30x50 cm section columns 5 m tall, 30(8)x161(40) cm tapered I beams 16 m long and 1.35x0.29 cm section 6 m long TT roof elements.

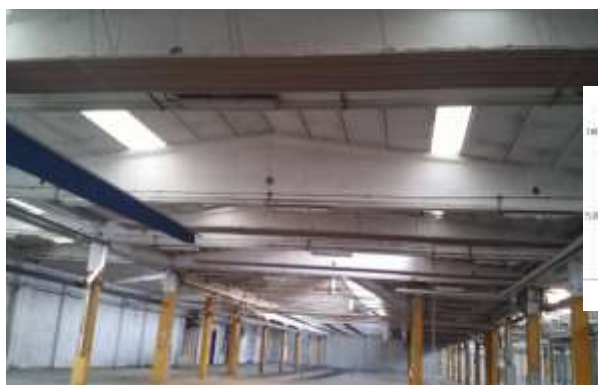
Figure 5. Typology 4.

Typology 4 (Figure 5), built in 1973, is similar to the previous one (the beams are spanning 18 m with deeper section of 1.8 m) except by the roof elements, which are in this case flat with hollow core section.

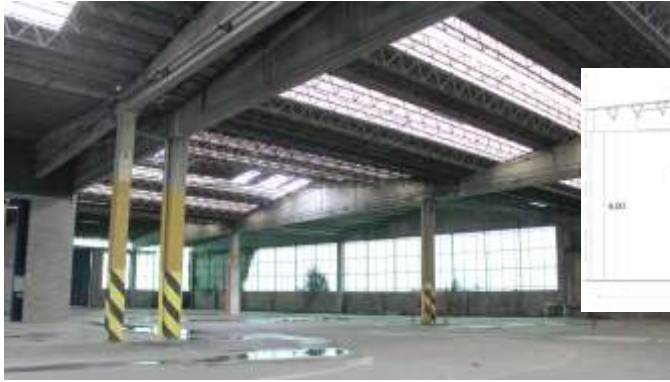
Figure 6. Typology 5.

Typology 5 (Figure 6) dating back 1972 is characterised by a precast portal frame made with 50x50 cm 6 m tall columns and 30(10)x200(80) cm spanning 20.5 m tapered I beams. The roof is composed by 16 m long steel spatial trusses having triangular section.

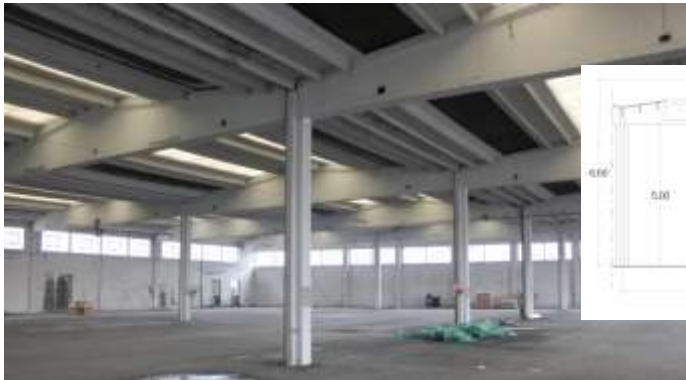
Figure 7. Typology 6.

Typology 6 (Figure 7), built in the early '70s, is made with portal frames consisting of 43(15)x56(32) cm cross-shaped section 5 m tall columns, 30(8)x160(40) cm tapered I beams spanning 13.5 m and TT elements spanning 10 m.

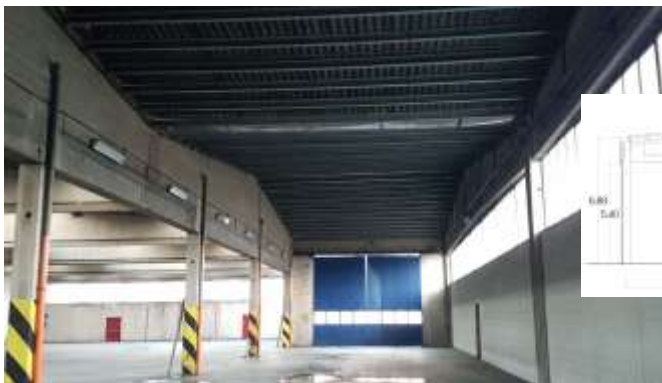
Figure 8. Typology 7.

Typology 7 (Figure 8) is peculiar: the roof made with IPE 200 steel profiles spanning 10 m is supported with a relevant one-side only overhang of 4 m by a precast portal frame made with 40x60 cm section 5.4 m tall columns and prestressed 26(8)x180(60) cm tapered I beams spanning 26.3 m on one side and by a masonry wall built over rectangular section beams seated over the same columns of the typology 8.

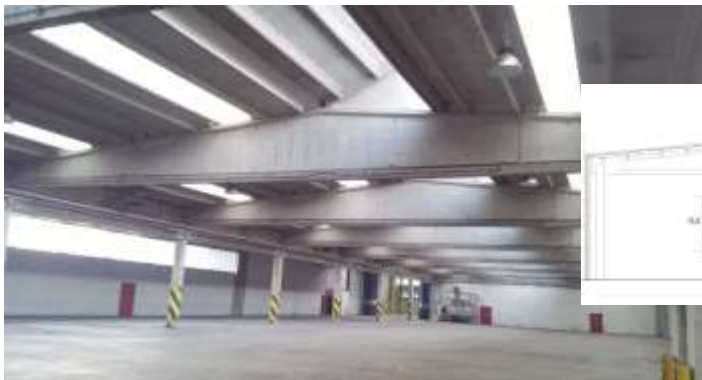
Figure 9. Typology 8.

Typology 8 (Figure 9) was built in between the last '70s and the early '80s with a precast frame structure made with 40x40 cm section 5.2 m tall columns, prestressed 30(8) x 200(60) cm tapered I beams spanning 25 m and 10 m long TT roof elements.

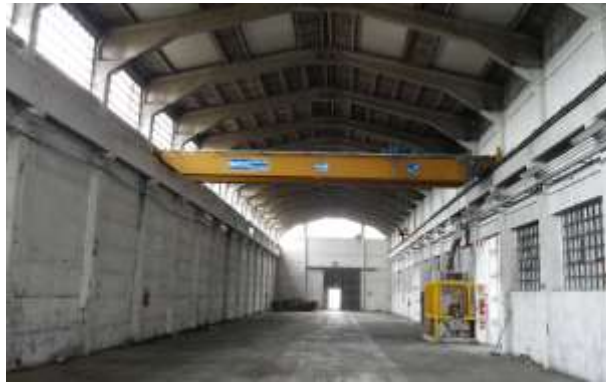
Figure 10. Typology 9.

Typology 9 (Figure 10) was built in the early '60s with clamped portal frames with variable section made by bolting and grouting of 4 segments. The gross maximum height is about 10.5 m at midspan. The inclined upper part of the portal has decreasing depth from the joint with the column (120 cm) to midspan (57 cm). The orthogonal 84 cm deep beams are T-shaped with width of 30(10) cm. The column elements are I-shaped 40(12) x 31 cm with regular stiffeners each 80 cm. The centre to centre distance of the portal frames is 5 m. A secondary beam order made of inverted U-shaped roof elements covers the distance between the portals.

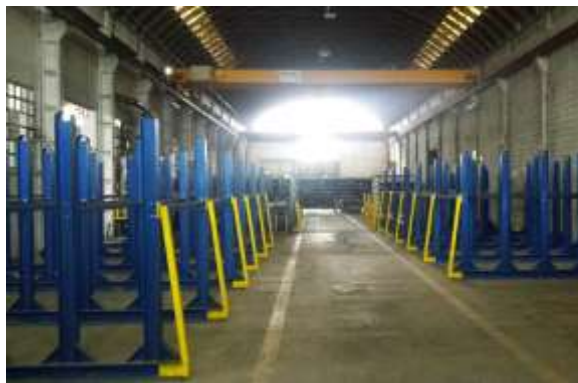
Figure 11. Typology 10.

Typology 10 (Figure 11) was also built in the early '60s with an arched strut-tie roof system spanning 14.1 m employing I-shaped concrete arch segments connected at the top with bolts and a steel tie per each arch. An indentation is present in the section at the support with the beam. The arches are placed at each 1 m and their distance is covered by masonry blocks with an upper cast-in-situ concrete topping. Beams and columns are the same of typology 9. The column has a clear height of 7.75 m from the pavement. The maximum height of the building is about 10.5 m at midspan of the arches.
