# Effect of protective casing on the cathodic protection condition of a buried pipeline at rail crossing

## Abstract

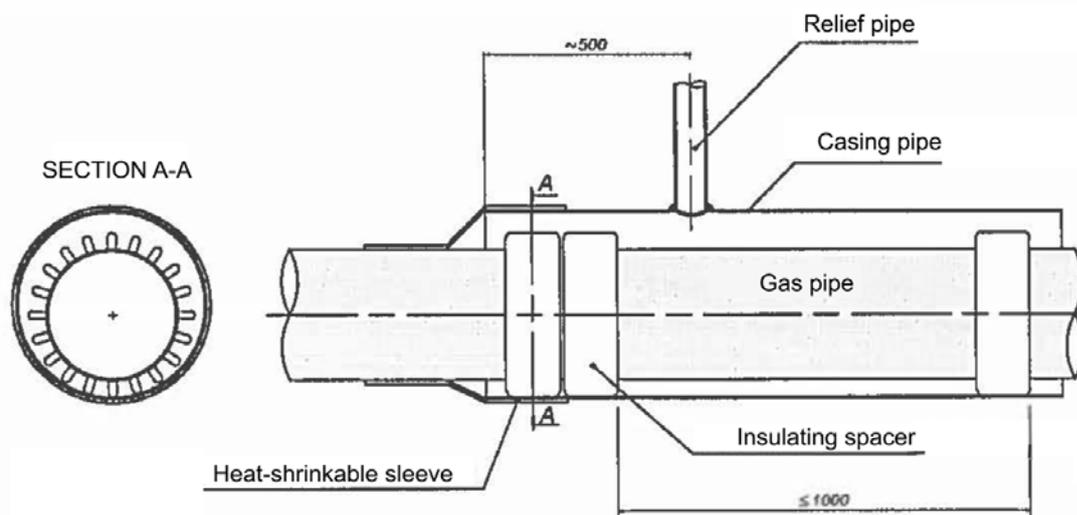
*Figure 1 Schematic configuration of a gas transportation pipe encased in a casing pipe, separated by insulating spacers*

The Italian Ministerial Decree dated 4<sup>th</sup> April 2014 [3] demands that ducts buried in correspondence of rail crossings or parallelisms shall be encased in a coated steel pipe, called casing pipe. To ensure the protection of the inner tubing (carrier pipe), the ends of the casing pipe must guarantee the perfect watertight seal of the annulus while spacers of insulating material keep the two tubes electrically separated (Figure 1). In practice, it is almost impossible to achieve a perfect watertight seal. To avoid corrosion of the carrier pipe, a first possibility is the injection of a suitable filler material into the annular space. The filler material should either inhibit corrosion (e.g. visco-elastic compounds, inhibited wax) or be designed to allow CP current to reach the carrier pipe [4]. For casings that pass CP current (i.e. bare or poorly coated steel pipes or uncoated concrete pipes), the external cathodic protection of the carrier pipe can be effective in protecting the carrier pipe provided there is no contact between the carrier pipe and the casing, and that there is enough electrolyte in the annular space. Without any electrolyte in the annular space, atmospheric corrosion can occur at coating defects. Moreover, if CP of the casing is required, the casing should be resistively bonded to the carrier pipeline.

The aim of this work is to investigate the behavior of the pipes in cases when the insulation of the carrier tube is not granted: this can occur if an electrolyte is present between the two tubes because of a leakage in the watertight system or in the casing. Laboratory tests have been carried out to investigate the protection (and over-protection) of the carrier pipe (from here on called “gas pipe”) and the interference condition of the casing pipe, in case of water in the annulus. Different conditions were taken into consideration in order to verify the effects of coatings on the casing pipe and eventually the effect of an electrical connection between the two tubes, which aims at avoiding anodic interference of the internal surface of the casing tube. In all conditions, CP was applied to the gas pipe and both tubes were submerged in a conductive solution. This way it was possible to analyze the level of protection (or overprotection) on the gas pipe and the conditions of anodic/cathodic interference on the casing pipe.

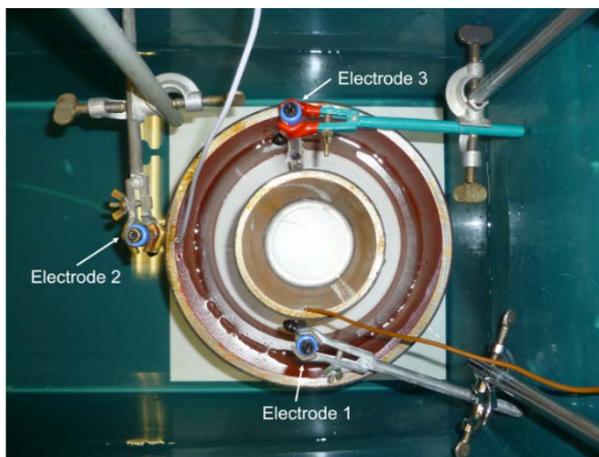
*Figure 2: IR-free potential monitoring system*

The cylinders were immersed in a 70 x 30 x 40 cm box in a conductive solution, such as to fill the gap between gas and casing pipe up to a 15 cm height. The external surface of the casing pipe was dipped by 15 cm as well. Two electrolytes were taken into consideration, both consisting in a solution of NaCl in distilled water, having resistivity 50  $\Omega$  m and one 200  $\Omega$  m, respectively. Three Ag/AgCl/KCl<sub>sat.</sub> reference electrodes (+0.2 V SHE) were accurately positioned to measure the IR-free potential of the gas tube and of both the internal and the external side of the casing pipe (Figure 2). As shown in Figure 2, Reference Electrode 1 was placed close to the defect of the gas pipe, Reference Electrode 2 was placed close to the external side of the casing pipe (close to the defect, if present) and Reference Electrode 3 was positioned close to the internal side of the same (close to the defect, if present).

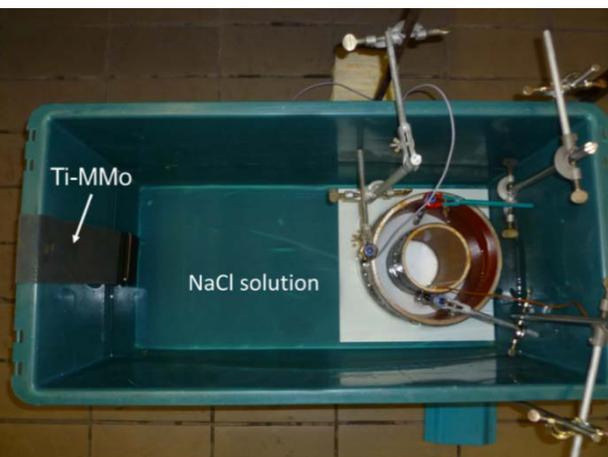
*Figure 3: Cathodic protection and monitoring systems*

The free corrosion potential was measured 15 minutes after immersion. Then, the gas pipe was connected to an impressed current cathodic protection system by a DC power supply, using an activated titanium (Ti-MMo) mesh as an anode.

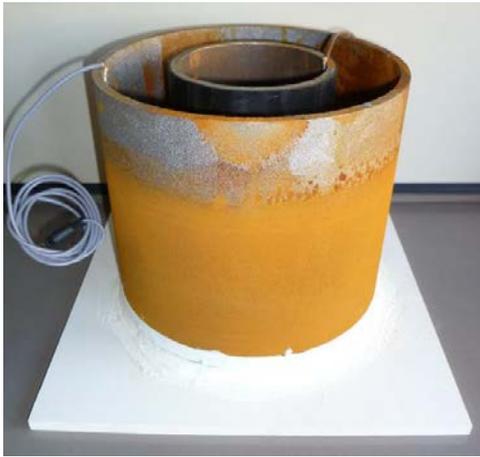
*Figure 4: Conditions A and D*

- A. Uncoated casing pipe, both on internal and external surfaces (Figure 4),
- B. Uncoated casing pipe (as case A), having a through hole (diameter 1 cm) facing the coating defect of the gas pipe (Figure 5),
- C. Internally and externally coated casing pipe, with a 3 cm<sup>2</sup> defect on both sides (Figure 6); the coating defect on the internal side of the casing faces the coating defect on the gas pipe,
- D. Uncoated casing pipe electrically connected to the gas pipe by a 10 Ω shunt (Figure 4).

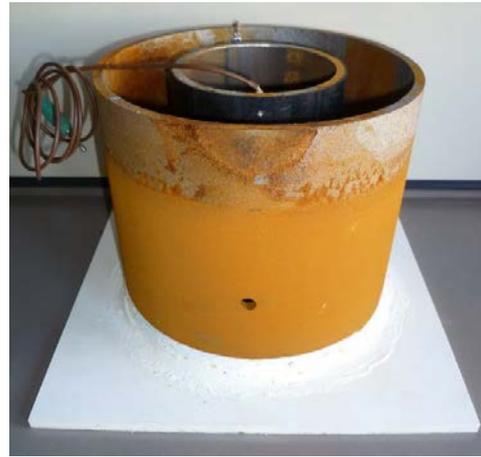
*Figure 5: Condition B*

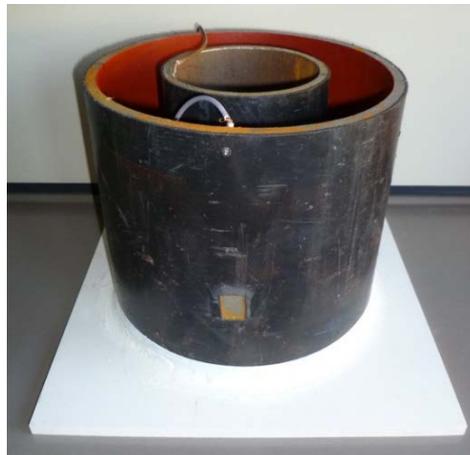
*Figure 6: Condition C*

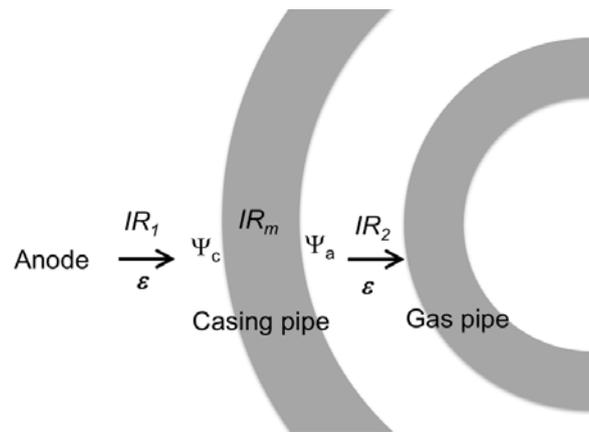
Figure 7: Contributions of ohmic drop and overvoltages to the cell voltage

Figure 7 shows the cell balance.

It is possible to state that, in presence of an electrolyte between gas pipe and casing pipe, the application of a voltage higher than a minimum value,  $V_{min}$ , causes cathodic interference on the external side of the casing pipe, anodic interference on the internal side of the casing pipe and cathodic polarization on the external side of the gas pipe.

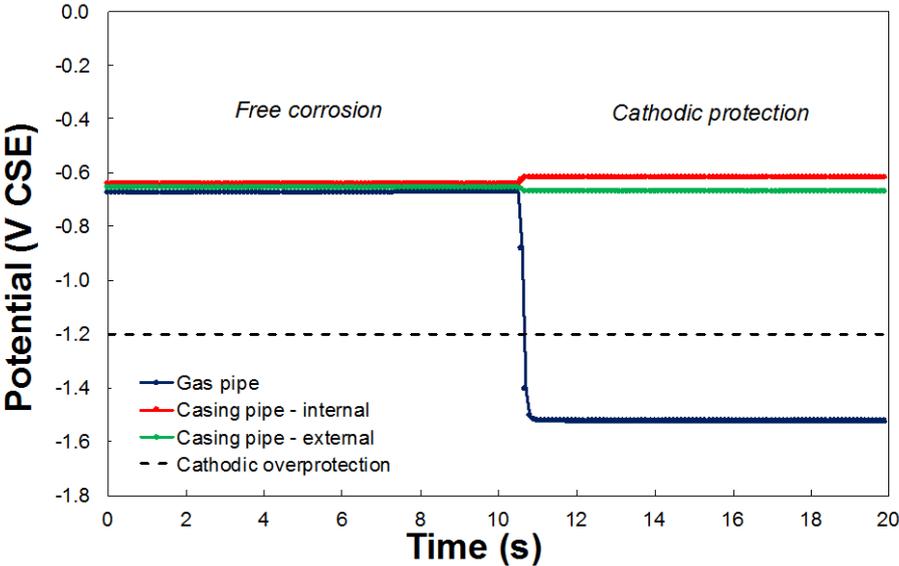
Figure 8 IR-free potential of gas and casing pipe before and after the application of a 2.5 V cell voltage (case A)

In this case, overprotection conditions were reached at voltage of 2.5 V. Figure 8 shows the behavior of the three measured potentials when such a voltage is applied. For the sake of simplicity, IR-free potential measurements are referred to CSE (Cu/CuSO<sub>4</sub>, +0.318 V SHE) reference electrode.

At first, both gas and casing pipe are in free corrosion conditions at a potential of -0.65 V CSE. Then, when CP is turned on, the gas pipe is cathodically polarized, reaching overprotection conditions, i.e. potential lower than -1.2 V CSE (dashed line on the diagram). The current supplied by the anode interferes cathodically with the external side of the casing pipe; therefore, the potential measured on this surface also slightly diminishes. This happens because the current density on the casing pipe is much lower than on the gas pipe, since its surface area is approximately 350 times bigger than the 3 cm<sup>2</sup> defect on the gas pipe. On the internal side of the casing pipe, on the other hand, anodic interference is observed: a consequence of this is the increase of corrosion rate, according to Tafel's law.

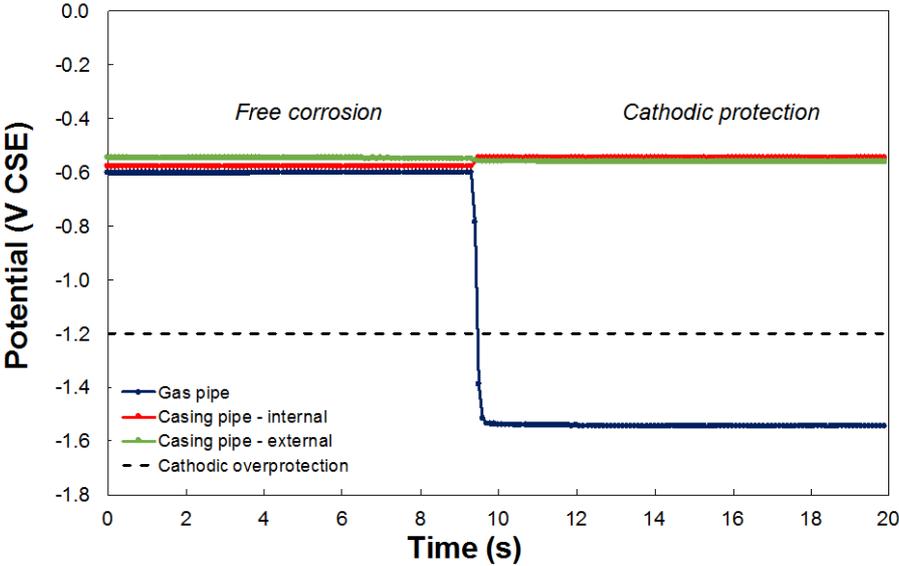
Figure 9 IR-free potential of gas and casing pipe before and after the application of a 2.5 V cell voltage (case B)

Overprotection condition of the gas pipe was reached at a voltage of 2.5 V. The behavior of the casing pipe is slightly different from the previous case: as shown in Figure 9, the variation in potential observed on the casing pipe is smaller than for case A. This can be explained by the

fact that the current can flow in two different parallel paths: across the metallic pipe and through the hole. Results show that part of the current causes interference on the casing pipe (cathodic on the external side, anodic on the internal side), while part of it finds a preferential path through the hole. The percentage of current interfering with the pipe depends on the relative position of the through hole and the defect on the gas pipe: if they face each other, as in this case, more current passes through the hole and the interference effects are limited. It should also be considered that in case B, just like in case A, the casing pipe is uncoated, therefore the current density is low and this furtherly justifies the limited effects of interference.

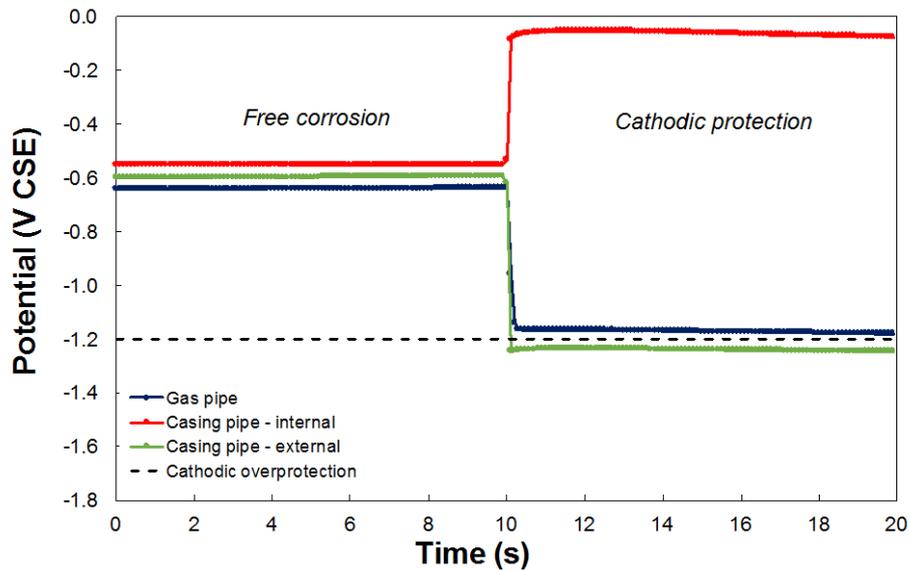
Figure 10 IR-free potential of gas and casing pipe before and after the application of a 3.5 V cell voltage (case C)

The presence of a coating with a defect on the casing tube leads to a smaller current flow in the cell: the smaller the defect (i.e. the higher the current density), the higher the overvoltage  $\psi_{c,casing}$  and  $\psi_{a,casing}$ , which means that the reactions on the casing pipe dissipate a bigger part of the voltage supplied. Since less current flows, the overprotection conditions are reached at higher cell voltage (3.5 V). In this case, the current density on the casing pipe is much higher because the current interferes on a smaller area (3 cm<sup>2</sup>). Moreover, since the dimension (i.e. the current density) of the coating defects of the casing and gas pipes is the same, on the external side of the casing we have cathodic polarization at approximately the same potential as the gas pipe, while on the internal side we observe anodic polarization (Figure 10).

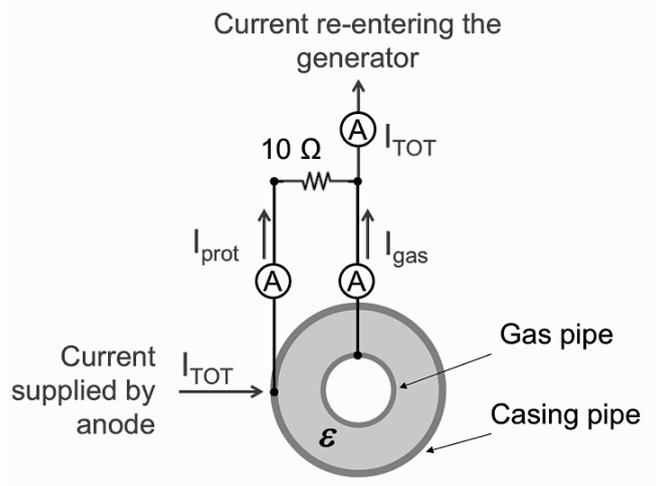
Figure 11 Electrical circuit in case D

This time the casing pipe is uncoated and connected to the gas pipe by a 10  $\Omega$  shunt. A scheme of the circuit is represented in Figure 11. The total current supplied by the anode is indicated as  $I_{TOT}$ . In correspondence of the casing pipe, the current finds a parallel circuit: part of the current ( $I_{gas}$ ) interferes on the casing pipe and, though the electrolyte in the annulus re-enters the generator. Another part of the current ( $I_{prot}$ ) can follow the parallel path and re-enter the generator through the 10  $\Omega$  shunt: this current causes the cathodic polarization of the external side of the casing pipe, but does not interfere anodically on the internal side. The sole responsible for the cathodic polarization of the gas pipe, instead, is  $I_{gas}$ .

By measuring the circulating current vs. applied voltage, it was observed that  $I_{TOT} \cong I_{prot}$ : this means that it is easier for the current to flow through the 10  $\Omega$  shunt than through the electrolyte. It is important to note that the total current flowing in test D is much higher than in test A: at an equal applied voltage, the measured current is higher because of the addition of the parallel resistance path through the 10  $\Omega$  shunt reduces the total circuit resistance. Figure 12 shows the potential of the gas and casing pipes after the application of a 10 V potential. The gas pipe is only slightly polarized thanks to the flow of  $I_{gas}$ , but it never reaches overprotection conditions, even at 50 V. On the other hand, the major percentage of current ( $I_{prot}$ ) flows through the external

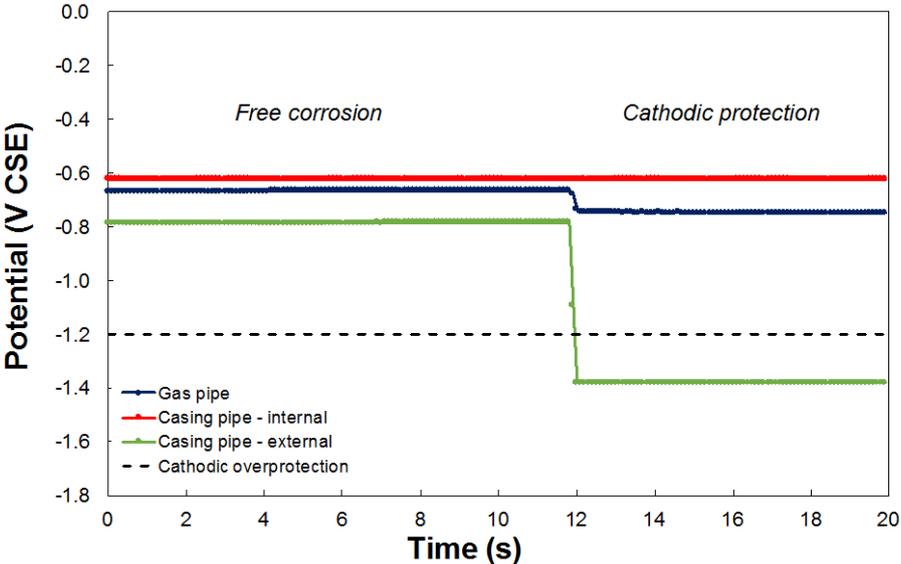
Figure 12 IR-free potential of gas and casing pipe before and after the application of a 10 V cell voltage (case D)

side of the casing pipe, which reaches overprotection conditions. The internal side of the casing pipe instead, as previously stated, is not interfered, as both  $I_{\text{gas}}$  and the current density are very small.
